Earthquake Repairs to Canterbury Homes

Home Inspection Survey Report

August 2015

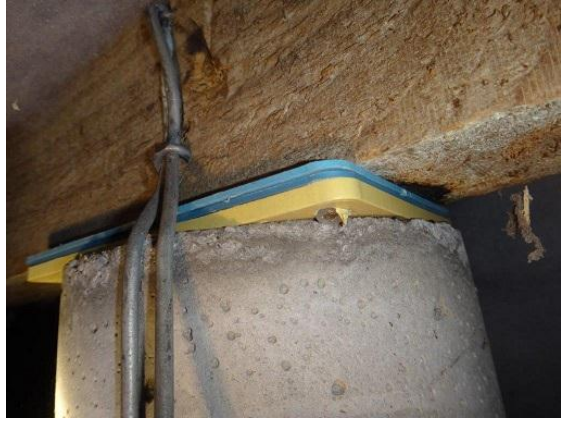
A photograph showing a compliant jack and pack repair. A concrete pile is supported by a timber bearer. A yellow packer is placed between the pile and the bearer, and a blue beam is fixed to the pile. A metal rod is also visible, secured to the pile.
<p>Example of Compliant 'jack and pack'</p> <ul style="list-style-type: none">• Packers fixed to bearers• Piles fixed to timber bearers

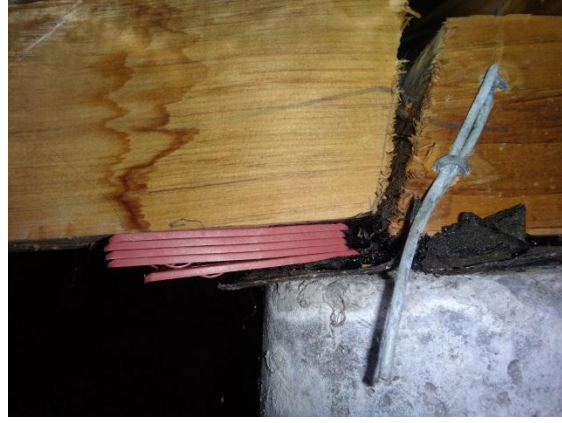
A photograph showing a non-compliant jack and pack repair. A concrete pile is supported by a timber bearer. A red packer is placed between the pile and the bearer, but it is not fixed to the bearer. A metal rod is also visible, but it is not fixed to the pile.
<p>Example of non-compliant 'jack and pack'</p> <ul style="list-style-type: none">• Packers not fixed to timber bearers• Timber bearer not fixed to piles
