Technical investigation into the collapse of the Stadium Southland roof

**DEPARTMENT REPORT TO THE MINISTER FOR BUILDING
AND CONSTRUCTION**

May 2012

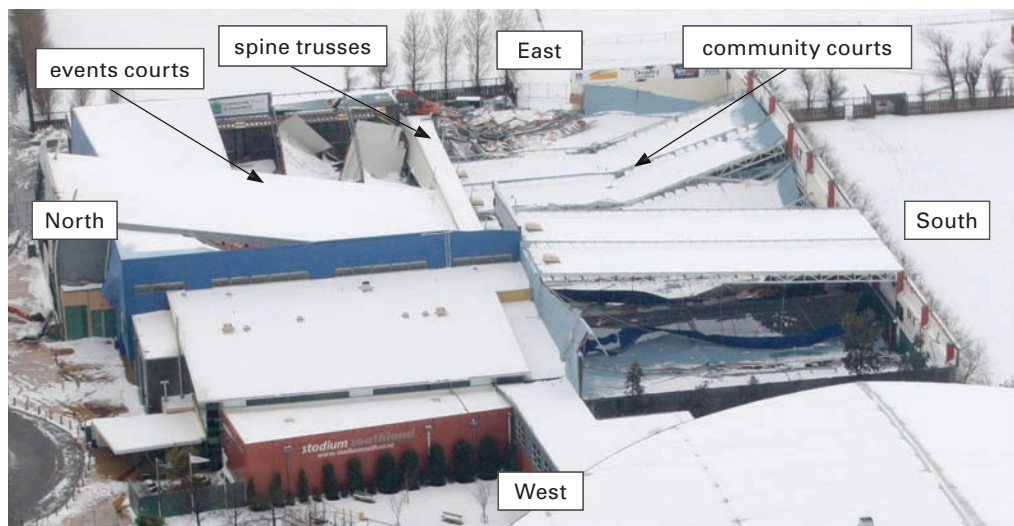
Figure 3 on the following page gives a schematic view of the stadium and the structural components. The photograph below in Figure 2 shows the collapsed stadium on 19 September 2010. The access stair to the eastern end of the spine trusses had been demolished for safety reasons by this time. Figure 3 will help understanding of the description of the structure and the collapse sequence.

Figure 2 Stadium Southland following collapse – 19 September 2010
(copyright The Southland Times)

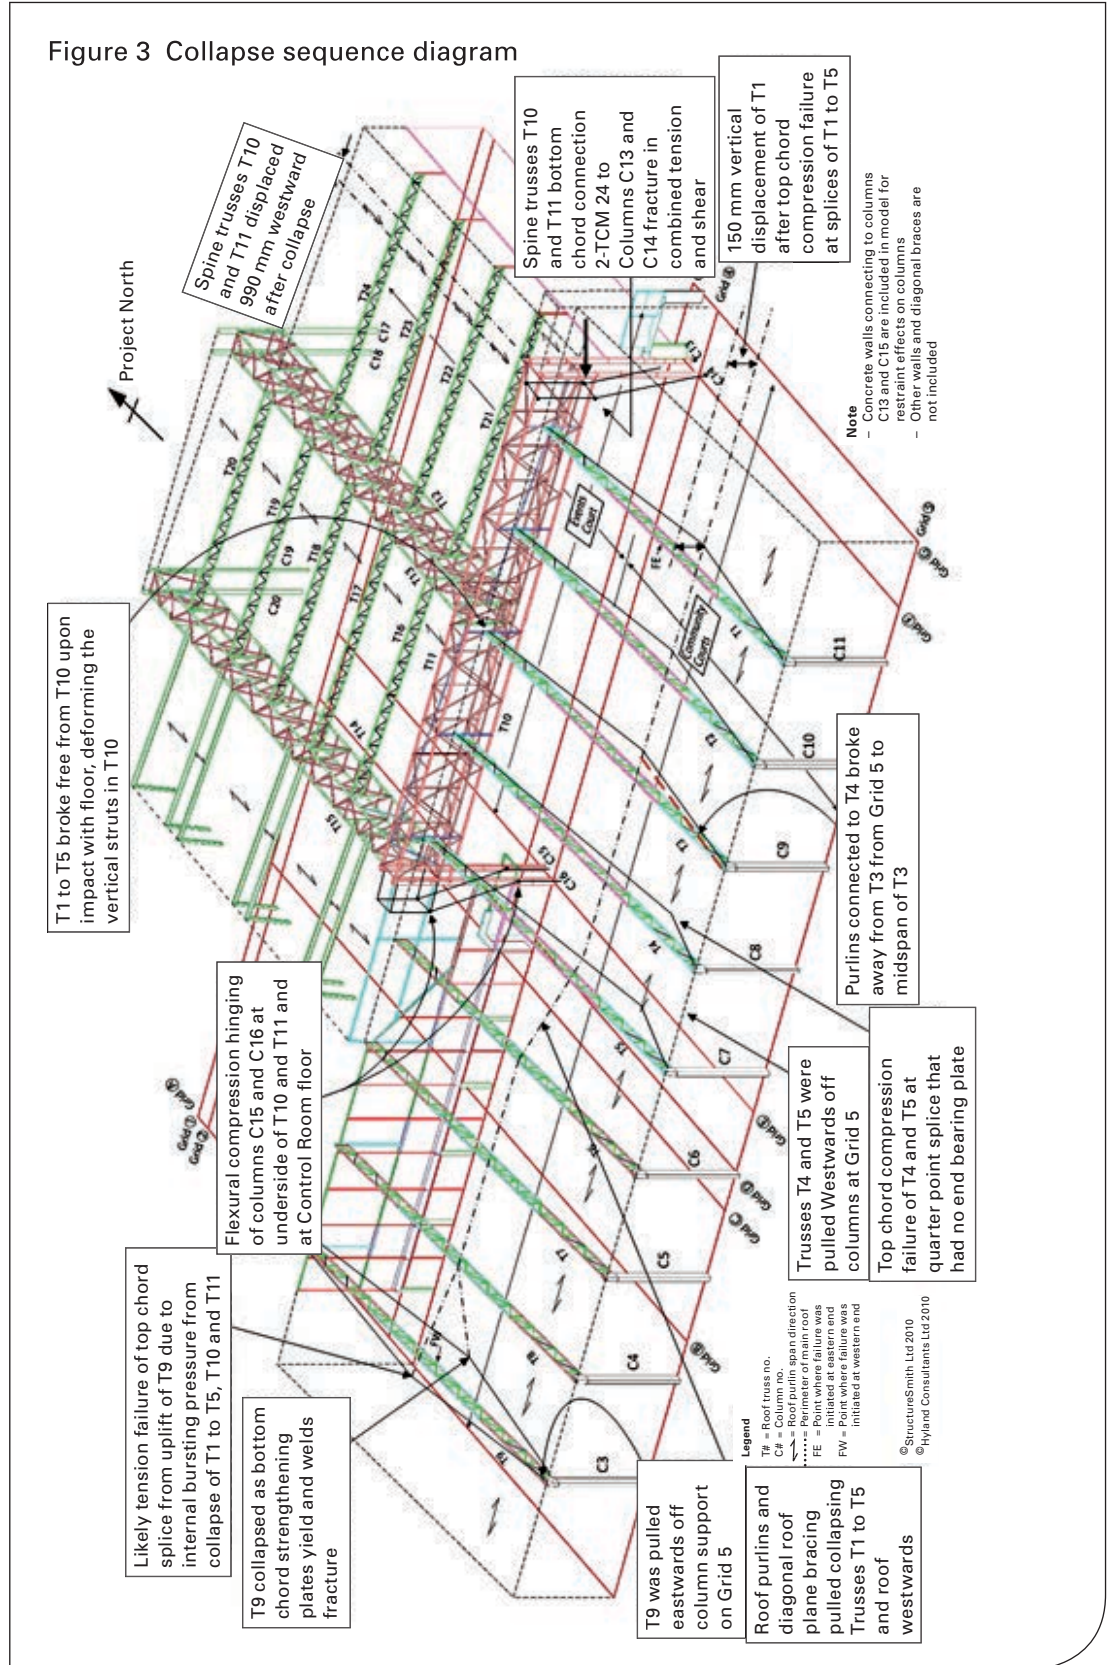
Figure 3 Collapse sequence diagram

The stadium collapse is likely to have been initiated by the compression failure of the defective mid-span top chord splice in one of the roof trusses over the eastern end of the community courts (see Figure 3). The collapse then progressed through other roof trusses causing a westward displacement of the trusses and their supporting columns. As the building displaced westward, the bottom chord bolts that were connecting the spine trusses to the two easternmost columns fractured. The spine trusses then fell to the ground as the two westernmost support columns collapsed. At the western end of the community courts, one of the roof trusses fell to the floor soon after and in response to the collapse of the trusses at the eastern end. Welds failed and strengthening plates peeled away on some of the roof trusses.
