**Final report into the investigation of the
collapse of a Balcony at 598 Castle Street,
Dunedin**

August 2016

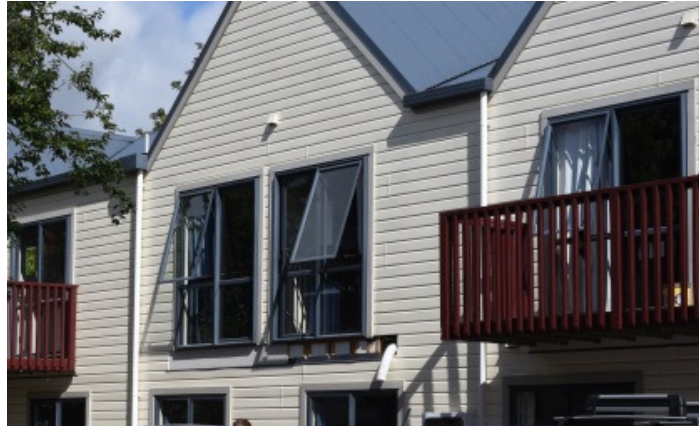
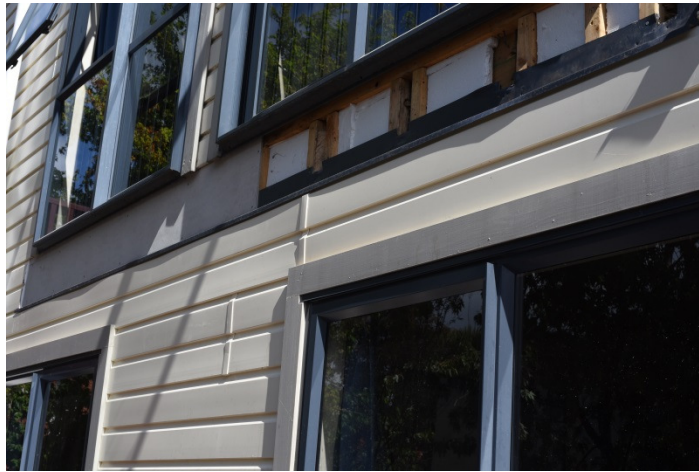
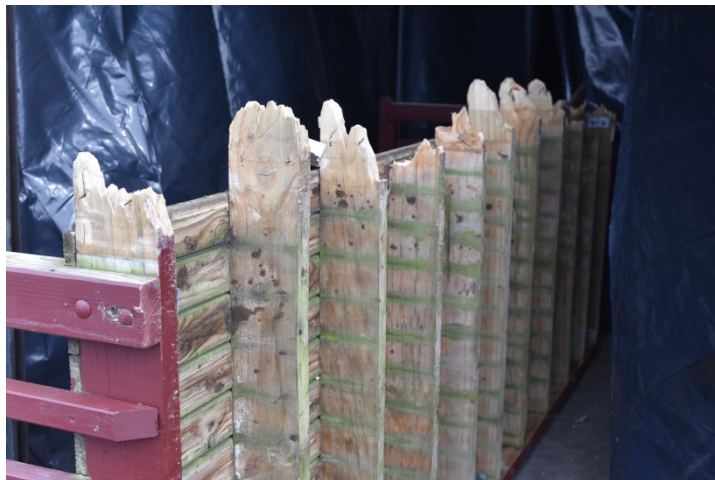
Appendix B Selection of Photographs

The balcony remnant comprised a complete balcony floor with all the joists severed at the wall face. The balustrade along the front and one side of the balcony had broken away. No evidence of decay or deterioration of the wood in any of the joists in the vicinity of the fractures was observed during the 7 March 2016 site visit by MBIE.

At the time of the MBIE site visit to the building at 598 Castle Street a temporary piece of cladding had been installed to cover the failed ends of the joists over half the balcony length. In the remaining uncovered part of the wall where the balcony had been located, the ends of the failed joists were able to be inspected. Through openings in the blocking between the failed joists, colour flashes observed along the length of the joists indicated they had been machine stress graded.

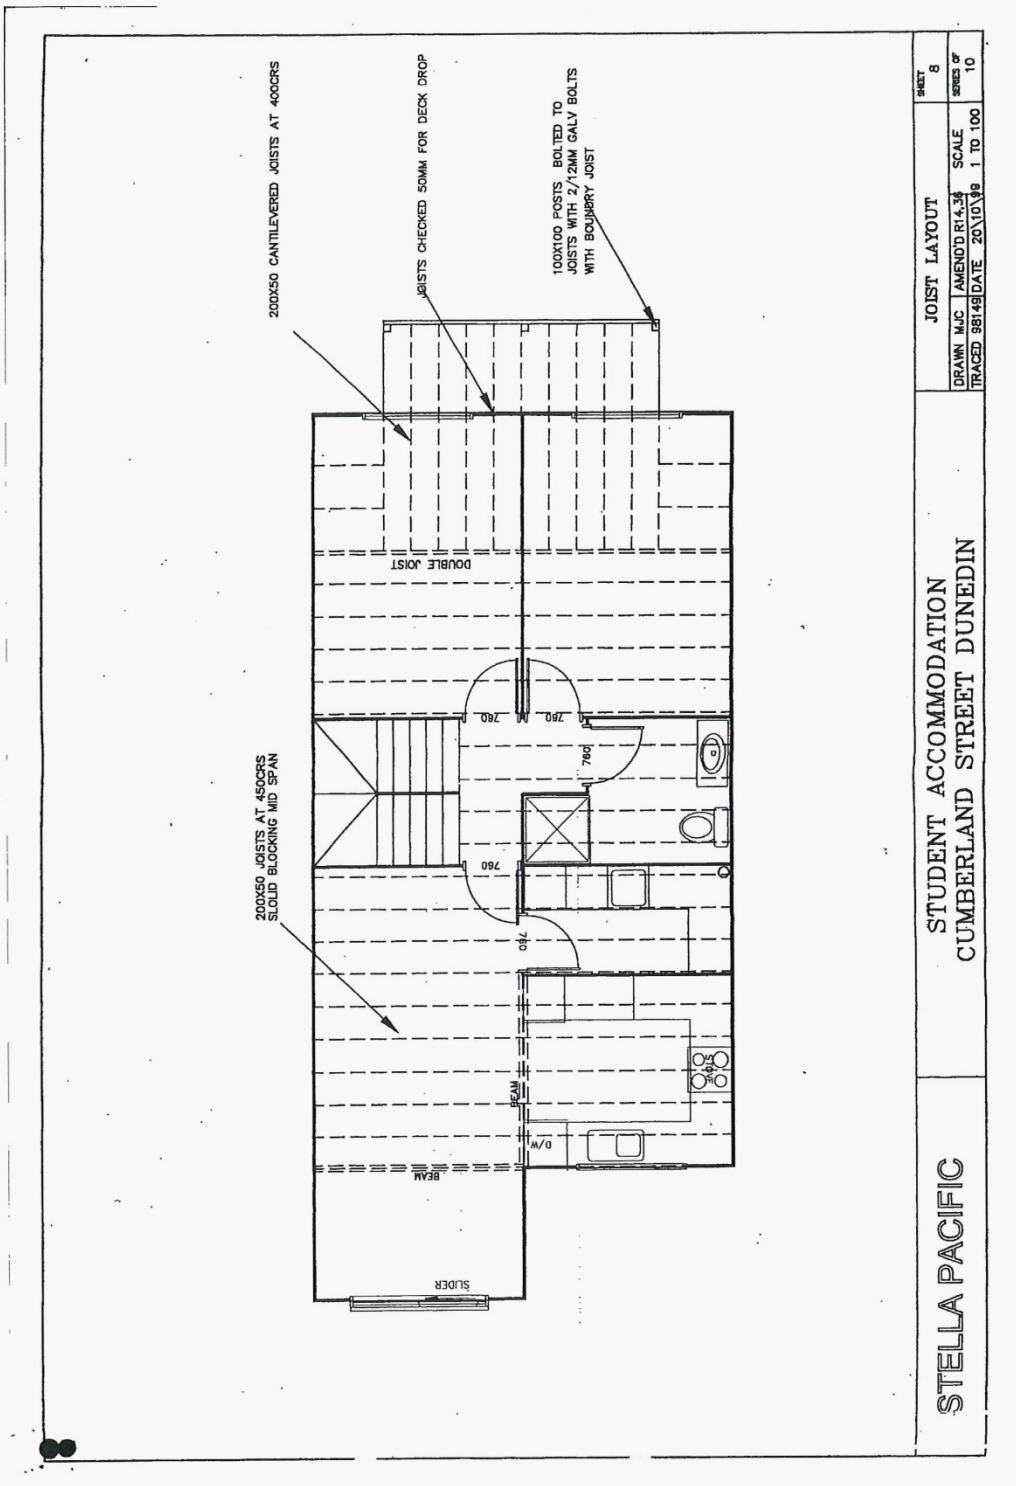
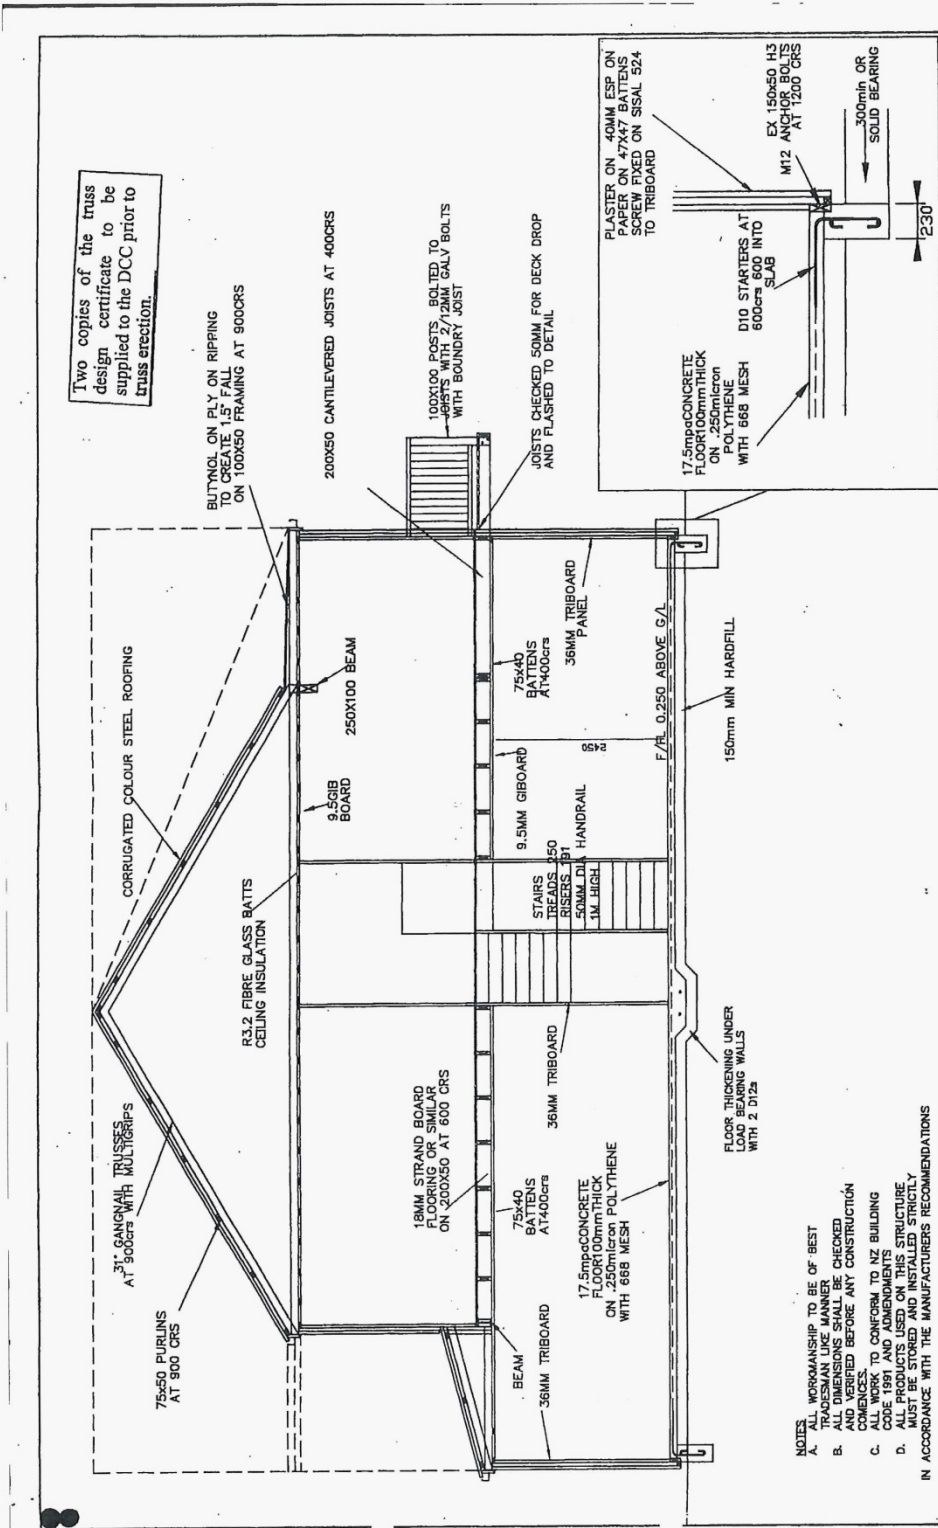
Appendix C Relevant Drawings of Balcony

A review of the relevant consent drawings (Appendix C) indicates the balcony was designed with 11 cantilevered joists spaced at 400 mm centres, projecting 1200 mm from the external face of the building framing and extending 1800 mm into the floor to double floor joists running at right angles to the balcony's joists. The drawings show the joists as continuous nominal 200 mm x 50 mm members. The finished size of the joists was measured as 190 mm x 45 mm with a 50 mm step down that reduces the size to 140 mm x 45 mm.

The designed joist dimensions comply with Table 7.2 of the Timber Framed Buildings Standard NZS 3604: 1990. The on-site observations of the joists suggest that they were machine stress graded *radiata pine*. At the time of construction, machine stress graded timber was commonly substituted for the No. 1 Framing grade specified in NZS 3604: 1990.

The Timber Framed Buildings Standard was revised in 2011 and Table 7.2 of NZS 3604: 2011 requires the net depth of supporting joists to be 190 mm x 45 mm for a balcony span of 1200 mm. The balcony design would not comply with the current Timber Framed Buildings Standard NZS 3604: 2011.
