MBIE AND EQC

SURVEY OF SEISMIC RESTRAINT OF NON STRUCTURAL ELEMENTS IN EXISTING COMMERCIAL BUILDINGS

Report on Stage 2 – Full Study Volume 1

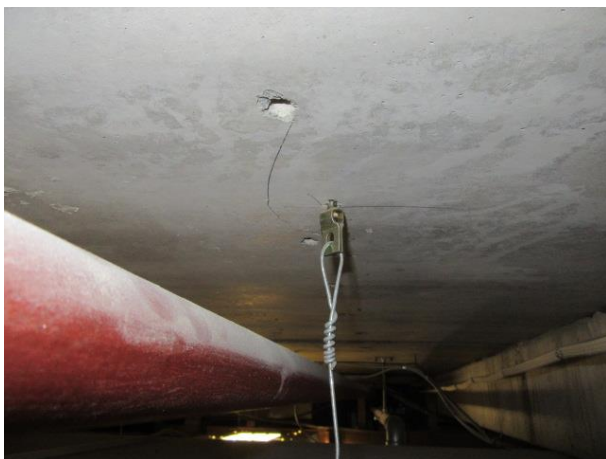
6mm Dynabolt pulling out of Hollowcore concrete slab

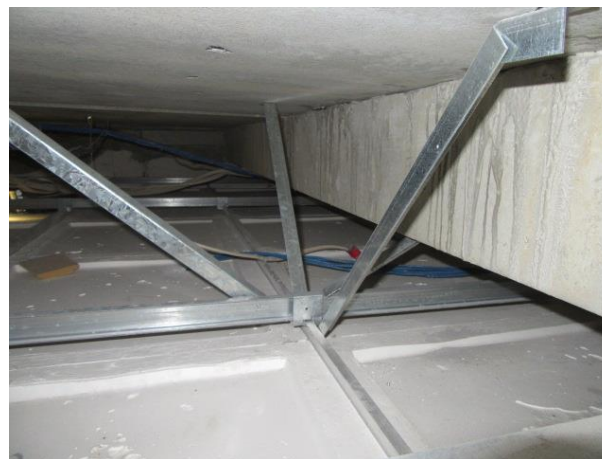
Ceiling bracing. Weakest element is 3.6mm aluminium rivet fastening to grid. Dynabolts in Hollowcore also failing

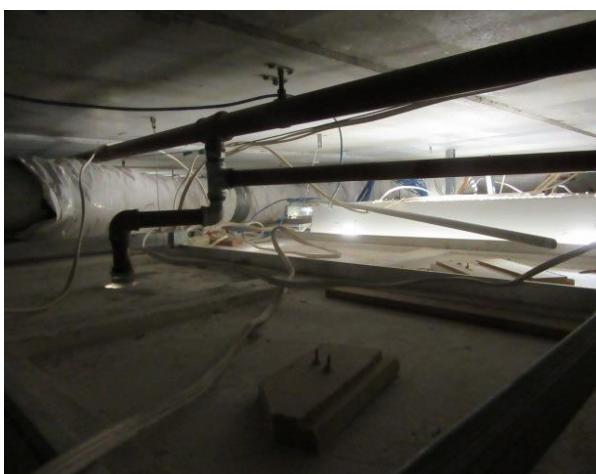
Fire sprinkler within 150mm of slab, unrestrained light (not supported independently), soft ducting unrestrained over 3m length.

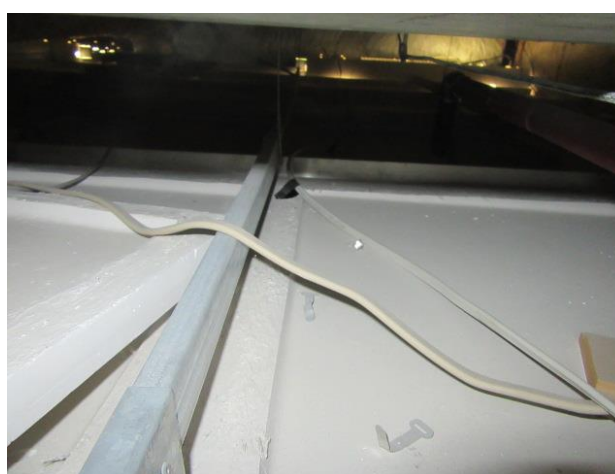
Electrical wires laid directly on ceiling.

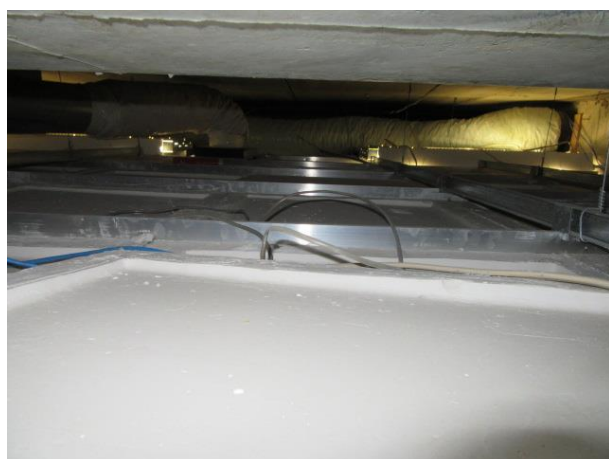
No ceiling bracing present. Cables leading down into unrestrained partition wall and unrestrained soft ducting in background.

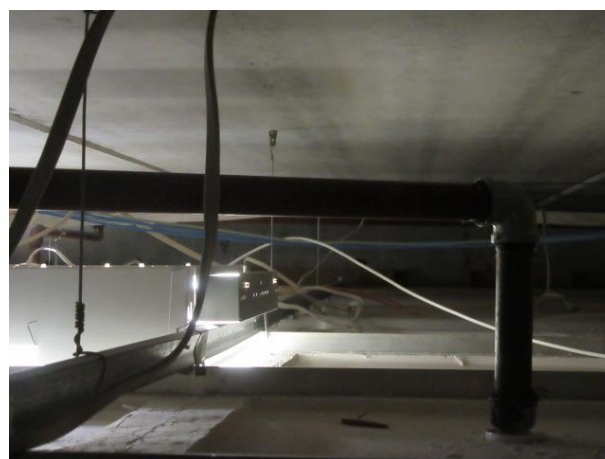
Fire Range End not supported independently; supported by ceiling only. Light fitting not supported or restrained independently.

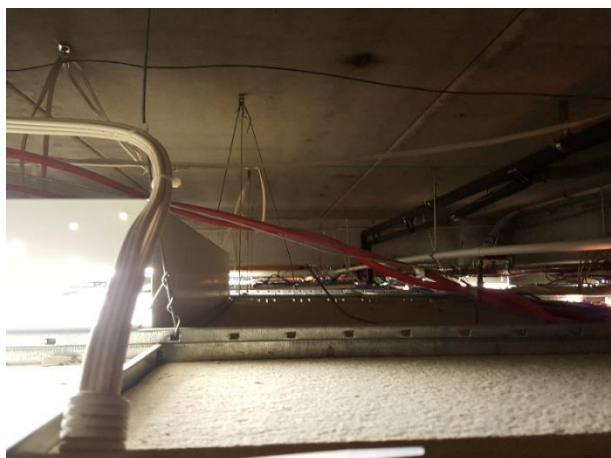
6mm Dynabolt pulling out of Hollowcore concrete slab

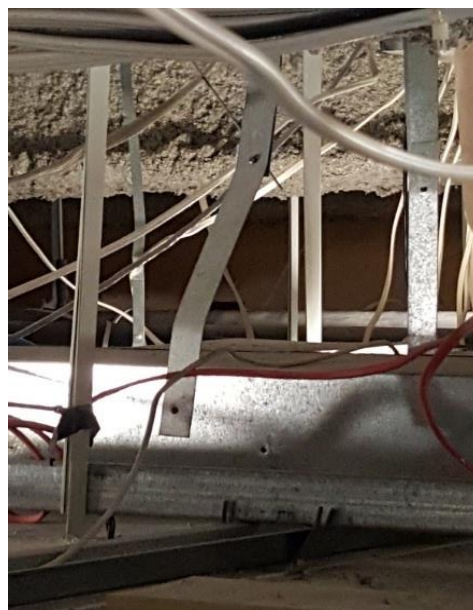
Duct hanger rivet fail

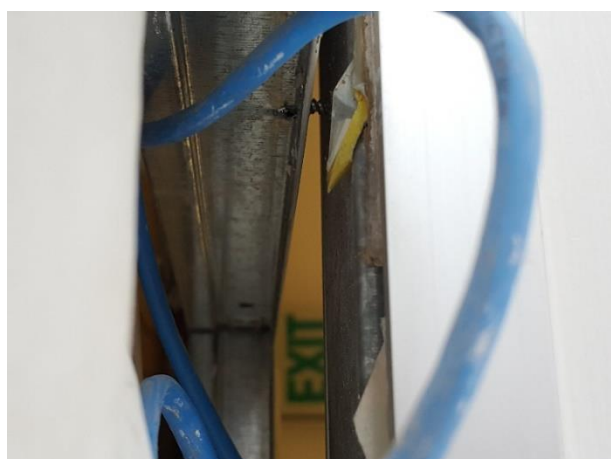
Typical partition wall to ceiling fastener

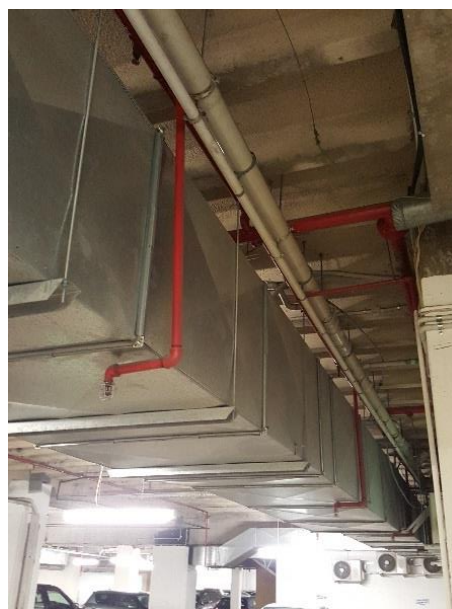
Interaction between ducting and fire sprinklers likely.

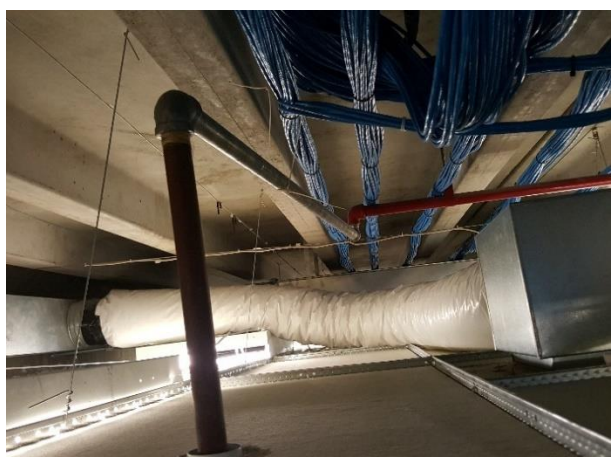
Range supported by cable tie, unbraced

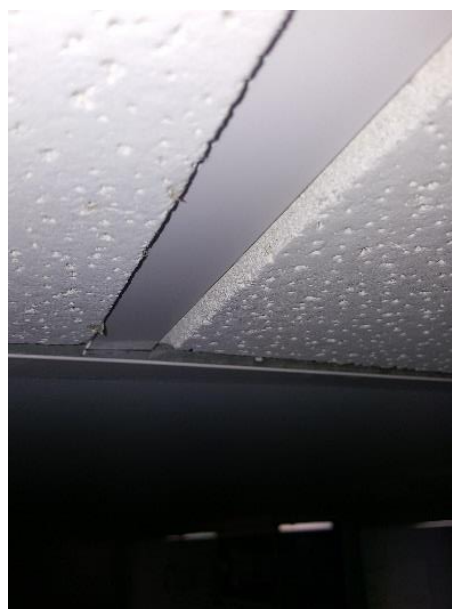
Grid ceiling to rondo ceiling not fastened

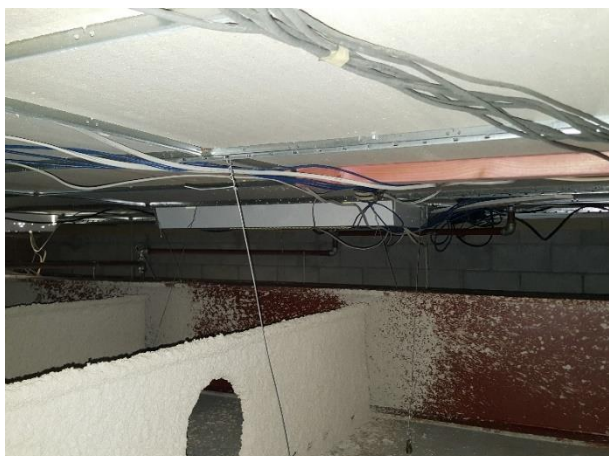
Unsupported or braced range end

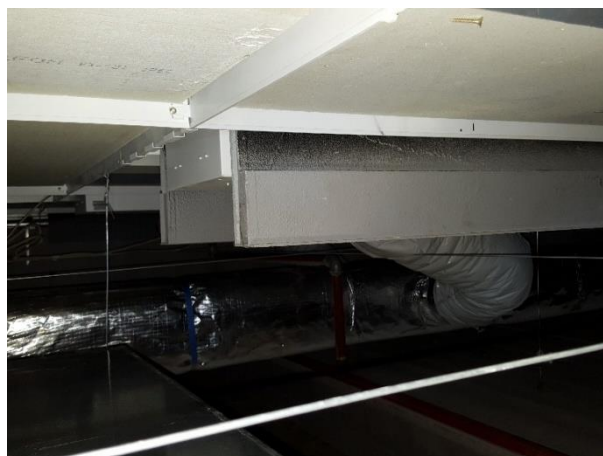
Large lighting not independently supported

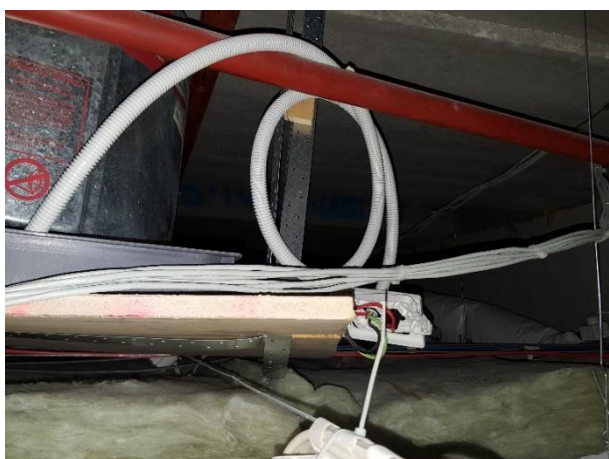
Water tank on a swing could interact with sprinkler

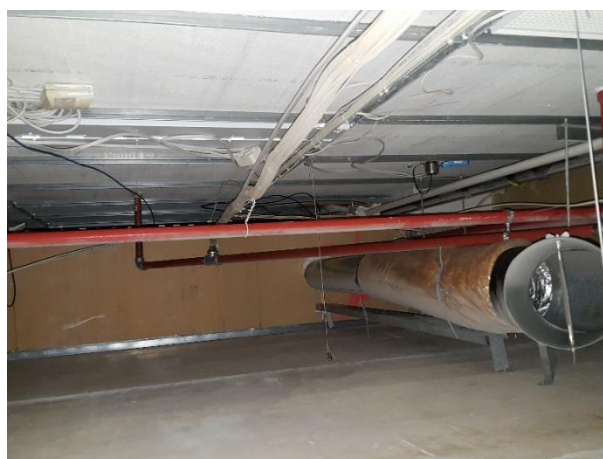
Long range ends unrestrained or hung

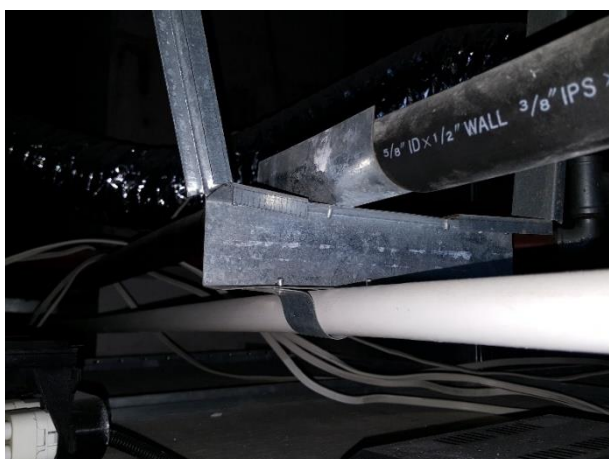
DIY at it's finest

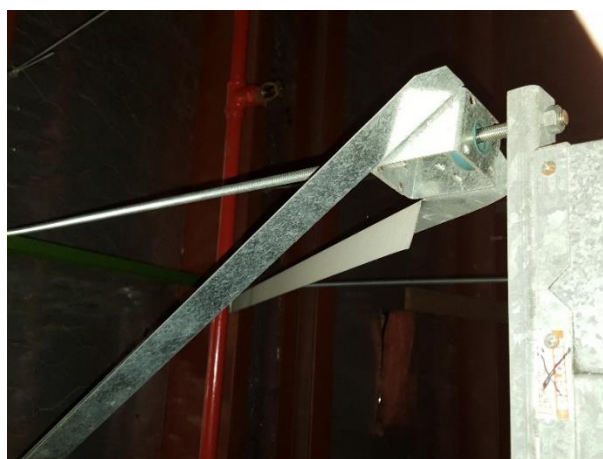
Air handling bracing let down by clearance, angle and general poor methodology

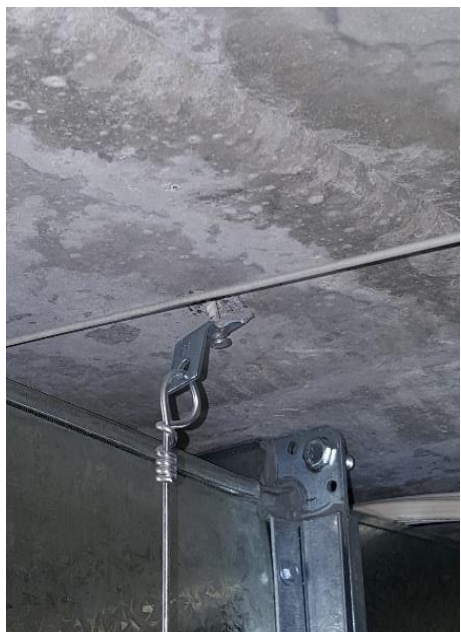
Ceiling bracket appears to have been shot to hollowcore

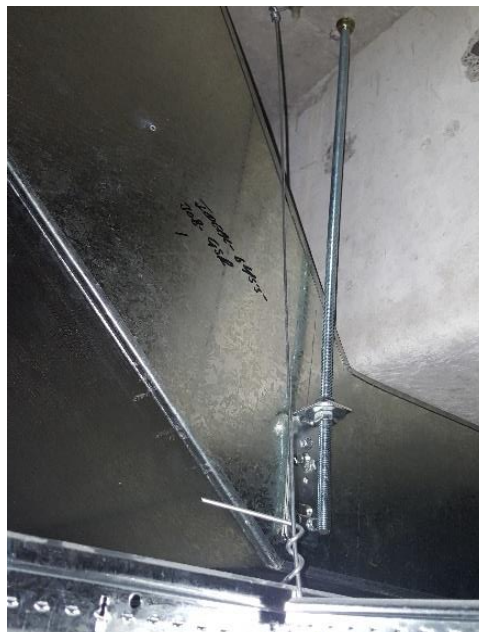
Large ducting could interact with ceiling hangers

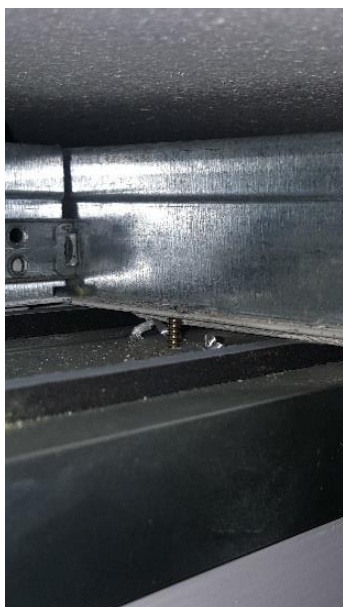
Typical wall to ceiling fasten. This appears to have sheared.

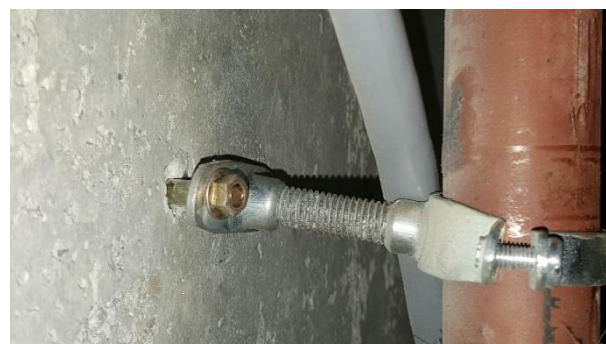
Failing in hollowcore, previous drift evident

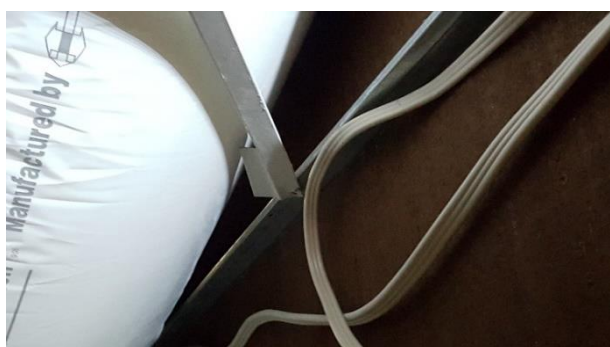
Inadequate ceiling brace

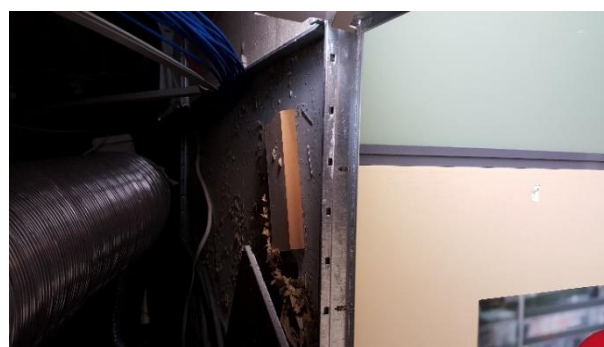
Typical wall fasten through tile to MDF

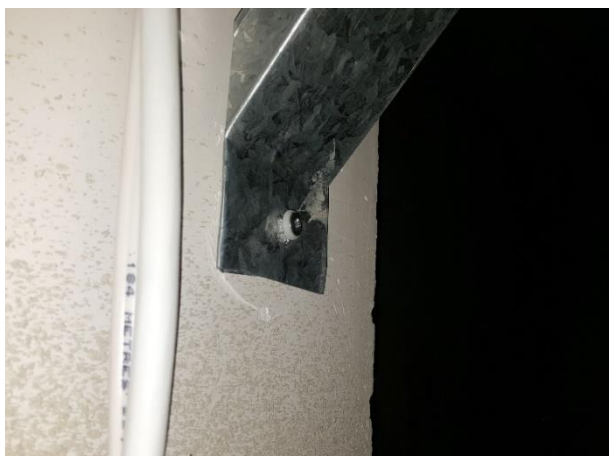
Partition wall bracing let down by fasteners 2

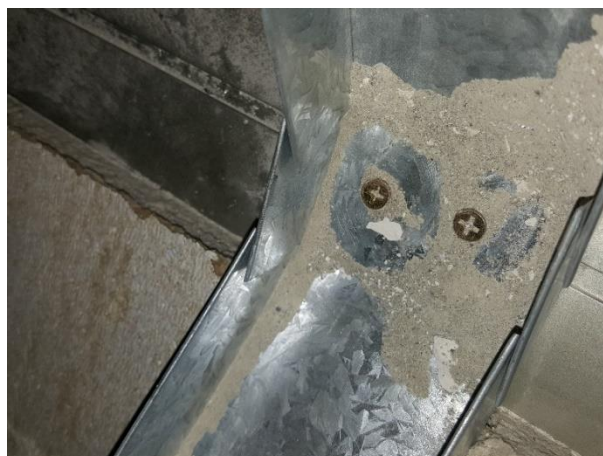
Partition wall bracing let down by fasteners

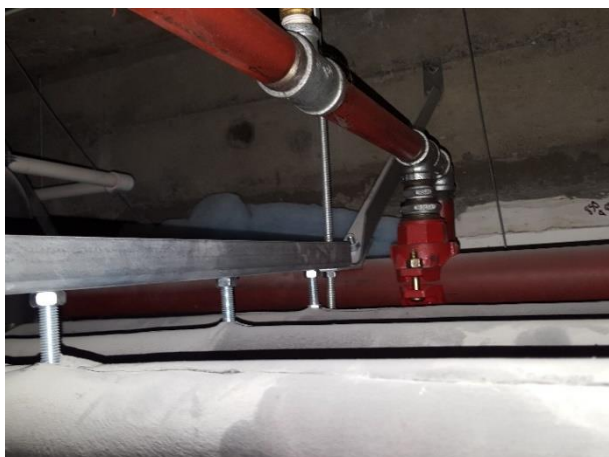
Pipework trapeze; inadequate clearance to fire

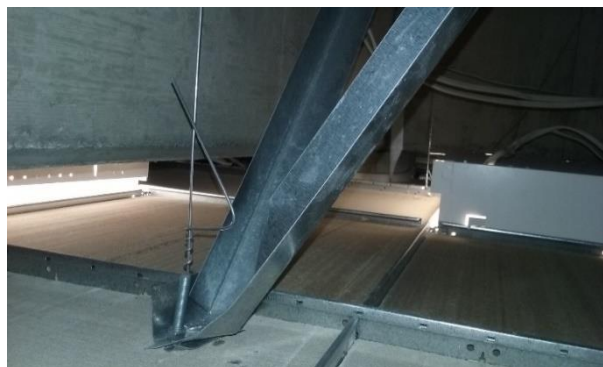
Partition wall poorly braced

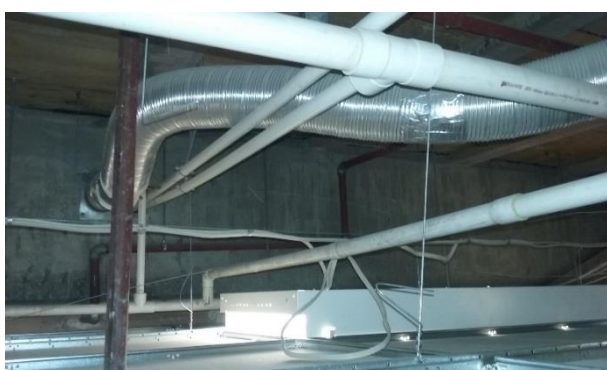
Range ends not braced, Light not braced Pipe work not braced or supported.

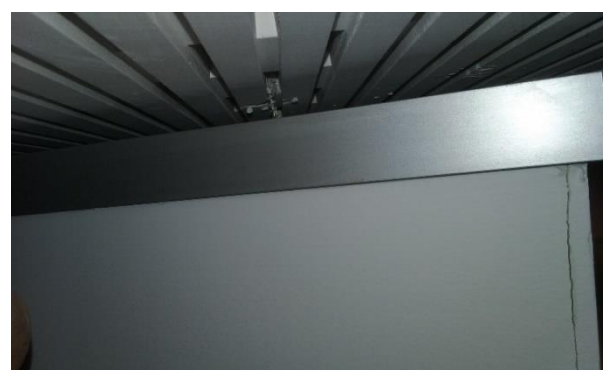
Partition wall to plaster ceiling fastening

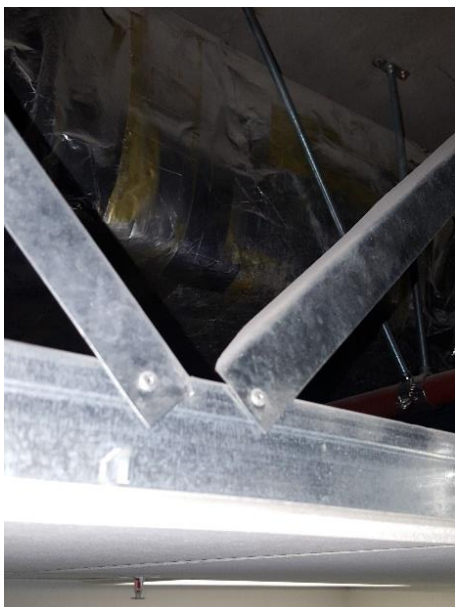
Ceiling bracing let down by weak fastener at element, note poor angle of fire brace in back ground

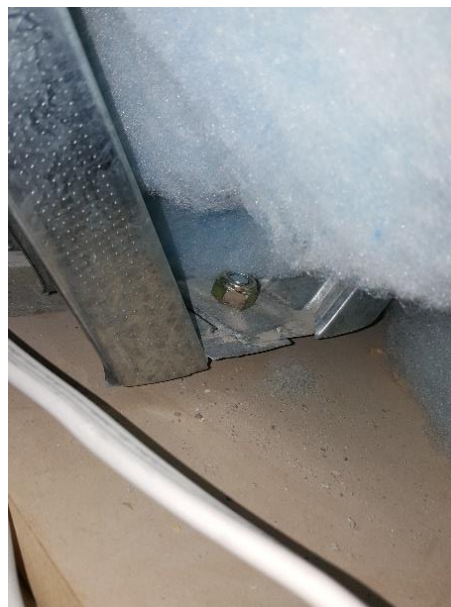
Partition bracing, no clearance around penetration suspect fasten

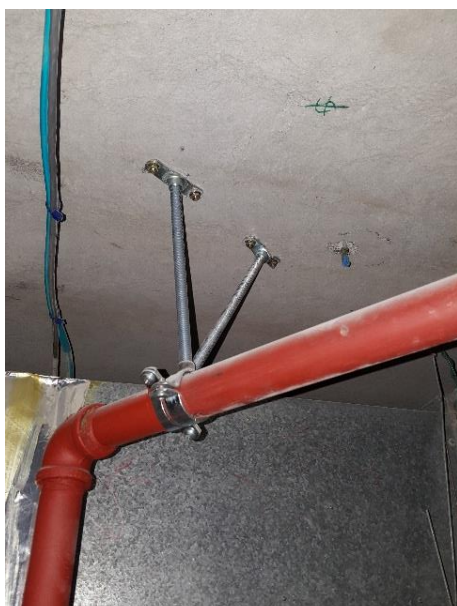
Ceiling bracing let down by weak fastener at element, note poor angle of fire brace in back ground

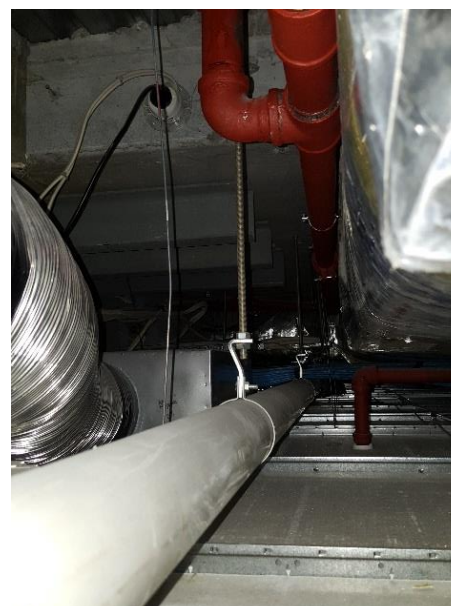
Ceiling bracing let down by weak fastener at element, note poor angle of fire brace in back ground

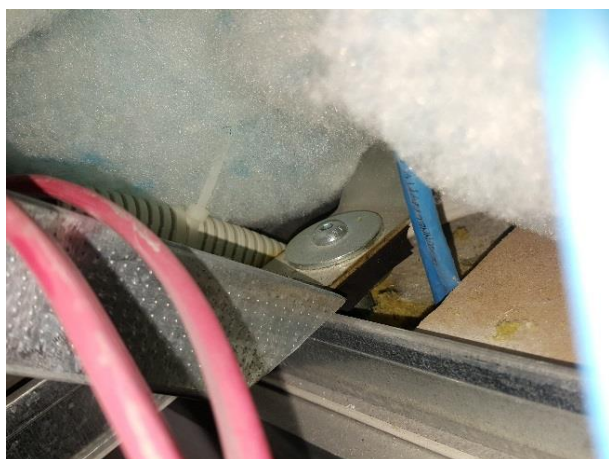
Track-lok bracing of partition walls

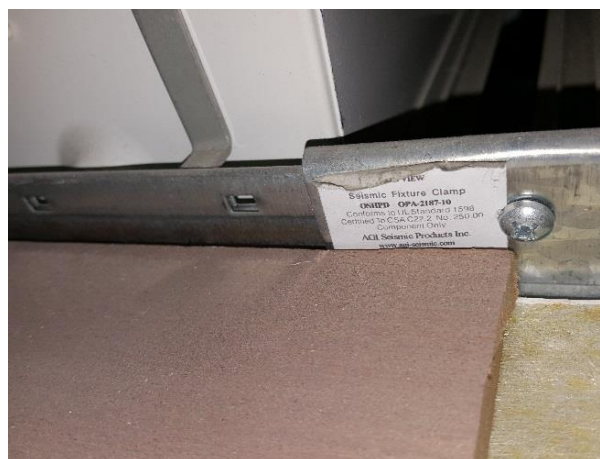
Grid fastened around lights

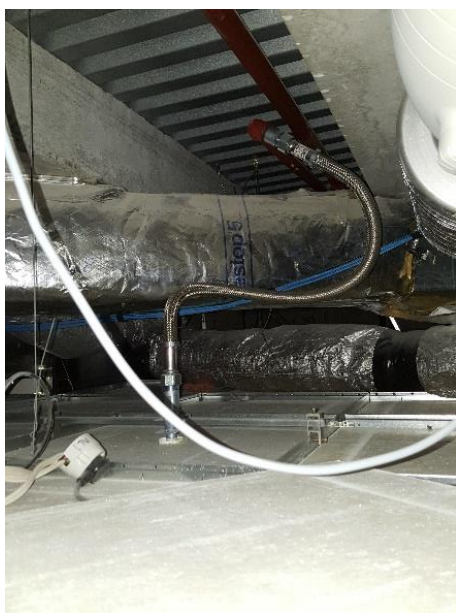
Flexible range
