# Economic Benefits of Code Compliant Non-Structural Elements in New Buildings

Ministry of Business, Innovation & Employment

Date: 20 March 2017  
Reference: 6-DP292.01  
Status: Final

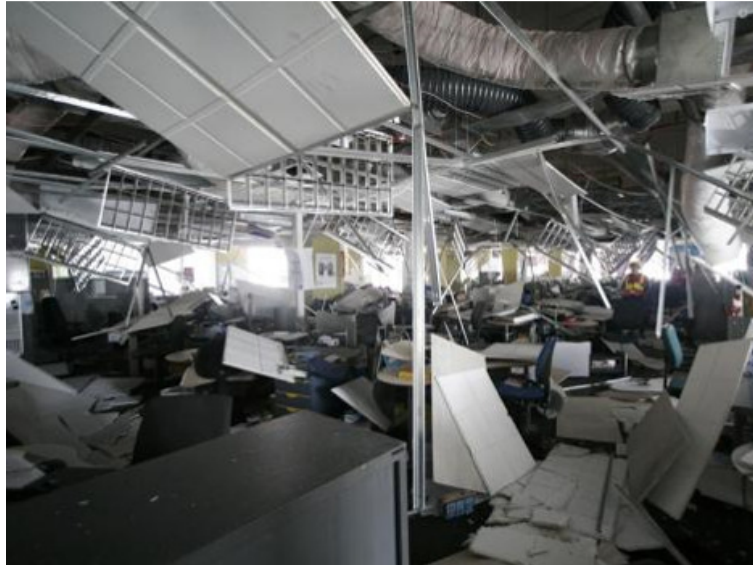
**Figure 4: Failure of ceilings and services in Christchurch commercial building**

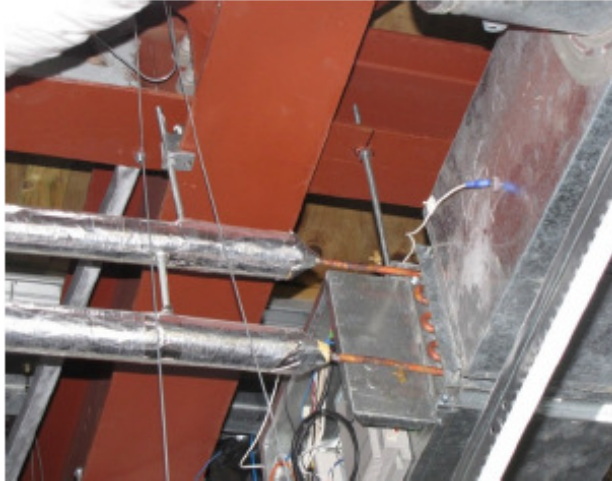
- Equipment suspended within ceiling voids was, in some cases, found to not comply with Clause 5.2.2 of NZS 4219 which requires flexible connections when services and ceilings are not supported together. Examples of non-compliance included unrestrained pipe branches connecting to unrestrained ventilation equipment, without a flexible connection.
- Mechanical equipment weighing in excess of 10kg was found to be unrestrained. This does not comply with Clause 5.9 of NZS 4219.

**Figure 5: Lack of flexible connections to mechanical plant**

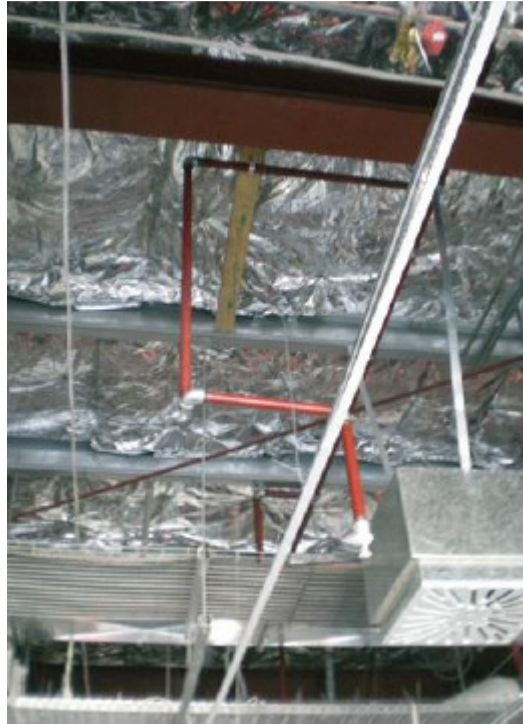
- Ventilation grilles and diffusers weighing in excess of 10kg were observed to be unrestrained. This does not comply with Clause 5.9 of NZS 4219 and leaves the equipment at significant risk of failure. The economic cost of failure of the diffuser needs to be considered in the context of what is around the diffuser/grille. The damage and associated repair costs is likely to be more than just the diffuser/grille itself, as the effect of this equipment swinging around is likely to cause damage and require repairs to nearby pipework, connections, equipment, ceiling hangers and other near-by services, and may also cause suspended ceilings and other equipment to fall and render the area unusable and cause interruption to business operations.

**Figure 7: Unrestrained diffusers**

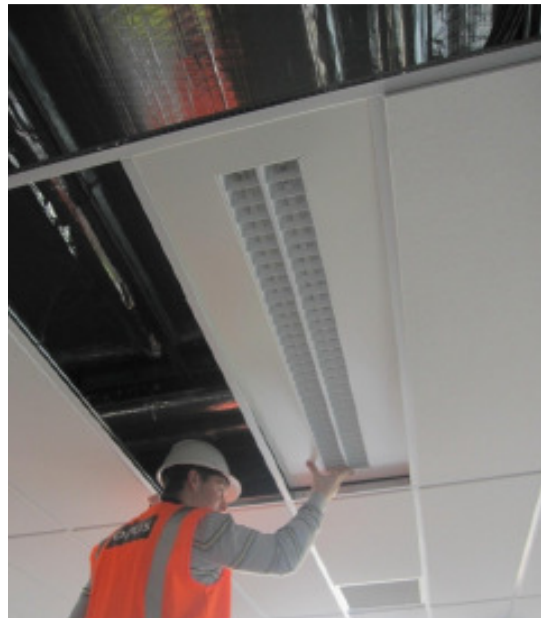
- Luminaires dislodged from ceiling grids
  - Installations were observed where recessed luminaires did not appear to be positively fixed to the ceiling grid and therefore failed to comply with Clause 5.14 of NZS 4219. The weight of recessed luminaires can be significant and if they fall they risk injuring occupants below and causing business interruption.

**Figure 8: Unsecured recessed luminaires**

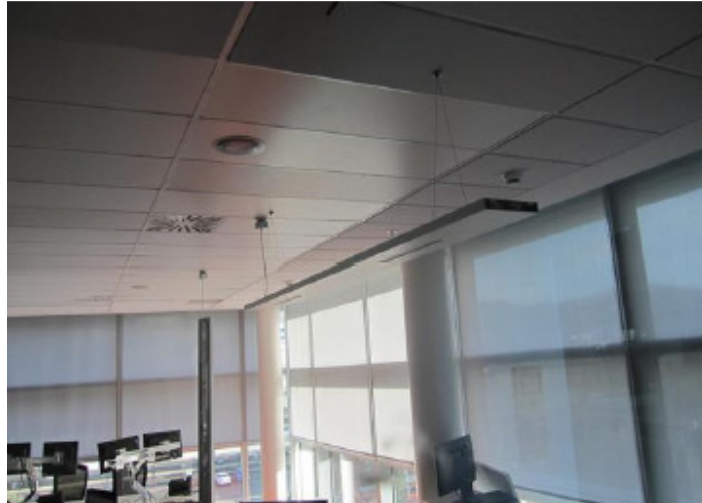
- Freely suspended luminaires suspended on stay wires from ceiling tiles were observed. The use of vertical stay wires does not meet the requirements of NZS 4219 - Clause 5.14 as it allows the luminaire to move in an earthquake and impact with the building or other equipment. In some instances the support wires broke causing the luminaires to fall.

**Figure 9: Typical suspended luminaire**

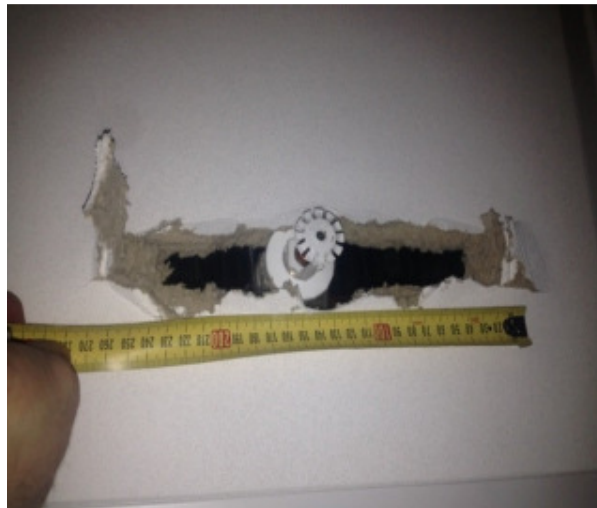
- Direct connection of sprinkler droppers to fixed cable tray and ductwork supports did not meet the code (NZS 4541) requirement that the sprinkler pipes and joints will not experience undue deflection. In particular failure was observed when the dropper arm was connected to heavily loaded unrestrained cable tray. The costs of consequential damage and business interruption due to failure of the sprinkler head is substantial with the potential for water damage that drains to multiple floors.

**Figure 10: Relative movement of sprinkler and ceiling**

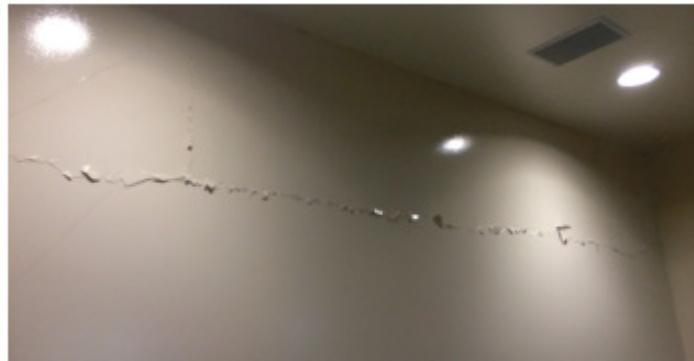
**Figure 12: Cracked gypsum board wall in hospital**

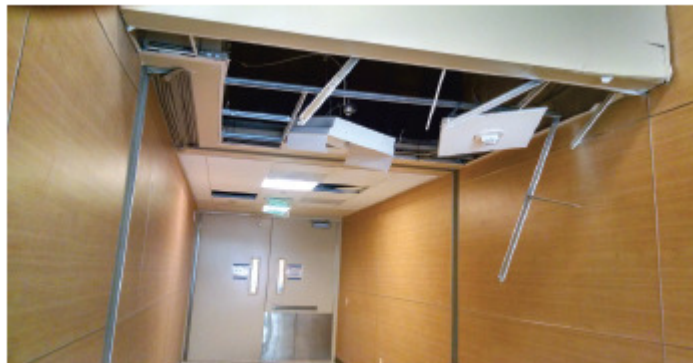
**Figure 13: Ceiling damage in hospital corridor link**

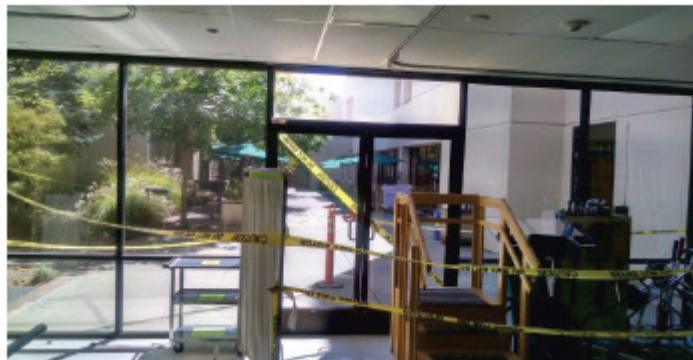
**Figure 14: Damage to glazing leading to entrance being posted as "restricted use"**

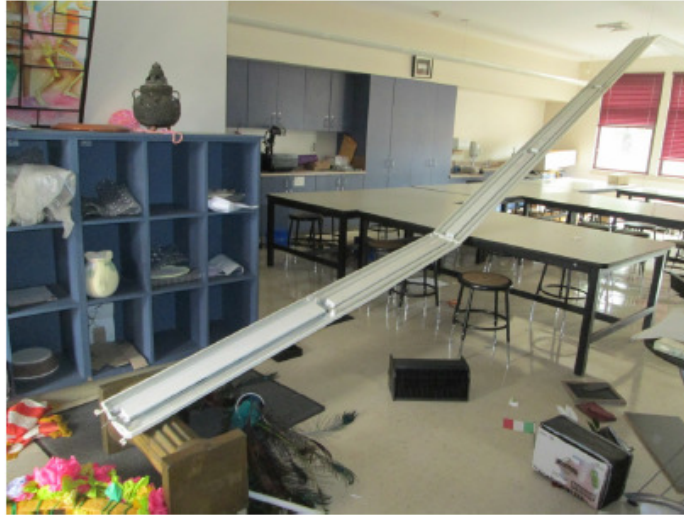
Figure 15: Damaged light fixtures - commonly observed in school facilities

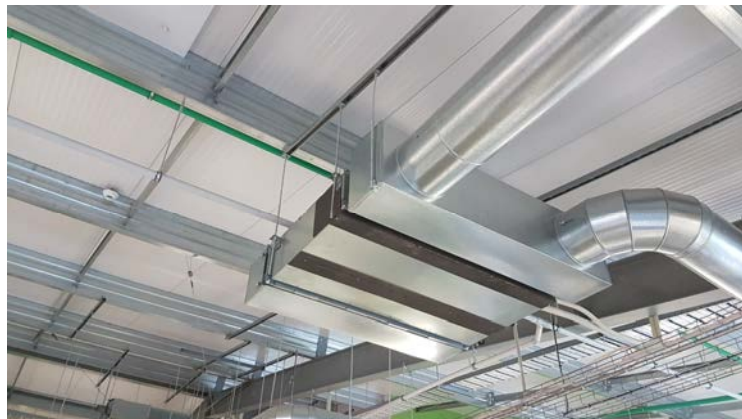
**Figure 16: Non-compliant installation of overhead mechanical plant (no lateral restraint provided) – building completed and received Code Compliance Certificate 2015**
