# Investigation into the Collapse of the Forsyth Barr Building Stairs on 22<sup>nd</sup> February 2011

Prepared for Department of Building and Housing (DBH)

By Beca Carter Hollings & Ferner Ltd (Beca)

26<sup>th</sup> September 2011

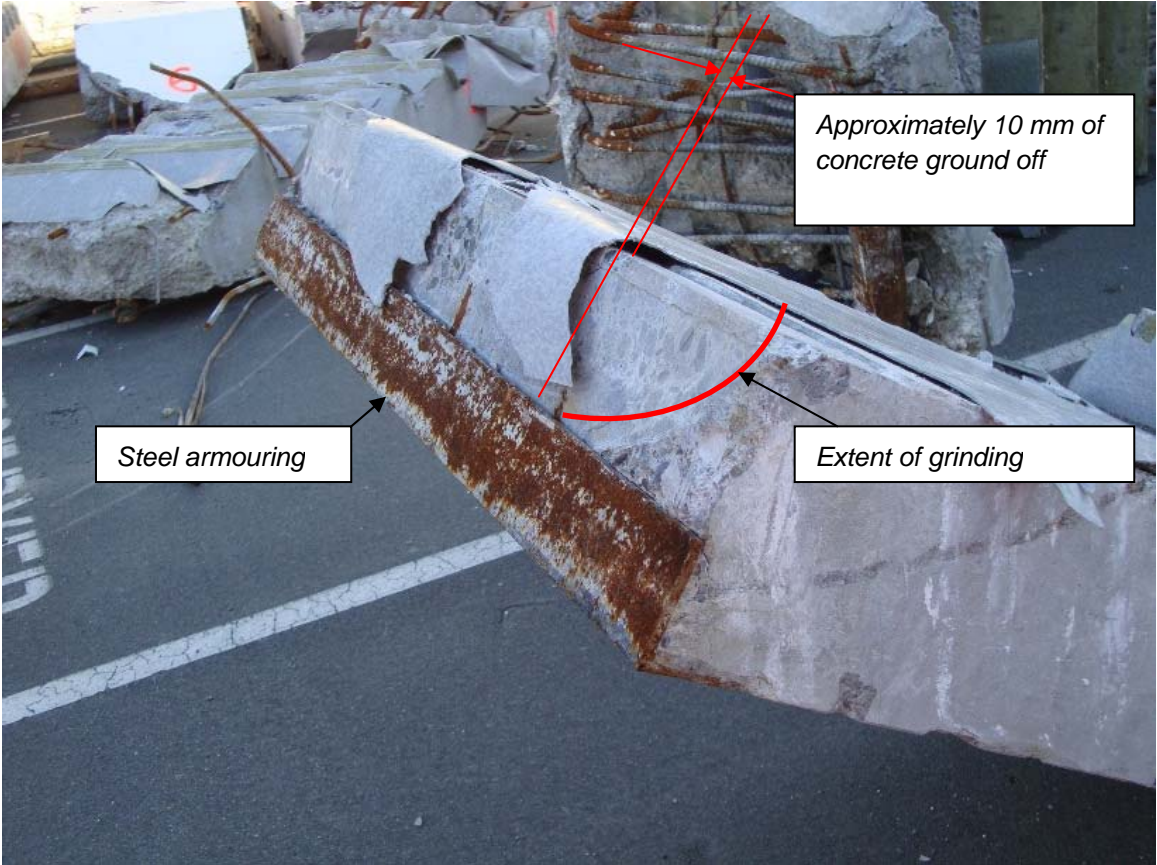
Figure 4.8 : Ground-Back End of Landing in Collapsed Stair Unit

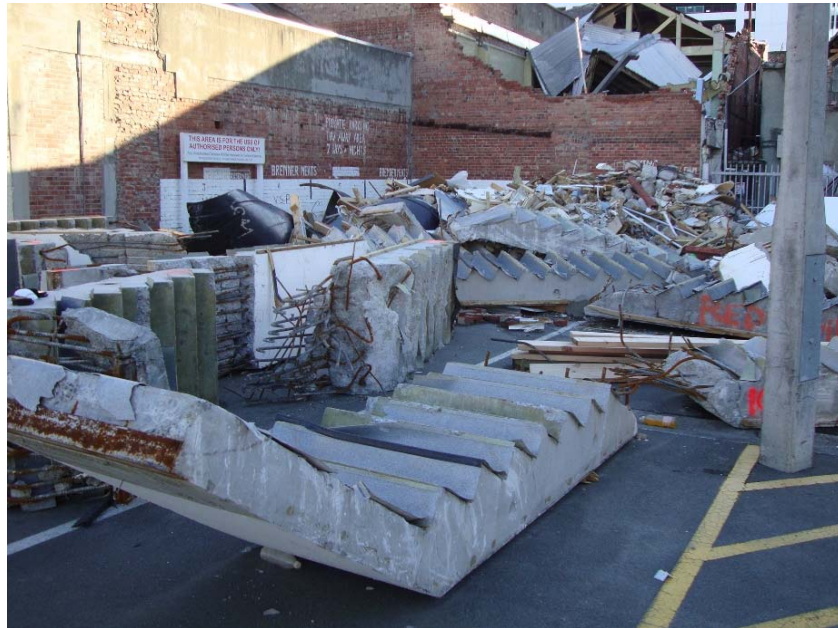
The units that had been removed from the building were available for inspection/testing (refer to Figure 7.1) but it was impossible to judge from which levels they had come. It was also difficult to judge whether or not the damage to these flights caused the collapse or was a result of impact from falling or being hit by other stair units.

**Figure 7.1 :** Collapsed Stair Units Removed from Stairwell

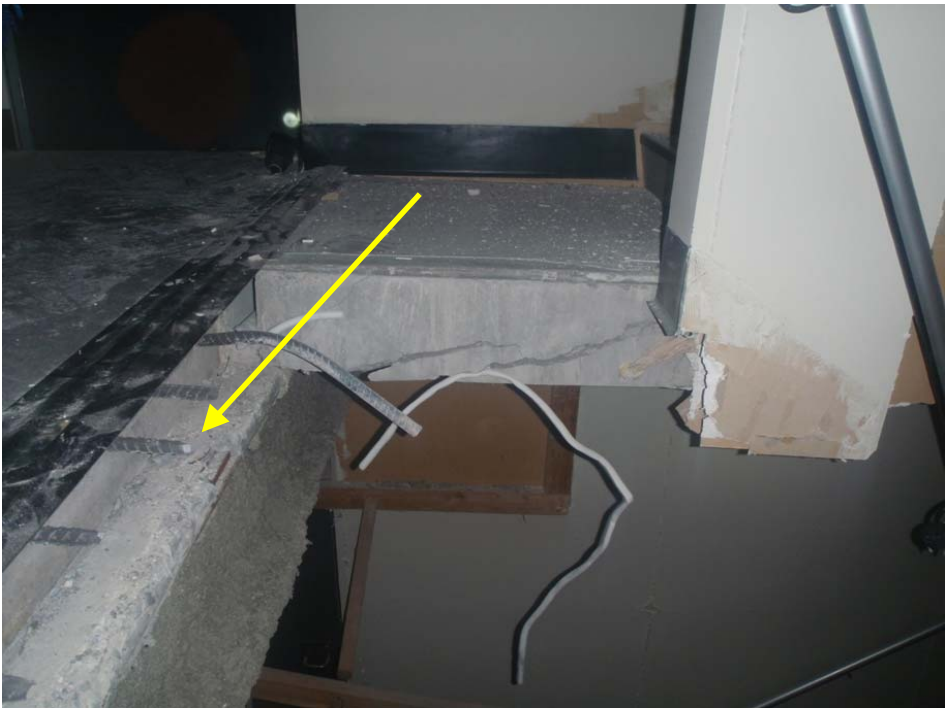
**Figure 7.2 :** Fractured Top Starter Bars

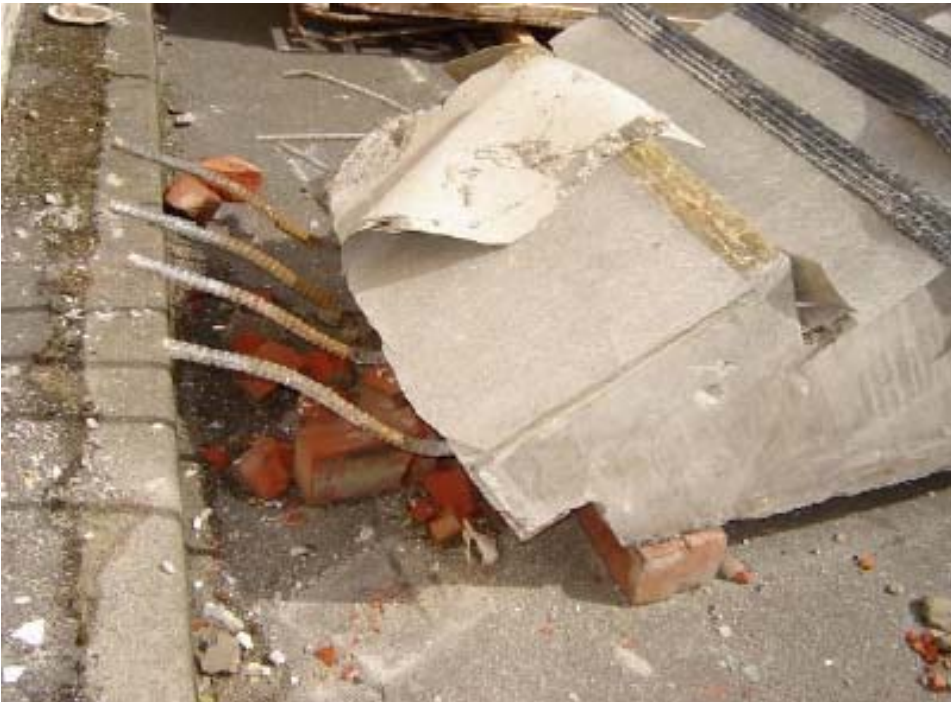
**Figure 7.3 :** Top Starters Pulled Out

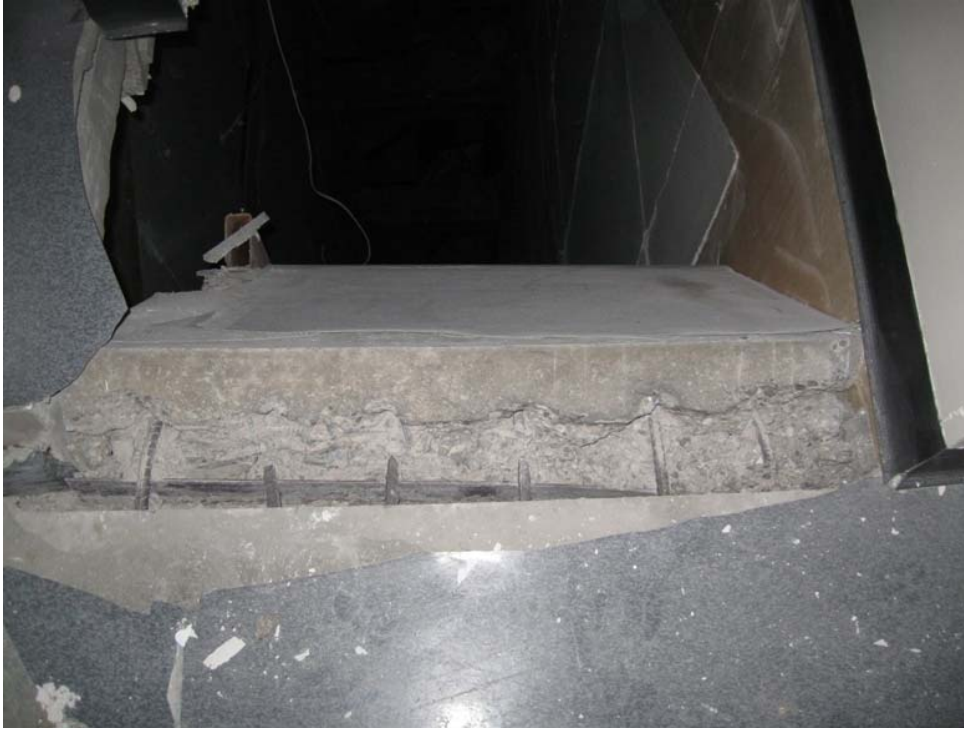
**Figure 7.4 :** Stair Flight Hanging from Top Starters (photograph taken from the top stair landing looking down the stair shaft).

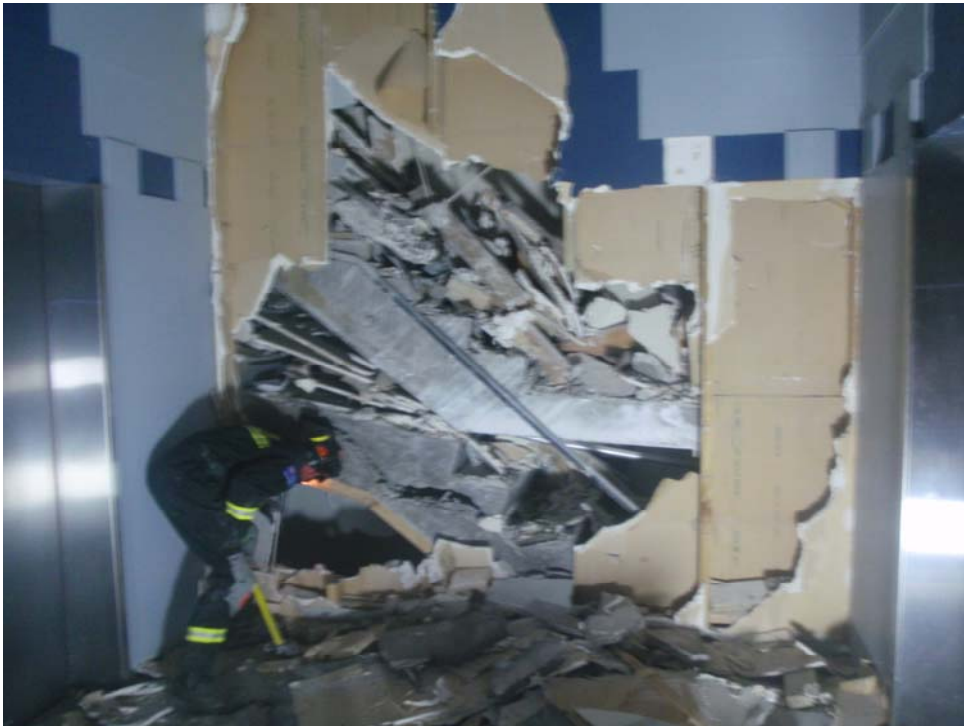
**Figure 7.5 :** Fallen Stair Flights at the Bottom of the Stairwell

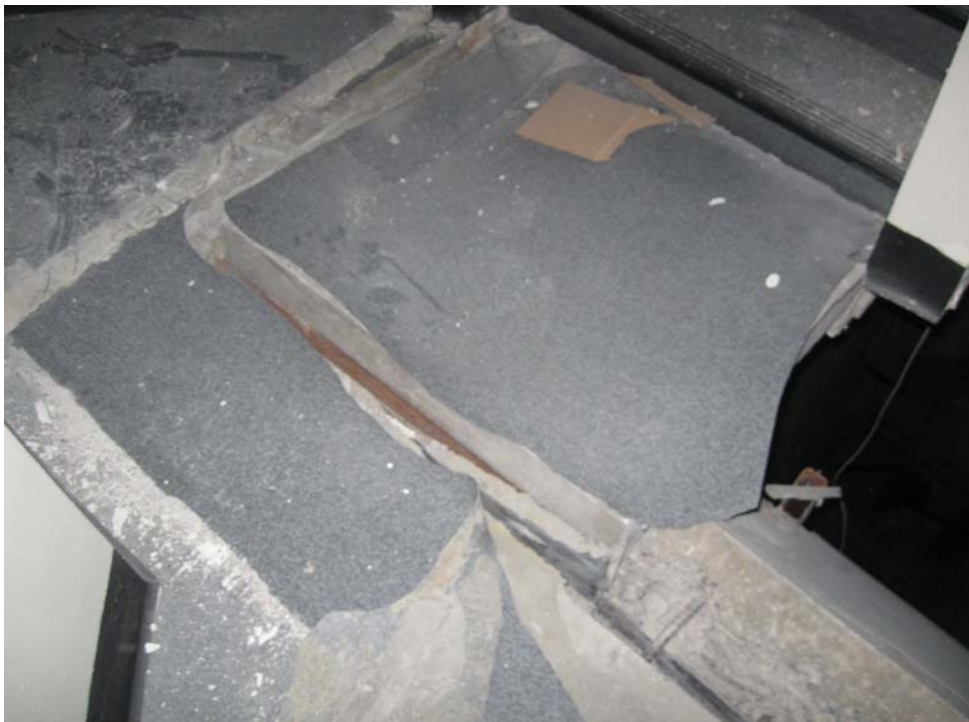
**Figure 7.6 :** Permanent Displacement at Bottom-Landing Seismic Joint

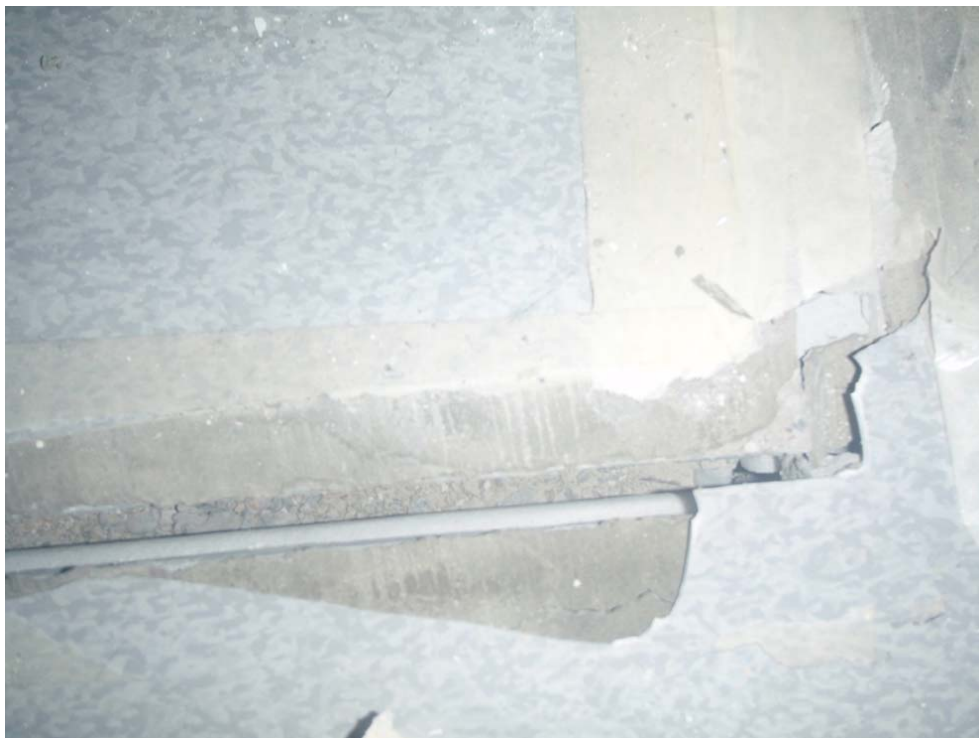
- At least some of the seismic joints are said to have been filled with construction debris, polystyrene packing, and/or mortar. This observation was also made after the 4<sup>th</sup> September 2010 earthquake. Refer to Figures 7.7, 7.8 and 7.9 (all taken after 22<sup>nd</sup> February 2011).

**Figure 7.7 :** Mortar-Filled Seismic Joint

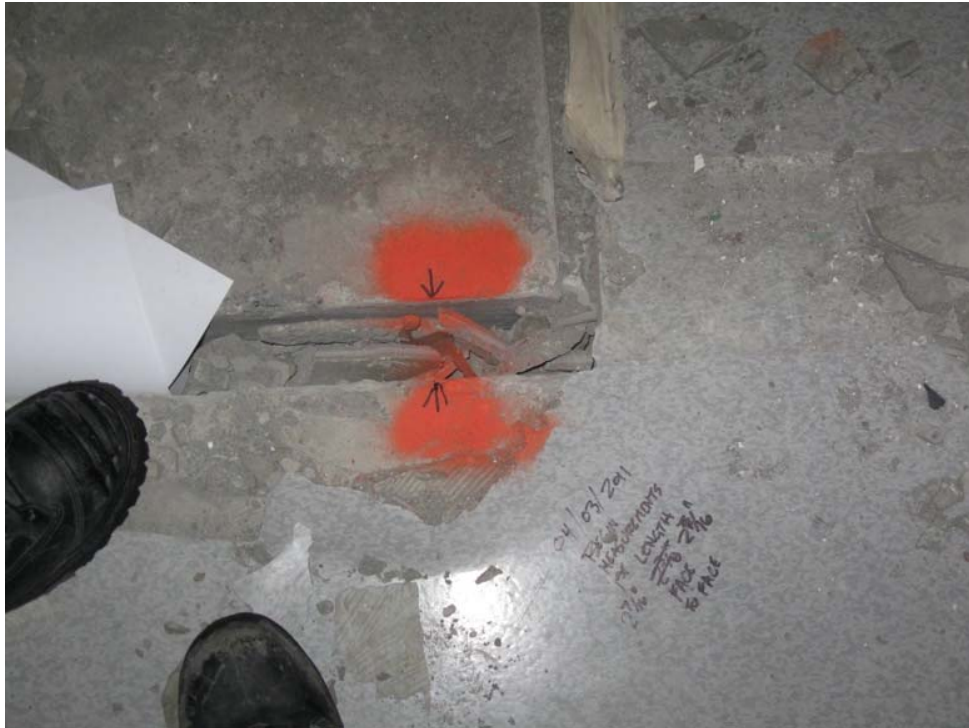
**Figure 7.8 :** Debris/Mortar in Displaced Seismic Joint

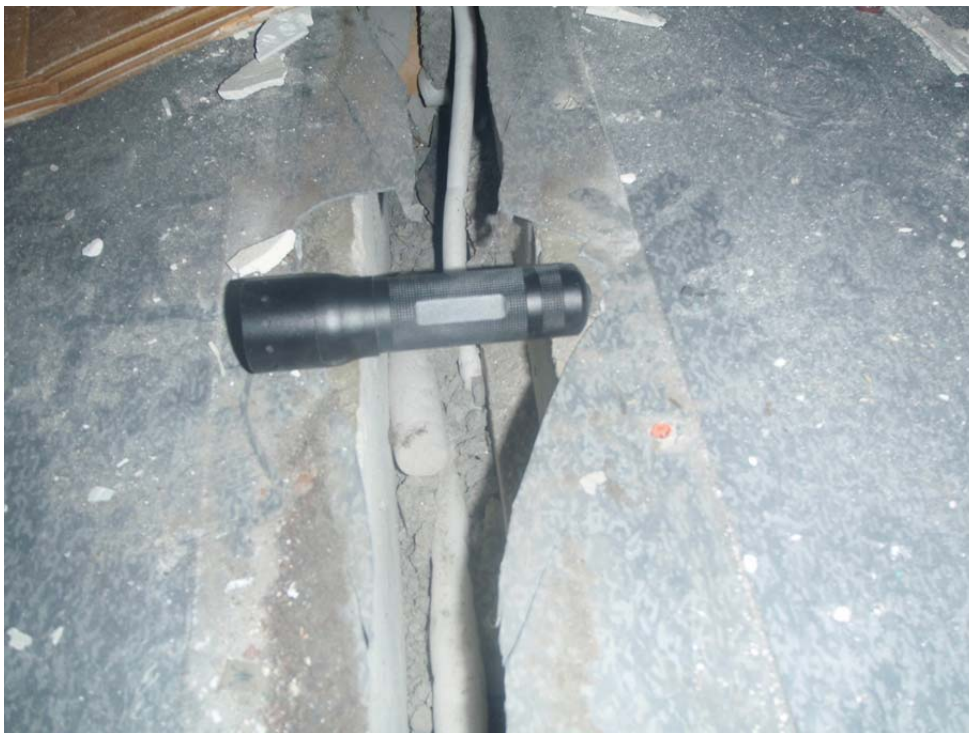
**Figure 7.9 :** Debris/Crushed Mortar below Sealant Backing-Rod

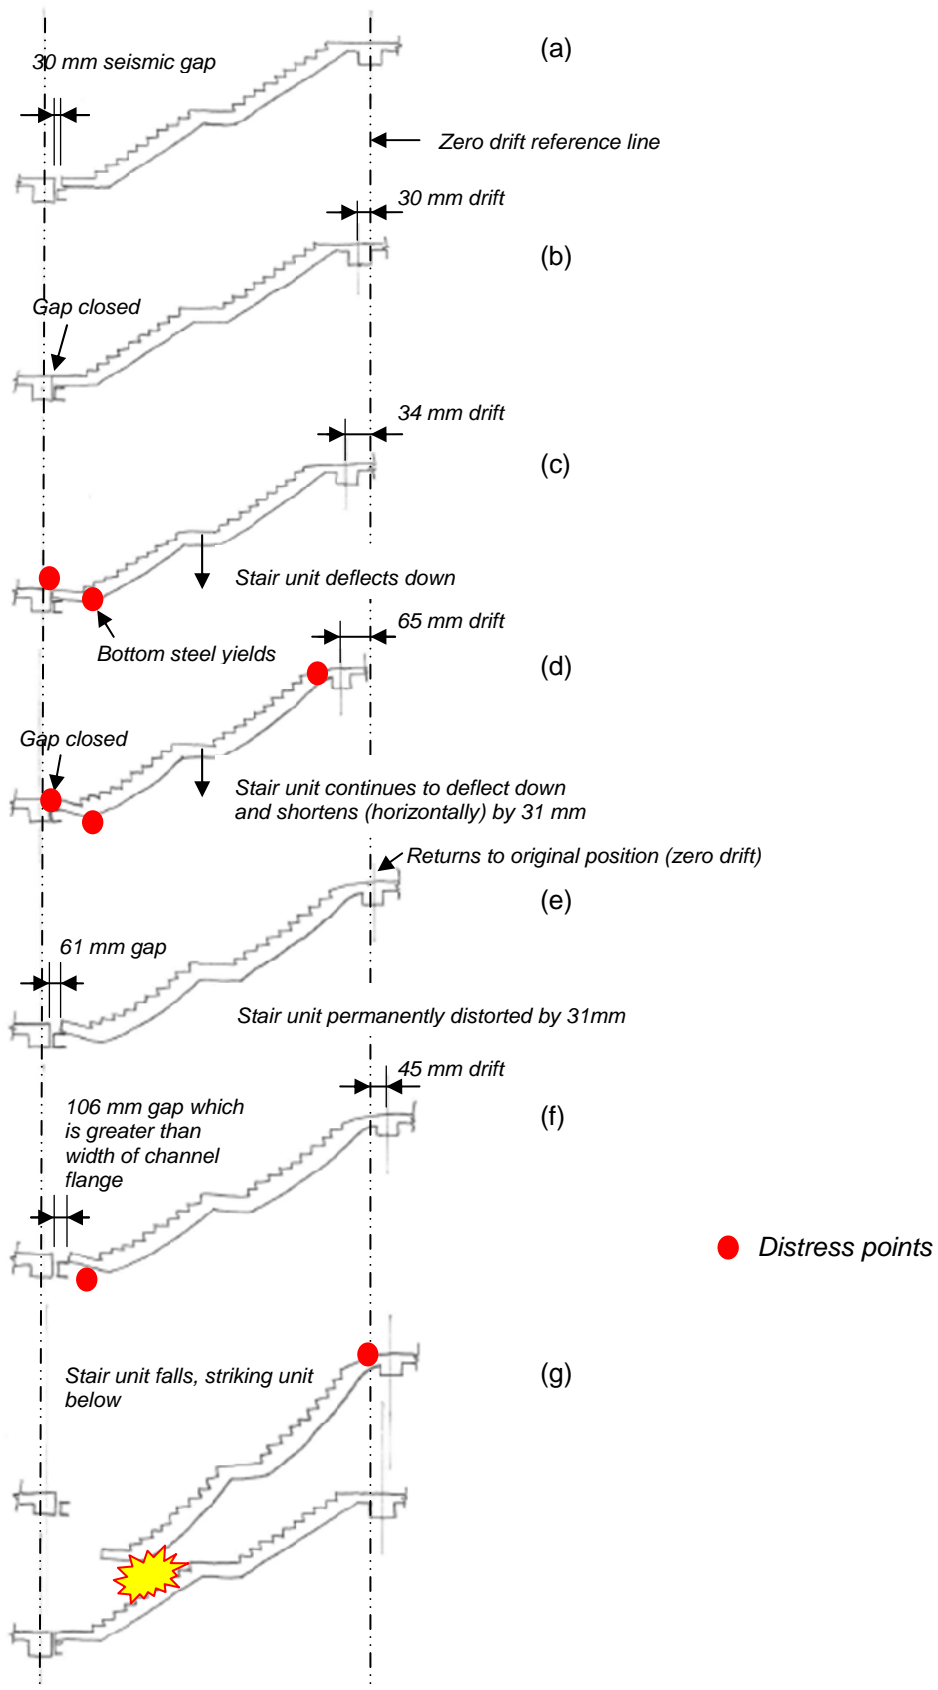
Figure 8.2 : Inferred Collapse Sequence

- When acting as struts, at least some of the units became overloaded and yielded in flexure at to the bottom step/riser. Analyses indicate that yield in this location will occur once inter-storey drifts of the order of 4 mm occur after the stairs become locked between floors (i.e., for drifts exceeding  $30 + 4 = 34$  mm). Refer to Figure 8.2(c).

- Yielding can also occur where the top step meets the top landing, but would not cause additional overall shortening of the unit.

- Further inter-storey drift beyond 34 mm causes more flexural yielding, locking in further shortening of the unit.
