CTV Building Geotechnical Advice

This report presents the review of geotechnical conditions at the site of the CTV building, 249 Madras Street, Christchurch, together with the results of an assessment of the dynamic response parameters for the foundations of the building.

This work has been carried out for the Department of Building and Housing (DBH) through the Hyland/Structure Smith Consultant Team, responsible for the investigation of the structural performance of the building during and following the Christchurch earthquake of 22 February 2011.

CTV Building Geotechnical Advice - Addendum

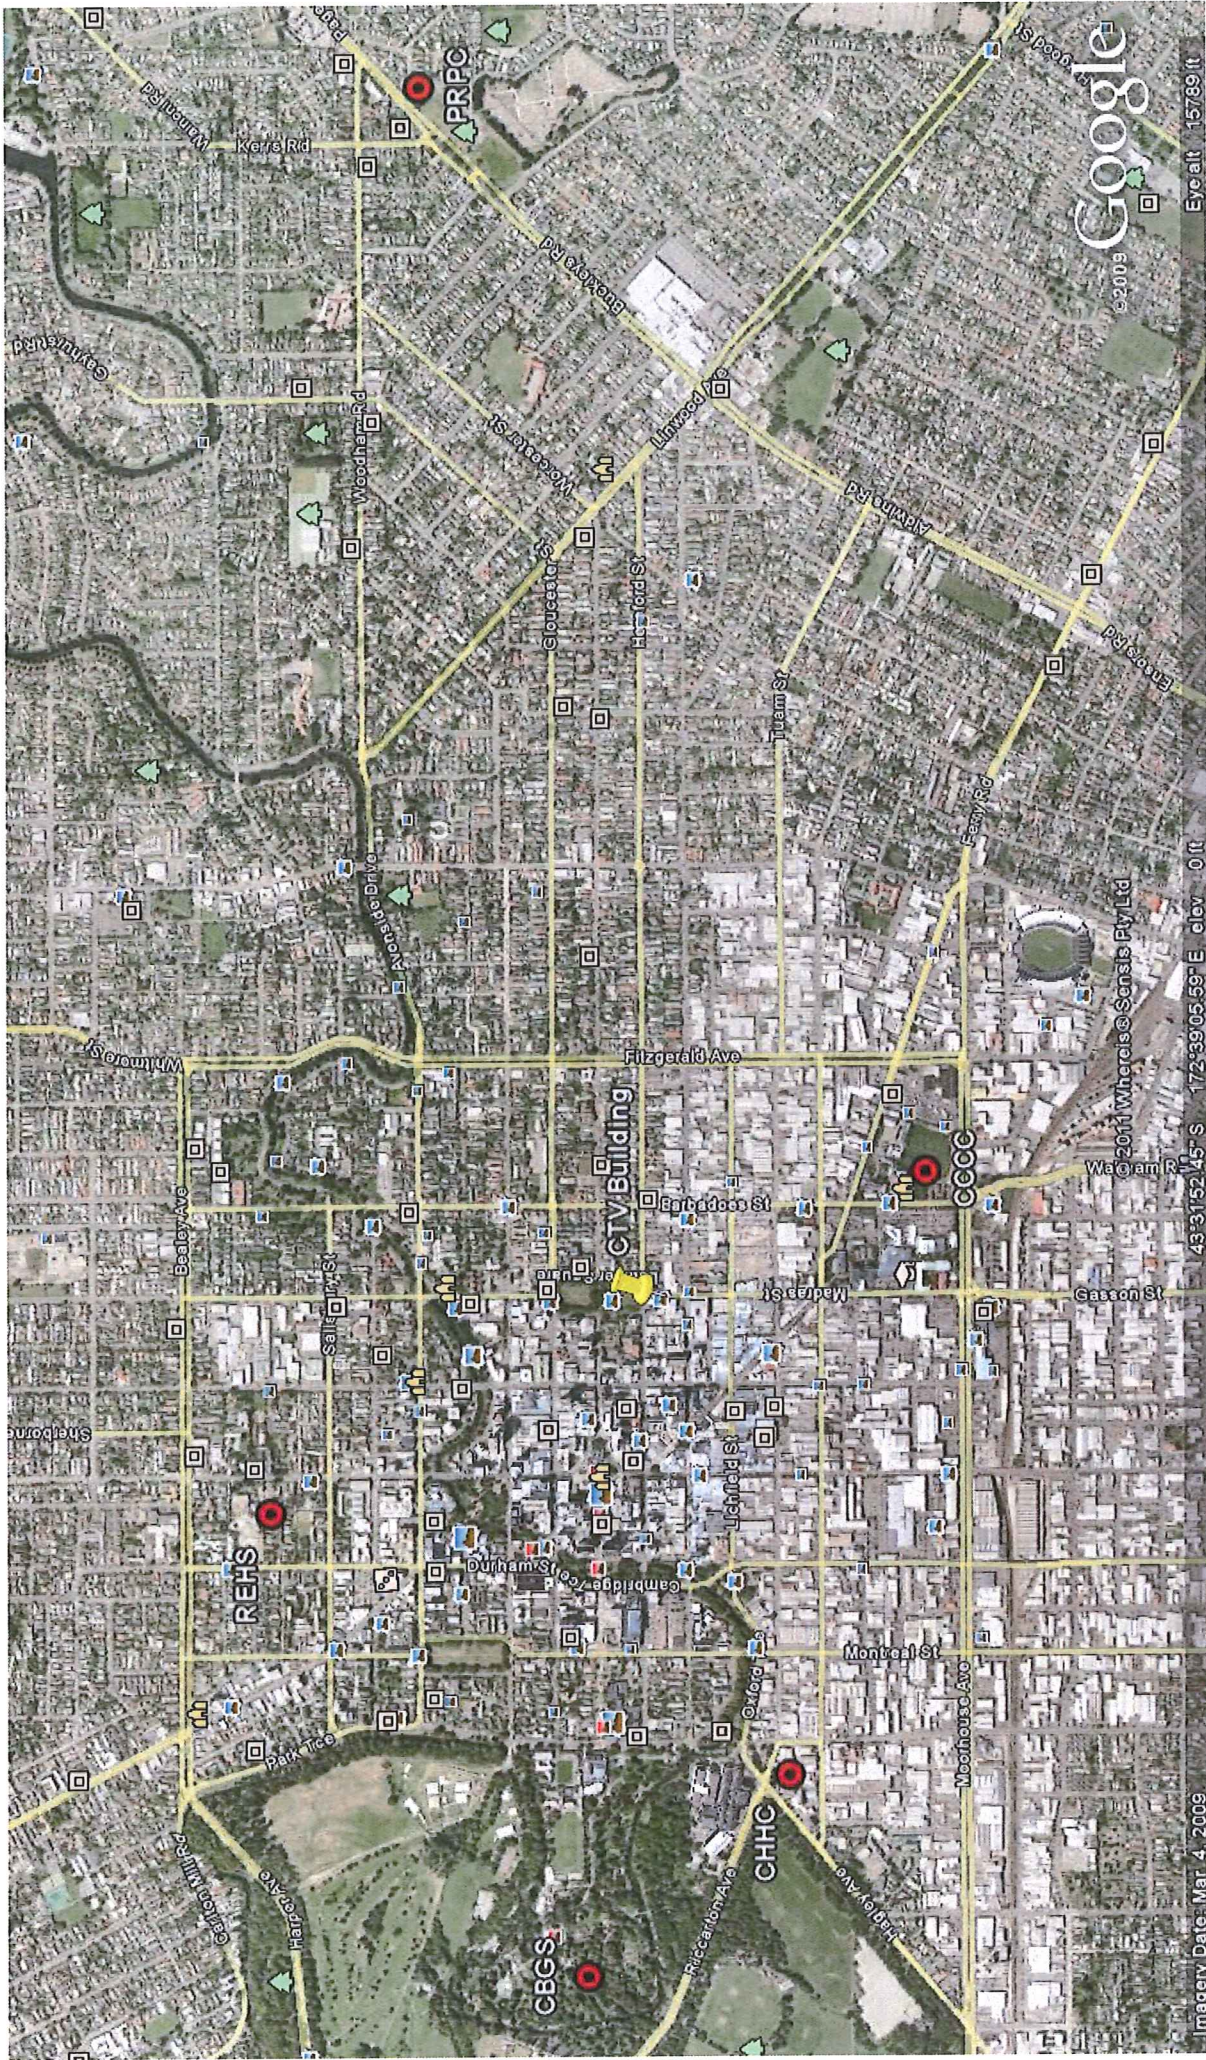
Figure 2: Locations of Strong Motion Recording Stations

The five stations of interest are shown on Figure 2 and are listed below:

- Botanical Gardens: CGBS
- Cathedral College: CCCC
- Christchurch Hospital: CHHC
- Rest Home Colombo Street: REHS

- Page Road Pumping Station: PRPC

The last two of these (REHS and PRPC) show significantly higher amplification than the others, both with respect to Peak Ground Accelerations (PGA) and spectral accelerations.

A borehole (BH 103) drilled for the Department of Building and Housing (DBH) at the REHS site logs significant thickness of “very soft organic silt” and “very soft peat”. Other borehole records near REHS (ECAN bores 2140 and 2142) suggest the presence of peat or clayey soils of about 6m thickness. These support the general knowledge of the area that would predict “silts, clayey silt and peat” north of Peterborough Street.

The PRPC station is located in a known liquefaction zone, with a nearby borehole (ECAN – M35/5124) logging sand to 27m depth, overlying sands and gravels.

The other three stations (CGBS, CCCC, CHHC) are all expected to have generally similar profiles of variable inter-bedded silts, silty and gravelly sands, overlying dense sands.

The response characteristics are generally governed by the soil profile to rock which would be about 300 m depth, and so thin layers near surface are not likely to make much difference. The exception, of course, could be the presence of deep liquefiable soils and/or the presence of peat. For this reason we consider the REHS and PPC records should be disregarded and the CTV site response should be assumed as similar to the average of the other three stations.

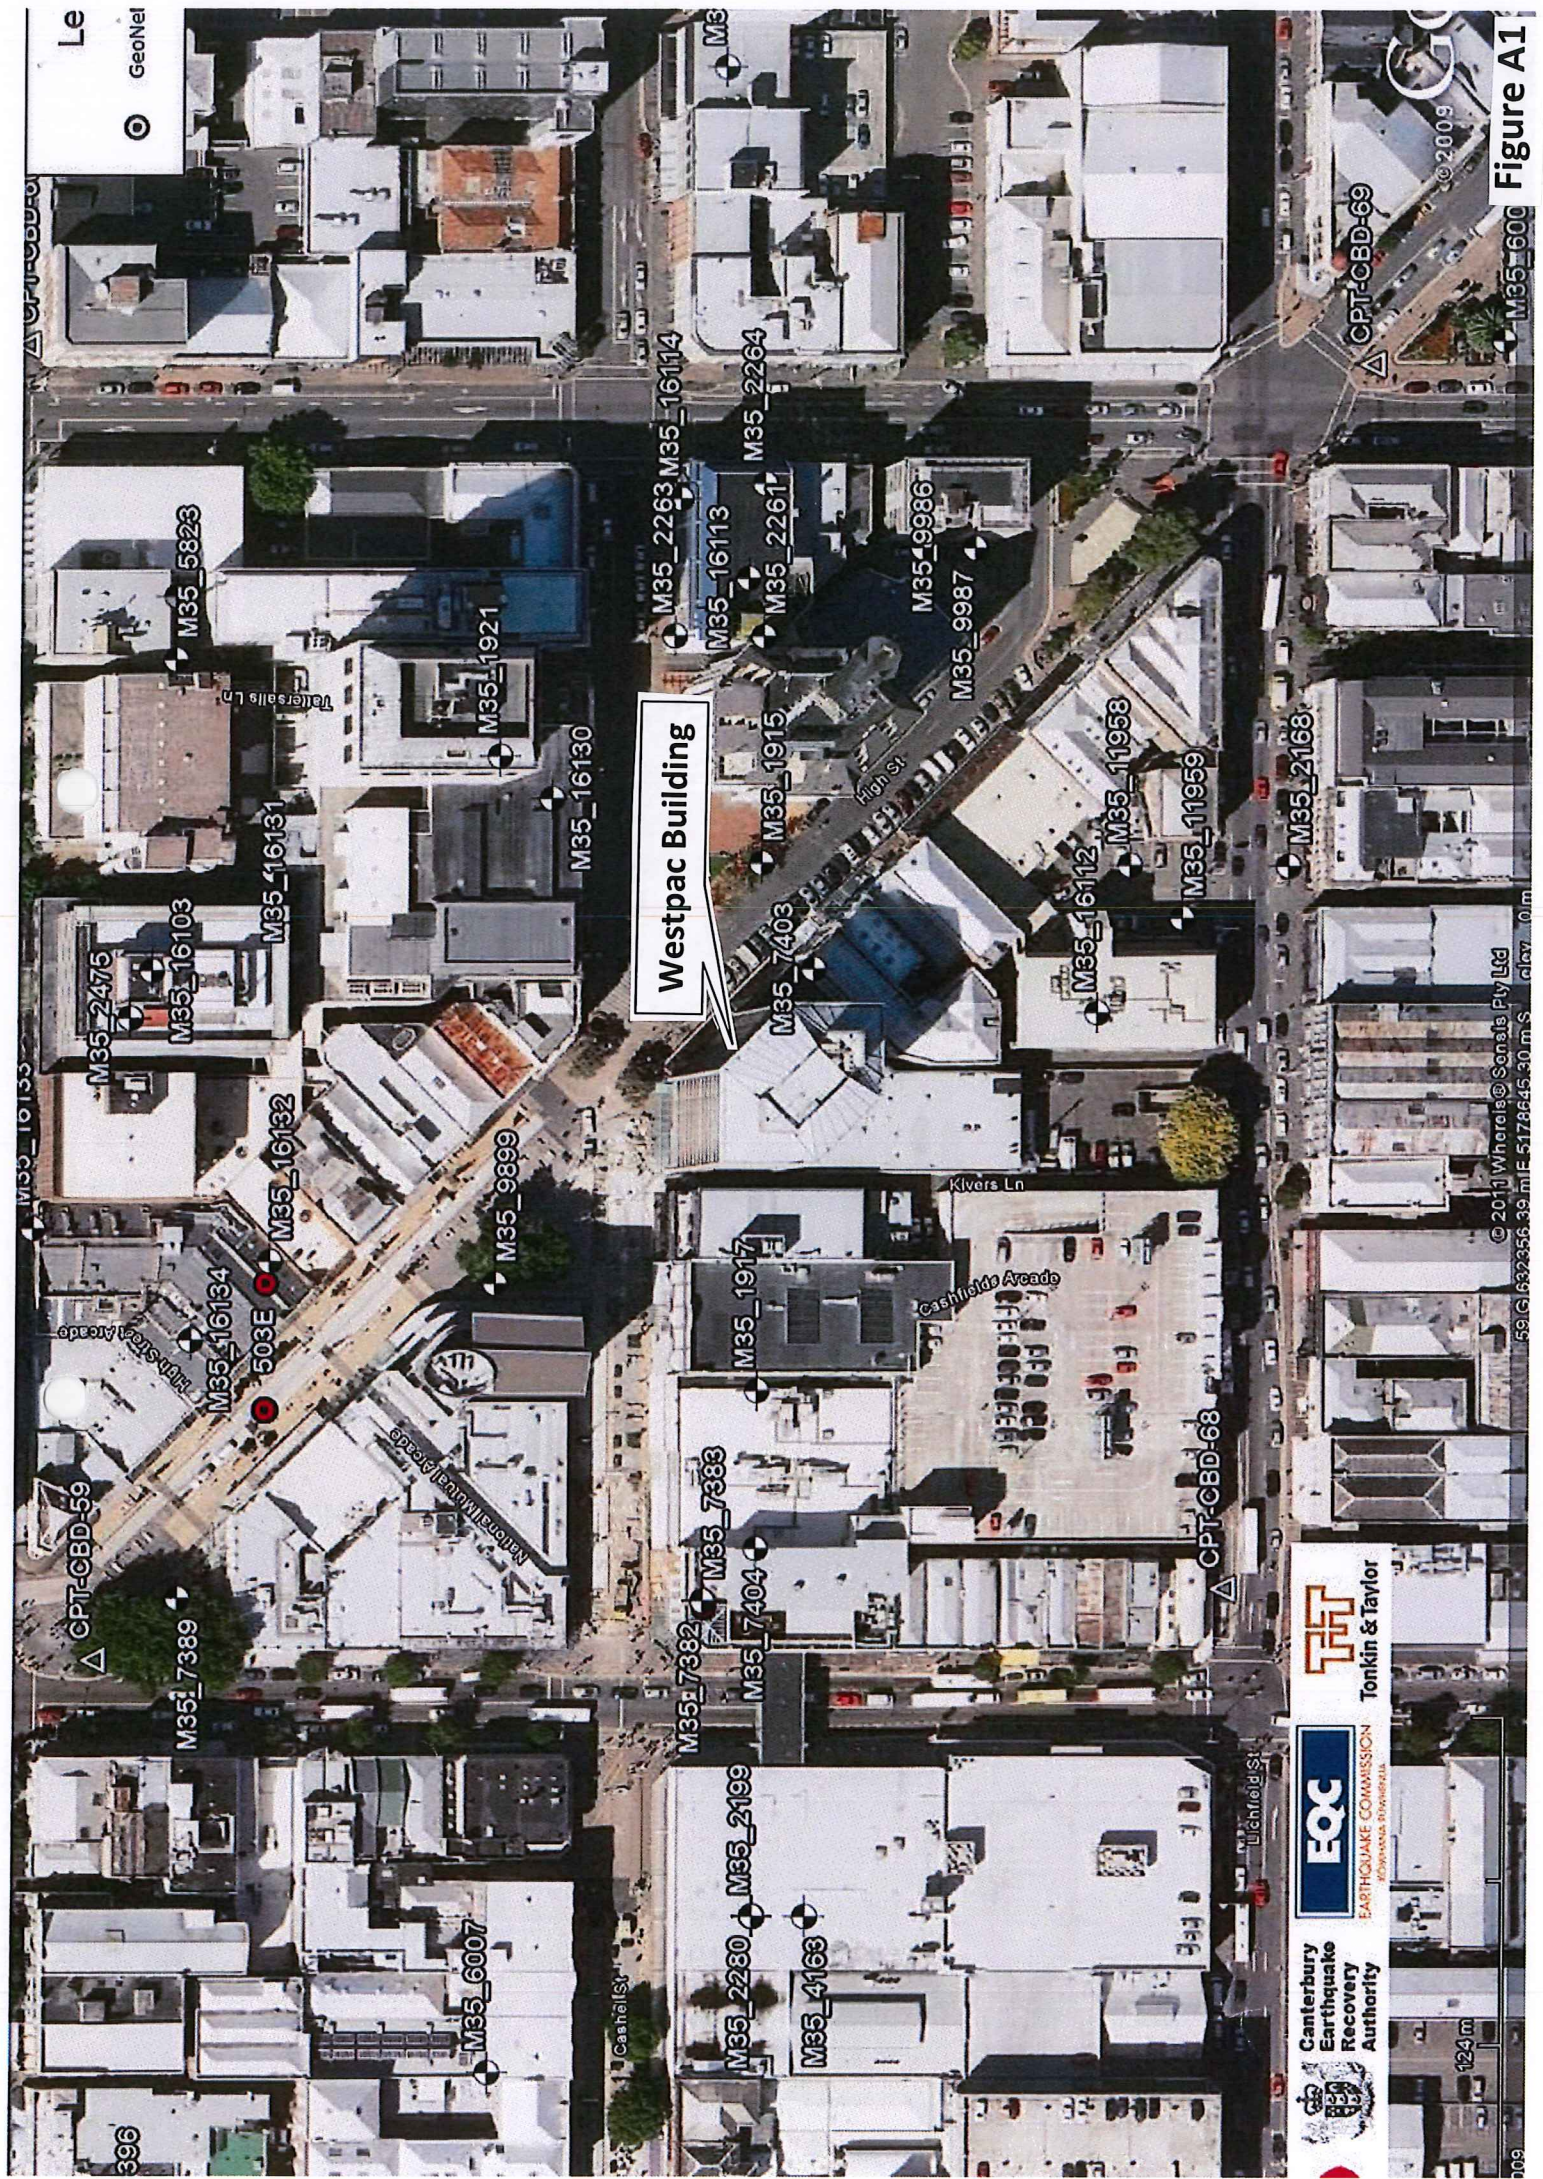
- i. The locations for the site investigation points surrounding the Westpac Building are shown on Figure A1 attached. (Note: Station 503E is marked on this plan but not in exact location due to co-ordinate discrepancy.)

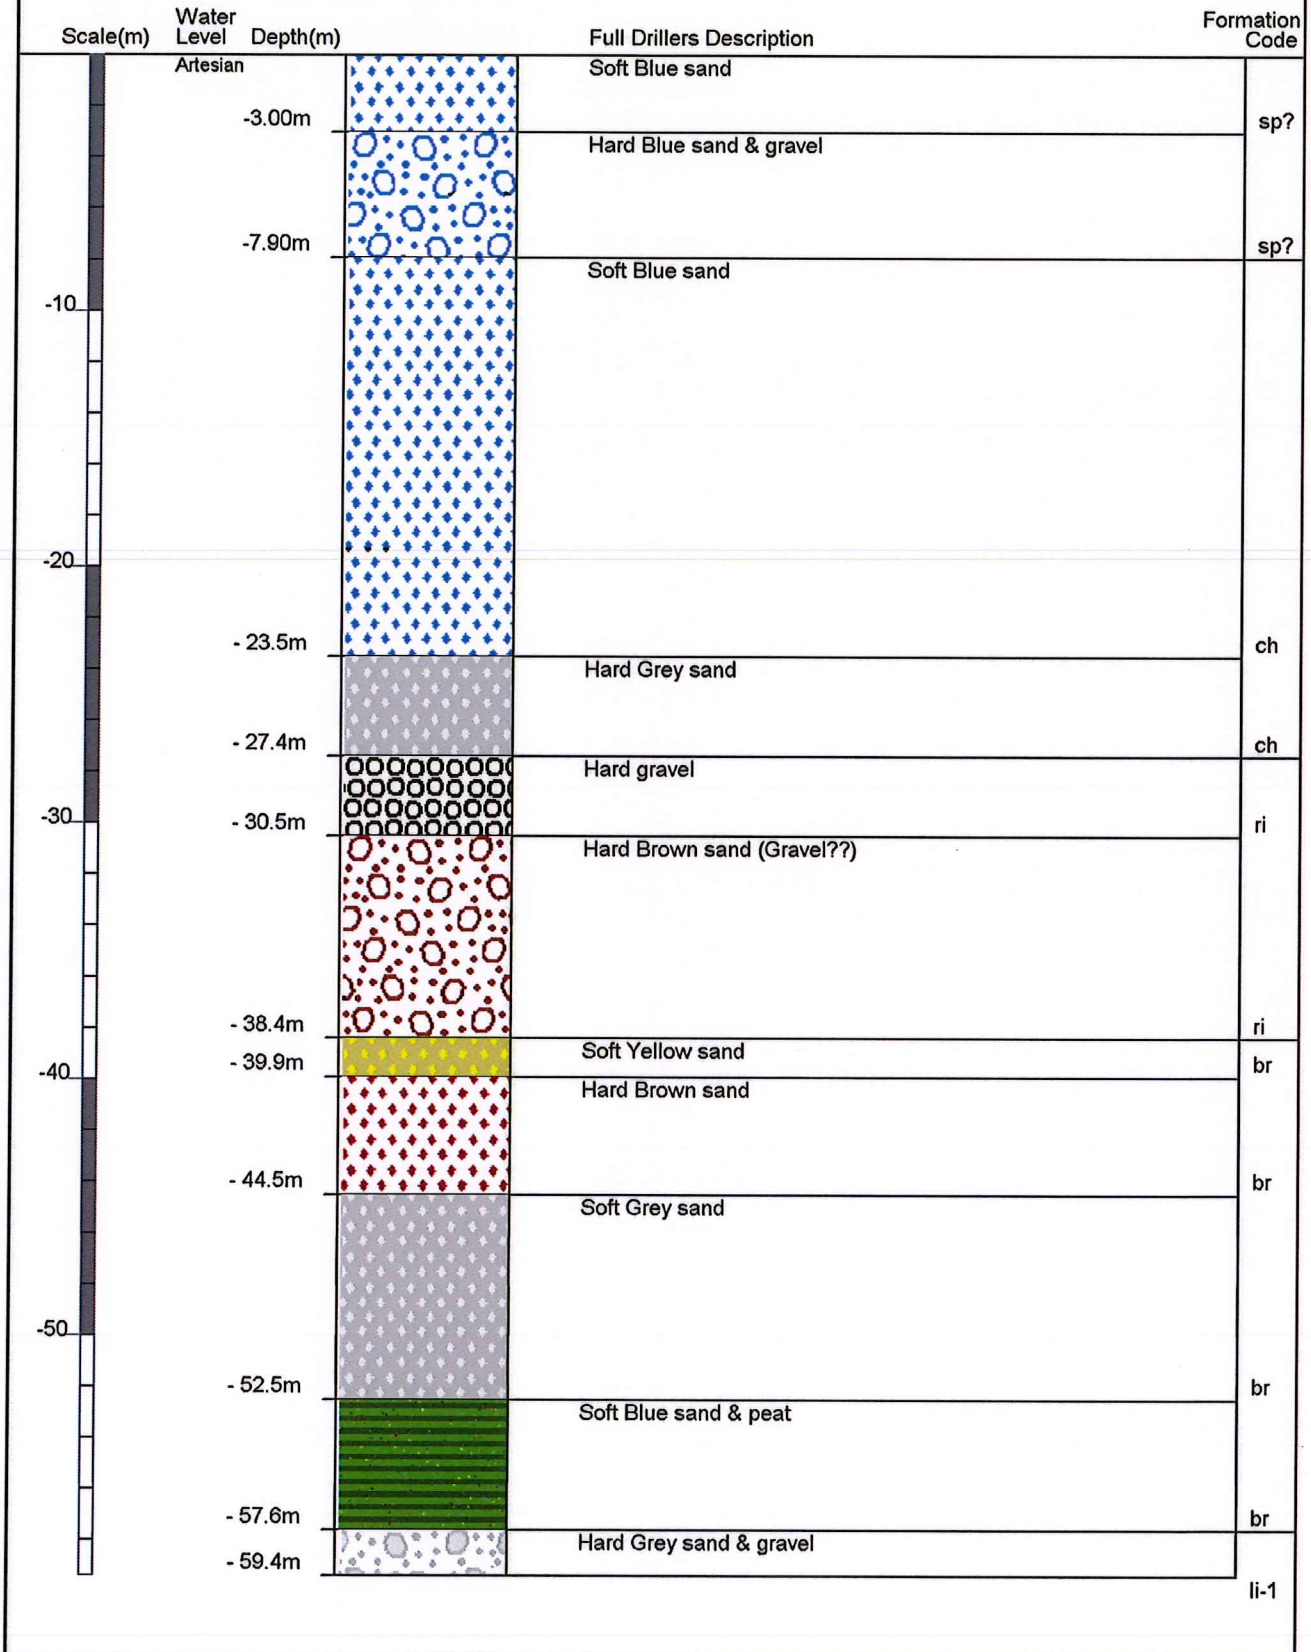
Borelog for well M35/7403

- ii. One ECAN borehole log is available at this location (M35 – 7403), attached for information as Figure A2.
- iii. Tonkin & Taylor have carried out investigations for the Triangle Centre (T&T Ref No. 52157) immediately north west of the Westpac Building. The logs of boreholes give detailed subsurface information to about 27 m depth. Whilst not being able to include the logs of boreholes and cone penetration tests (CPT), the information enables us to have confidence in interpretation of the subsurface profile.

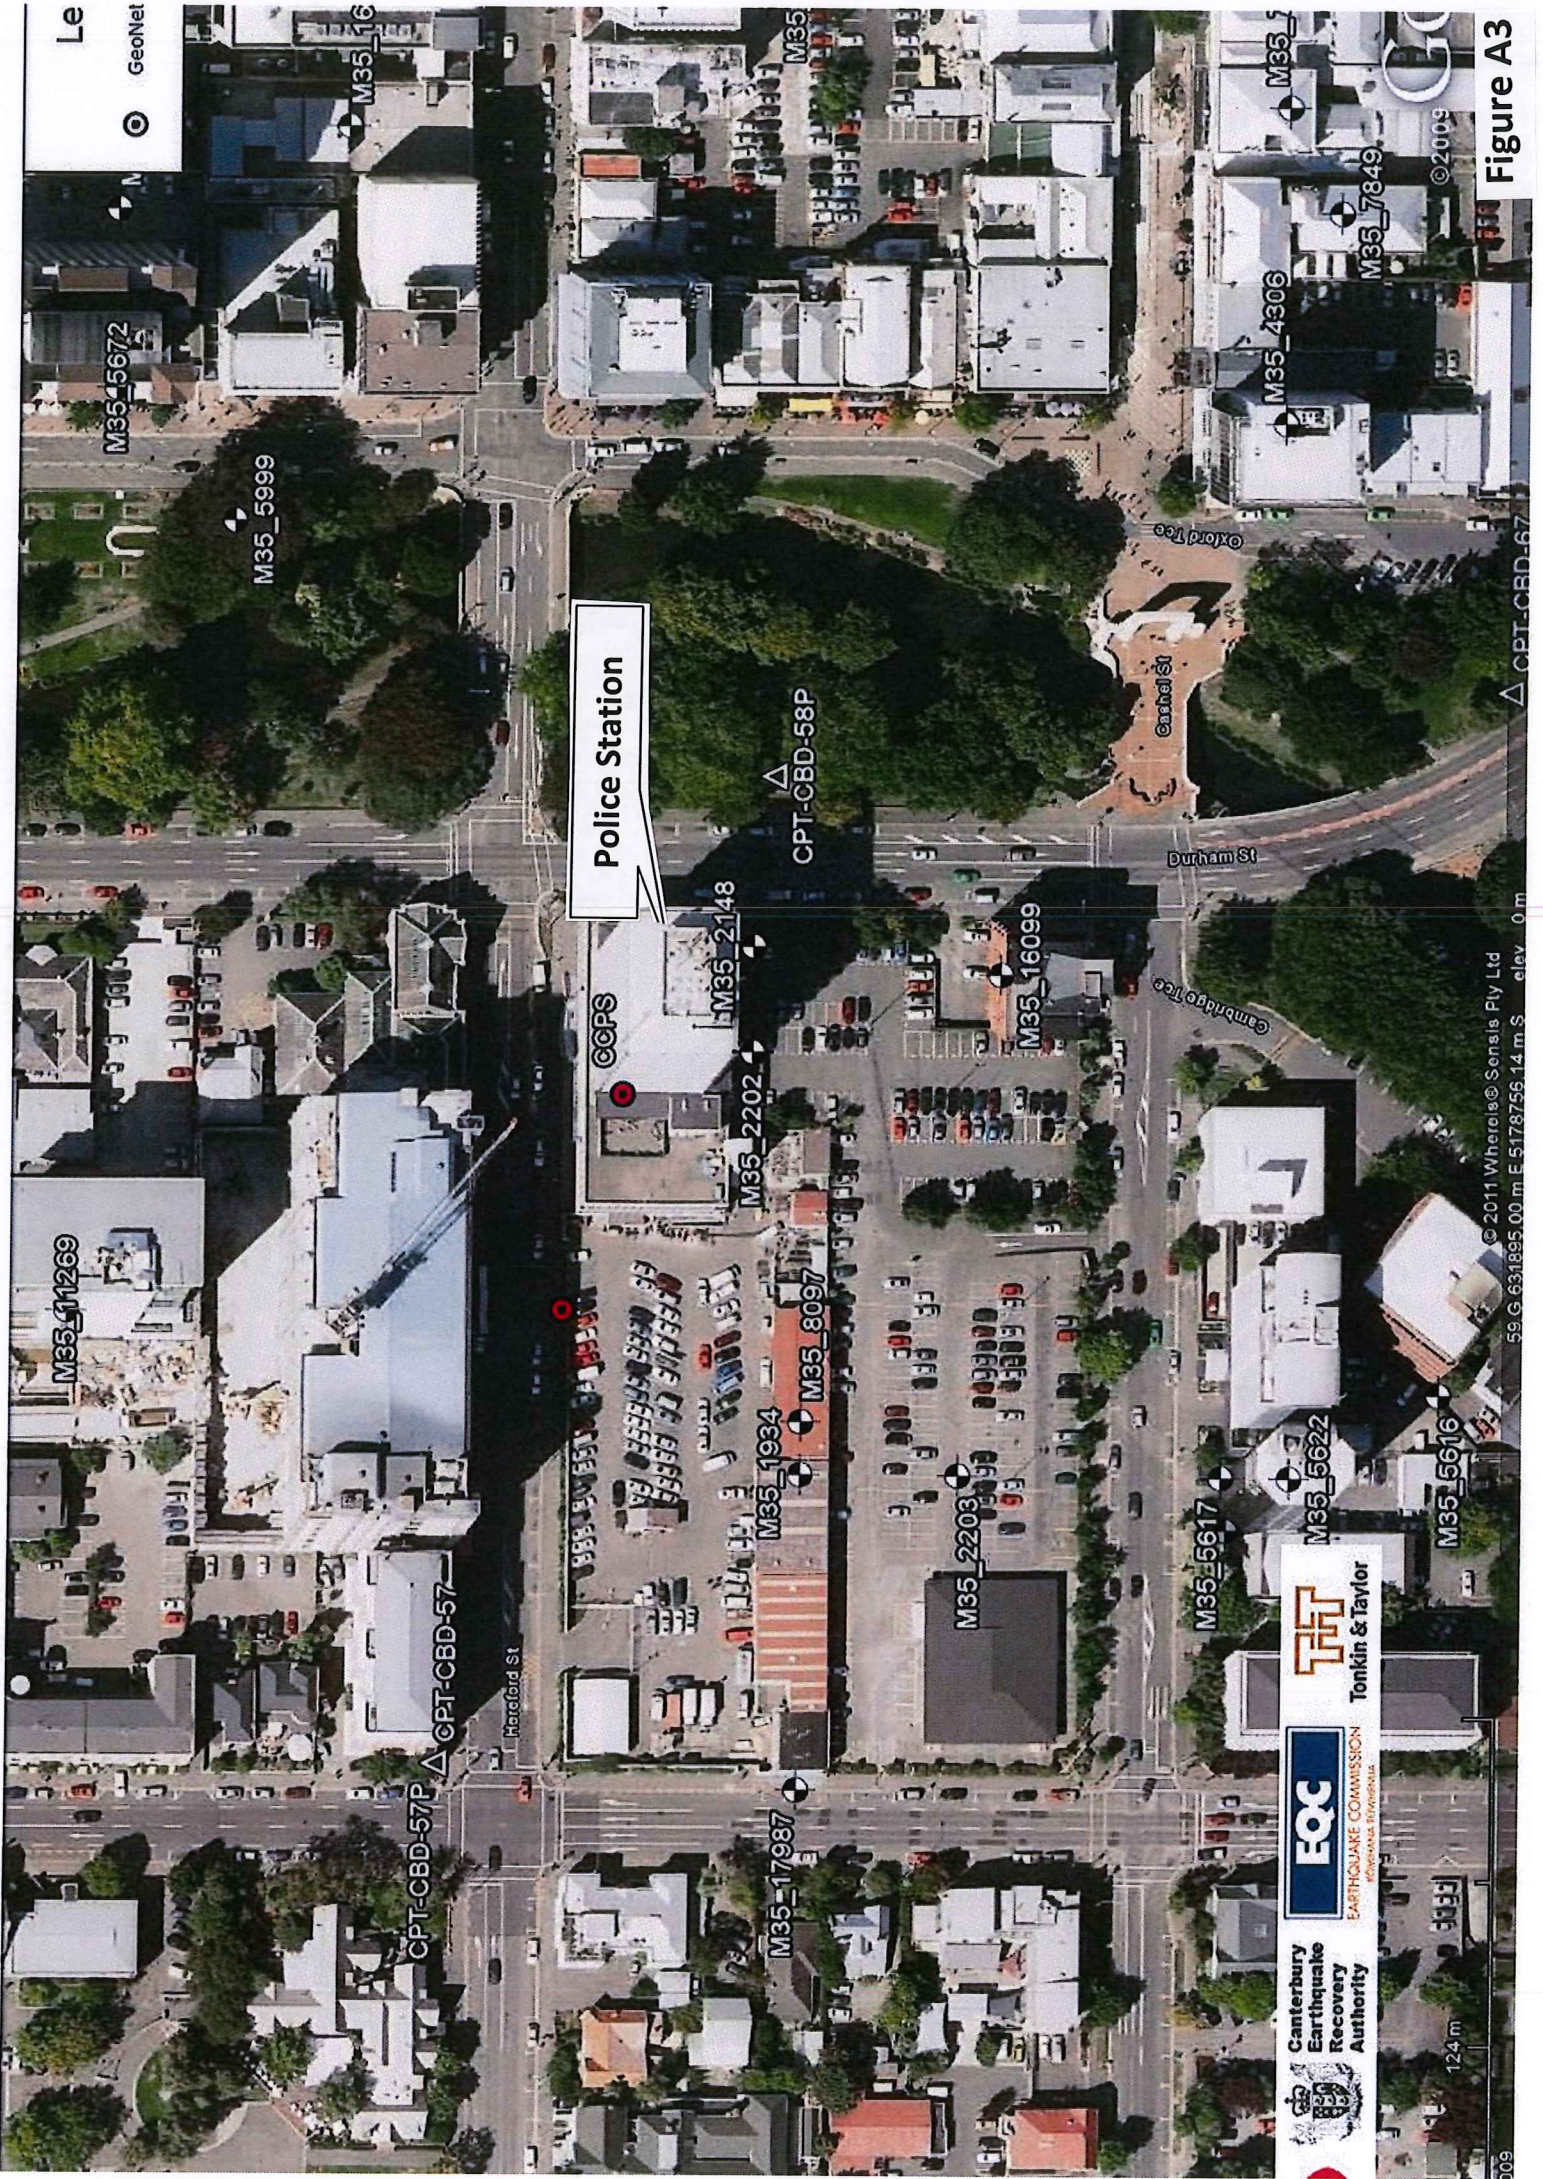
- i. The locations of the site investigation points surrounding the Police Station are shown on Figure A3 attached. The recording station CCPS (501) is also marked.
- ii. Several ECAN borehole logs are available for the immediate vicinity of the Police Station. Log for M35-2148 and M35-8097 are attached for information as Figures A4 and A5 (1 & 2)
- iii. Recent CBD investigations give detailed near-surface information (ref CPT CBD-58 attached as Figure A6- 1 & 2).
- iv. The GeoNet DELTA site gives information that is reasonably consistent with the other sources.
- v. Conclusion: The site conditions at the Police Station are similar to those at CTV Building site, though slightly more favourable/stiffer due to greater depth of near-surface gravel.
