PYNE GOULD CORPORATION BUILDING  
SITE EXAMINATION AND MATERIALS TESTS  
FOR DEPARTMENT OF BUILDING AND HOUSING  
17TH SEPTEMBER 2011

REPORT PREPARED FOR:  
**DEPARTMENT OF BUILDING AND HOUSING**

**DR CLARK HYLAND**

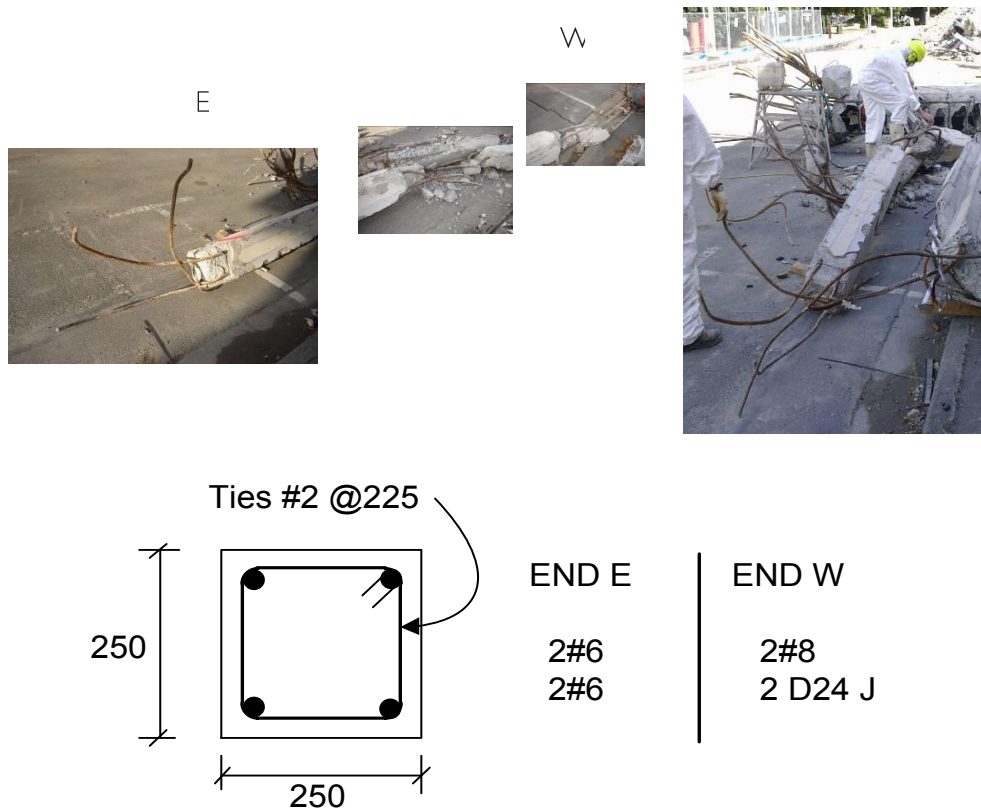
Figure 2 - Item 1 - 250 x 250 Concrete Column

This 250 x 250 mm concrete column had 12 mm solid plaster render on each face. It was possibly continuous over two levels with a 2200 mm portion designated W, separated by an 800mm gap to a 2970 mm portion (Figure 2).

The W portion had four #8 bars, two of which had bamboo deformations and a "JAPAN" rolling mark. The other two bars had diagonal deformations.

A bar with bamboo deformations measured 23.0 mm diameter using callipers. One with diagonal deformations measured 24.7 mm diameter. The bamboo bars therefore appear to have been metric 24 mm bars sourced from Japan, whereas the bars with diagonal deformations were #8 or 1" diameter bars. Samples of the Japanese bars were extracted for tensile testing and chemical analysis.

The E portion had four #6 bars with #2 ties at 225 centres. The ties had 135° re-entrant bends.

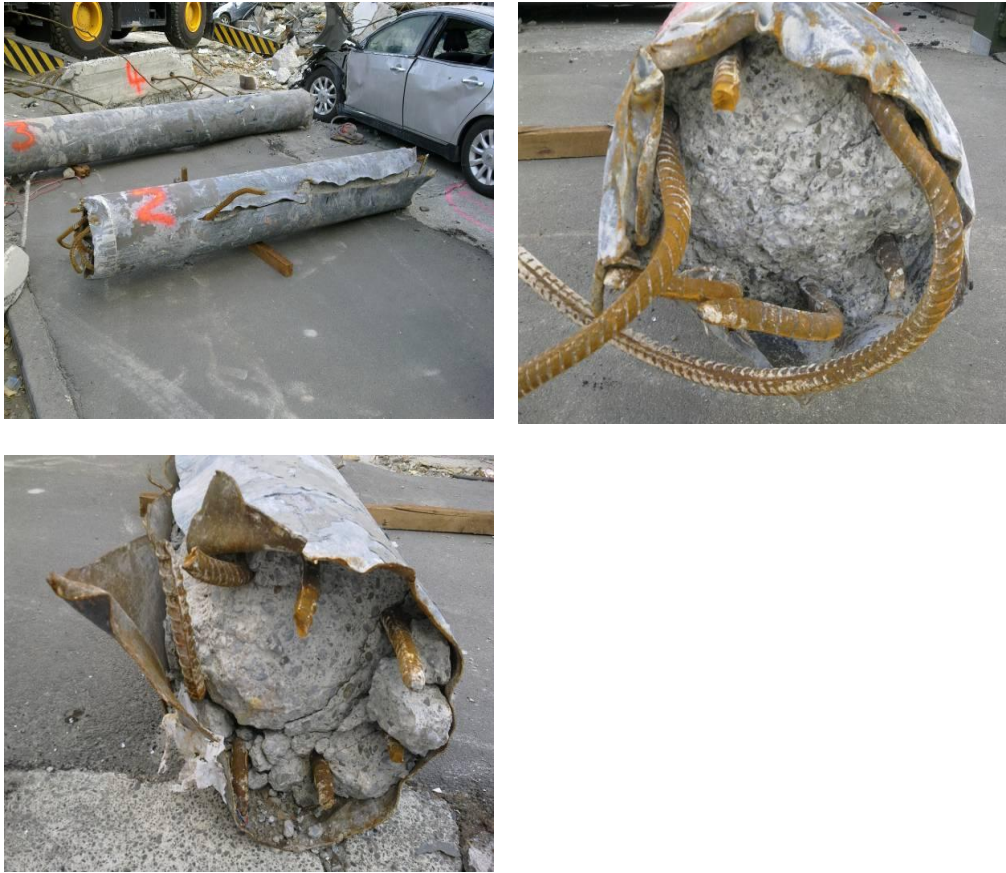
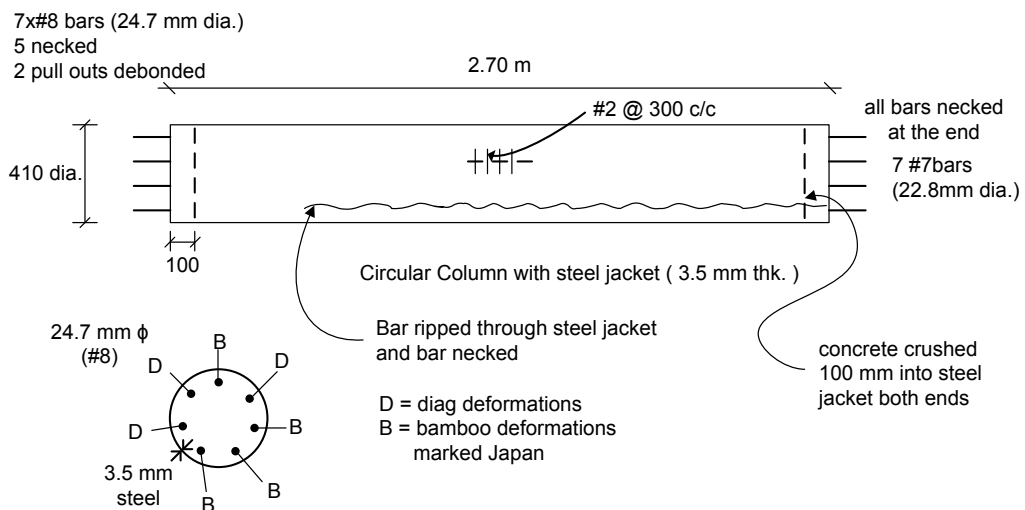
The steel jacketed concrete column was 2700 mm long and 410 mm diameter, with a 3.5 mm thick jacket.

Four bars had bamboo style deformations and had the rolling mark "JAPAN". These measured 23.0 diameter using vernier callipers. The other three had diagonal deformations and measured 24.7 mm in diameter. This indicates that the bamboo deformed bars were metric size D24 bars sourced from Japan, and the others were imperial size #8 bars.

One longitudinal bar had torn through the steel jacketing and the internal ties.

Five of the bars had necked and fractured and two had de-bonded at the end adjacent to the painted "2" marking on the beam.

At the other end all seven bars had necked and fractured.

Figure 3 - Item 2 - 410 dia. Steel Jacketed Concrete Column; (photos clockwise from top left) (a) Torn steel jacketing; (b) Numbered end of column with 5 fractured and 2 de-bonded bars; (c) Other end with 7 necked and fractured bars and crushed concrete zone

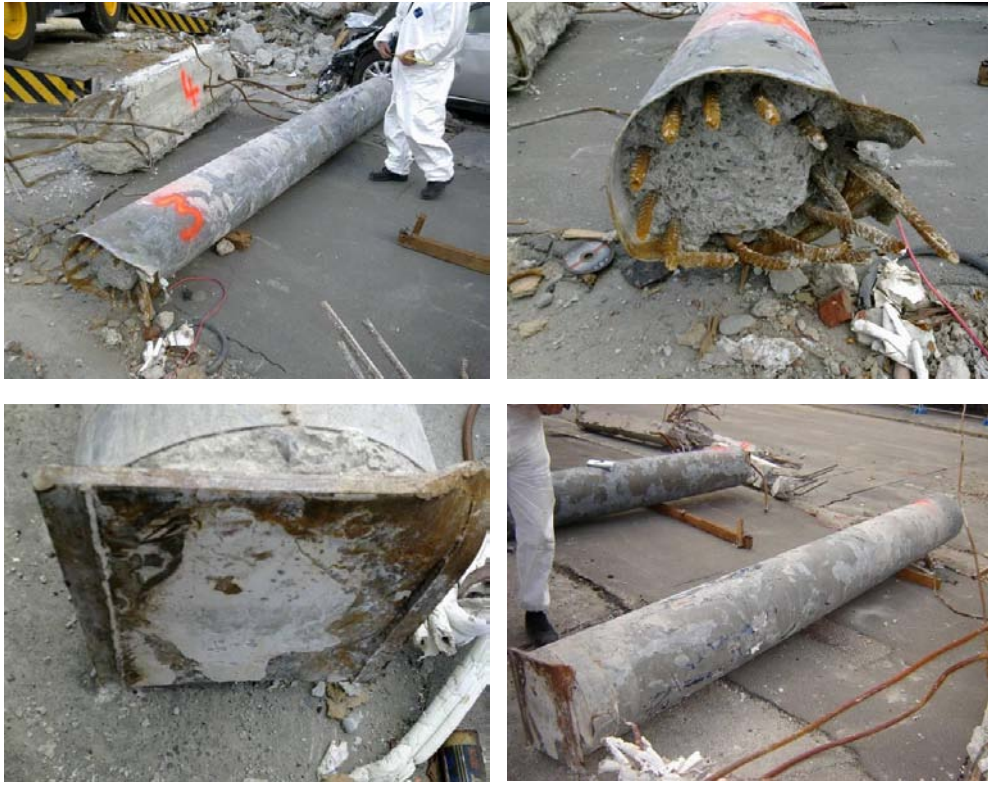
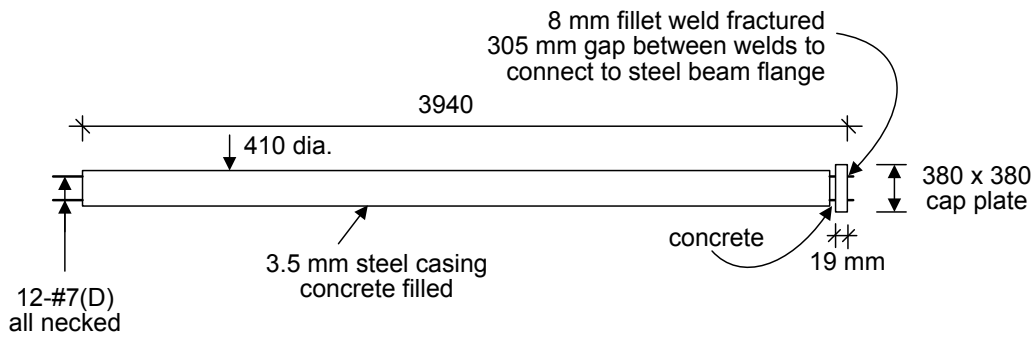
At the end of the column, adjacent to the painted "3" marking, which appeared to be the column base, all of the bars had necked and fractured.

The steel jacket had burst on one side and the concrete in that area crushed further up the column than the other side, indicating that compressive flexural failure occurred, rupturing the steel jacket.

A 380 x 380 x 19 mm cap plate was fixed to the top of the column. Two lines of 8 mm fillet weld spaced 305 mm apart had fractured where they connected what is thought to have been a steel welded girder, similar to those still in place at the time onto the remaining portion of Level 2 structure that was still standing (Figure 13).

Figure 4 - Item 3 -410 dia. Steel Jacketed Concrete Column with Cap Plate (photos clockwise from top left): (a) Column bottom end; (b) Burst jacketing on one side with deep crushed concrete zone and necked and fractured longitudinal bars; (c) Top end with cap plate; (d) Cap plate with two lines of fractured fillet weld 305 mm apart.

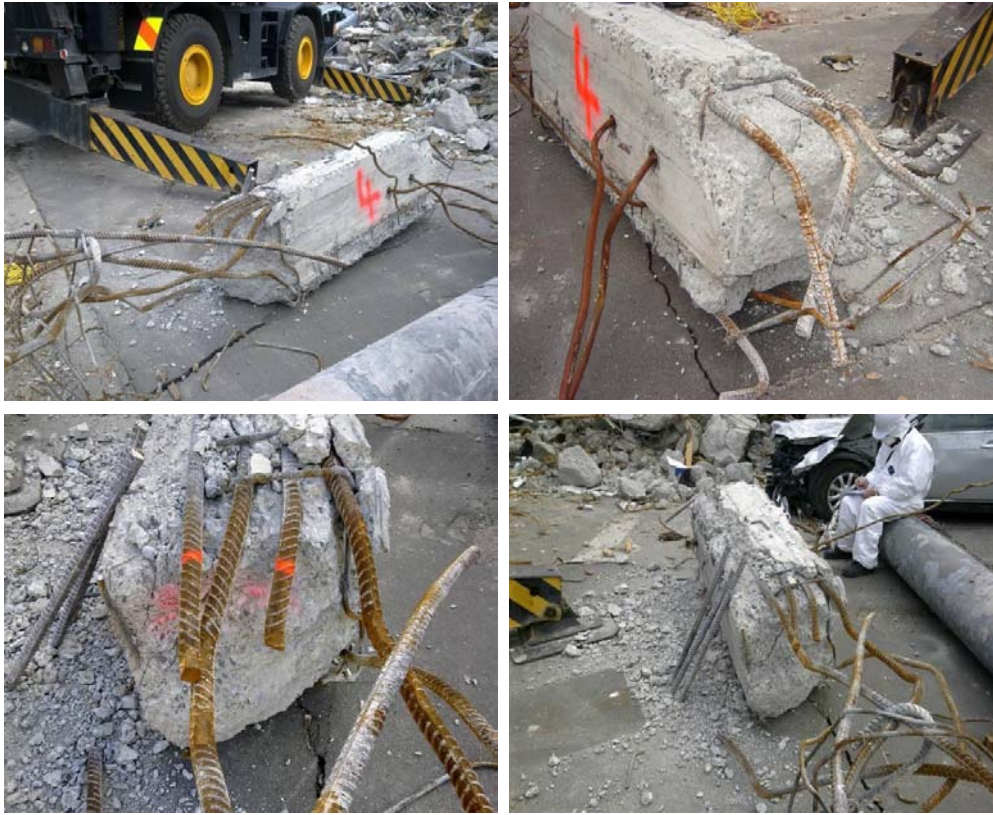
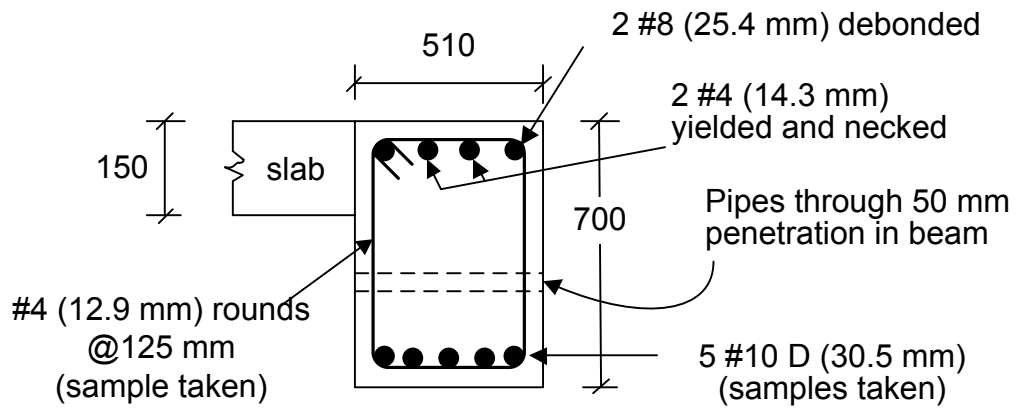
This 700 x 510 mm concrete beam remnant had five #10 (30.5 mm) bottom bars, two of which had flat fractures (Figure 6). The two fractured ends were removed for examination. This showed that the fractures most likely occurred during deconstruction, initiating at heavy abrasion marks and localised deformations on the bar surfaces from that process (Figure 6).

On the top of the beam there were two #8 (25.4mm) bars that had de-bonded and two #4 (14.3 mm) that had necked and fractured.

There was hairline diagonal cracking in the beam sides.

Figure 5 - Item 4 - 700 x 510 Concrete Beam (photos clockwise from top left): (a) Front with slab side down; (b) Rear; (c) Bar extracted; (d) Marked #10 bars with flat fracture surfaces

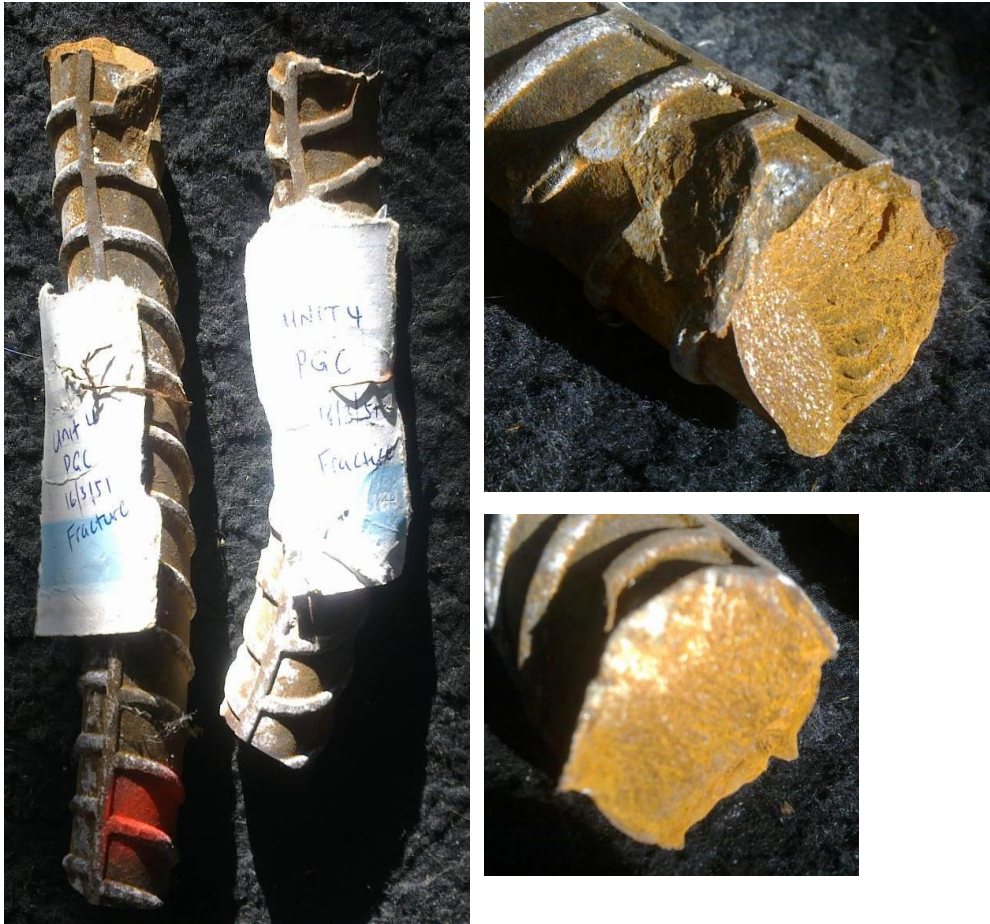
These bars were found during laboratory testing by SAI Global (NZ) Ltd to be of higher strength than the other bars and conformed to NZS 1879:1964 Grade HY60 (414 MPa) (SNZ 1964).

During tensile testing some fractured suddenly with a flat fracture surface similar to that seen on site after yielding, but prior to attaining their potential ultimate tensile strength.

Figure 6 - Item 4 - Orange marked #10 bars samples shown in Figure 5 with flat running fractures initiating from surface abrasion marks likely caused during deconstruction.

This achieved higher strength through the use of higher levels of carbon and other alloys resulting in a carbon equivalent that made it very susceptible to cracking when welded (Table 3). This can lead to sudden running flat fractures under load where notch defects are present, as was observed on site in Item 4 and during tensile testing.

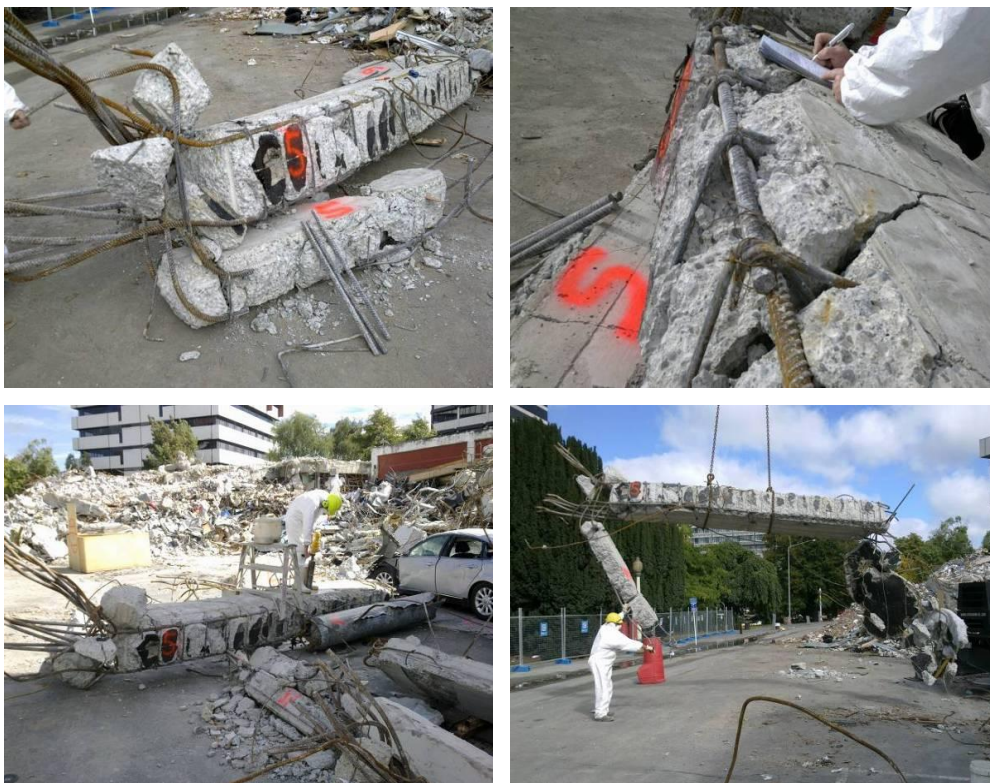
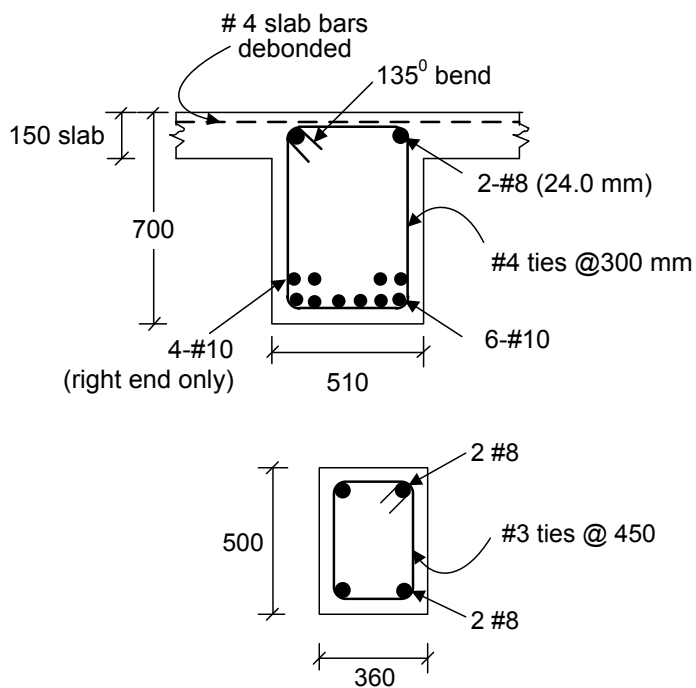
Black bituminous waterproofing remains were found on the top surface.

The #4 slab topping bars at 250 mm centres had de-bonded from the top of the beam.

Large diagonal shear cracks had opened up on the side of the beam and the 135° re-entrant stirrup hooks had partially straightened to around 100° in the proximity of the crack.

Figure 7 - Item 5 - 700 x 510 mm Concrete Beam and 500 x 350 mm Transverse Beam (photos clockwise from top left): (a) Top of concrete surface showing water proofing membrane remains; (b) Deep diagonal shear cracks in beam side with stirrup 135° re-entrant bend having partially straightened to around 100°; (c) beam being moved with transverse beam hanging down; (d) Concrete cores being drilled for compression testing.

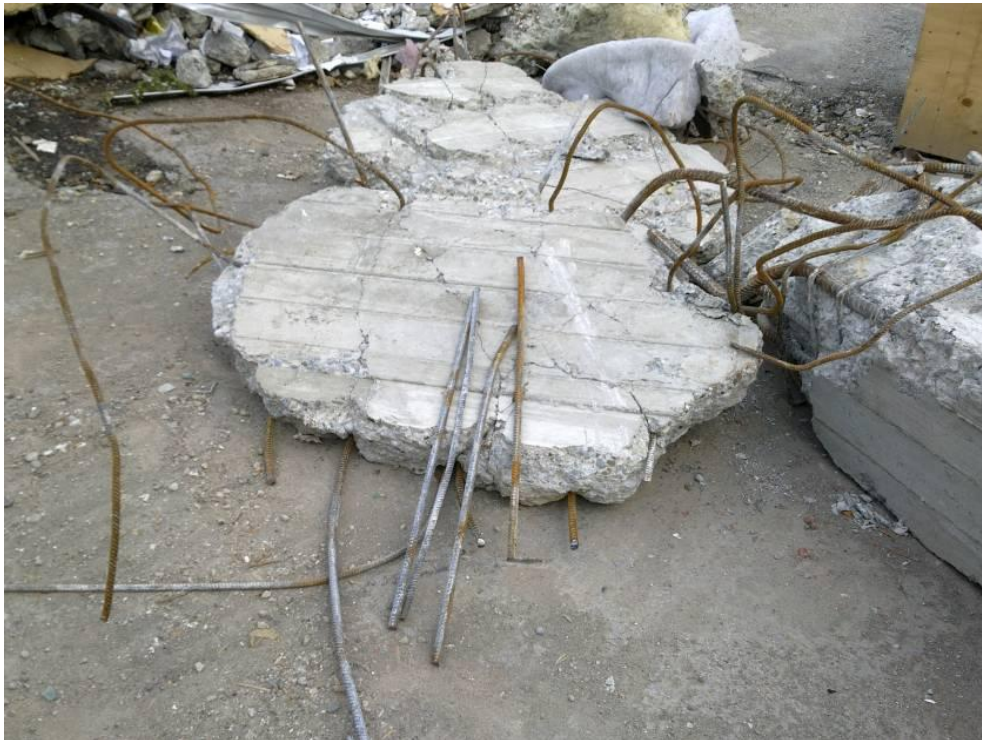
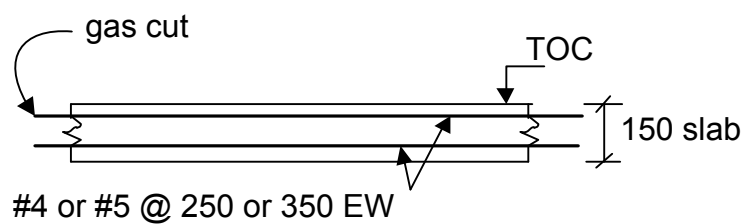
Figure 8 - Item 6 - 150 mm Slab

The reinforcing consisted of #4 or #5 bars at 250 or 350 mm centres each way on the faces. These had "Pacific Steel" roller markings.

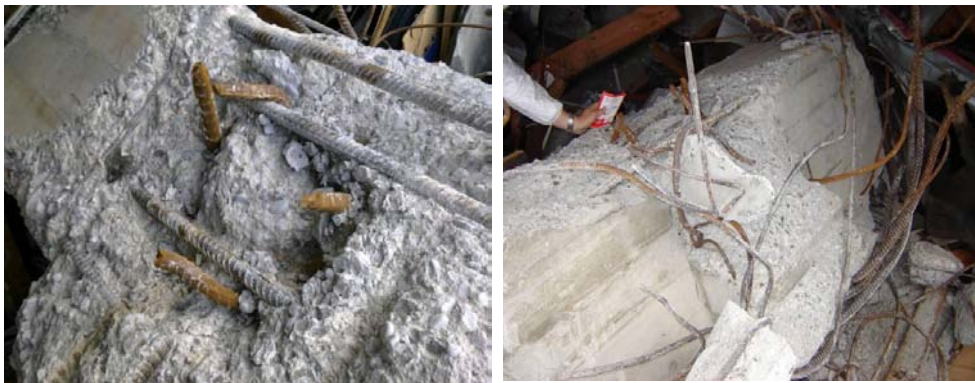
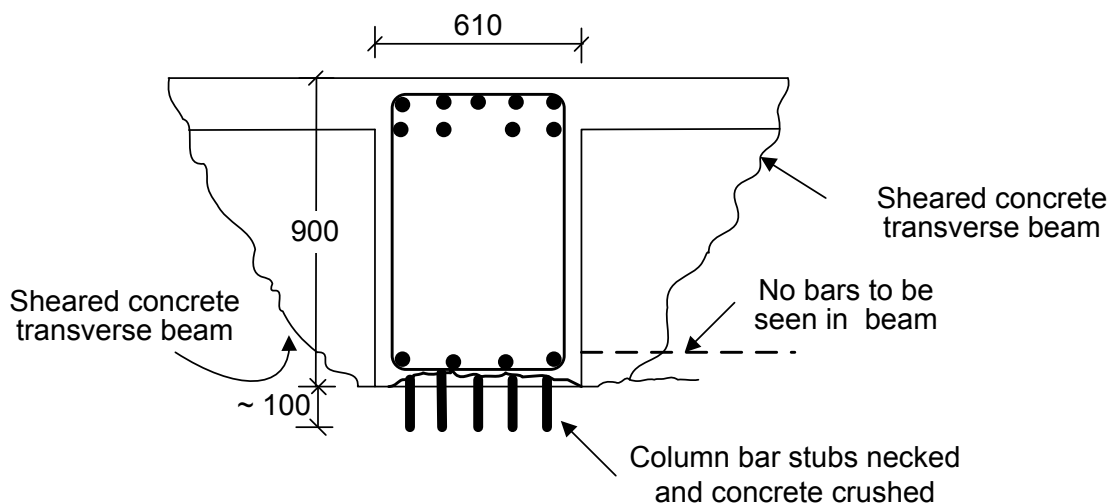
This was a beam to beam and 410 mm diameter steel jacketed concrete column junction, similar to that in Item 2 (Figure 3). There were nine necked and fractured #7 bars seen on the underside of the junction (Figure 10).

Concrete had crushed and spalled away from the bottom four beam bars that ran through the junction.

The two transverse beams that ran into the junction each side had sheared off and stubs with diagonal fracture faced remnants were left.

Main beam – with beam/column joint at secondary beam (junction)  
 - 9 #8 bars in top  
 - 4 bottom bars in beam

Figure 10 - Item 8A - 900 x 610 mm Concrete Beam to Steel Jacketed Column Joint (from left to right): (a) Underside of junction with 9 necked and fractured steel jacketed column bars and crushed concrete zone; (b) Underside of beam is on top with diagonal fracture face of tributary beam shown.

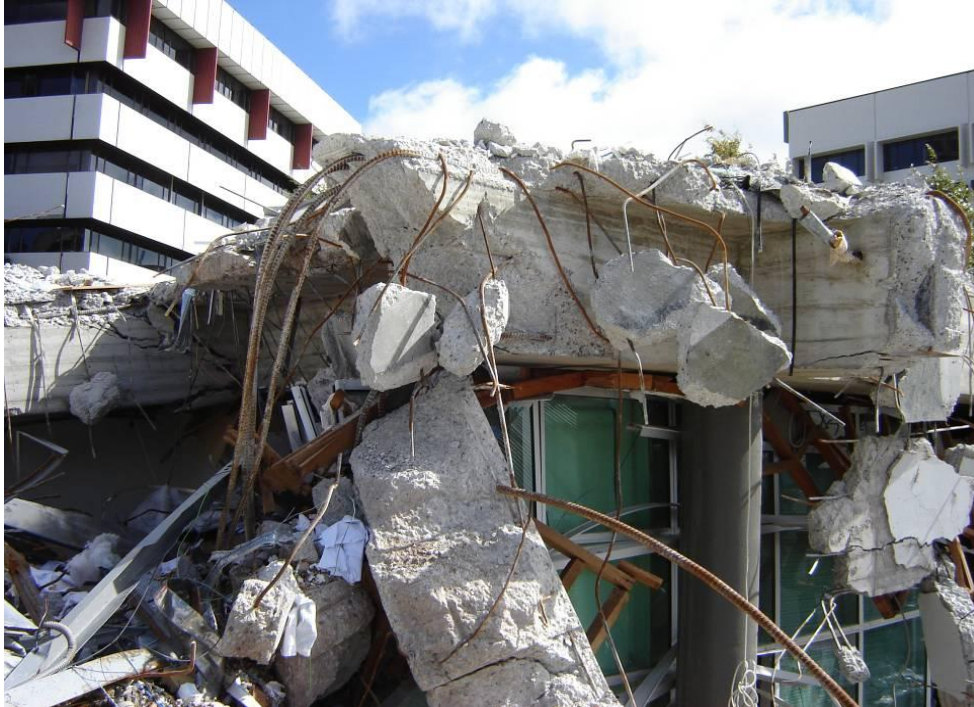
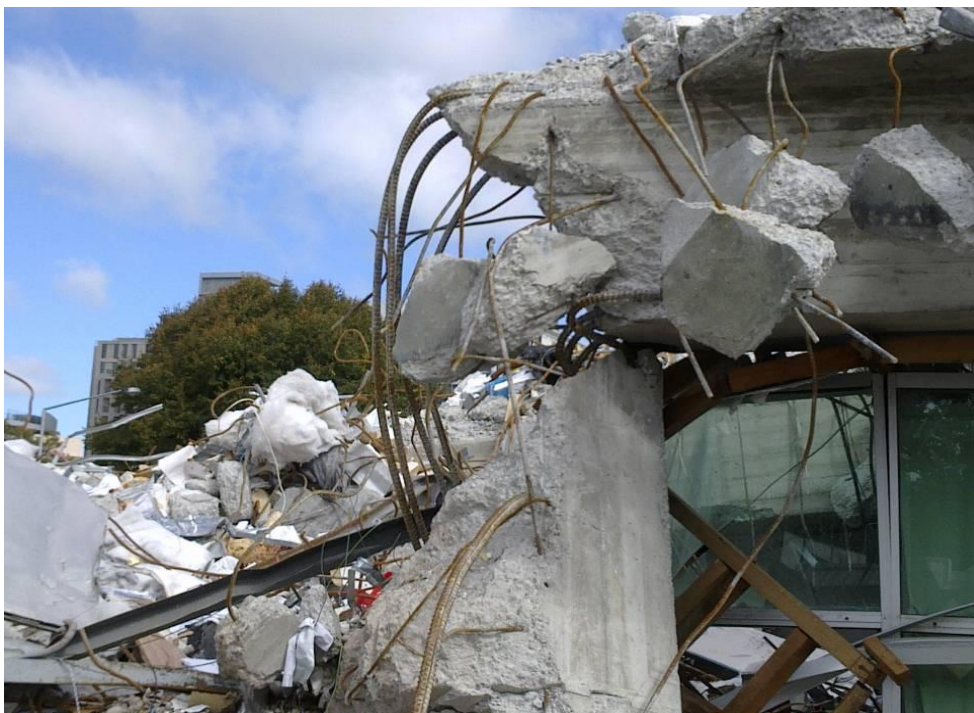
Figure 12 - Sheared concrete beam attached to portion of floor still standing

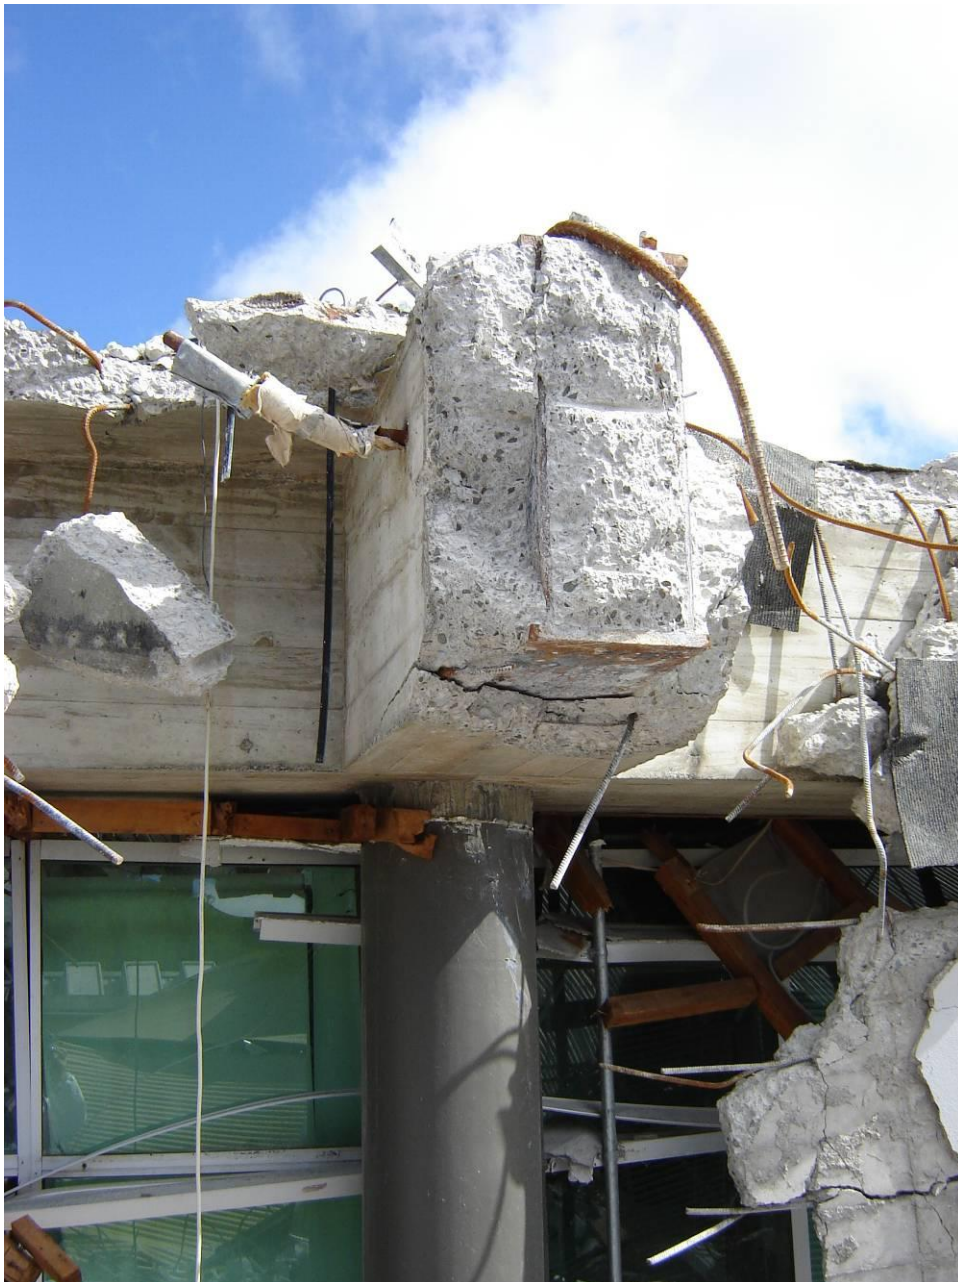
Figure 13 - Concrete Encased Steel Girder on Steel Jacketed Concrete Column

This was the end stub of a concrete encased double web welded steel girder on the portion of suspended floor still remaining standing (Figure 13).

The form of construction is consistent with that seen on the steel jacketed column with cap plate and fractured weld described in Item 3 (Figure 4).

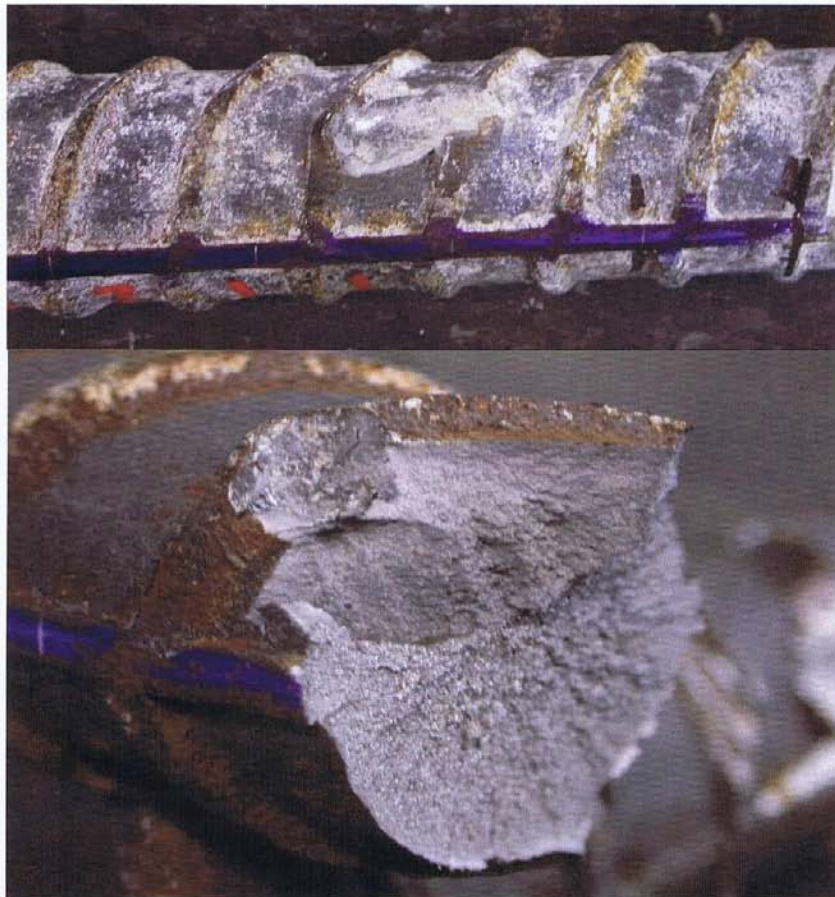
Two of the #10D Unit 4 16/3/11 samples had sustained damage and are shown in figure 4 and figure 5.

**Figure 4 – Unit 4 16/3/11a before and after fracture**
