Investigation into the Collapse of the Pyne Gould Corporation Building on 22nd February 2011

Prepared for Department of Building and Housing (DBH)

By Beca Carter Hollings & Ferner Ltd (Beca)

26th September 2011

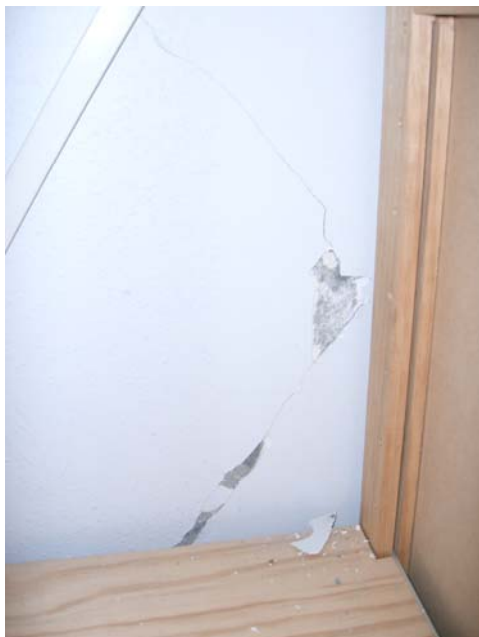
(a) Cracking to Level One Shear Wall in Storeroom (inside the Southern End of the Shear-Core). Crack Widths between 0.2 and 0.6 mm.

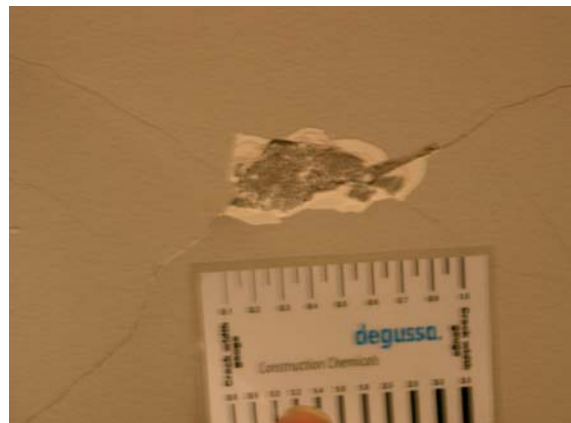
(b) Cracking to Level One Shear Wall. Typically less than 0.2 mm.

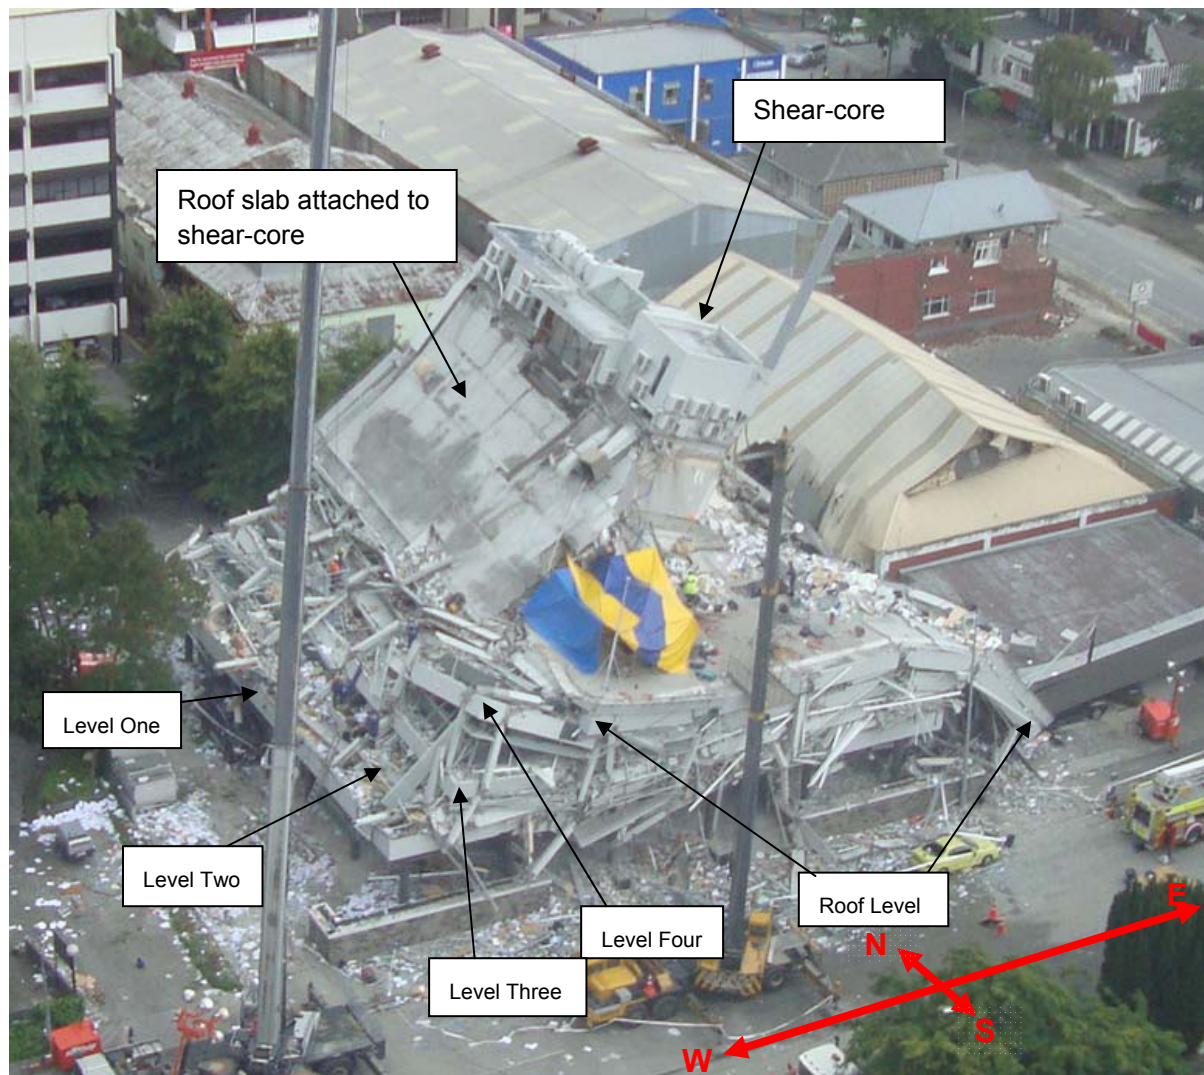
Figure 7.1 : General Location of Main Structural Components after Collapse

- The shear-core had rotated about the west wall at Level One and was finally left at an angle of approximately 68 degrees to the horizontal.
- The shear-core east wall was lost between Level One and Level Two
- The floor slabs at roof and at Levels Four, Three, Two and One were displaced to the east by approximately 9, 4.5, 3.8, 2.5 and 0 metres, respectively.
- The floor slabs to the west were stacked almost on top of one another indicating very little rotation in plan occurred (i.e., collapse occurred almost entirely along the east-west axis of the building).

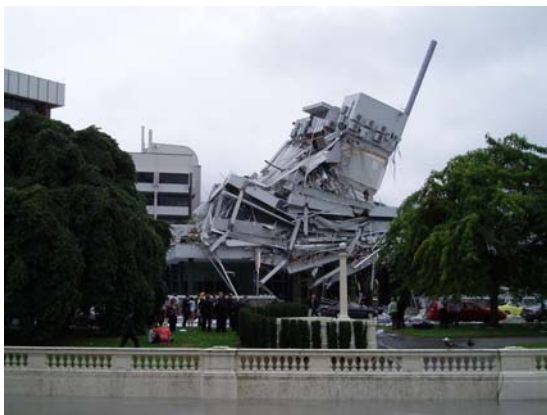
(a) View from the South

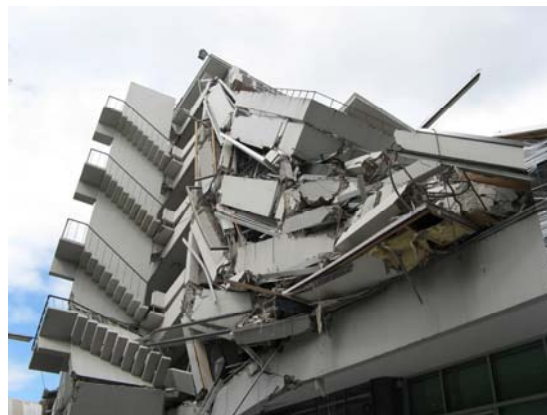
(b) View from North-West showing Floors still Attached to Shear-Core on West Side

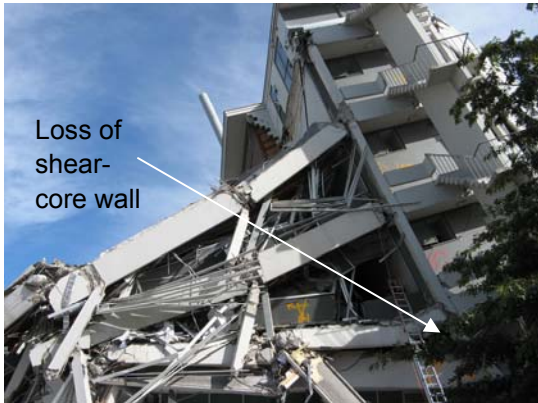
(c) View from the North-East showing Levels Two, Three and Four Floor Slabs still Attached to Shear-Core. Note Loss of Shear-Core East Wall between Levels One and Two

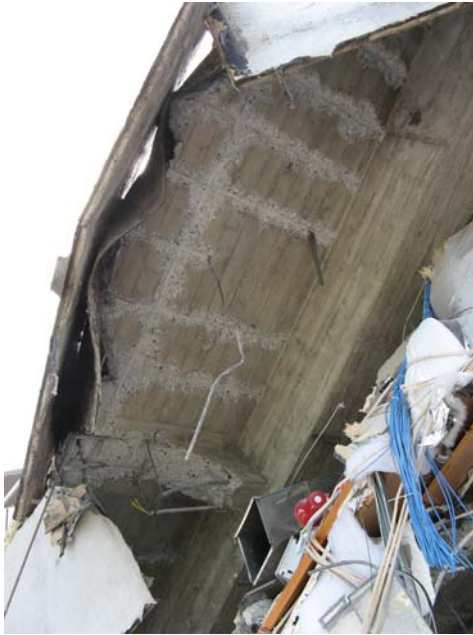
(g) Soffit of Slab Showing where Slab Reinforcement has been Ripped from Slab

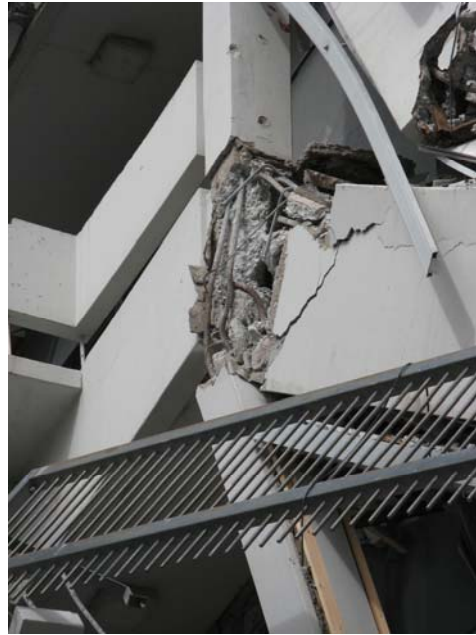
(h) Typical Perimeter Beam/Column Joint. Note Lack of Joint Ties

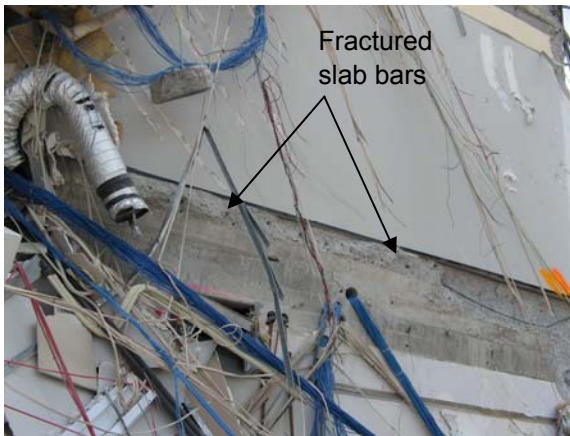
- The slabs detached from the east and south sides of the shear-core. The roof slab on the east side of the shear-core detached and slid over the collapsed floors below into the adjacent building.
- The roof slab remained attached to the west side of the shear-core. Photographs taken from the north indicate that the other slabs may have also remained attached on this side but this has not been confirmed.
- The joint regions between the perimeter columns and beams suffered extensive damage (spalling of concrete), with a number of columns punching into the joint or completely detaching from the beams.
- There was evidence of slab reinforcement, close to the slab surface soffit having been pulled from the concrete.
- There was also evidence of slab reinforcement having fractured at the junction between the slab and wall.

(i) Fractured Slab Reinforcement at Wall/Roof Slab Interface on the East Side of the Shear-Core

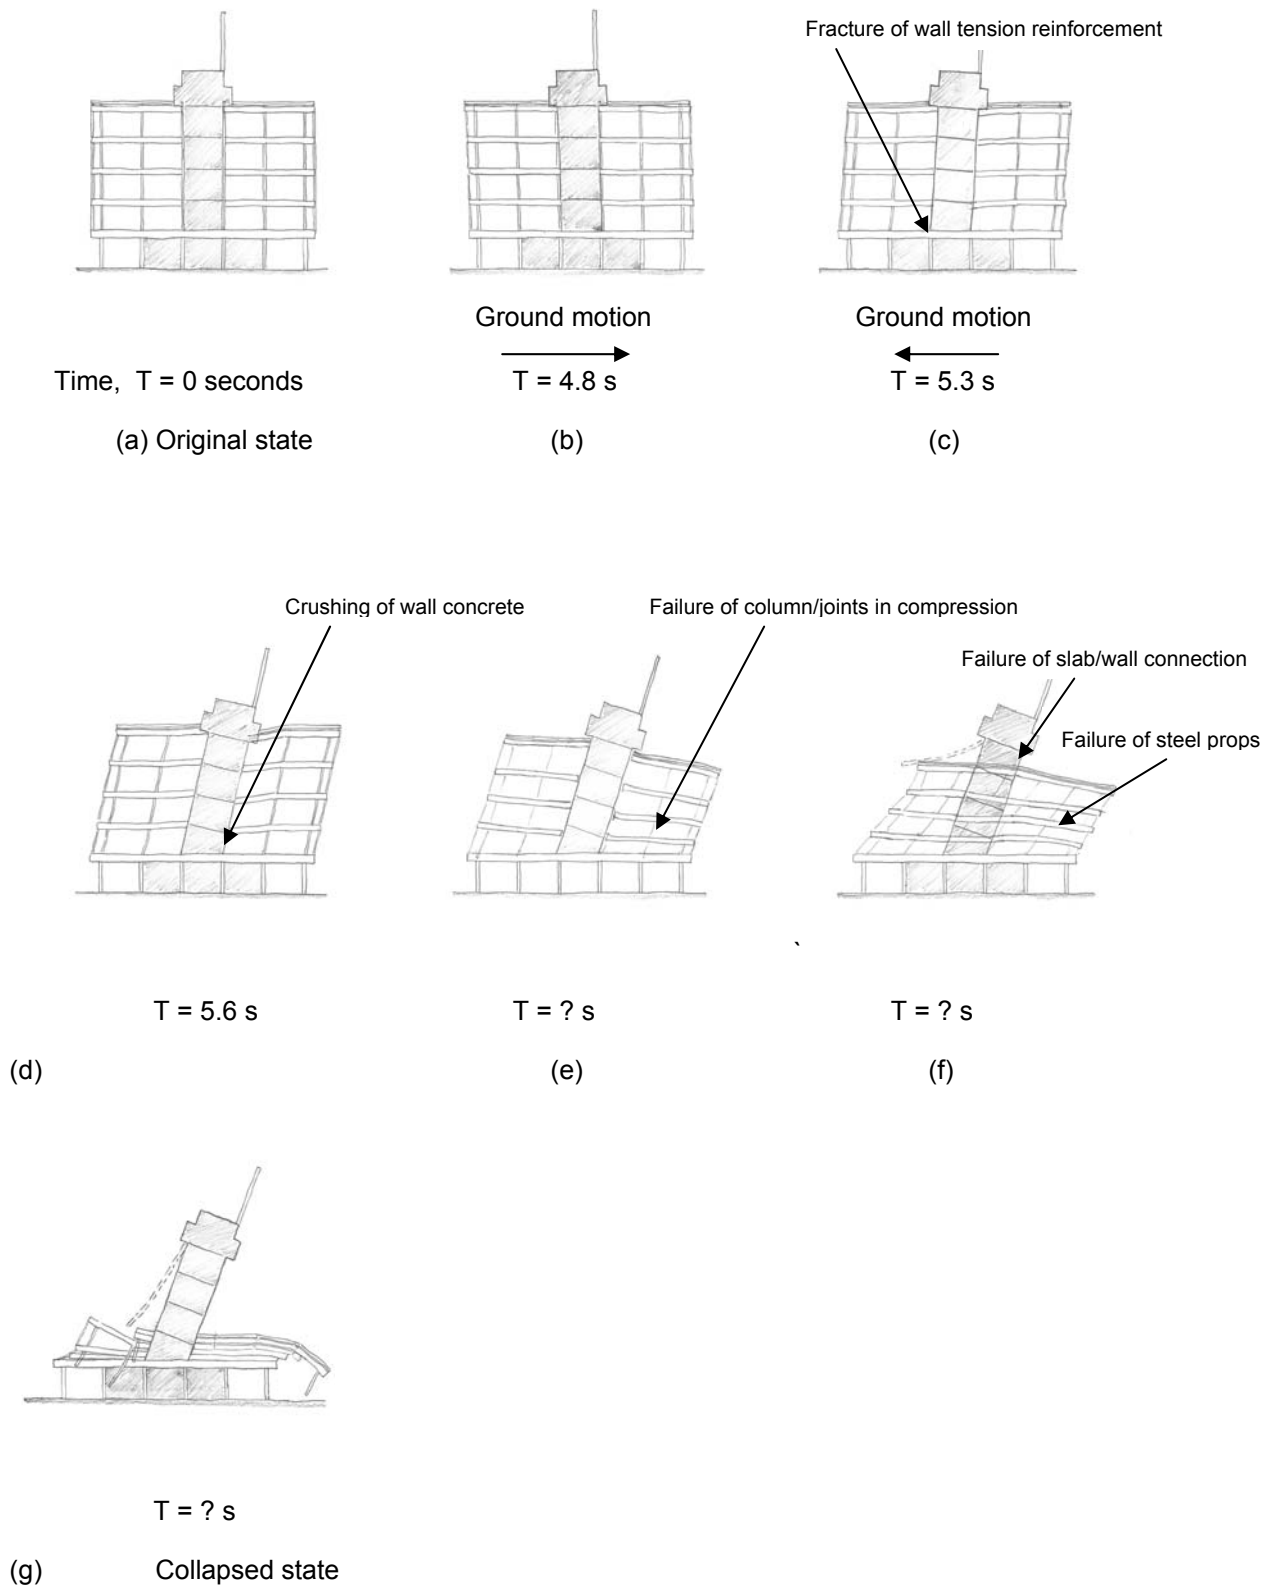
Figure 9.1 : Inferred Collapse Sequence

- In the early stages, the building experienced violent shaking that caused various parts of the shear-core to yield (i.e., to stretch plastically). This is likely to have resulted in moderate cracking, but this has not been able to be confirmed.
