Christchurch Earthquake

**Report on the Structural Performance
of the
Hotel Grand Chancellor
in the
Earthquake of 22 February 2011**

Prepared By:
Dunning Thornton Consultants Ltd

Final: 26 September 2011

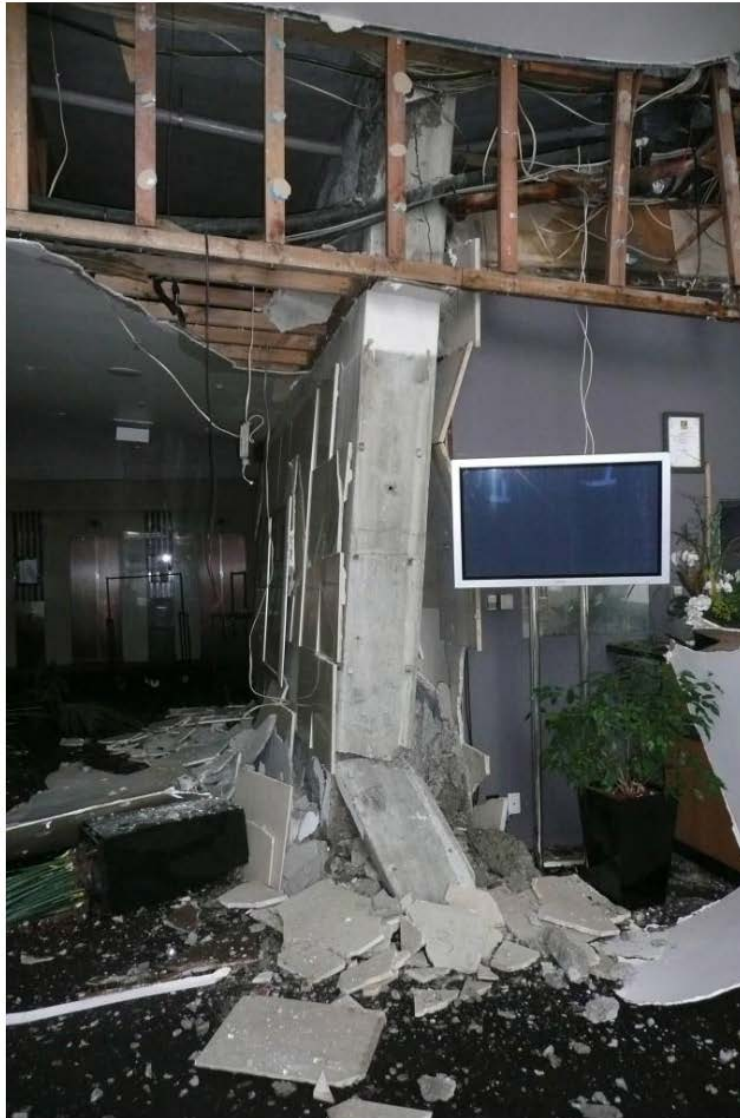
Photo 6 - Shearwall D5-6 - Base Failure

This wall failed between ground and first floor and effectively shortened by approximately 800mm. As a result, the tower structure developed a lean towards the south-east corner. The failure took the form of a brittle diagonal failure transversely across the wall that appears to have originated at the top of a vertical reinforcing splice located 700mm above the ground floor. The wall dropped, sliding off the diagonal crack, moving towards the west. There was

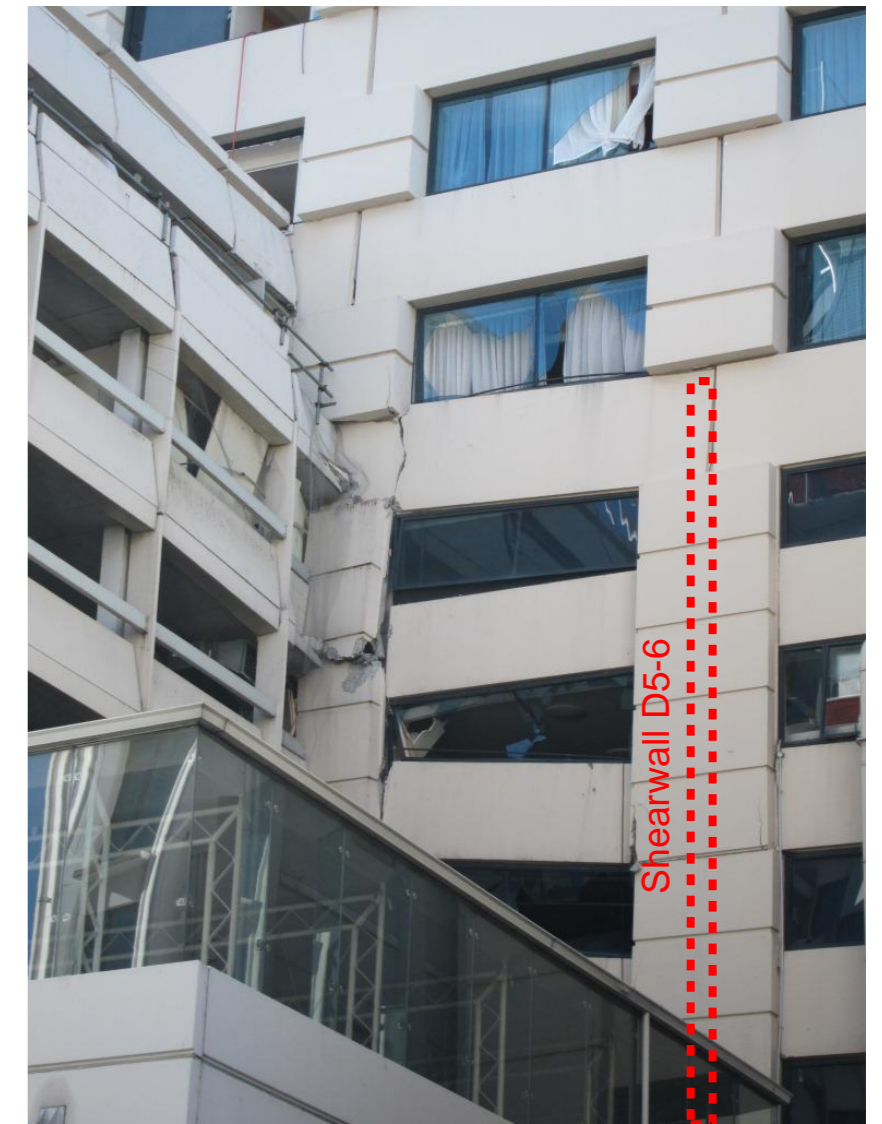
Photo 5 - Damage at junction between podium and tower - not related to pounding

Following the 22 February event, there were media reports that pounding was the cause of the Grand Chancellor failure. While the damage to the southern (Cashel Street) façade has an appearance that could, at first glance, be interpreted as resulting from pounding, this was in fact vertical displacement damage caused as the D5-6 wall failed. *[Refer App. C Photograph 5]*

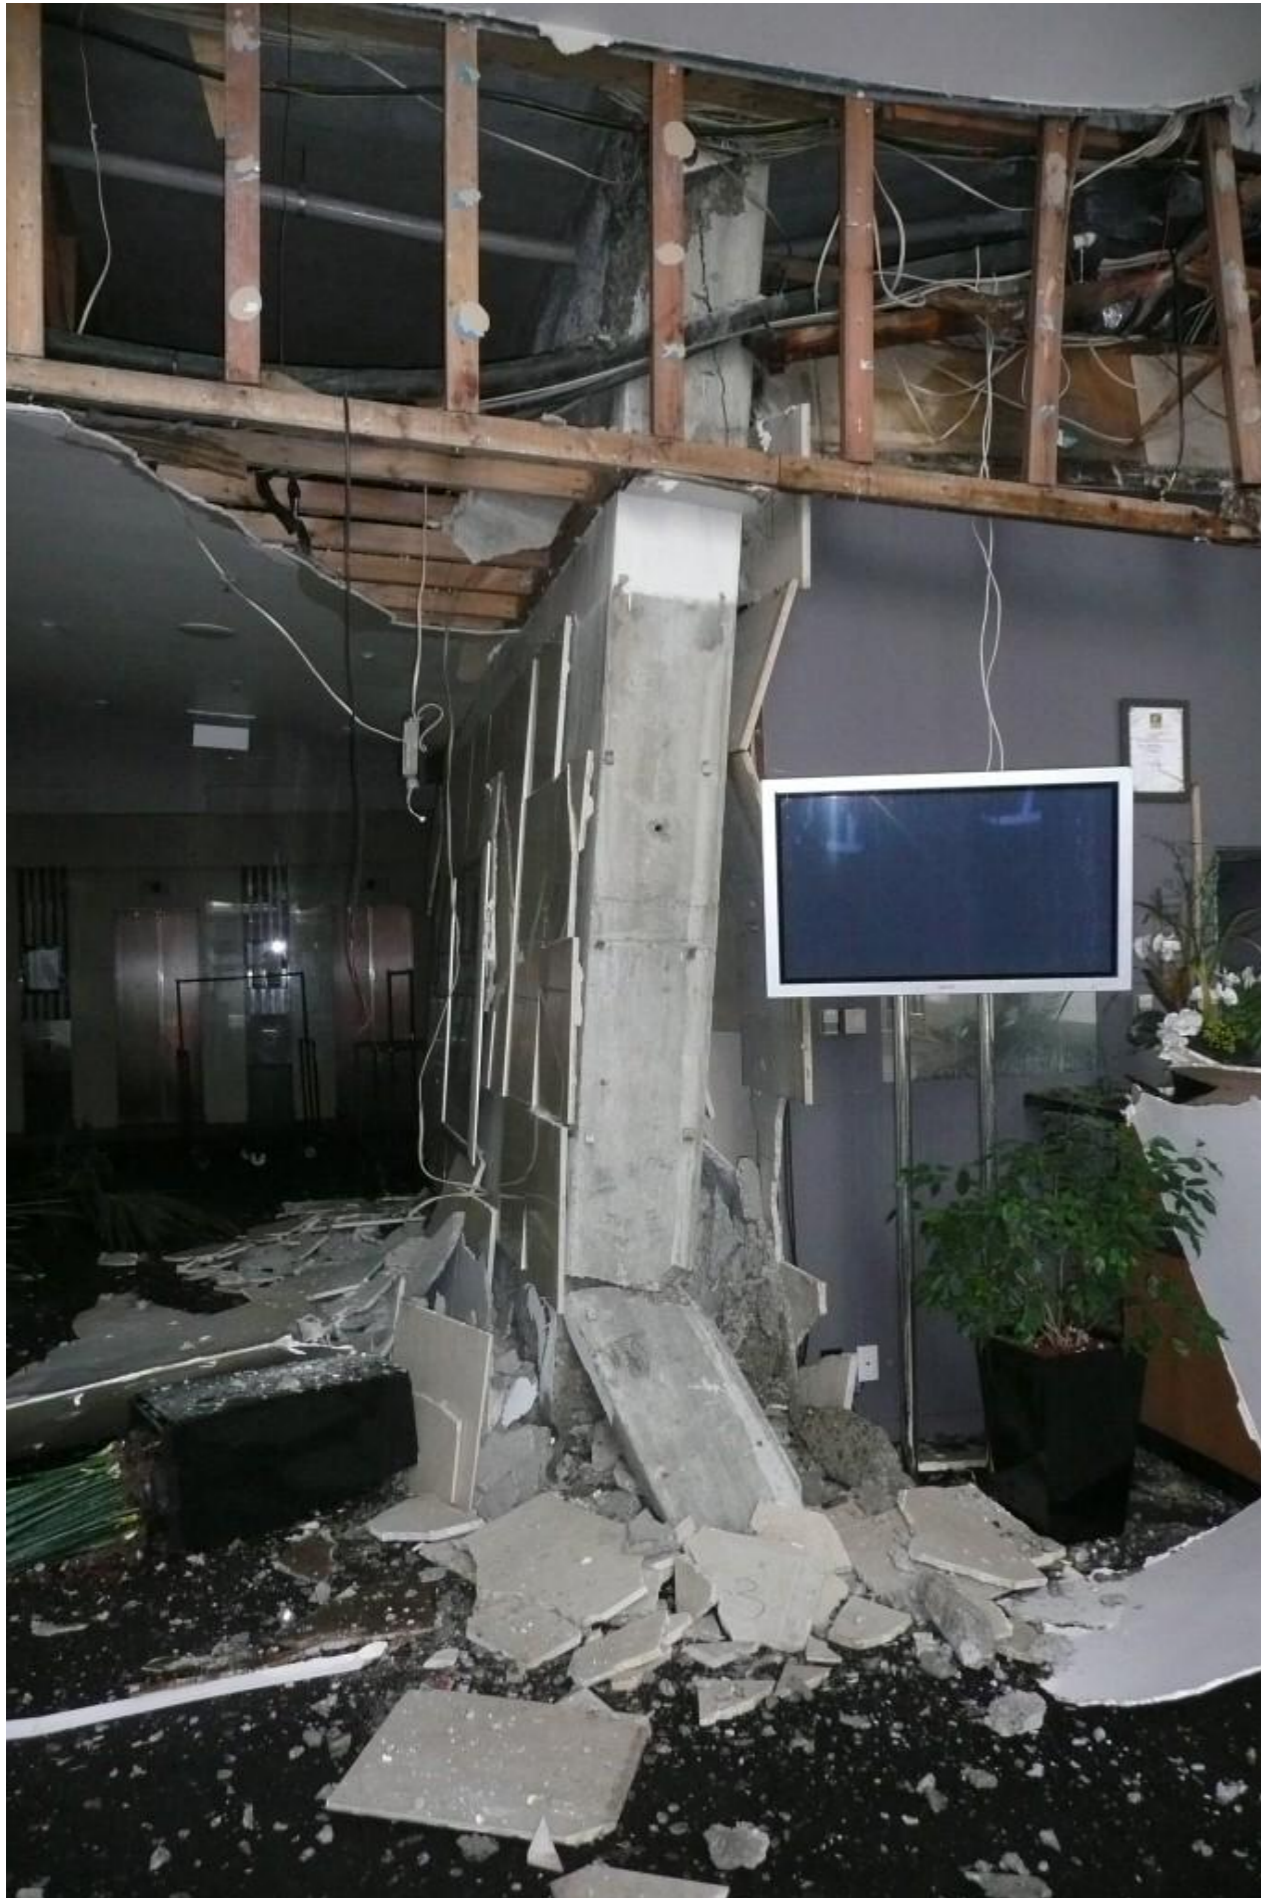
Photo 6 - Shearwall D5-6 - Base Failure

evidence of a corresponding lateral hinge at the underside of the first floor.
[Refer App. B page 12 & App. C Photographs 6-10]

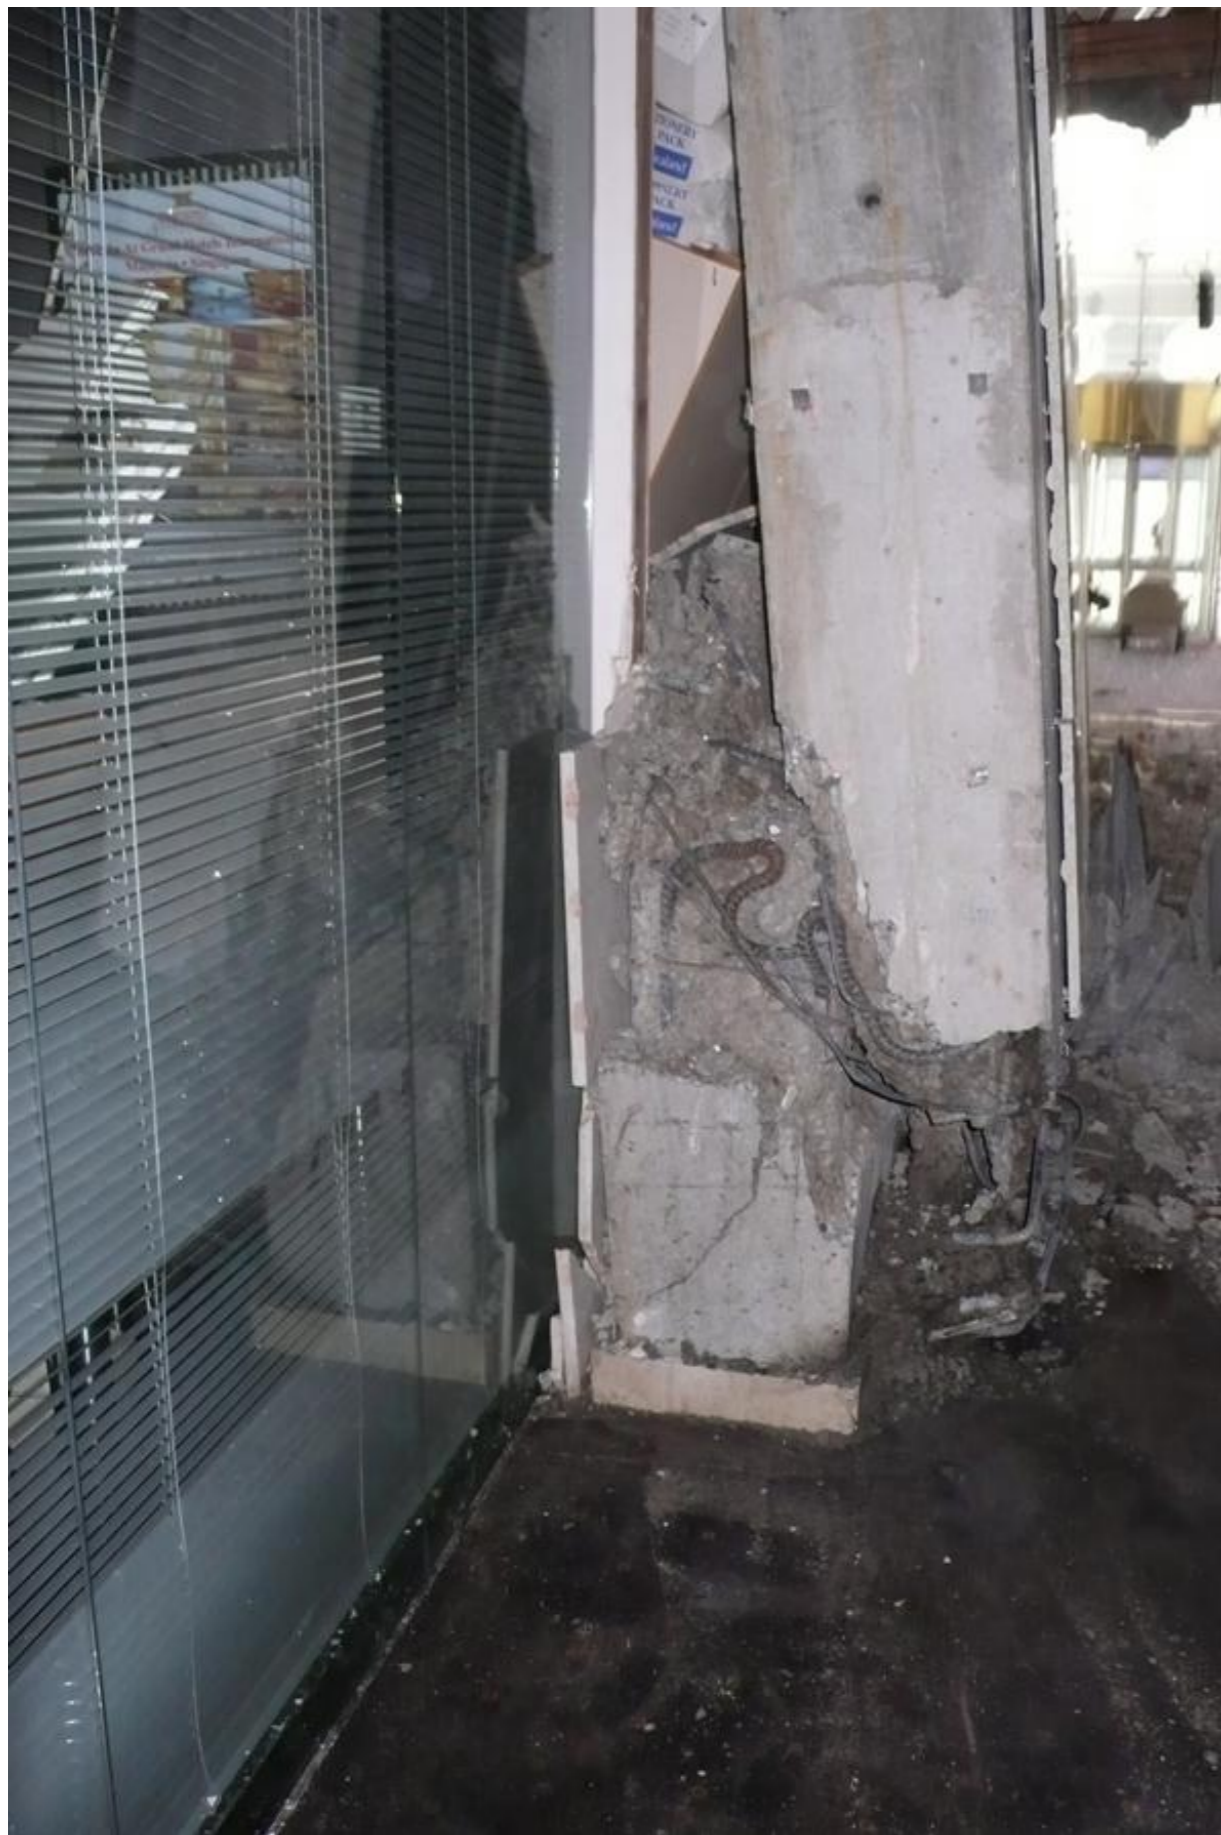
Photo 9 - Shearwall D5-6 Failure - End View

Brittle, transverse failure,
absence of confinement

Lapped reinforcing

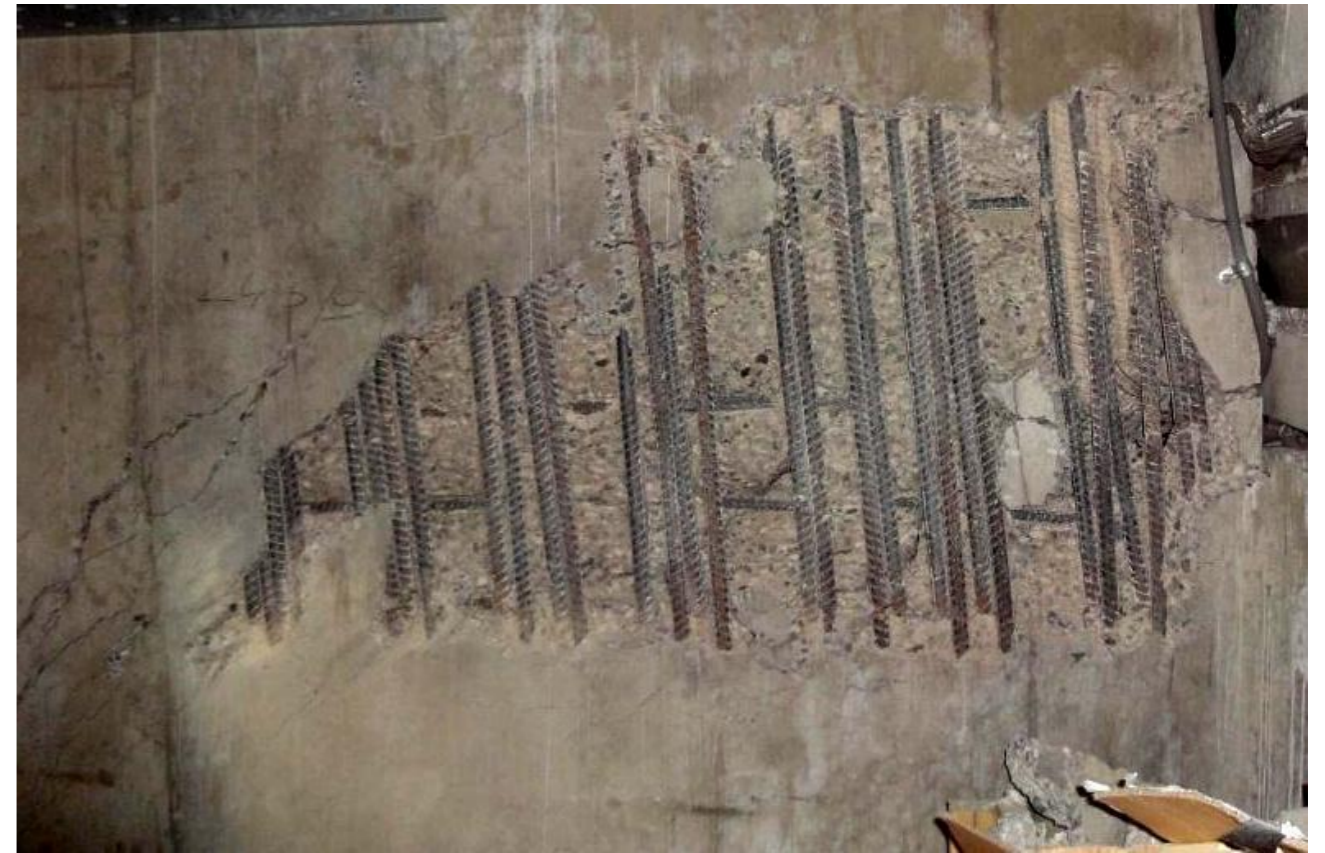
Photo 15 - Near-lap failure grid 8 cantilever transfer beam

Parallel to the level 12-14 cantilever transfer beams on grids 5 and 6 is a further cantilever beam on grid 8. This beam is also a full floor-to-floor depth between levels 12 and 14 and is an extension of the main spine shear wall on grid 8. This beam supports the hanging column at E8 which, as described in 6.4, experienced a major increase in load as the south-eastern corner of the tower dropped. As the hanger load increased a lap failure initiated in the lapped beam stirrups and the bars slipped by up to 80mm. This mechanism appears to have come close to collapse. *[Refer App. B page 14 & App. C Photographs 15 & 16]*

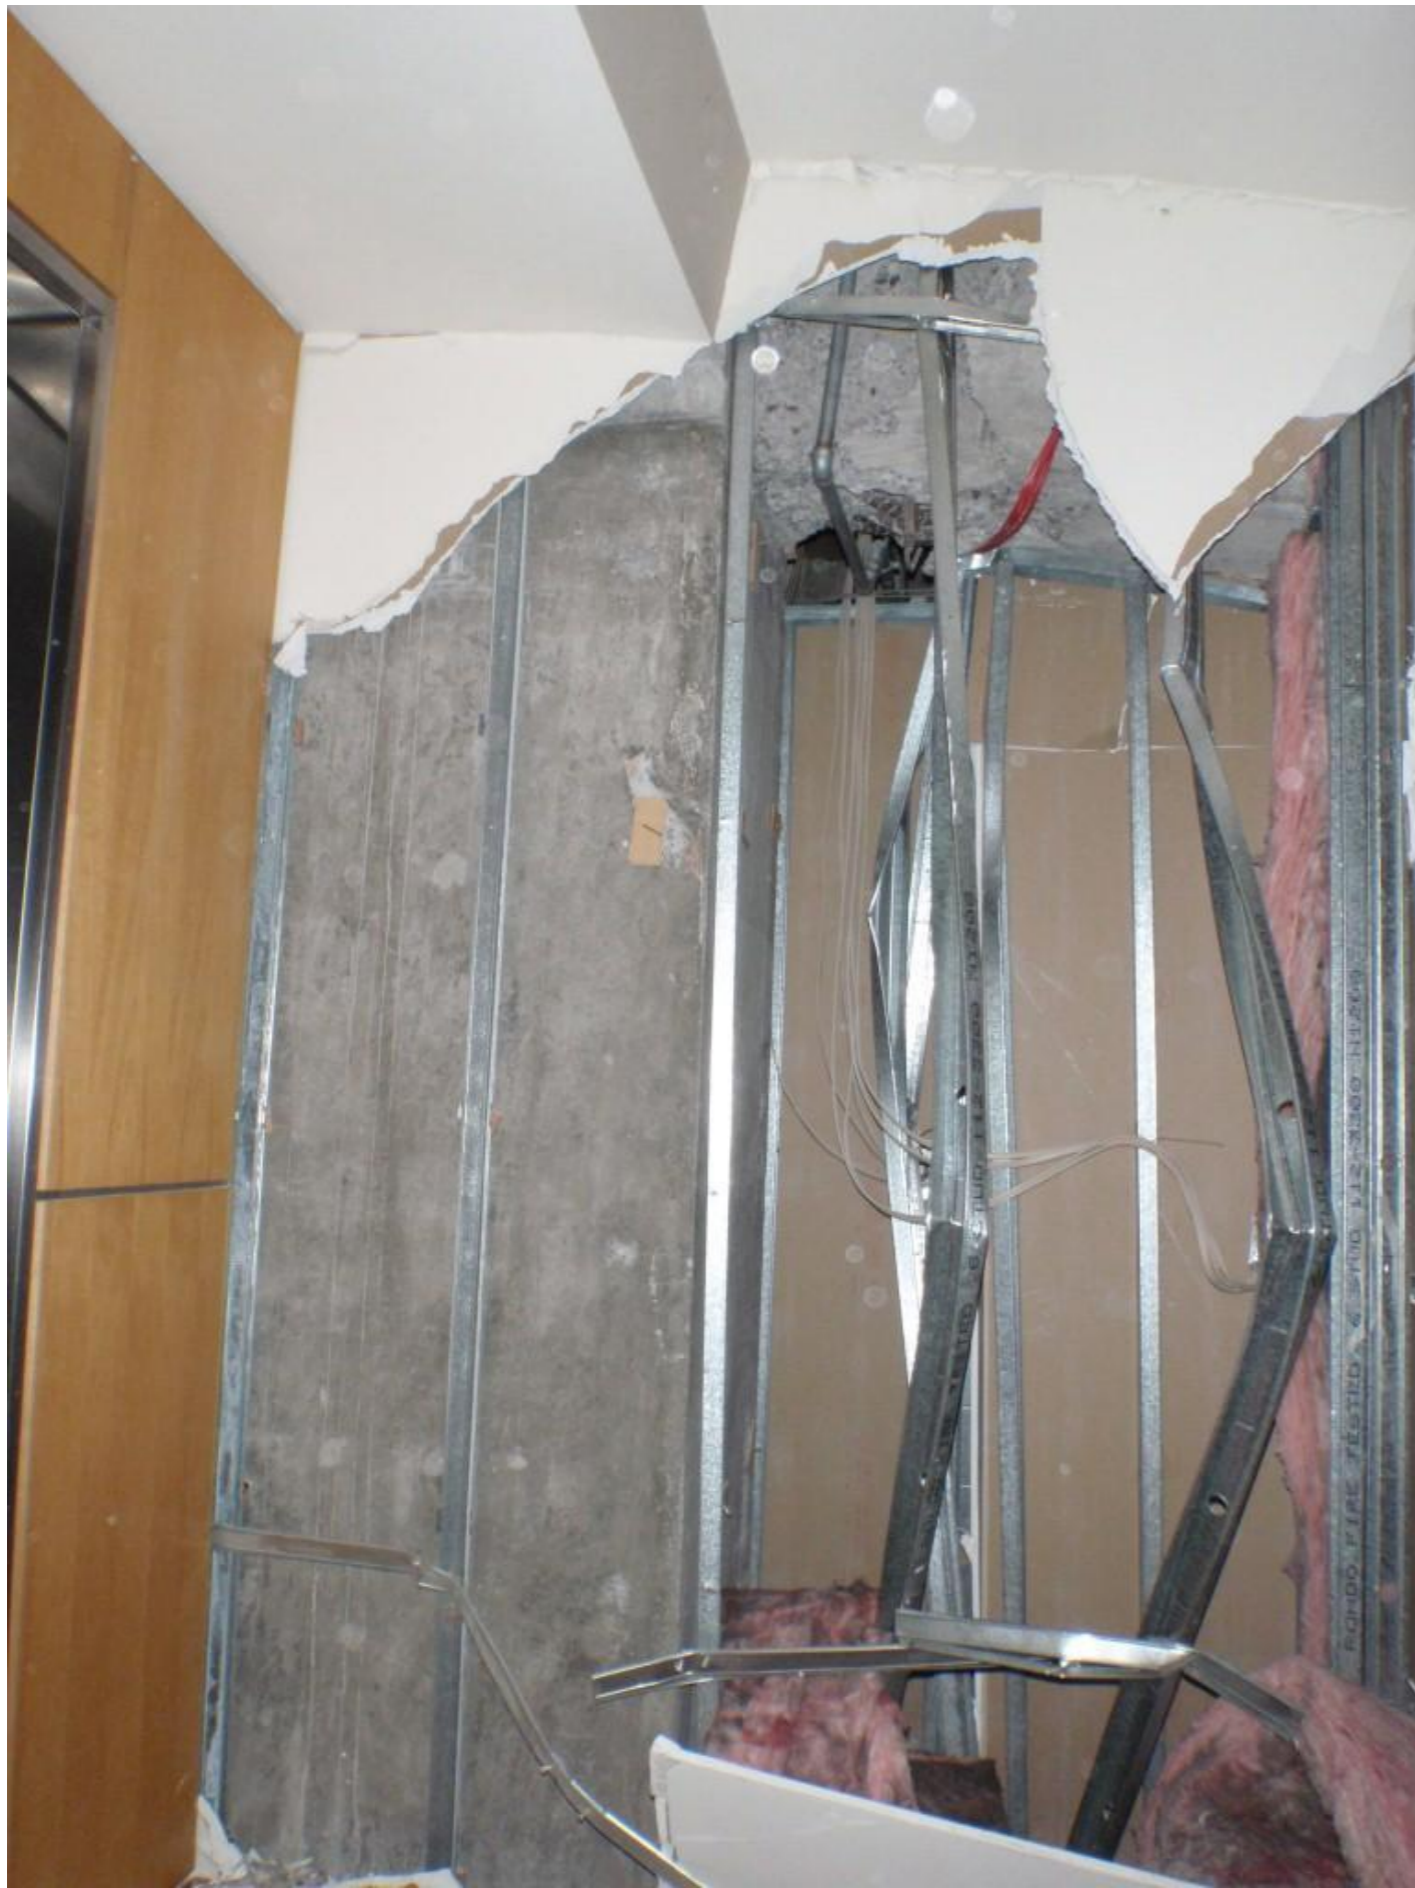
Photo 17 - Hingeing in grid D tower beams

As the upper columns at D5 and D6 dropped, following the shear wall below, these upper tower beams experienced major displacements, well in excess of their expected ductility demands. The beams formed large-rotation hinges at the faces of the columns but the reinforcing did not fracture. *[Refer App. B pages 11 & App. C Photographs 17-19]*

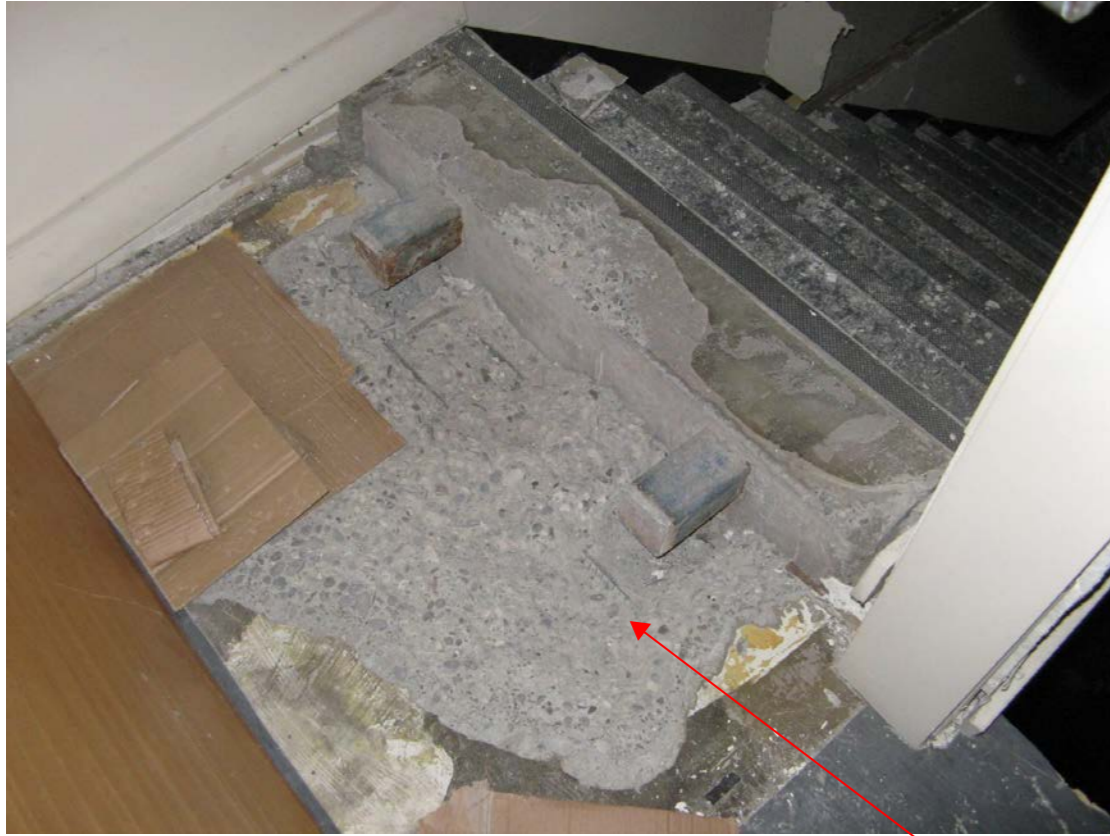
Photo 23 - Top of Intact stair flight

Landing damage
