CTV BUILDING

CTV BUILDING SITE EXAMINATION
AND MATERIALS TESTS
FOR DEPARTMENT OF BUILDING AND HOUSING
16TH JANUARY 2012

DR CLARK HYLAND

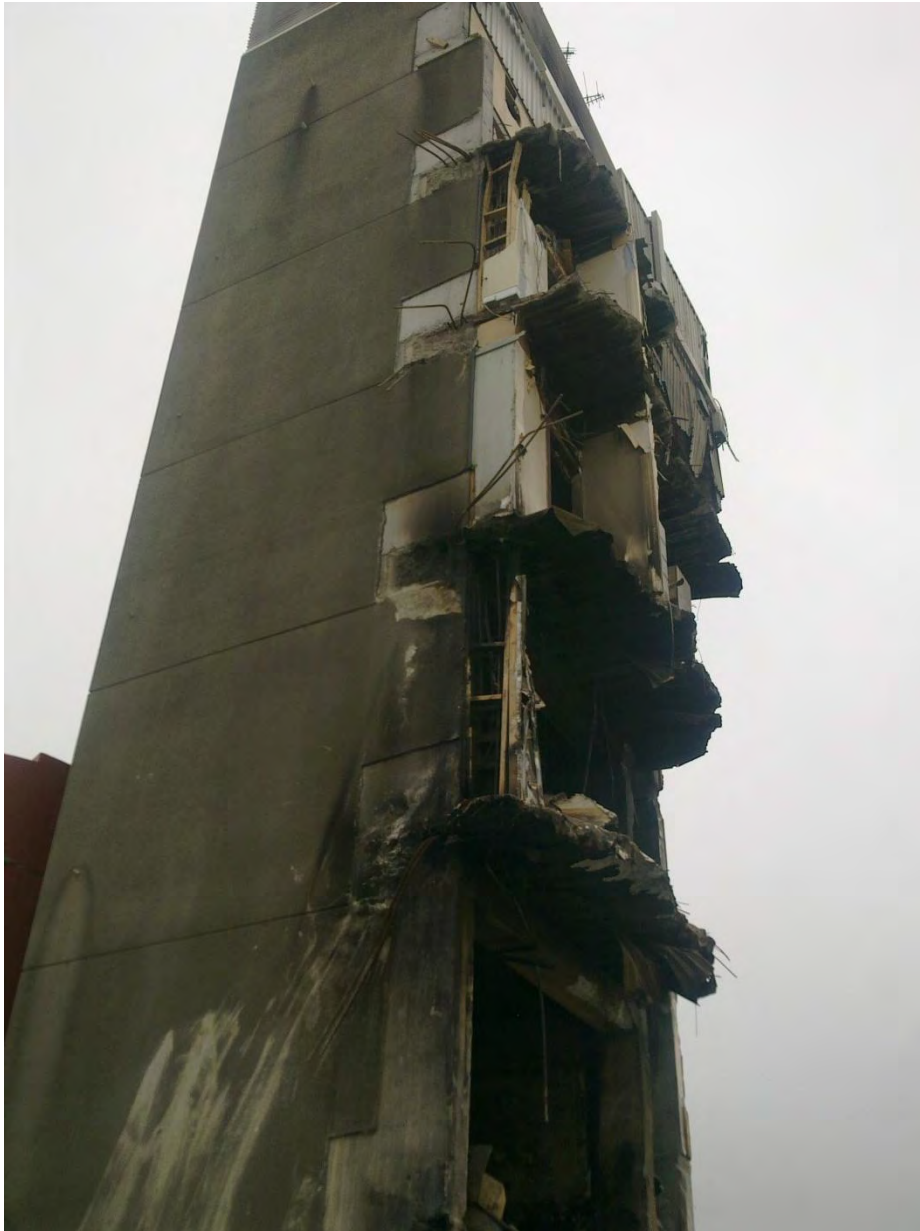
Figure 2 - West face of North Core (Wall Line C) showing the locations where the Line 4 beams had connected into the wall at Levels 3 to 6 without the bottom bars being developed into the wall as specified.

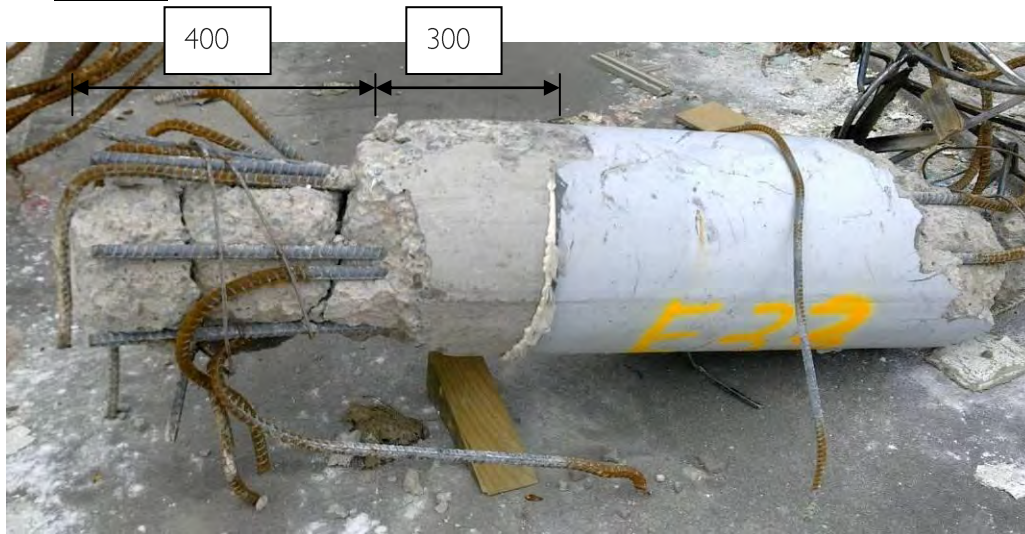
The exterior 400 mm diameter column (Item E33) had flexural failure at the floor level lap joint of the vertical reinforcing steel and compression-flexural fracture at the upper end of the column (Figure 10)

Figure 10 - 400 Diameter Exterior Column Item E33. (DENG C5 or C11, Dwg S15 (Figure 69)). Left end is bottom of column at floor level with concrete spalling over lapped vertical reinforcing. Horizontal cracking could be seen in the core confined by R6 spiral which had fractured. The unpainted portion measured at 700 mm long indicates it had been located between spandrel panels (Figure 5, Figure 72 and Figure 73). The fracture at the right end of the picture commenced approximately 1350 mm from the base of the column.

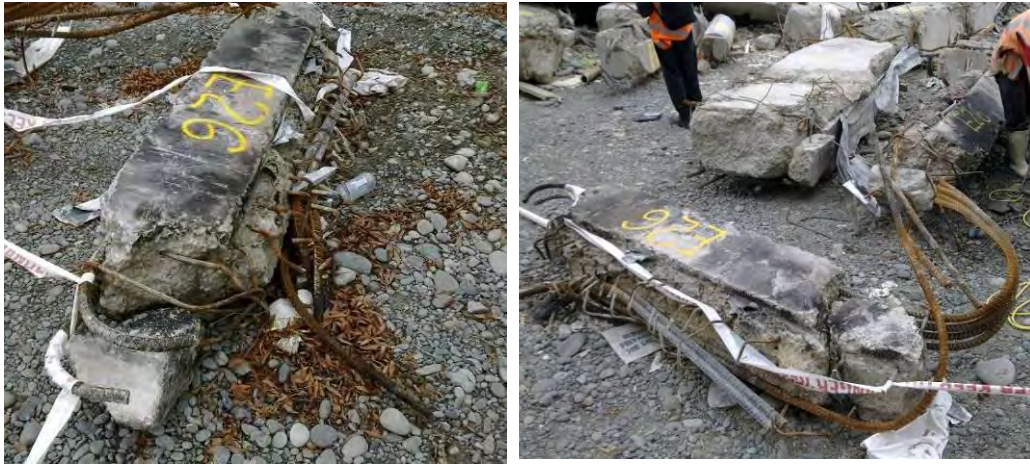
Figure 11 - Interior Pre-cast Log Beam from Line 2 and 3 (DENG Section 3 Dwg S15 (Figure 66)) (left to right) (a) Diagonal shear damage at end and smooth formed surface at beam-column joint; (b) Mid-portion of beam concrete has broken away and stirrups are pulled apart.

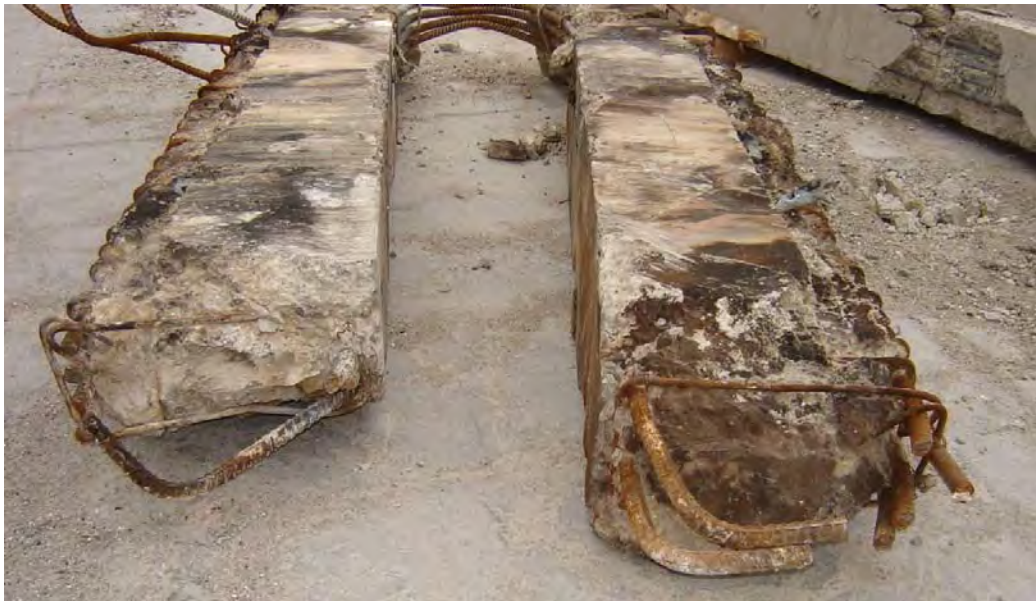
Figure 12 - Interior Pre-cast Log Beams from Line 2 and 3 (DENG Section 3 Dwg S15 (Figure 66)) showing smooth concrete formed for beam-column joint and bottom hooked bars that have pulled out of beam-column joints without any obvious straightening; metal decking has pulled away from slab seating; no slab remains attached to the beams

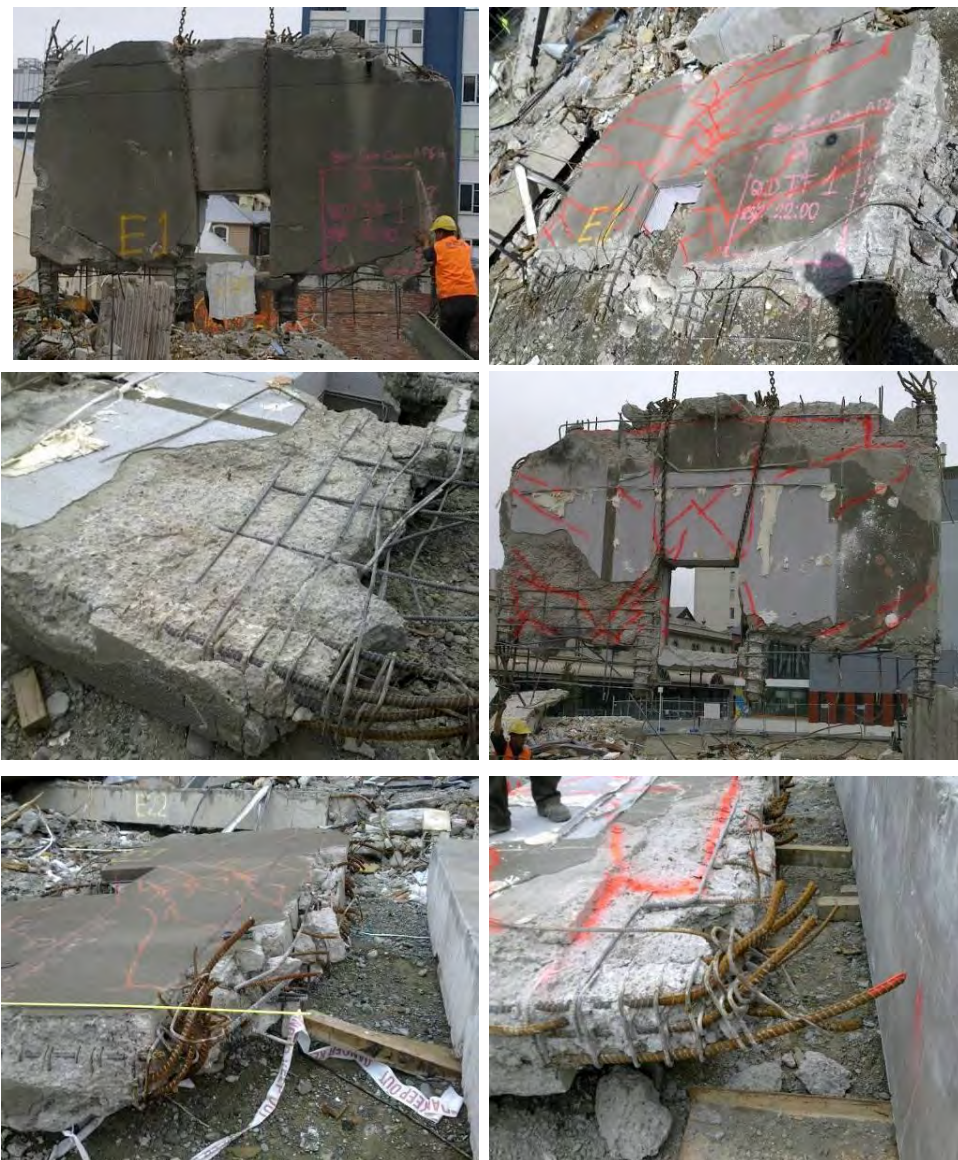
This panel showed flexural cracking patterns typical of cantilever shear walls (Figure 14).

Figure 14 - Line Shear Wall (Item E1) (clockwise from top left) (a) Outer face of wall with lower portion of concrete removed during deconstruction exposing the reinforcing steel; (b) Outer face with cracks highlighted by red paint; (c) Inside face with cracks highlighted by red paint; (d) Top west corner; (e) Top east corner; (f) Inside face of east pier

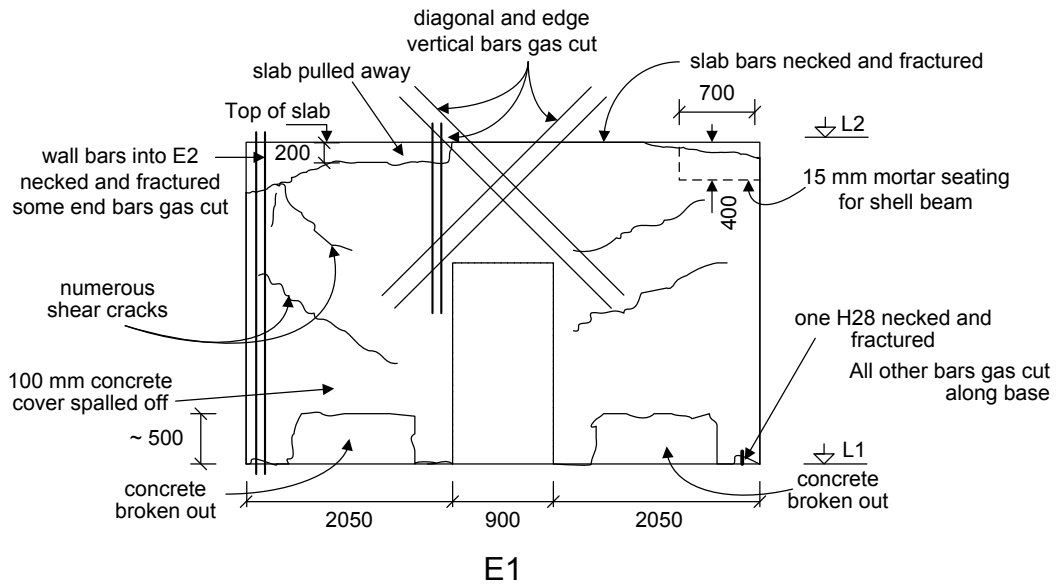
Figure 15 – South Wall Item E1 schematic of damage observed.

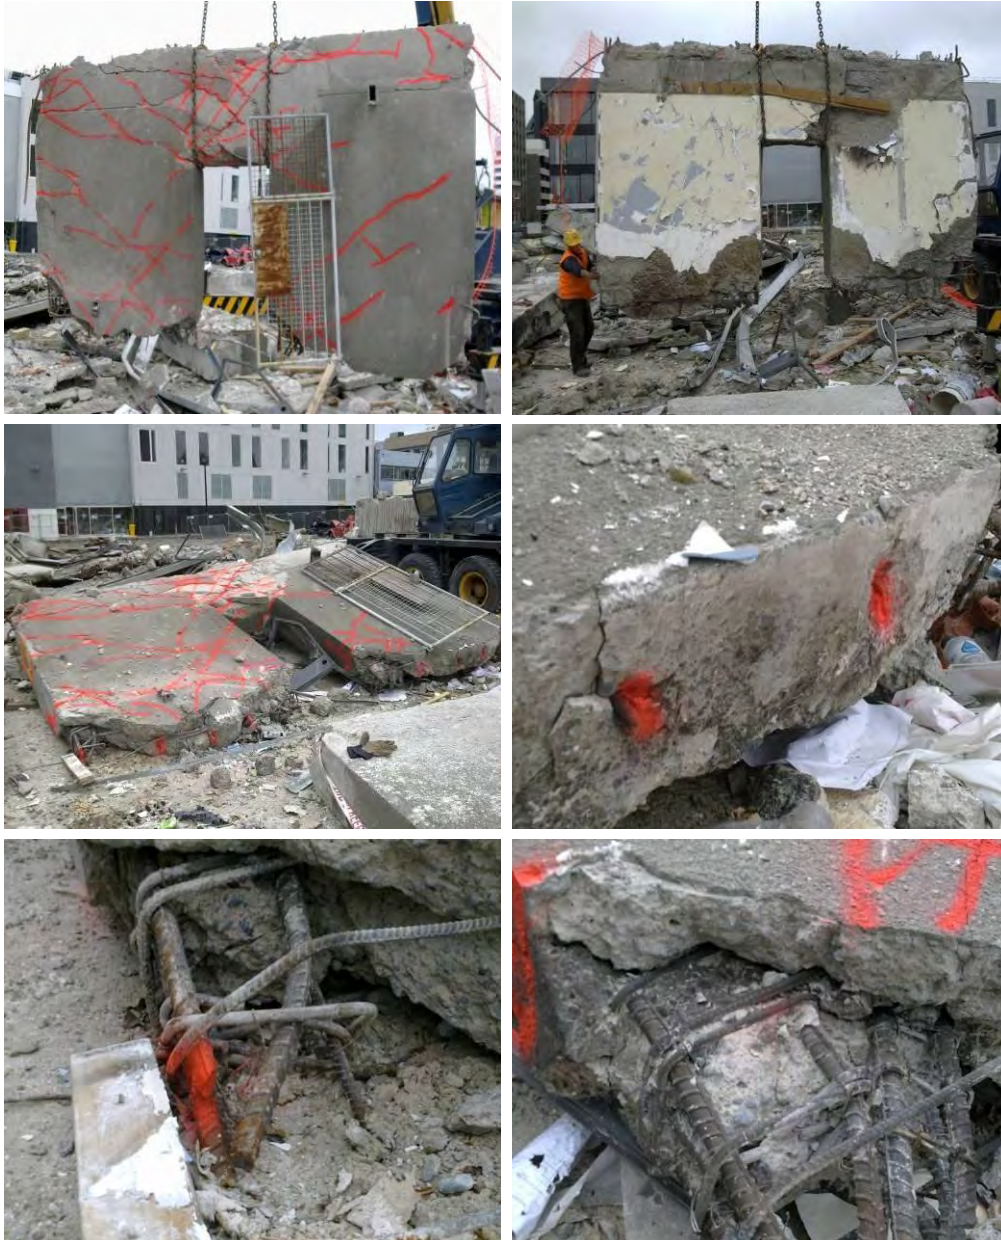
This panel had diagonal cracking in the piers consistent with cantilever wall behaviour and two way diagonal cracking in eth door head coupling beam (Figure 16).

Figure 16 - Line 1 South Wall Level 2 to Level 3 (Item E2) (clockwise from top left) (a) Outside face with fire escape door attached. Cracks marked by red paint; (b) Inside face of wall; (c) East pier construction joint with necked and fractured bars indicated by red paint; (d) Escape door edge of east pier showing thick cover concrete to reinforcing; (e) Outer edge of west pier showing necked and fractured bar indicated by red paint others were cut; (f) Outer face of wall with cracks and fractured bars marked.

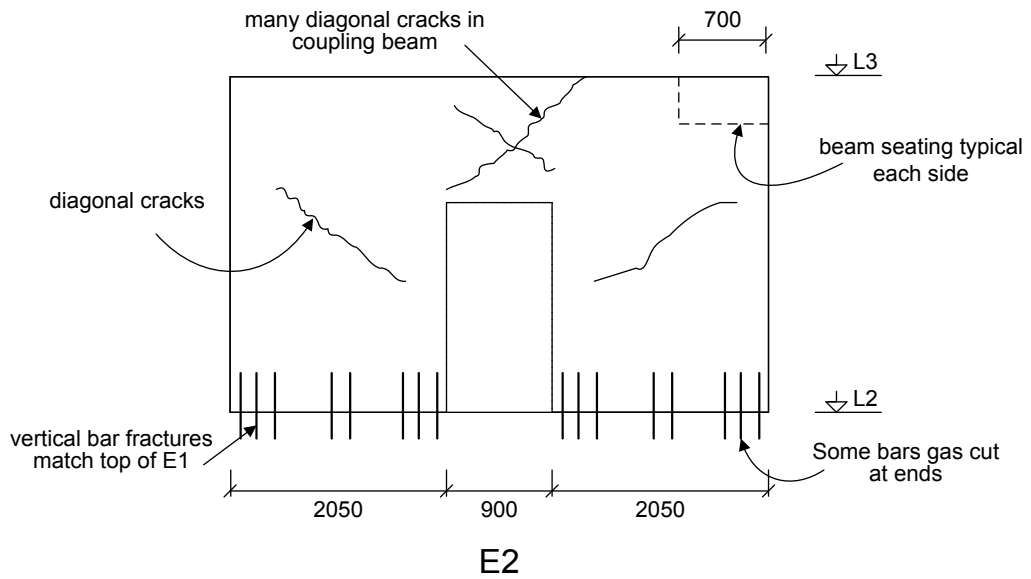
Figure 17 - South Wall Item E2 schematic of damage observed.

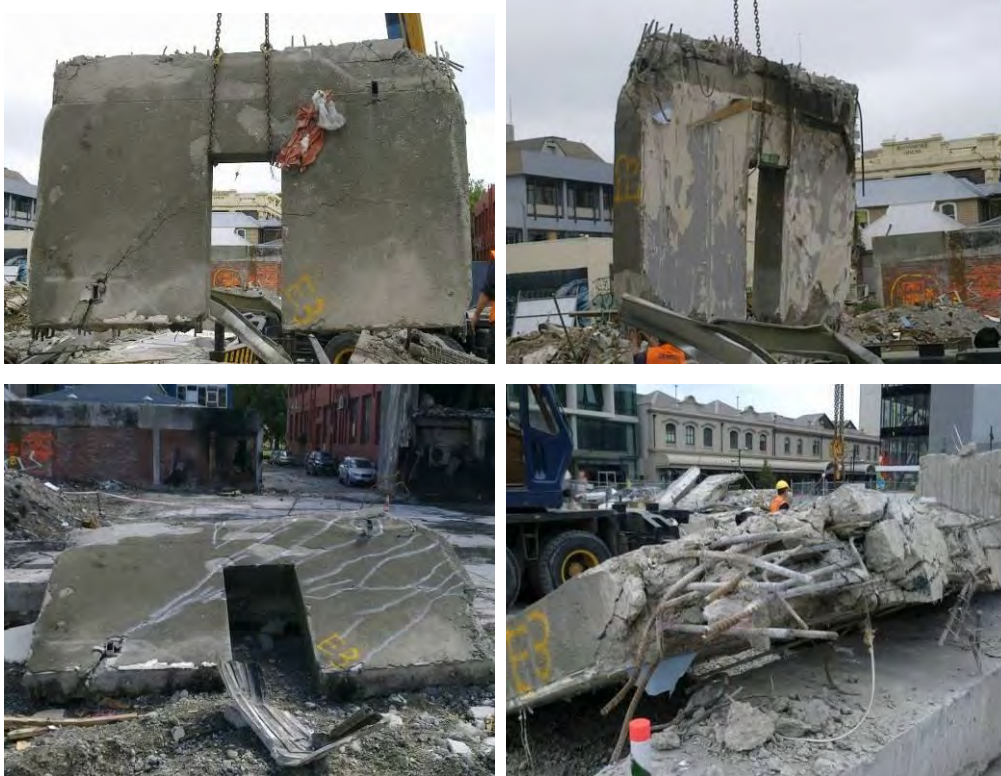
This panel had dominant uni-directional diagonal cracking running from the bottom west corner to the top east end (Figure 18).

Figure 18 - Line 1 South Wall Level 3 to Level 4 (Item E3) (clockwise from top left) (a) Outer face; (b) Inner face; (c) Damaged top east corner; (d) One way diagonal cracks running from bottom west to top east side marked by paint on outer face.

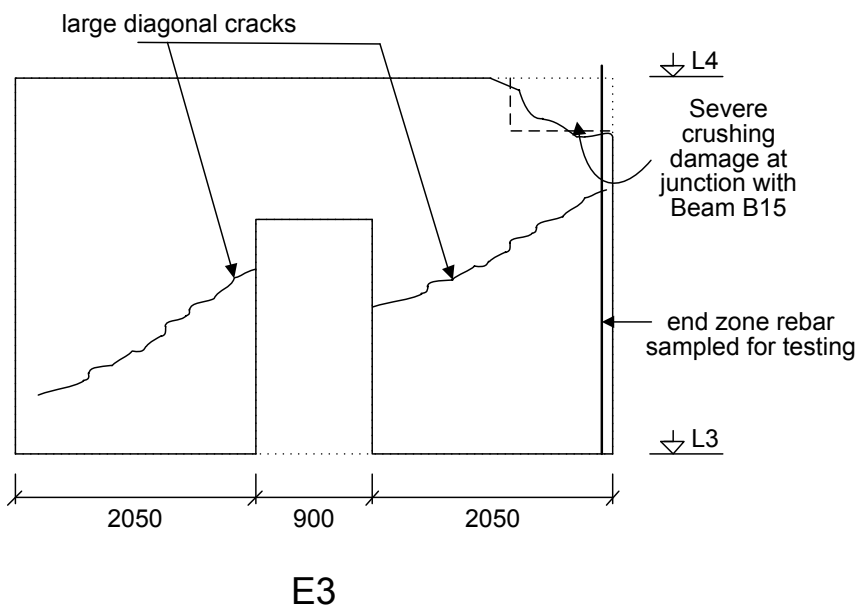
Figure 19 - South Wall Item E3 schematic of damage observed.

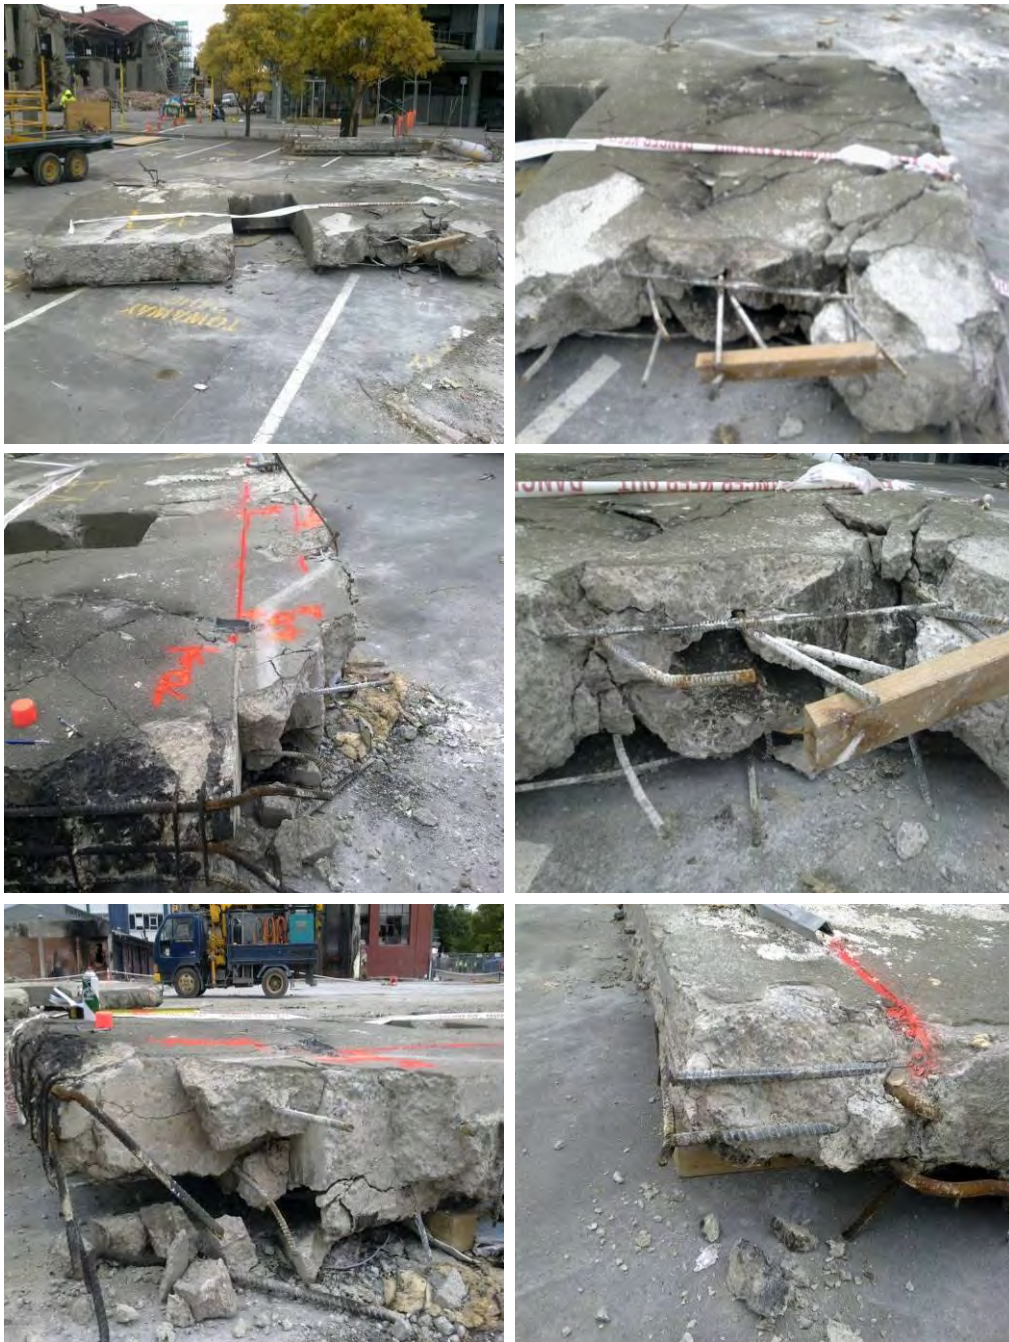
Severe two-way diagonal shear cracking in east pier and loss of cover to vertical reinforcing steel on east edge.

Figure 20 - Line 1 South Wall Level 4 to Level 5 (Item E4) (clockwise from top left) (a) Outer face with east pier on right with severe shear damage, and timber formwork remnant; (b) and (c) Charring on fractured concrete surfaces prior to deconstruction; (d) Top west corner showing saw-cut on top edge from deconstruction; (e) Top east corner showing smooth construction joint at interface with pre-cast beam B15 (DENG Dwg S18 (Figure 67)) and fire charring to spalled eastern edge; (f) View from east to west of top east corner construction joint notch.

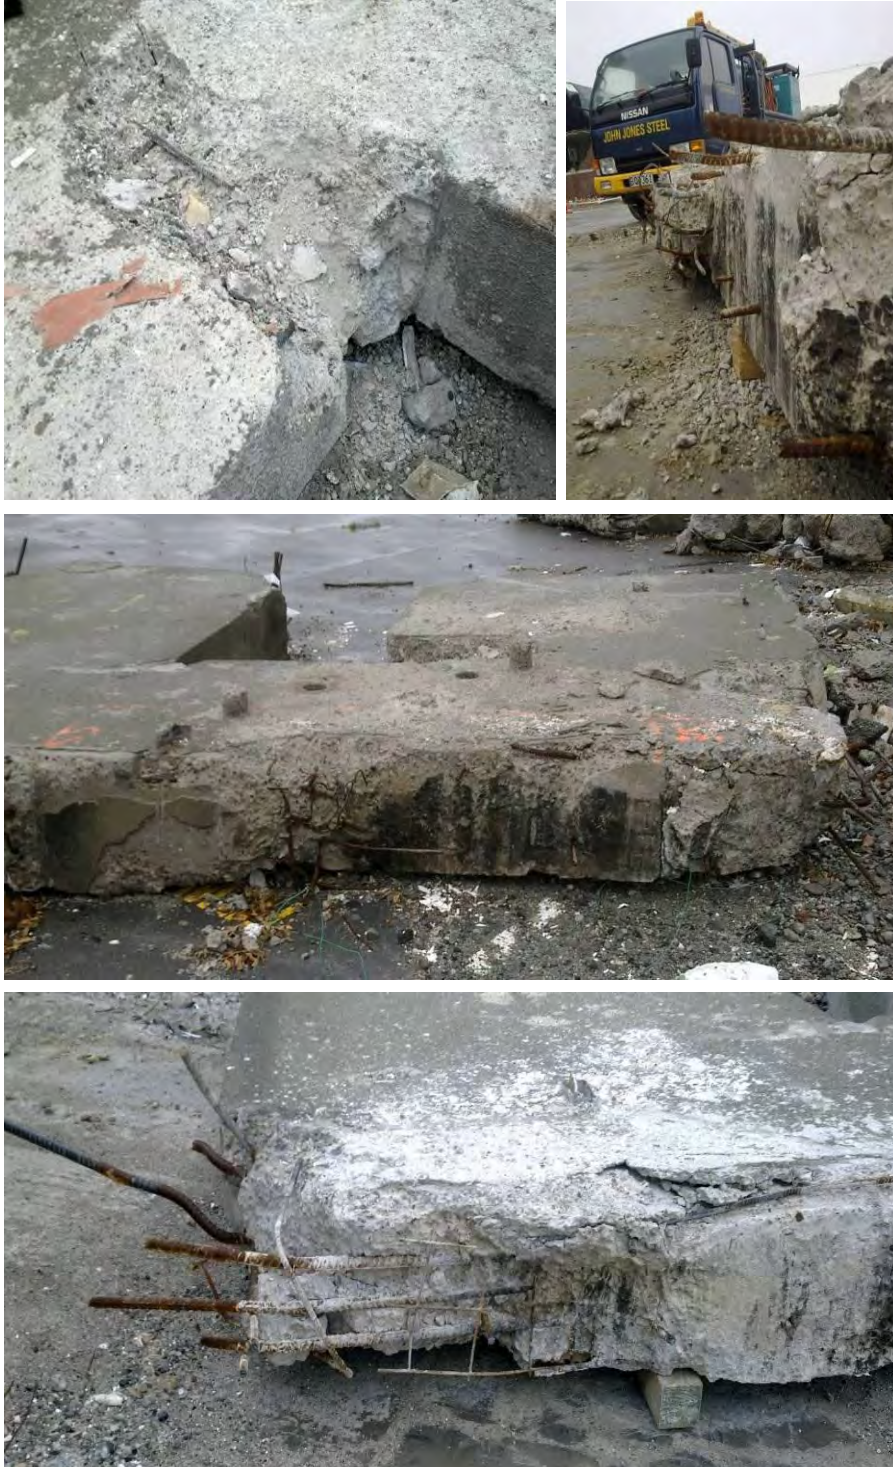
Figure 22 - Line I South Wall Level 5 to Level 6 (Item E5) (clockwise from top left) (a) Crumbly concrete at door edge of west pier able to be dislodged by boot; (b) Smooth and charred construction joint on top west surface looking east; (c) Charred construction joint above west pier. Door sill on left; (d); Top east corner with fractured top 3-H24 bars. Floor 664 mesh exposed.

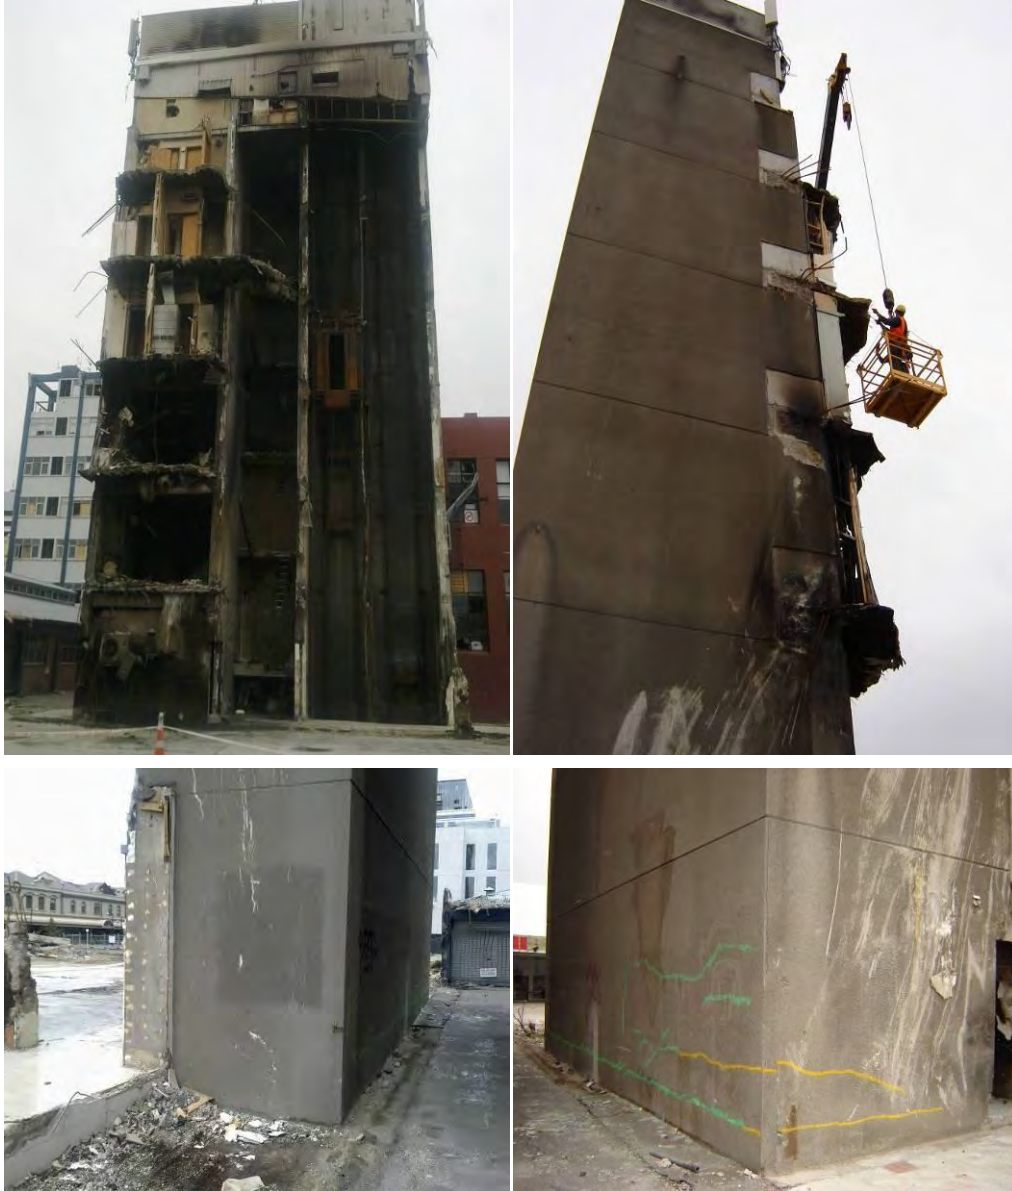
Horizontal flexural cracking on west and north face at Grid C/5 (Figure 25).

Figure 25 - Line 4 to 5 North Core (DENG Dwg S15 (Figure 65)) (clockwise from top left) (a) South face after site cleared with lift shaft for two cars on right, stair well in middle and amenity rooms on the left; (b) West face; (c) West and north face at Grid C/5 corner Level 1 to 2 with horizontal flexural cracks and construction joint identified by paint; (d) East face with column C18 remnant at far left

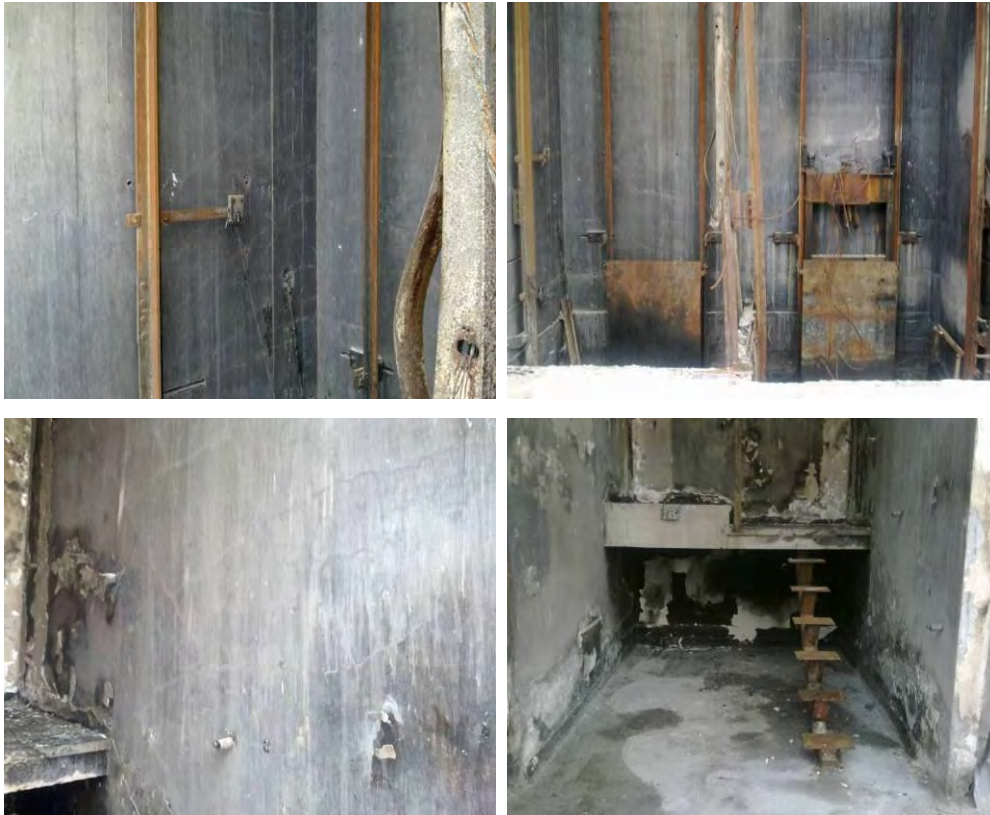
Fine two-way diagonal cracking on the inside faces of Level 1 to 2 walls (Figure 26).

Figure 26 - Lift and Stair well wall cracking Level 1 to Level 2 (clockwise from top left) (a) Lift wall face of Line D wall with fine diagonal shear cracking in both directions; (b) Lift wall face of Line 5 wall with fine diagonal cracking in both directions; (c) Stairwell area with steel stair stringer where concrete cores were extracted; (d) Stair well face of Line D wall with fine diagonal cracking in both directions.

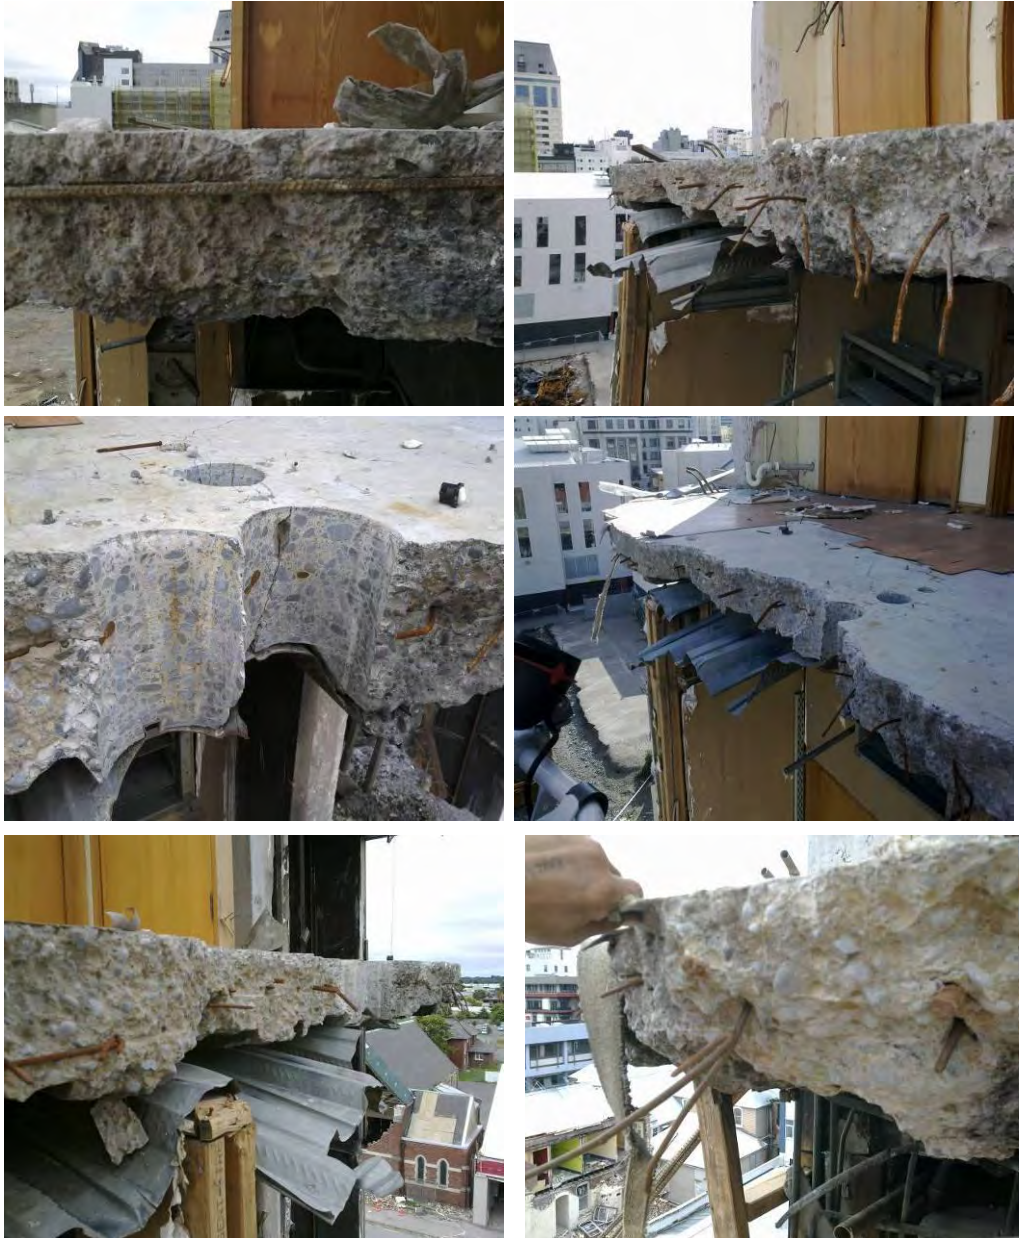
The slab had a vertical fracture face that coincided with the ends of the H12 saddle bars from the support beam on Line 4 (Figure 27).

664 mesh in the slab had fractured in a ductile manner.

The profiled metal deck steel decking had fractured in tension adjacent to the edge of the fractured slab edge.

Figure 27 - Line 4 Core Wall Slab Remnant at Level 6 amenity area (clockwise from top left) (a) Slab edge on stairwell wall looking west with H12 saddle bar exposed and ends of mesh below it; (b) Vertical concrete fracture surface with reinforcing mesh fractured; (c) Slab looking west with cores cut in floor for amenities; (d) Fractured mesh angled downwards; (e) Fractured slab edge looking east. Torn metal decking aligned approximately with concrete fracture edge; mesh at varying height within slab; (f) Cores for amenities at fracture edge.

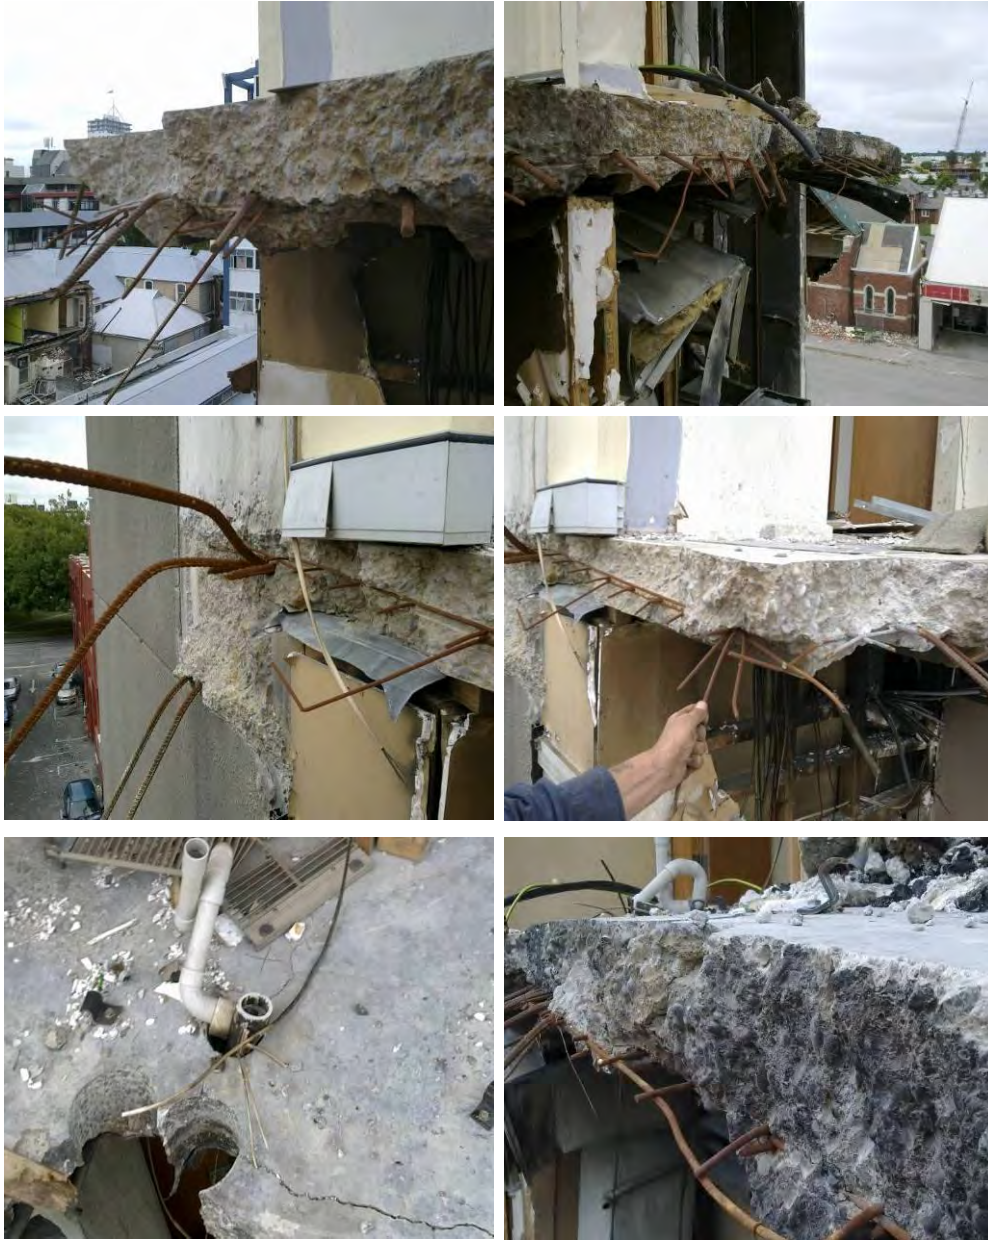
Figure 28 - Line 4 North Core Wall Slab Remnants Level 5 (clockwise from top left) (a) West end with H12 bar ends and mesh at bottom of slab above ribs. It was required on the drawings to be located near the top surface (DENG Dwg S16 (Figure 75)); (b) Looking east. Reinforcing angled down; (c) Slab edge on Grid C west end. Mesh angled down in bottom of slab on top of ribs; (d) Fire charred vertical fractured slab edges adjacent to stairwell. Mesh located low down in slab at top of slab ribs. Edge of mesh sheet with closely spaced parallel wires exposed. Fractured wires can be seen from the lapped mesh below; (e) Cracking in slab running from cored holes; (f) Connection of shell beam to wall with two fractured H24 top bars and two de-bonded top bars. No bottom bars from shell beam embedded in wall (DENG B23 Dwg S18 (Figure 67), Detail 5 S19 (Figure 71)), corresponding to the bent back bottom steel in shell beam Item E23 (Figure 8).

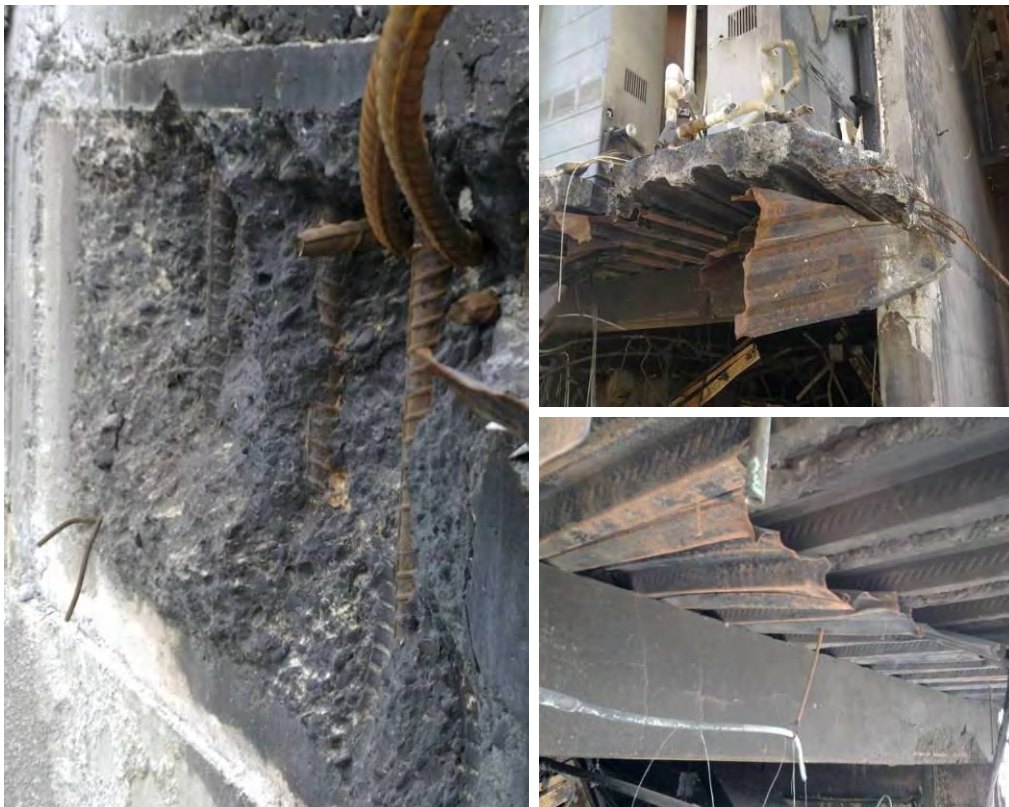
Figure 29 - Line 4 North Core Walls Level 4 slab remnants (top to bottom) (a) Connection of shell beam to wall with two fractured H24 top bars and two de-bonded top bars. No bottom bars from shell beam embedded in wall but imprints from bars evident (DENG B23 Dwg S18 (Figure 67), Detail 5 S19 (Figure 71)), corresponding to the bent back bottom steel in shell beam Item E23 (Figure 8); (b) Fractured vertical face of slab at stairwell wall, with fractured slab support beam (DENG B25 Dwg S18 (Figure 67)) top bar and charred fracture surface; (c) Torn profiled metal deck sheeting de-bonded from slab but still fixed in at pre-cast beam support.

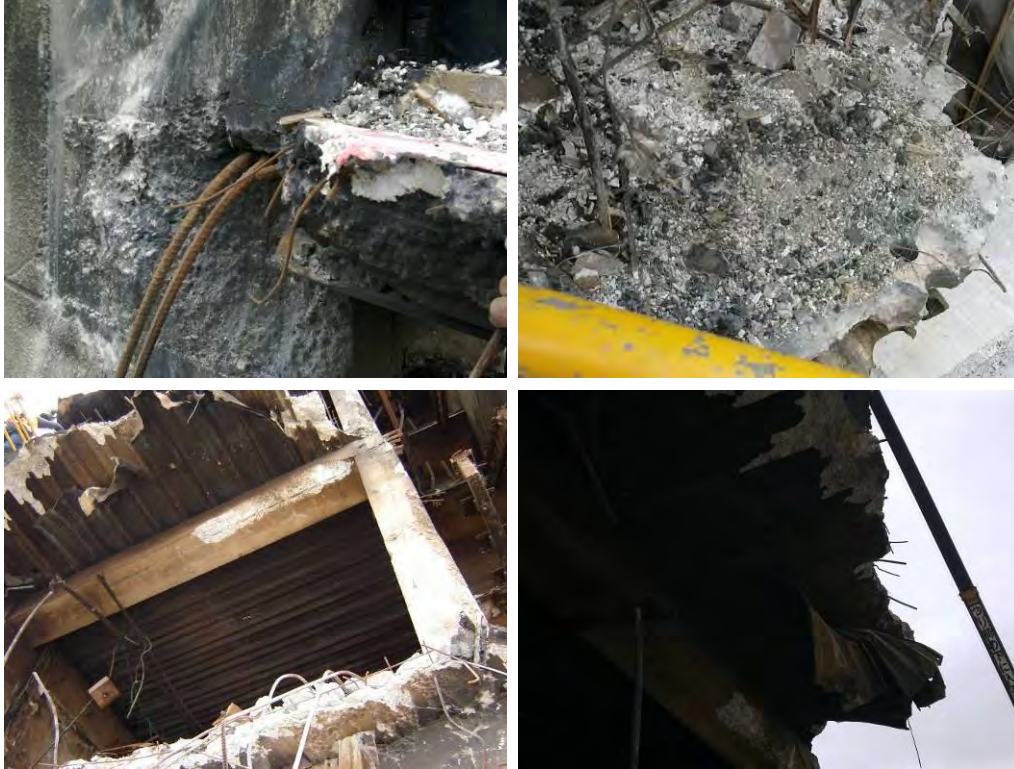
Figure 30 - Line 4 North Core Walls Level 3 slab remnants (clockwise from top left) (a) Connection of shell beam to wall with two fractured H24 top bars and two de-bonded top bars. No bottom bars from shell beam embedded in wall but imprints from bars evident (DENG B23 Dwg S18 (Figure 67), Detail 5 S19 (Figure 71)), corresponding to the bent back bottom steel in shell beam Item E23 (Figure 8); (b) Ash on slab; Cored holes at fractured edge; (c) Torn profiled metal deck sheeting de-bonded from slab but still fixed in at pre-cast beam support (DENG B24 Dwg S18 (Figure 67)); (d) Profiled metal deck and slab from below supported on beam B24.

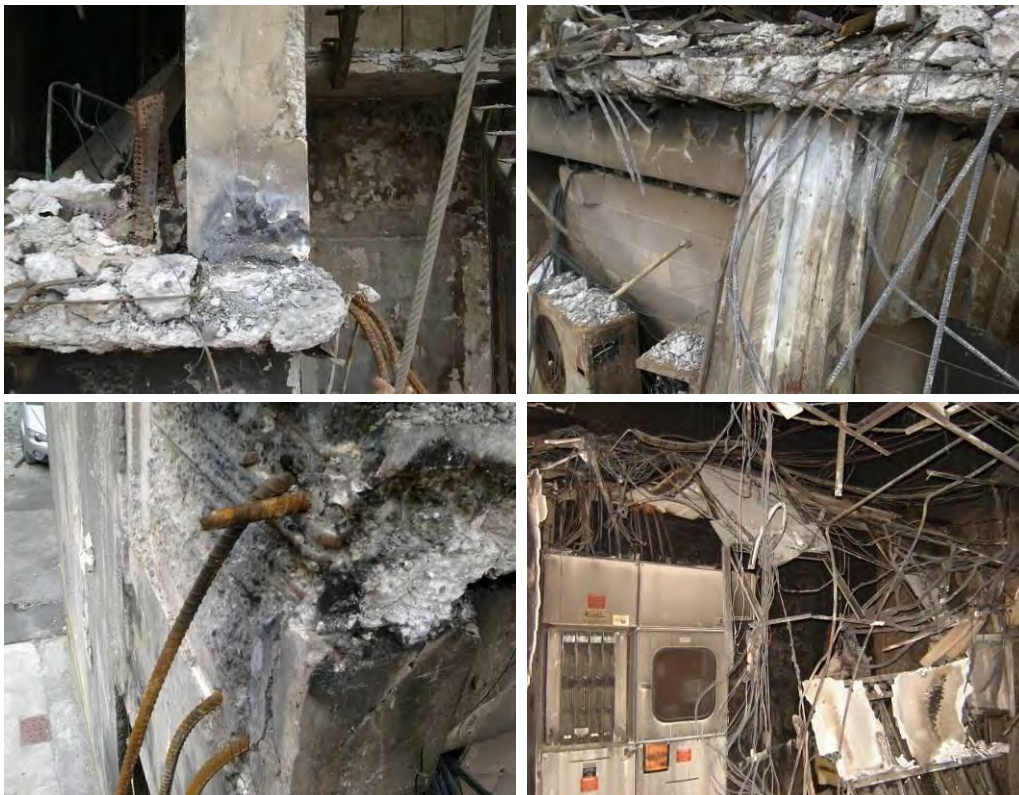
Figure 31 - Line 4 North Core Walls Level 2 slab remnants (clockwise from top left) (a) Slab edge broken back during de-construction adjacent to stairwell wall; (b) Broken back slab with H12 saddle bars exposed. Masonry wall with separation along top course; (c) Switch room under Level 2 slab; (d) Connection of shell beam to wall with two fractured H24 top bars and one de-bonded top bars. Bottom bars from shell beam have been embedded in wall as specified (DENG B23 Dwg S18 (Figure 67), Detail 5 S19 (Figure 71)). Some diagonal beam-wall joint zone shear cracking can be seen in the wall end..

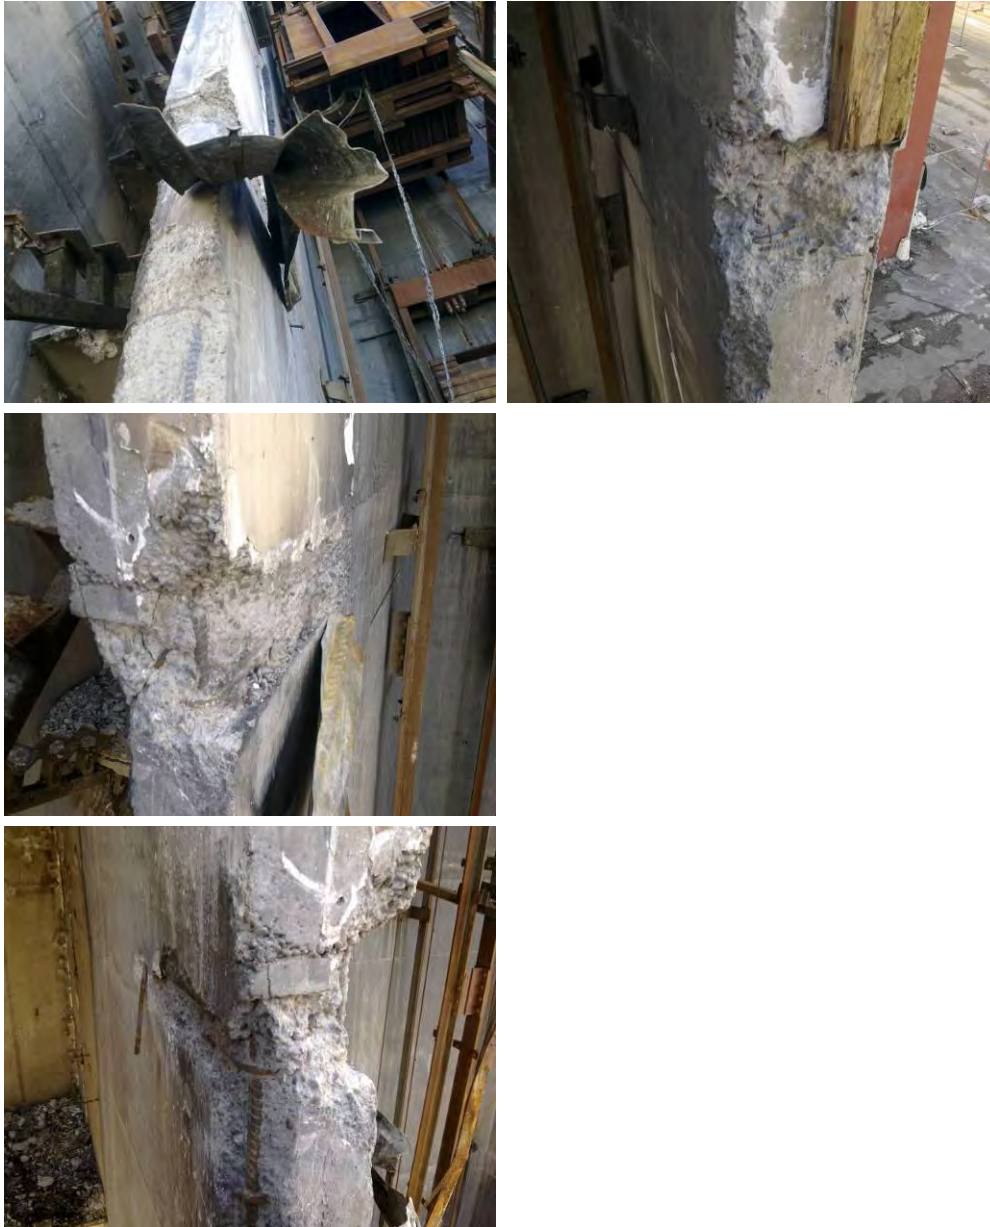
No reinforcing steel was found to have connected the east wing wall D/E to the slab (Figure 35).

Figure 35 - Level 3 Lift Well Wing Walls Grid D and D/E (anti-clockwise from top left) (a) Profiled metal deck decking side lapped into western Grid D wall, just hanging on; (b) H12 bar necked and fractured at centre of wing wall (indicated by chalk arrow); (c) Concrete cover appeared to have broken away as the slab pulled southwards; (d) Localised spalling of concrete. No reinforcing found connecting end of east wall with slab.

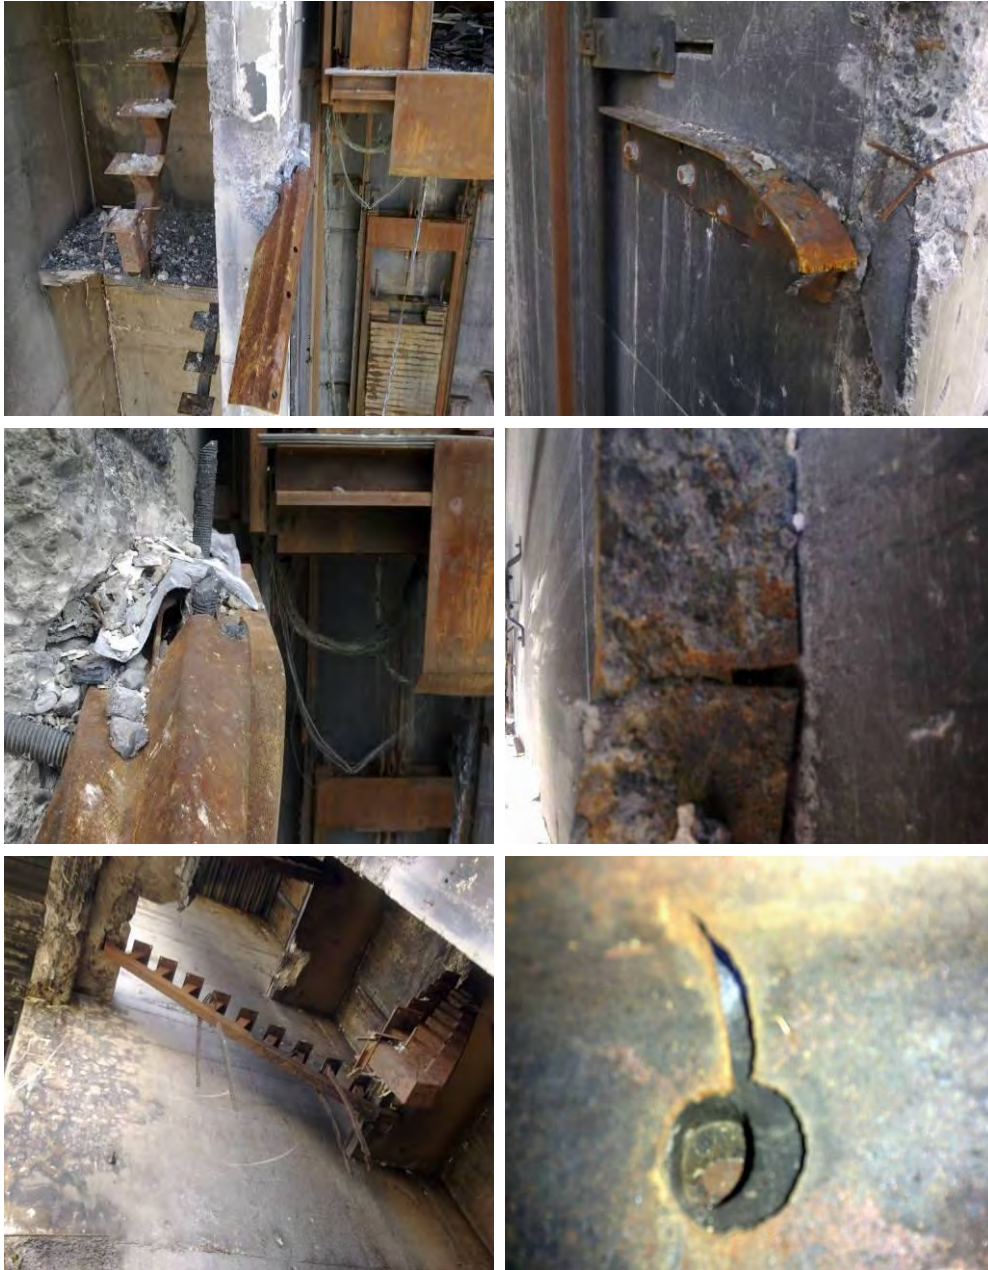
The Drag Bars on both the west and east wing walls had partially fractured in bending and tension. The epoxy grouted 20 mm threaded anchors that were fixed vertically into the slab and into the Drag Bar on the west wall appeared to have pulled out in tension as the slab pried it off as it rotated downwards during the collapse (Figure 36 and Figure 37).

Figure 36 - Level 4 Lift Well Wing Walls Grid D and D/E (anti-clockwise from top left) (a) 150x150x10 L with 51 x 3.2 SHS; 3-M24 threaded rods fixed into wall and 6 –M20 threaded rods 350 mm long fixed into the slab at the profiled metal deck rib with epoxy grout around rod; (b) Three M20 threaded rods remained upright in the Grid D Drag Bar. The 51x3.2 SHS had fractured in bending and tension at the bolt hole adjacent to last bolt into wall; (c) Stair stringer running up to Level 5 fixed rigidly into landings with visible vertical bow (DENG Stair S8 Dwg S31 (Figure 76)); (d) Initiation of fracture in the steel angle at the elongated hole without bolt into east wall; (e) Fracture in angle running from corner of angle out towards toe viewed from above; (f) Remnant of 150x75x10 L Drag Bar with 4-M24 threaded rods fixed into grid D/E wall. Angle has fractured in bending and tension two bolts in. End of Drag Bar had been gas cut during de-construction.
