CTV BUILDING

CTV BUILDING SITE EXAMINATION
AND MATERIALS TESTS
FOR DEPARTMENT OF BUILDING AND HOUSING
16TH JANUARY 2012

DR CLARK HYLAND

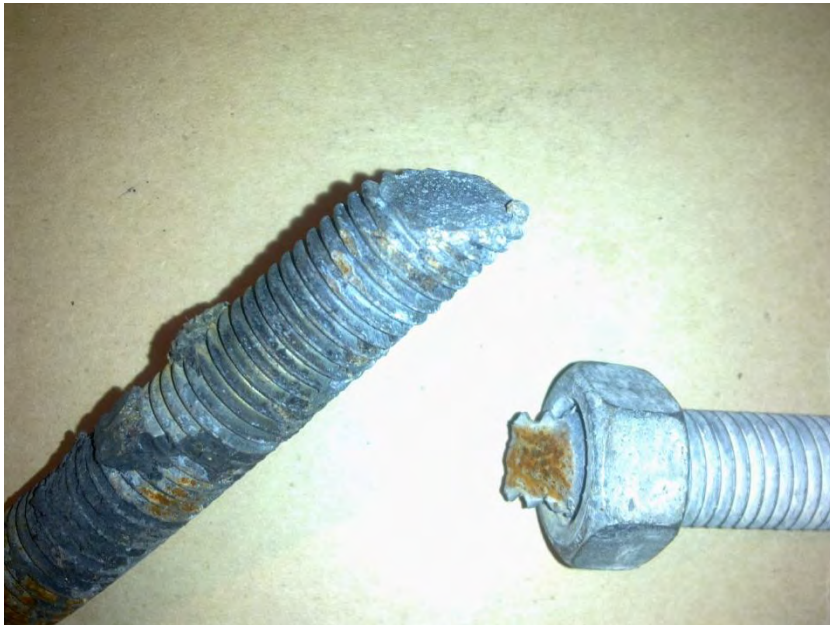
The Drag Bars on both the west and east wing walls had partially fractured in bending and tension. The epoxy grouted 20 mm threaded anchors that were fixed vertically into the slab and into the Drag Bar on the west wall appeared to have pulled out in tension as the slab pried it off as it rotated downwards during the collapse (Figure 36 and Figure 37).

Figure 37 - M20 Drag Bar Bolts (Portions shown are from two different bolts) (left to right) (a) Grey portion with smooth diagonal end had epoxy residue from slab indicating it was cut this way prior to installation; (b) Necked and dimpled fracture surface at underside of bolt typical of direct tensile fracture in threaded rods.

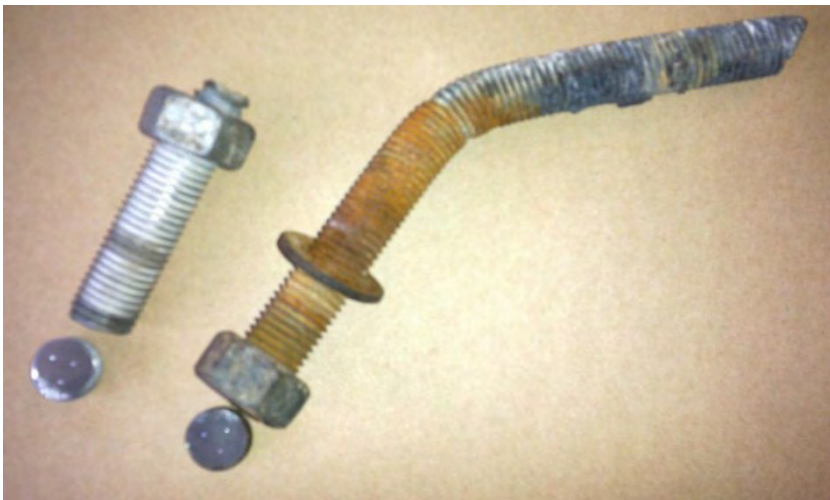
The 20 mm diameter Drag Bar threaded anchor rods were hardness tested by MTL (Figure 62) and found to have Rockwell Hardness HRB greater than the minimum required by AS 4291.1:2000 (SAA 2000) for Property Class 5.8 threaded rods.

Figure 38- M20 Property Class 5.8 threaded studs from Drag Bars after hardness testing by MTL (Figure 62)

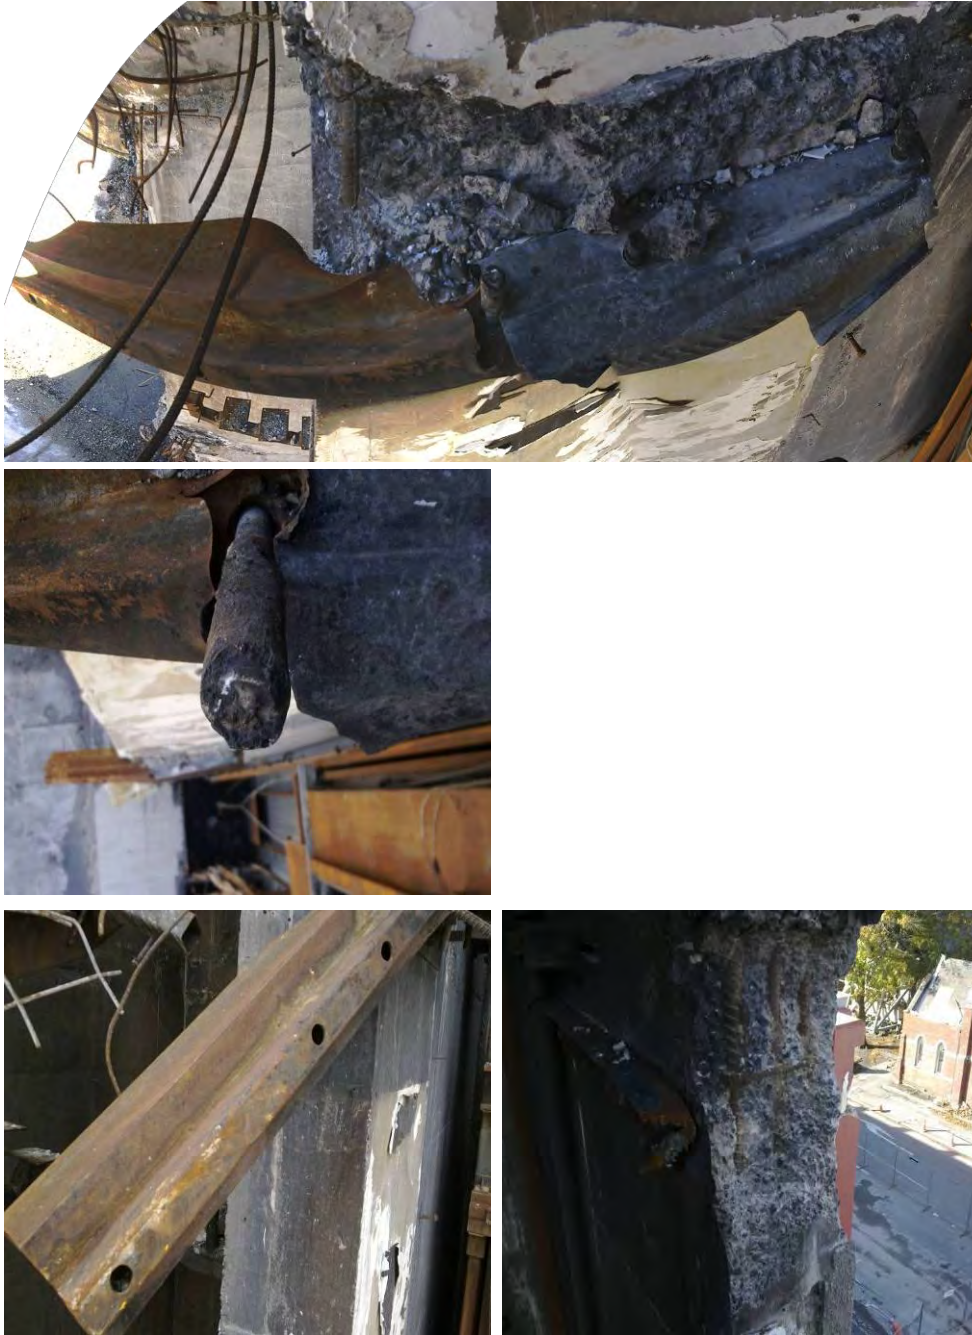
Figure 39 - Level 5 Lift Well Wing Walls Grid D and D/E (anti-clockwise from top) (a) 150x150x10 L with 51 x 3.2 SHS; 4-M24 bolts into wall and 6 –M20 threaded rods 350 mm long fixed through the slab at the profiled metal deck rib with epoxy grout around rod; Three M20 threaded rods remained vertical the Grid D Drag Bar. The 51x3.2 SHS had fractured in bending and tension at the bolt hole adjacent to last bolt into wall and twisted with the slab; (b) Epoxy grout around threaded rod in slab; (c) Holes for 3-M20 threaded rods in slab in twisted Drag Bar; d) 150x75x10 L Drag Bar with 5-M24 threaded rods fixed into wall D/E. End of Drag Bar had been gas cut during deconstruction.

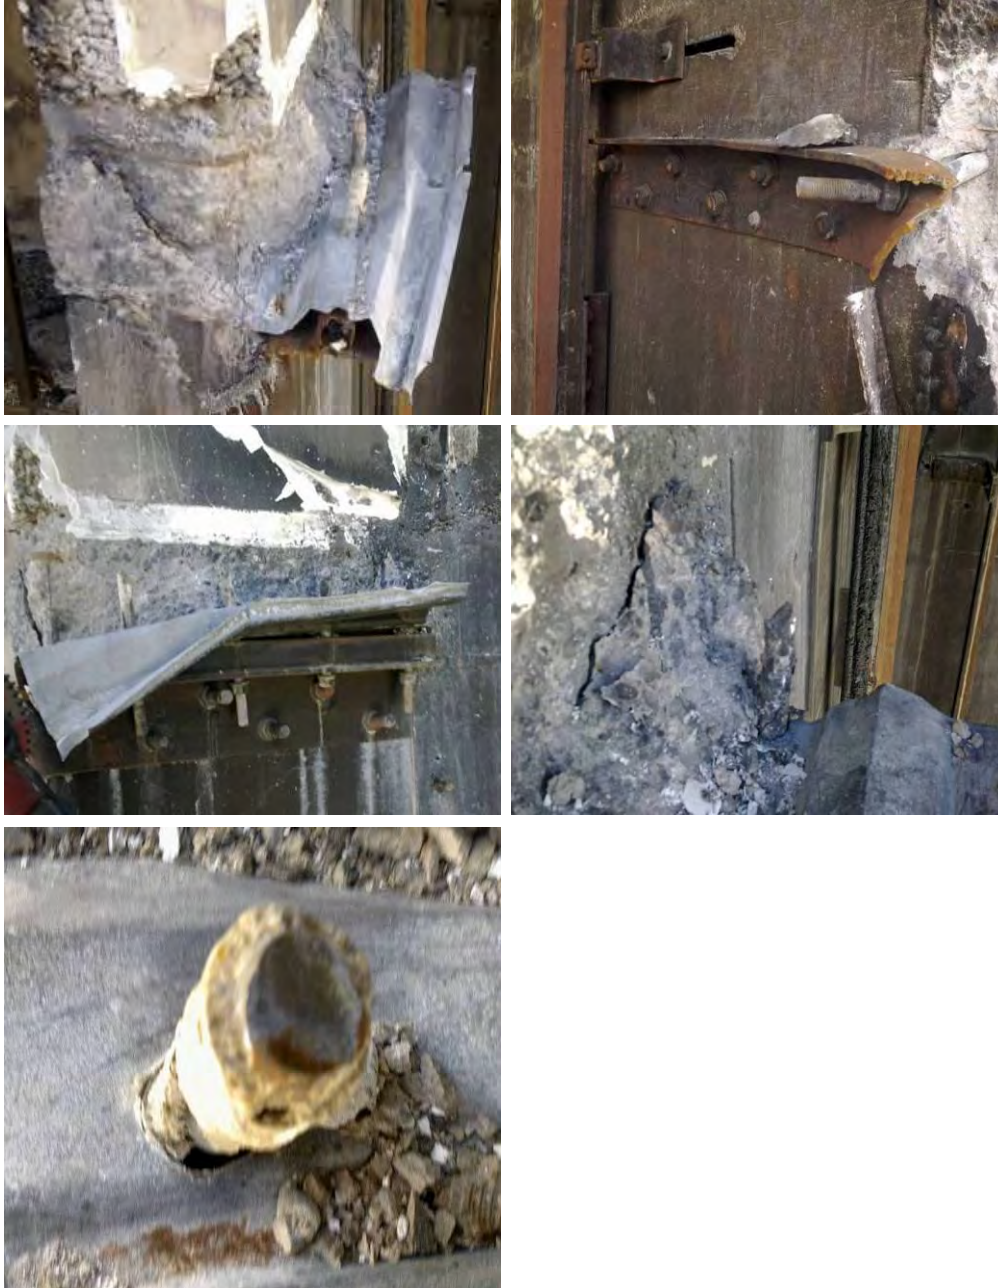
Figure 40 - Level 6 Lift Well Wing Walls Grid D and D/E (anti-clockwise from top left) (a) 150x150x10 L with 51 x 3.2 SHS into west wall on Grid D, similar to Level 5 and 4 Drag Bars; 6-M24 bolts into wall; The remaining 4 -M20 bolts 350 mm long had been fixed into the slab at the profiled metal deck rib with epoxy grout around bolt; These remained vertical and were measured with 110 mm stick-out above the item. The 51 x3.2 SHS has fractured in bending and tension at the bolt hole adjacent to last bolt into wall and the bar had twisted with the slab; (b) Side view of Drag Bar remnant showing deck uplift at end bolt; (c) Top surface of M20 threaded rod with typical smooth diagonal face and grout around rod through slab. (d) End rod with diagonal top surface and slab concrete remains; (e) 150x75x10 L Drag Bar with 7- M24 threaded rods fixed into east wall D/E. End of bar had been gas cut during de-construction.

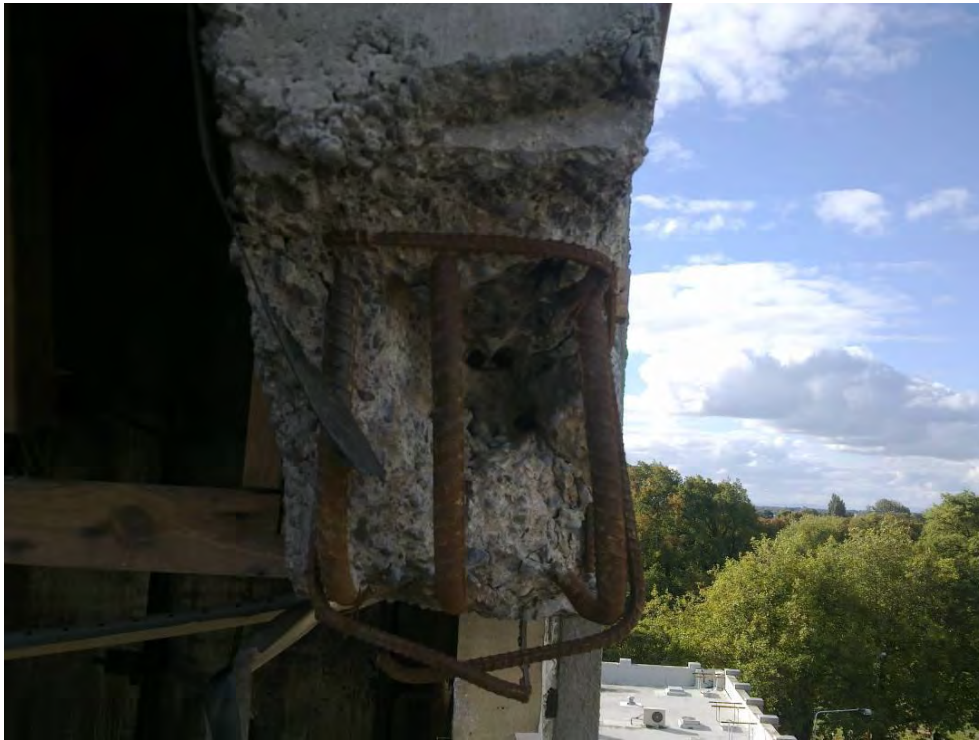
12. The connection of the C18 column (located at Line 4-D/E) into the lift core wall at Level 7 was less than specified and the bars had debonded.
13. A number of circular columns examined showed mid-height hinging failures as well as hinging at the base or head. This was also seen in a column remnant clearly identified as being a perimeter column that had been located between precast spandrel panels. Other circular columns were found full height with hinging damage at the head and base.

Figure 41 - Lift Well Wing Wall D/E: Column D/E 4 Connection (DENG Dwg S14 (Figure 69); 3 x 20 to 24 mm diameter holes could be seen where reinforcing bars from the column had pulled out. The drawing shows that 4-H20 bars were required to be bent into the wall.

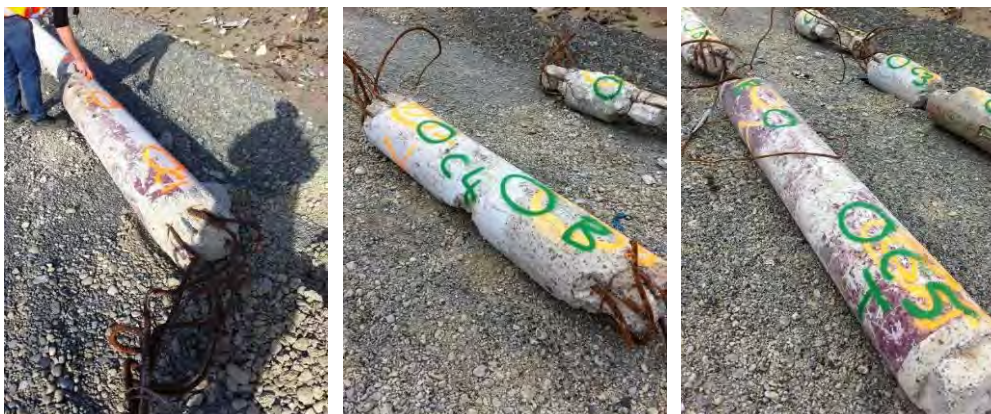
Figure 49 -400 mm diameter columns full height (left to right) (a) Test Item tC1 Level 6 to roof column with base hinging failure, still connected by reinforcing to tC8 below; (b) tC4 hinging top and bottom; (c) tC5 Level 6 to roof column with hinging at base.

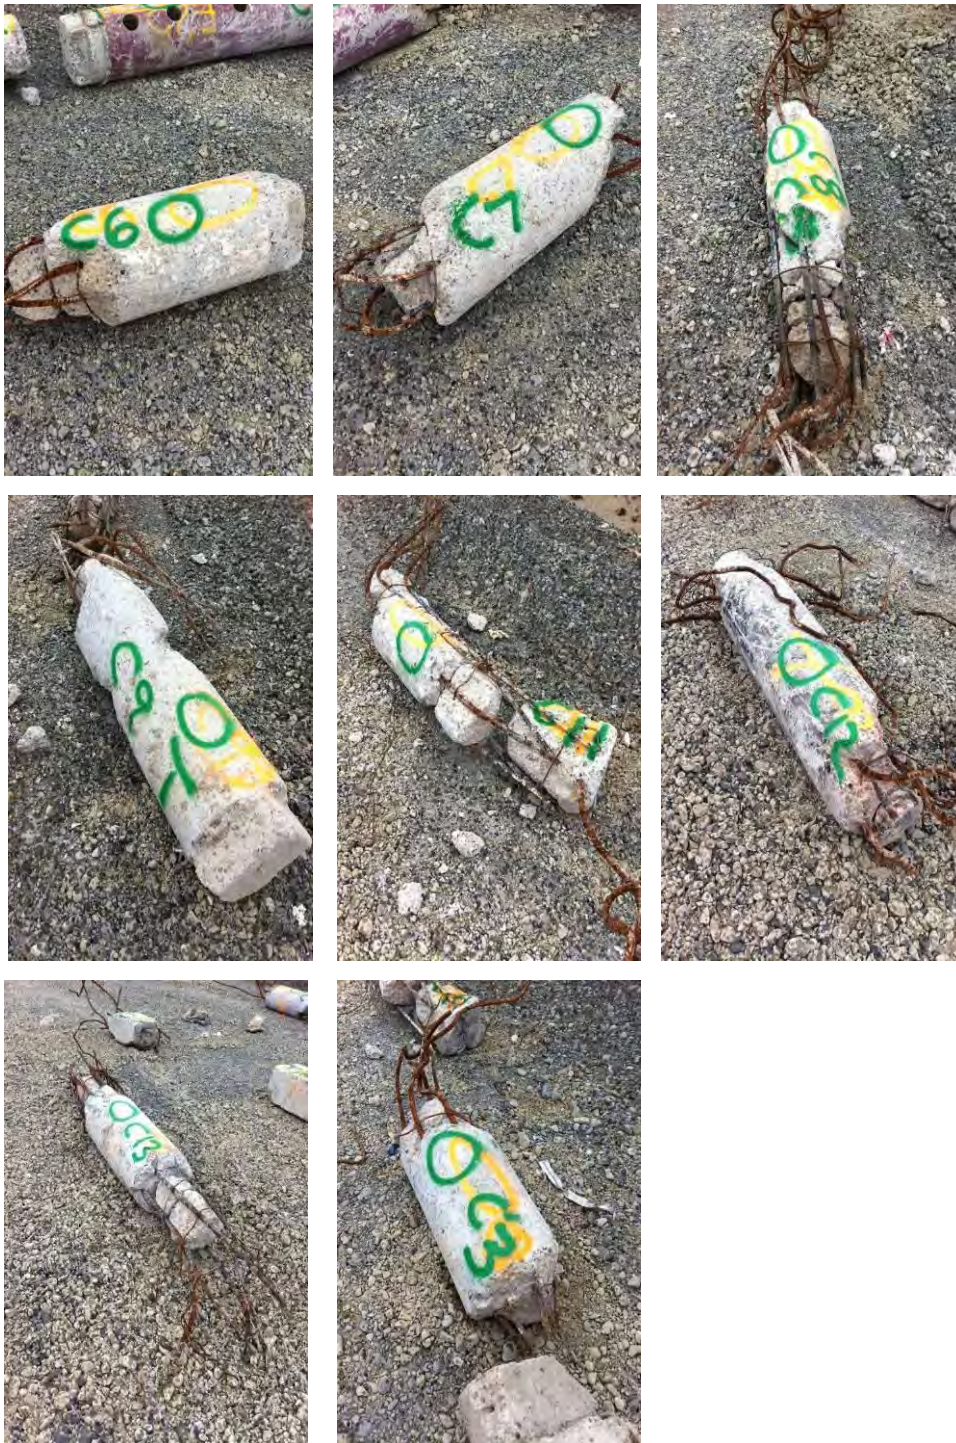
Figure 53 -400 mm Diameter Columns at Burwood showing similar base and/or mid-height failures (Left to right, top row down) (a) Test item tC6 Level 6 column head with mid-height failure; (b) tC7 with base and mid-height failures; (c) tC8 with base flexural (near end) and mid-height spearhead failures; (d) tC9 Level 6 column head with mid-height failure; (e) tC11 base (near end) and mid-height failure; (f) tC12 base and mid-height failure; (g) tC13 base and mid-height flexural failure (near end); (h) tC3 similar to tC13 but lower bars have been cut during de-construction at start of spalling.

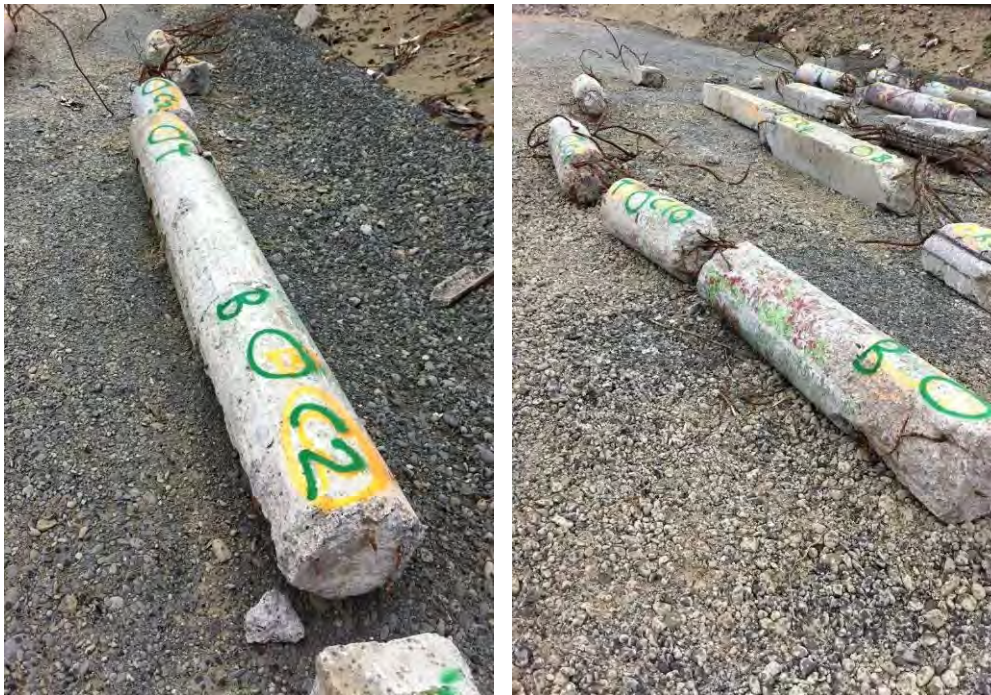
Figure 54 - Level I Entry 400 mm Diameter Columns (left to right) (a) Test item tC2, 6-D12 vertical bars fractured at base (DENG Dwg S14 C23); (b) Item tC10 with down pipe cast in (DENG Dwg S14 C21 or C22)

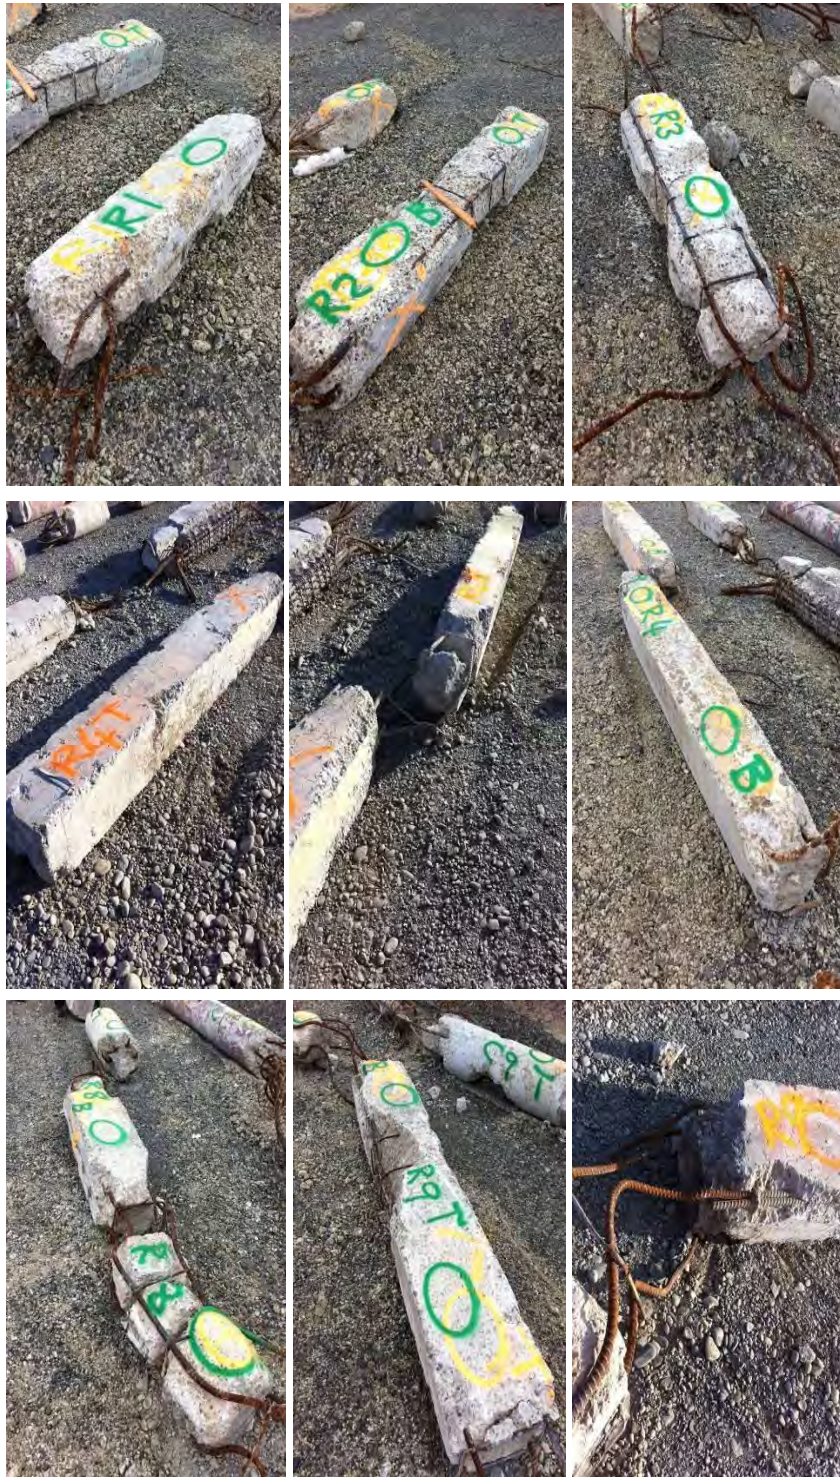
14. Rectangular columns which had all been located on Line A in the structure, typically exhibited beam-column joint failure as well as other damage.

Figure 55 -400 x 300 mm Rectangular Columns (Left to right, top down) (a) tR1 beam-column joint failure at base, mid-height failure; (b) Level 6 to Roof base or beam-column joint failure; (c) tR3 failure base and top; (d) tR4 Level 6 to Roof with beam-column joint failure, still connected by rebar to (e) tR4' below which also (f) indicates beam-column joint failure at tR4' base (near camera); (g) tR8 with damage from mid-height still connected to tR9 above (h) with beam-column joint failure with (i) underside of tR9 smooth.

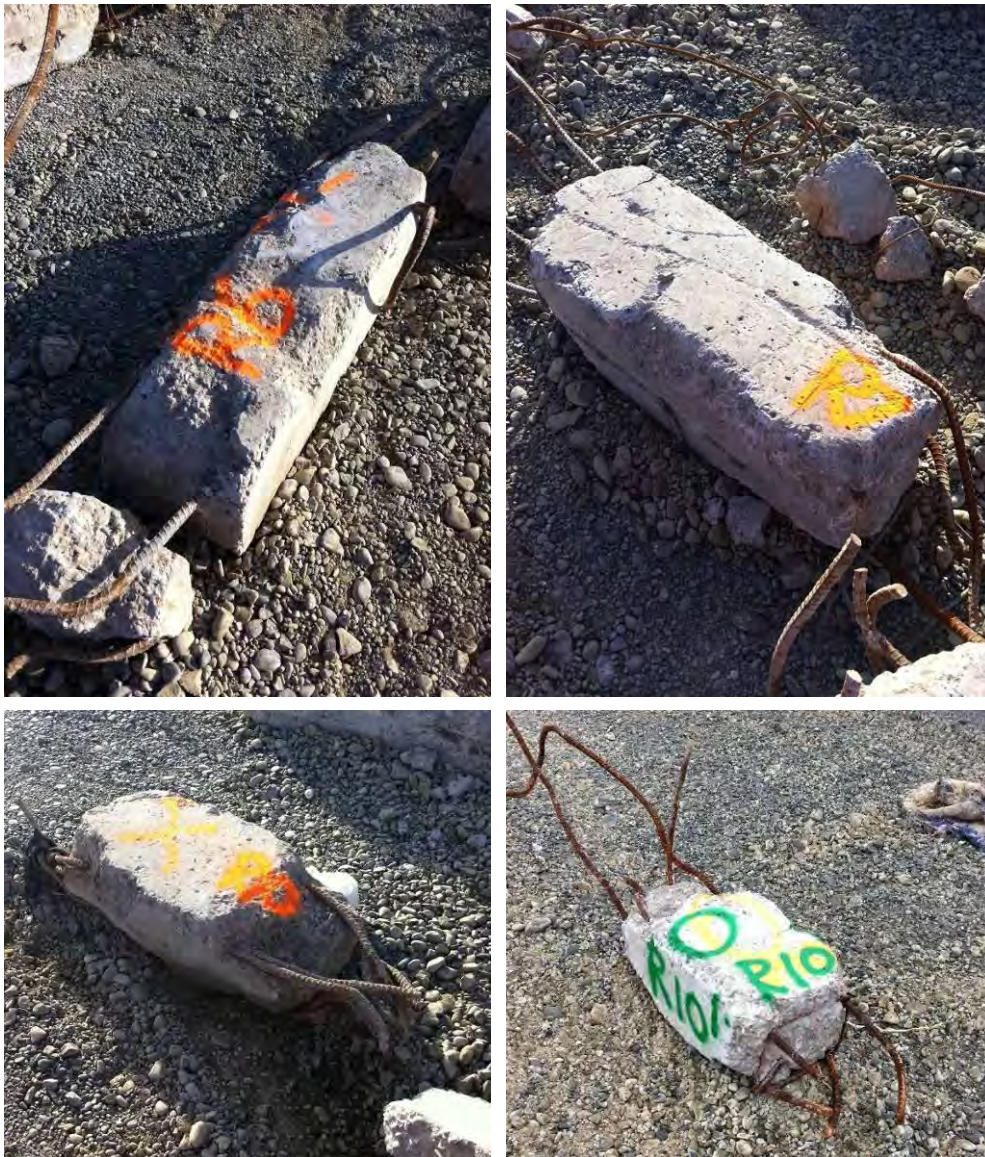
Figure 56 -400 x 300 mm Rectangular Columns (from left to right and top down) (a) tR6 base at far end connected by reinforcing to (b) tR7 below, with beam-column joint failure; (c) tR10 remnant; (d) tR10' remnant

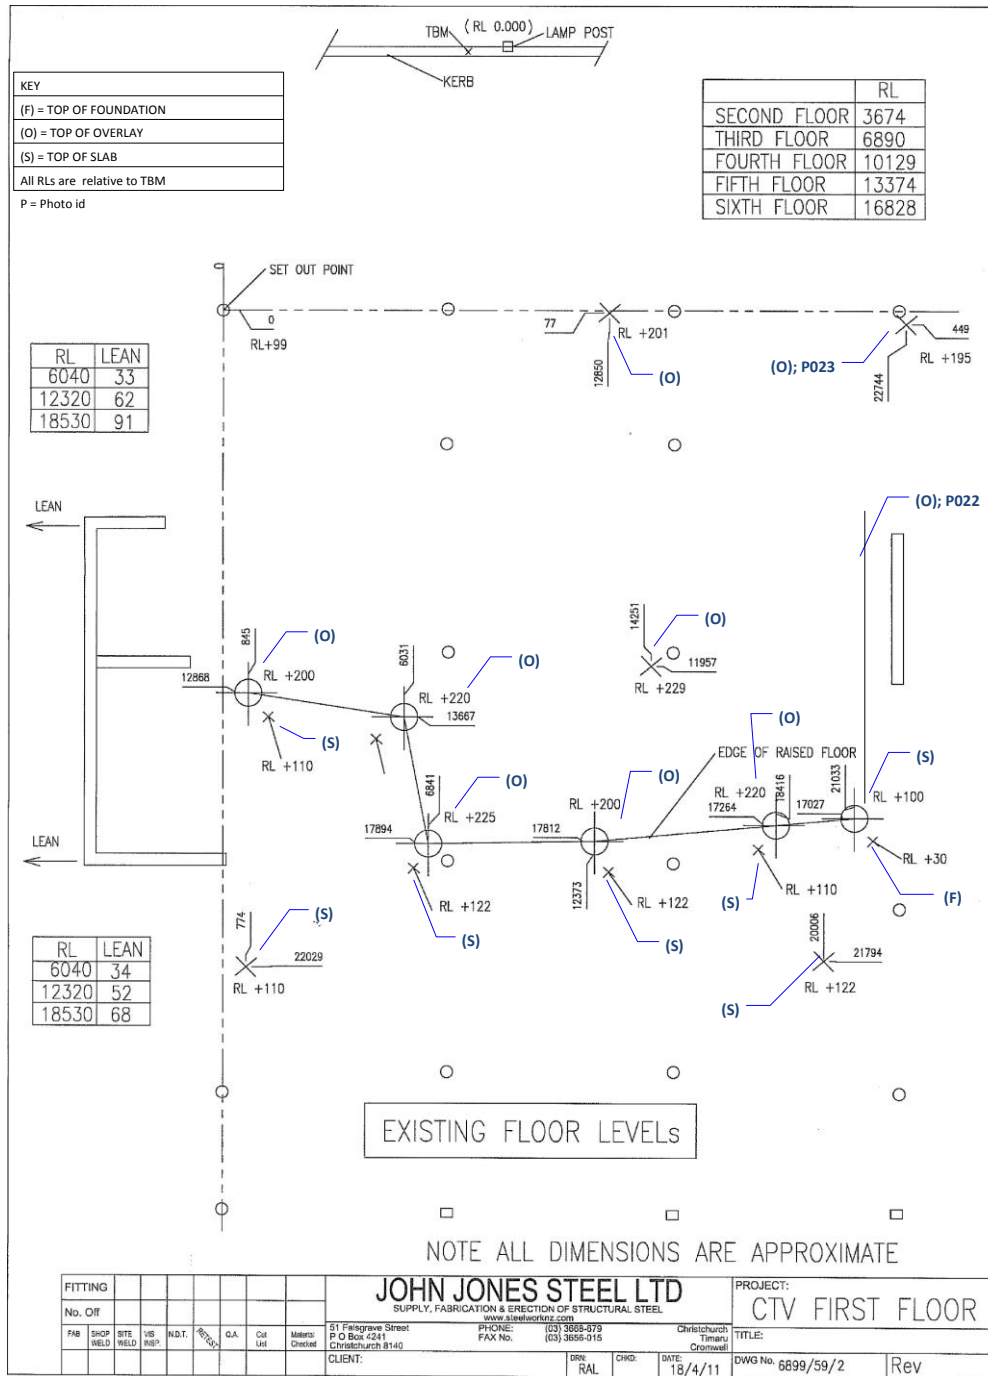
The North Core Line 5 wall was surveyed for verticality by sighting on the eastern and western corners of the north face of the wall. It was found that there was a northwards out-of-vertical measurement of 91 mm over 18.53 m between Level 1 and Level 7 at the northeast corner, and 68 mm over 18.53 m at the northwest corner (Figure 57).

Figure 57 - JJS Dwg 2: Location of overlay edge and lift core lean annotated with levels on adjacent concrete identified as 100mm overlay (O), 125mm slab (S) or foundation beam (F)
