CTV BUILDING

CTV BUILDING COLLAPSE INVESTIGATION
FOR DEPARTMENT OF BUILDING AND HOUSING
25TH JANUARY 2012

Part 3 of 3

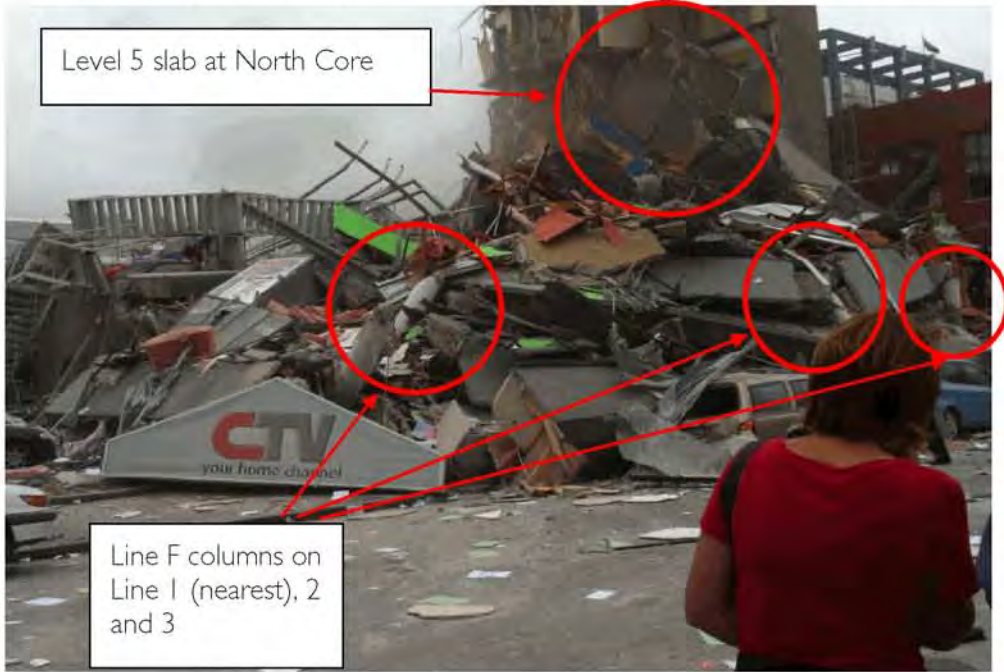
Figure 77 - Corner of Cashel and Madras Streets looking towards North Core. Fractured columns and fallen Spandrel Panels are visible (MSN photo).

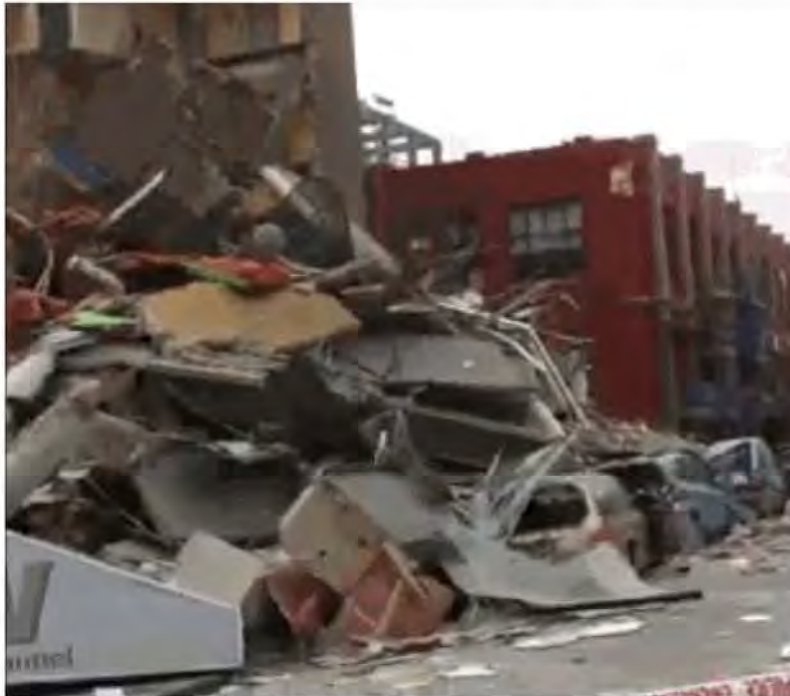
Figure 78 – View from southeast corner of CTV Building along Madras Street. This shows Line F Spandrel Panels fallen onto cars parked in the street indicating a tilt to the east during collapse.

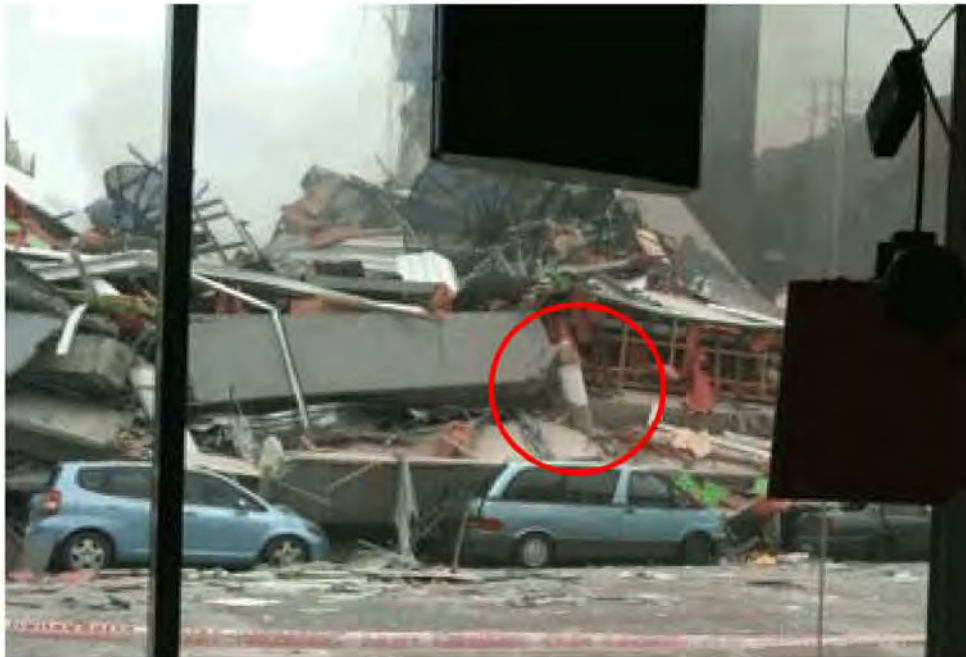
Figure 79 – View from looking west across Madras Street. A Line F/3 column is highlighted showing conical fracture in the painted portion above unpainted portion which had been enclosed by Spandrel Panels.

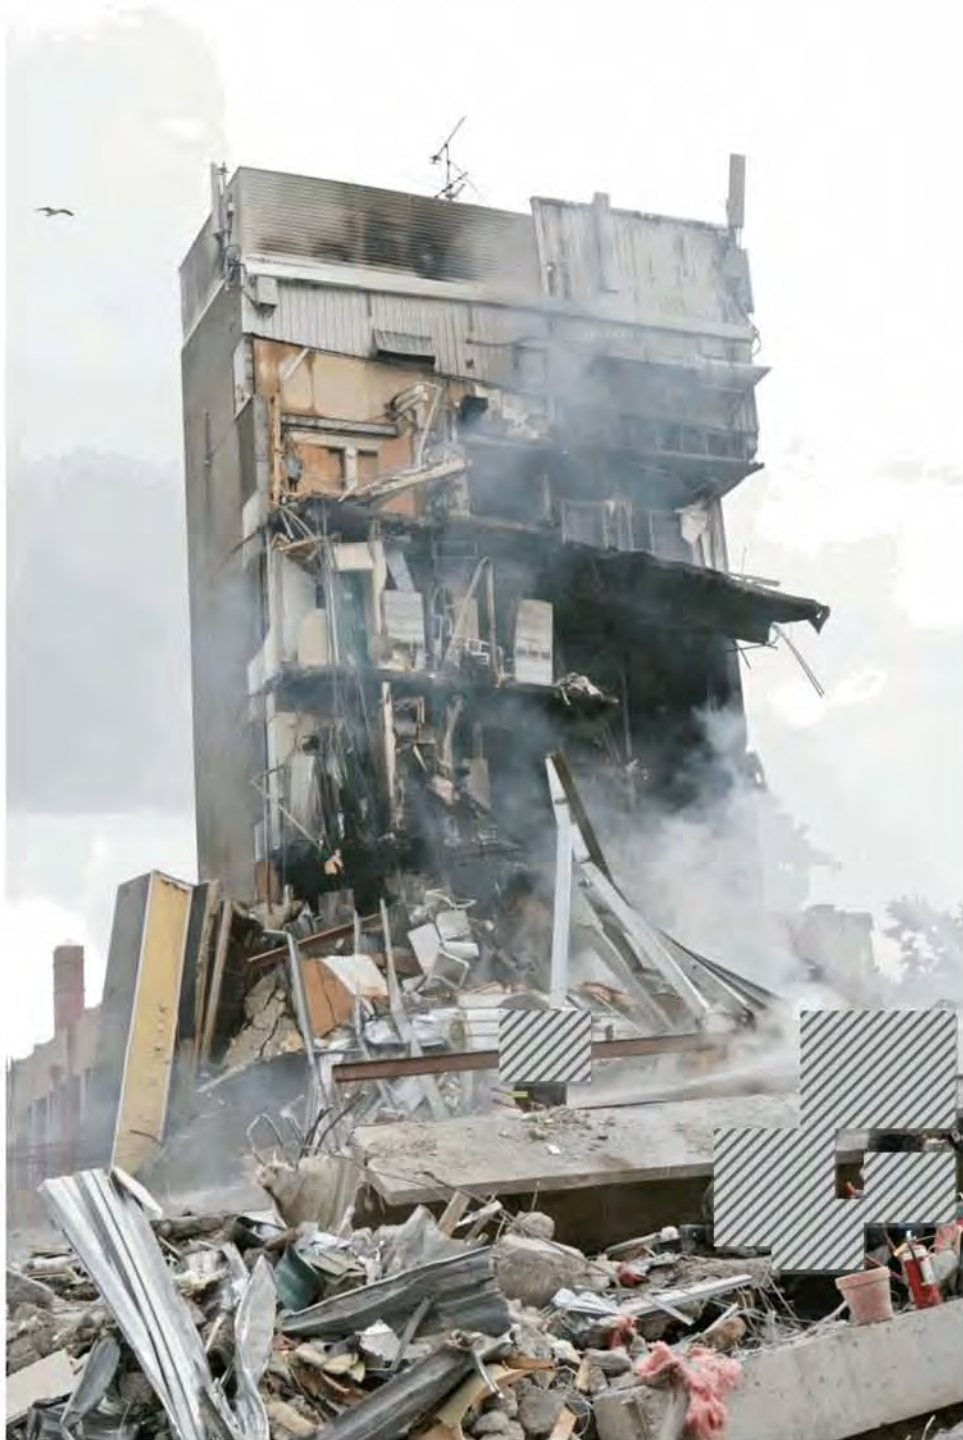
Figure 82 - Spandrel Panels and beams at Cashel Street Line 1 and on Line 4 in background standing vertical. Roof steelwork debris is visible.

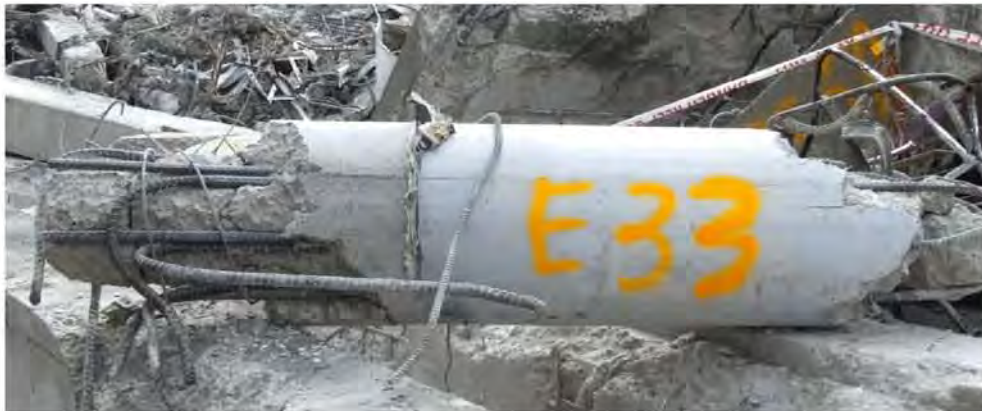
Figure 89 - Perimeter 400 mm diameter column with spalled base and bar lapping zone at left unpainted portion that would have been located at Spandrel Panel infill areas.

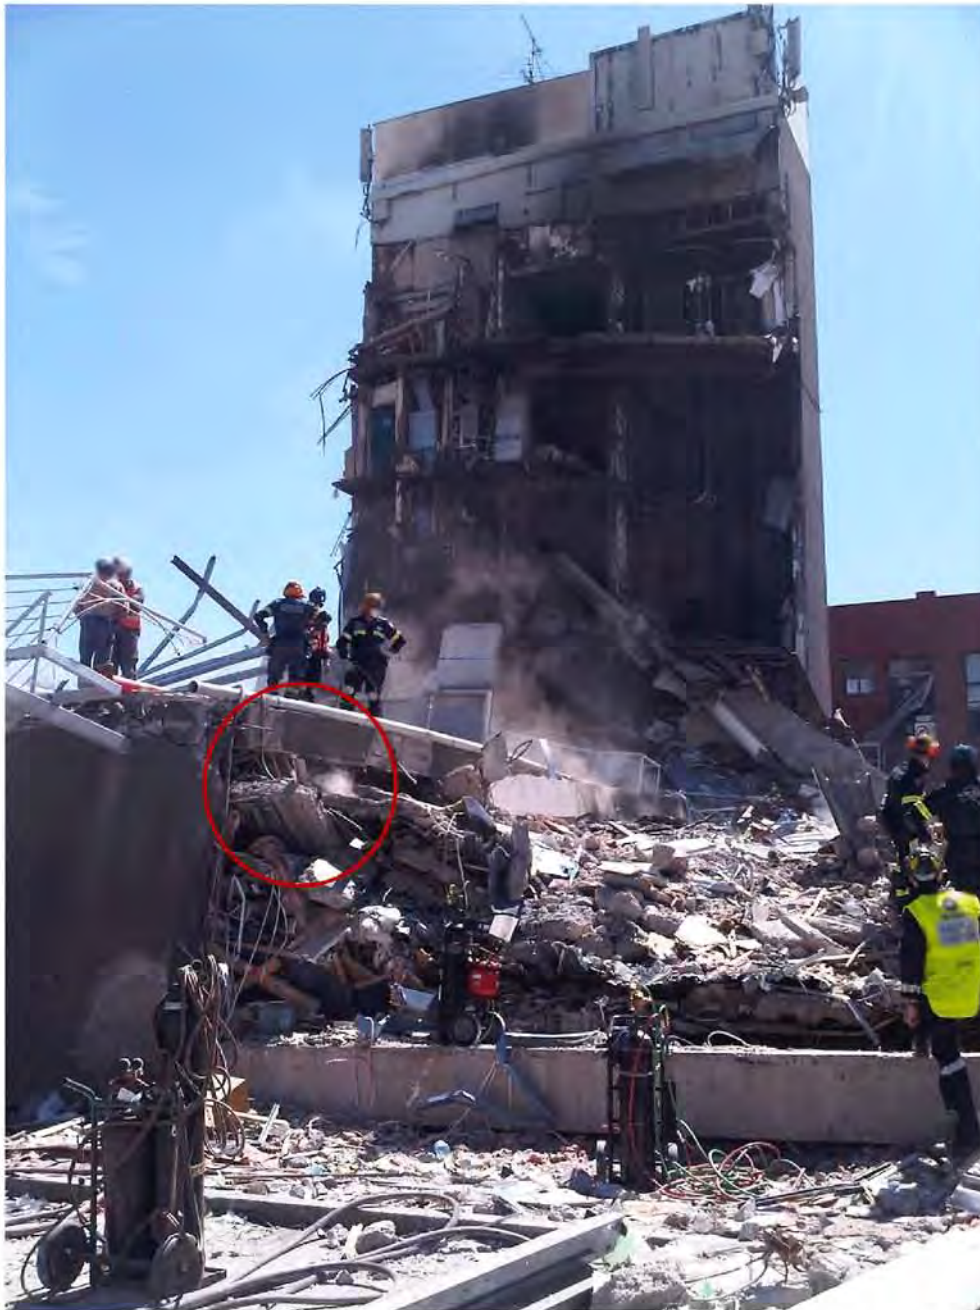
Figure 90 - View from Cashel Street east side of Line 1 with Line 1 South Wall lying on debris at left; trapezoidal end profile of floor slabs laying on top of each other in foreground; A portion of floor slab highlighted, appears to be still in contact with the South Wall at Level 2. Remnants of North Core slabs and the collapsed column on Line 4 D/E can be seen at the rear. The Level 6 slab in front of the lift well can be seen still suspended in mid-air by its Drag Bars connected at Walls D and D/E, even after loss of support from column 4 D/E.

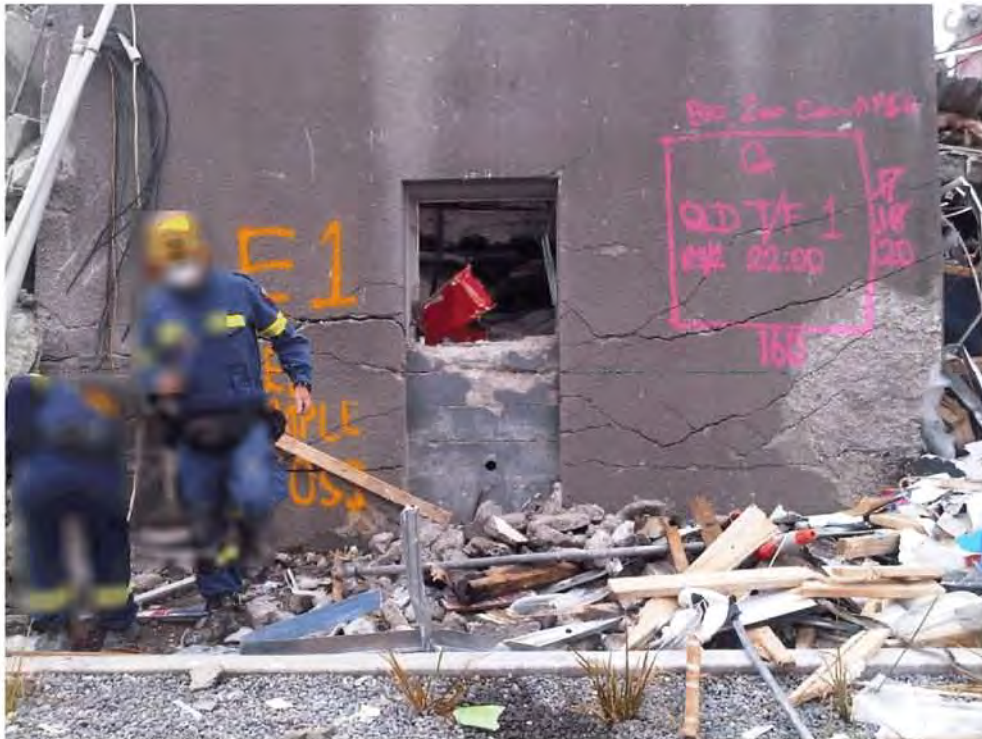
Figure 93 - Line 1 South Wall at Level 1 showing masonry in-fill at door opening, in-plane flexural fan-like cracking and spalling of concrete at right (east) end. A portion of profile slab can be seen end on through the opening

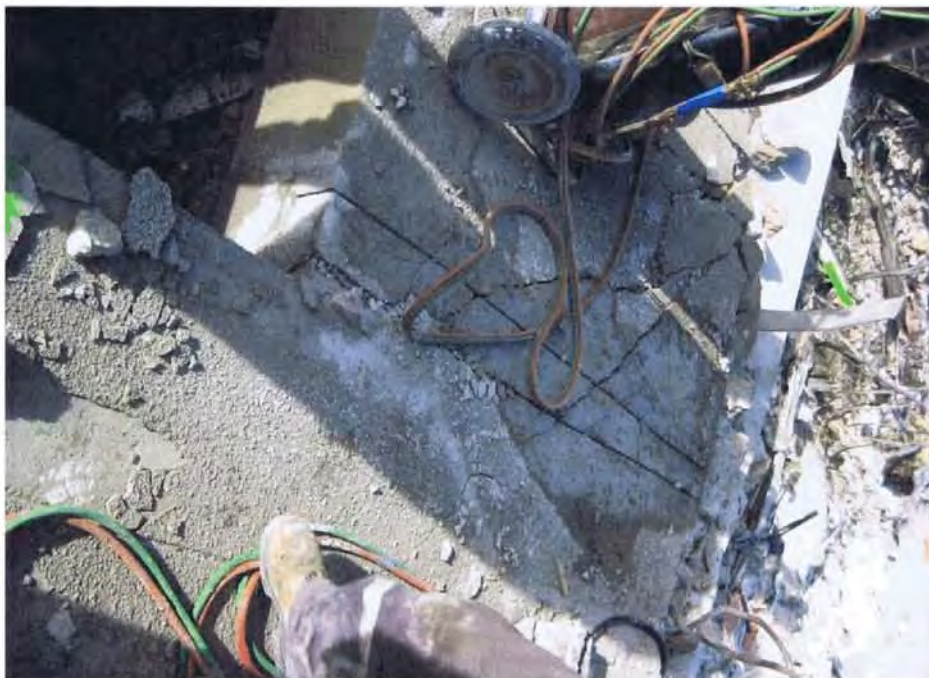
Figure 94 – Line 1 South wall at Level 4 showing severe diagonal cracking in east panel.

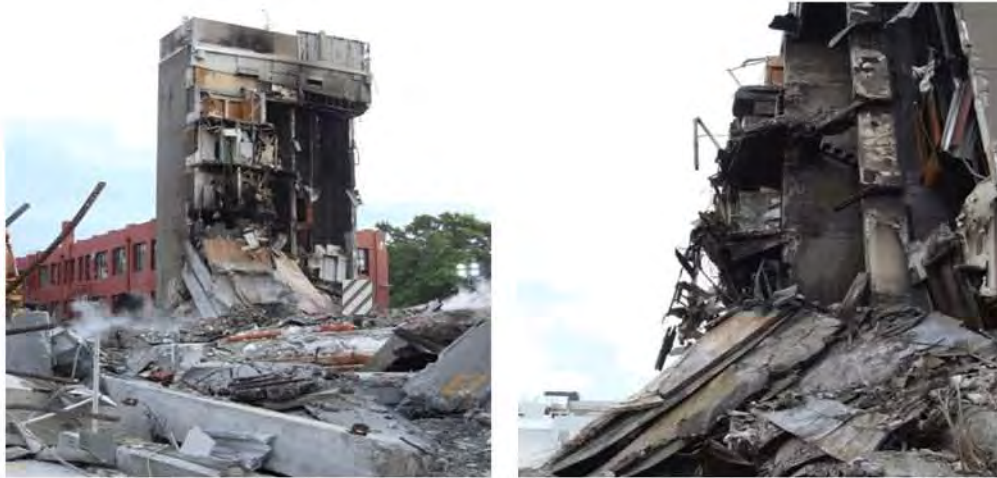
Figure 95 – View of North Core showing Level 4 slab lying diagonally on top of Level 3 slab. This indicates that the Level 3 and 4 slabs lost their vertical support on Line 3 prior to breaking away from the North Core.

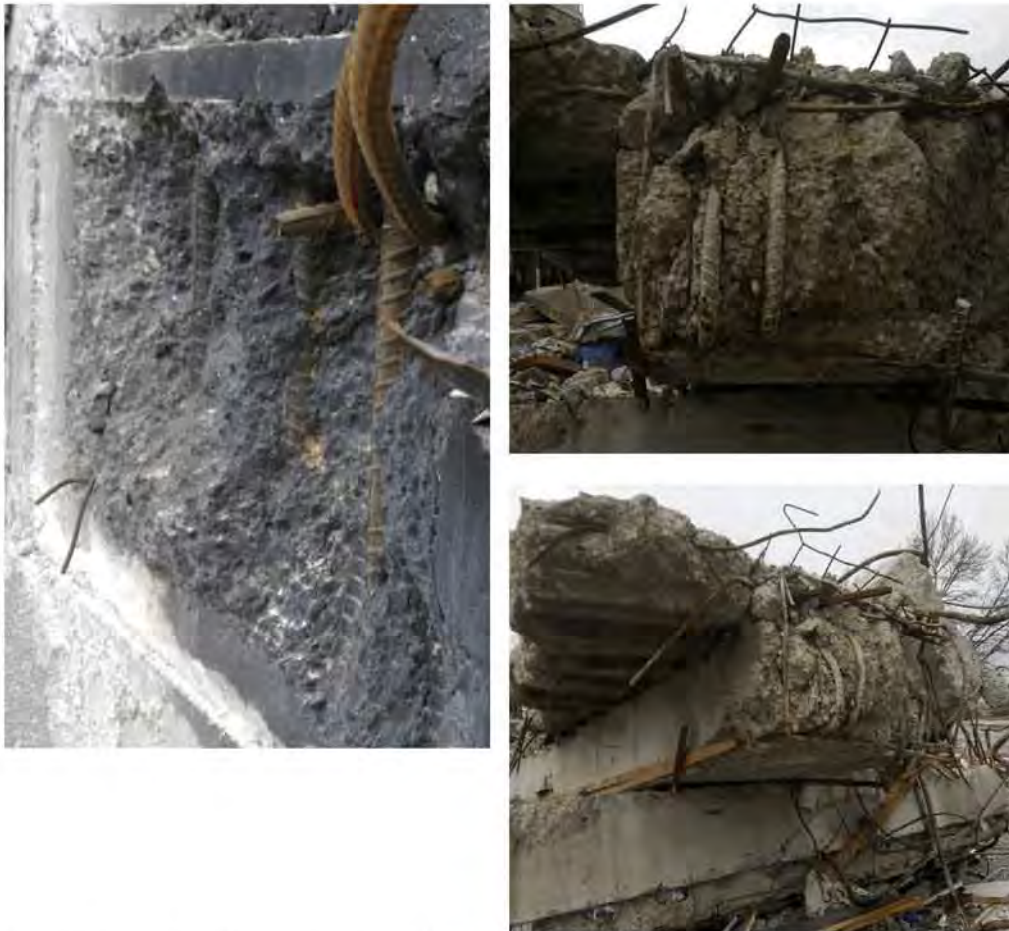
The bottom reinforcing steel in the shell beams had not been developed fully into the Grid C core wall on Line 4 as specified, except at Level 2. The bars had been bent back into the concrete infill in the shell beam (Figure I 05).

Figure 105 - Precast shell beam (Item E14) from northern face Grid 4, west side of North Core (DENG B23 Dwg S18). (clockwise from top right) (a) to (b) Fractured slab outstand remnant at east end from which slab concrete cores were extracted. The bottom H24 bars from shell beam have been turned back into the concrete infill rather than embedded in shear wall as specified (DENG Detail 5 Dwg S19). Notice the bar imprint on wall at the connection seen in (c) at Level 4 and at Level 3.. This meant that these beams would not have performed as intended.

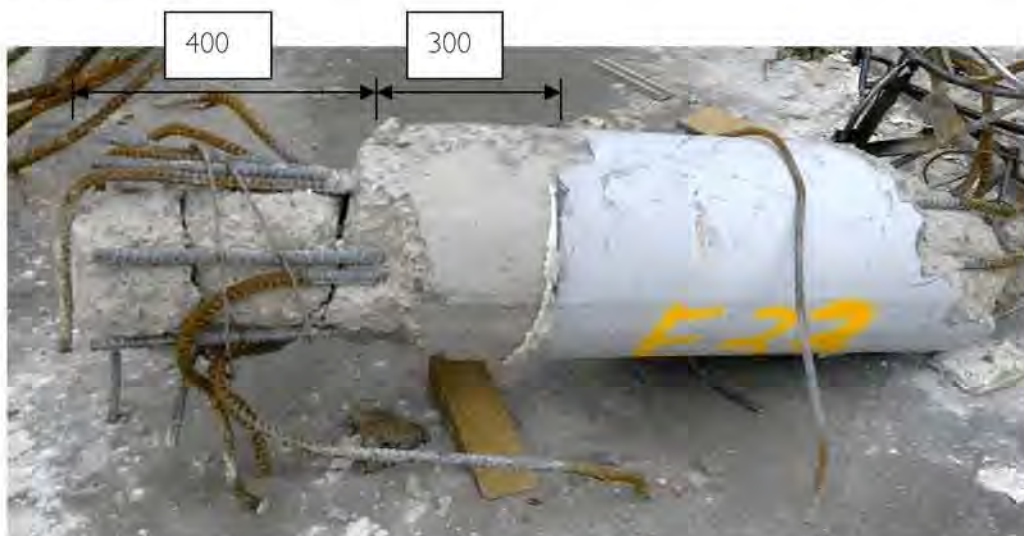
The exterior 400 mm diameter column (Item E33) had flexural failure at the floor level lap joint of the vertical reinforcing steel, and compression-flexural fracture at the upper end of the column (Figure 106)

The lap joint in the exterior columns was concealed by the external Spandrel Panels and interior linings.

Figure 106 - 400 Diameter Exterior Column Item E33. (DENG C5 or C11, Dwg S15). Left end is bottom of column at floor level with concrete spalling over lapped vertical reinforcing. Horizontal cracking in core confined by R6 spiral which had fractured. The unpainted portion was protected by Spandrel Panels.. Right-hand end fracture occurred below beam-column joint.

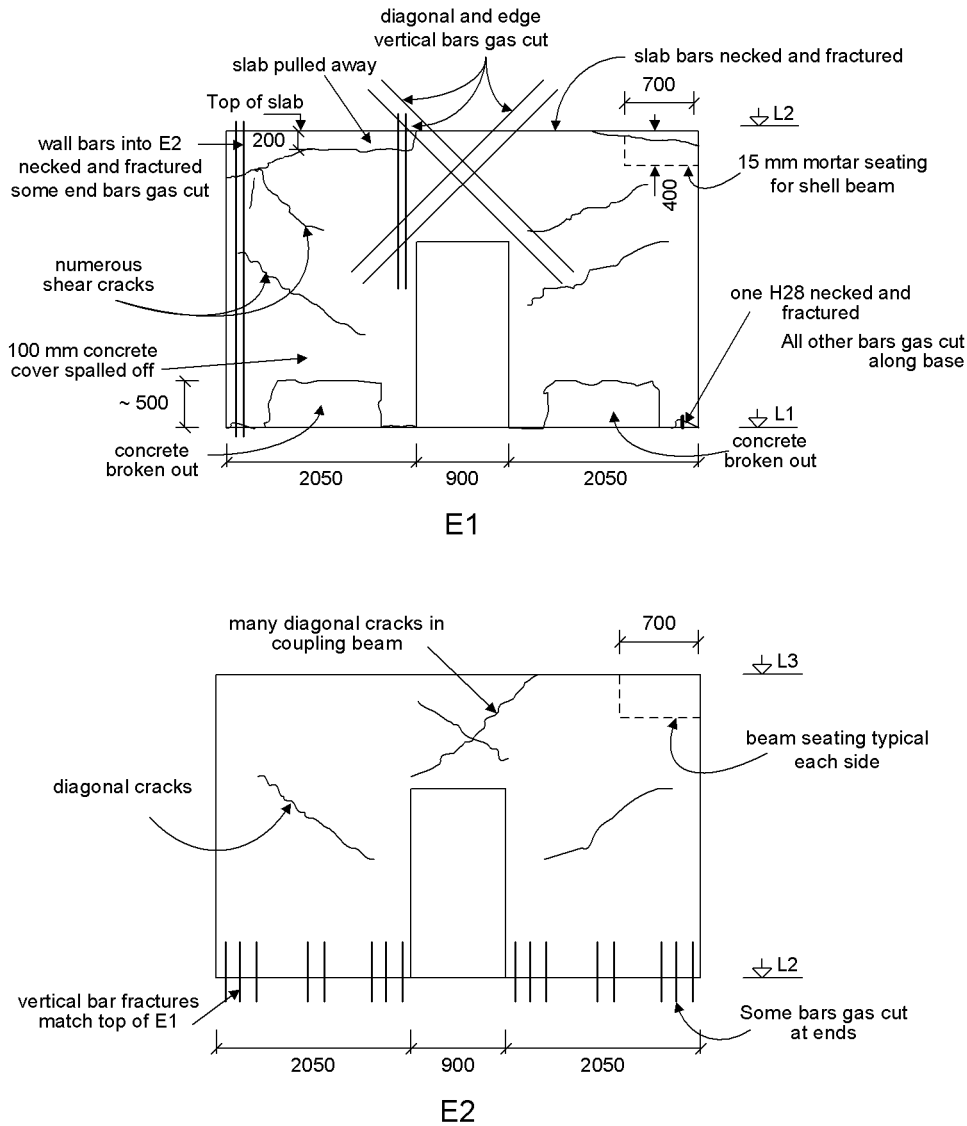
This panel showed flexural cracking patterns typical of cantilever shear walls rather than coupled shear walls (Figure 109). This was likely due to the effect of the Level 1 doorway having been in-filled with reinforced concrete masonry.

Reinforcing steel taken from the east end of the wall was found to have yielded and elongated prior to the collapse of the building.

Figure 109 - Line 1 South Wall remnants (top) E1 Level 1 to 2; (Bot) E2 Level 2 to 3.

This panel had diagonal cracking in the piers consistent with cantilever wall behaviour and two way diagonal cracking in the door head coupling beam (Figure 109).

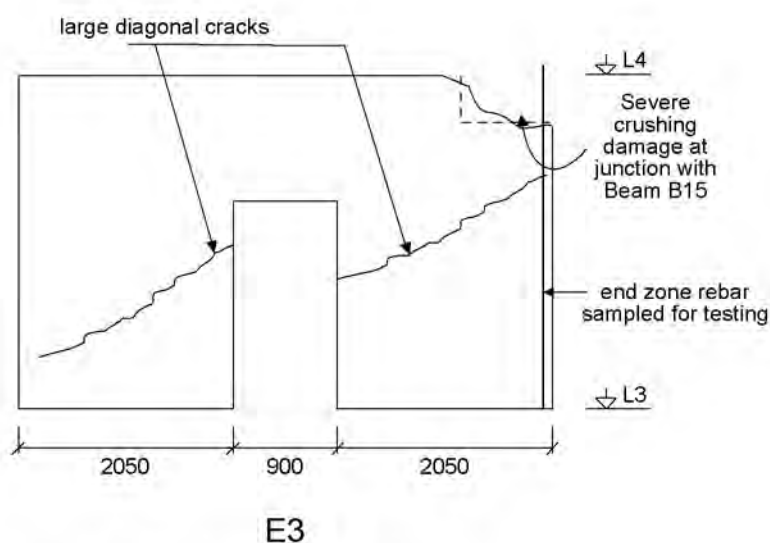
This panel had dominant uni-directional diagonal cracking running from the bottom west corner to the top east end (Figure 110).

Figure 110 - Line 1 South Wall remnant E3, Level 3 to 4.

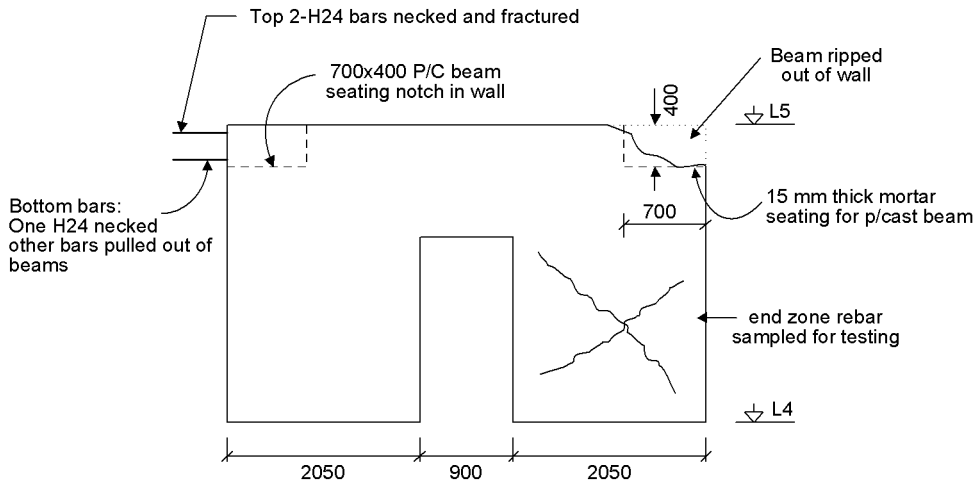
Figure III - Line I South Wall remnants E4 Level 4 to 5 and E4 level 5 to 6.

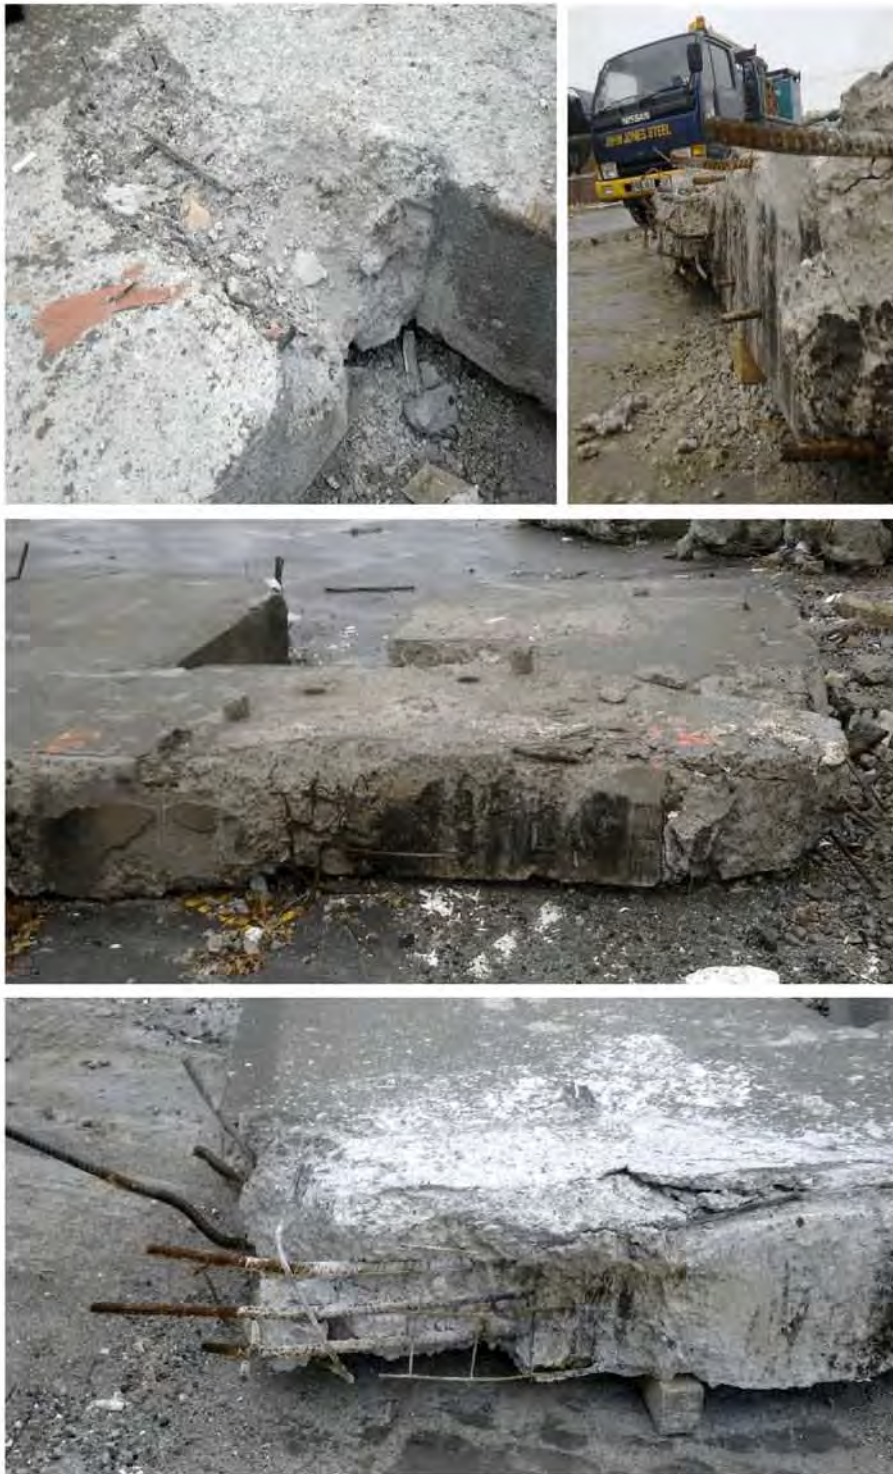
Figure 112 - Line 1 South Wall Level 5 to Level 6 (Item E5) (clockwise from top left) (a) Crumbly concrete at door edge of west pier able to be dislodged by boot; (b) Smooth and charred construction joint on top west surface looking east; (c) Charred construction joint above west pier. Door sill on left; (d); Top east corner with fractured top 3-H24 bars. Floor 664 mesh exposed.

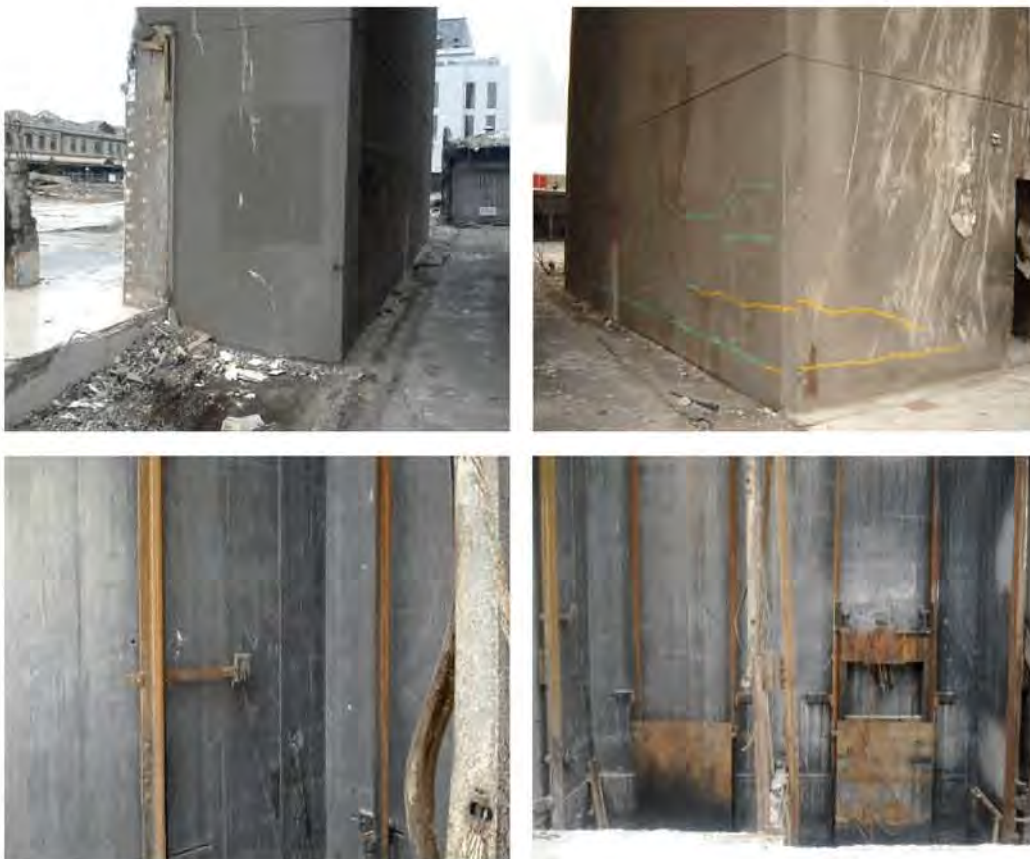
Only fine cracking was found on the North Core walls after collapse (Figure 113).

No obvious cracking on Line D/E wall.

Horizontal flexural cracking on west and north west face of Line 5 wall and north end of Line C wall at Line C/5.

Fine two-way diagonal cracking on the inside faces of Level 1 to 2 Line 5 and D walls in North Core.

Figure 113 - North Core cracking (clockwise from top left) (a) No obvious cracking on Line D/E wall; (b) Horizontal flexural cracking on west and north west face of Line 5 wall and north end of Line C wall at Line C/5; (c) Fine two-way diagonal cracking on the inside faces of Level 1 to 2 Line 5; (d) and D walls in North Core.

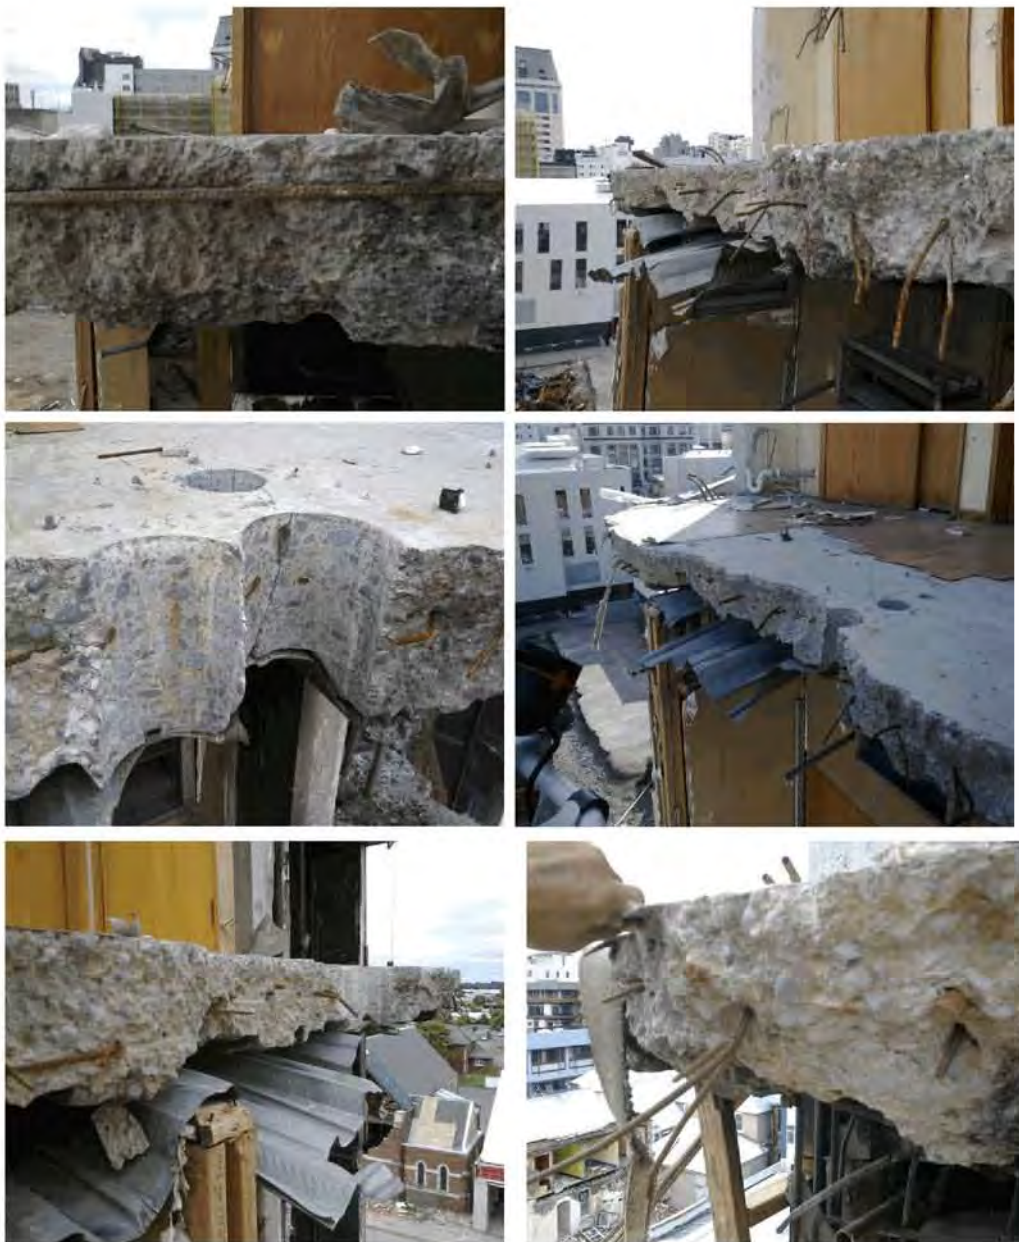
The slab had a vertical fracture face that coincided with the ends of the H12 saddle bars from the support beam on Line 4 (Figure 114).

664 mesh in the slab had fractured in a ductile manner which is the way it was intended to.

The profiled metal deck steel decking had fractured in tension adjacent to the edge of the fractured slab edge.

Figure 114 - Line 4 Core Wall Slab Remnant at Level 6 amenity area (clockwise from top left) (a) Slab edge on stairwell wall looking west with HI2 saddle bar exposed and ends of mesh below it; (b) Vertical concrete fracture surface with reinforcing mesh fractured; (c) Slab looking west with cores cut in floor for amenities; (d) Fractured mesh angled downwards; (e) Fractured slab edge looking east. Torn metal decking aligned approximately with concrete fracture edge; mesh at varying height within slab; (f) Cores for amenities at fracture edge can be seen and are a small proportion of the total fracture surface length.

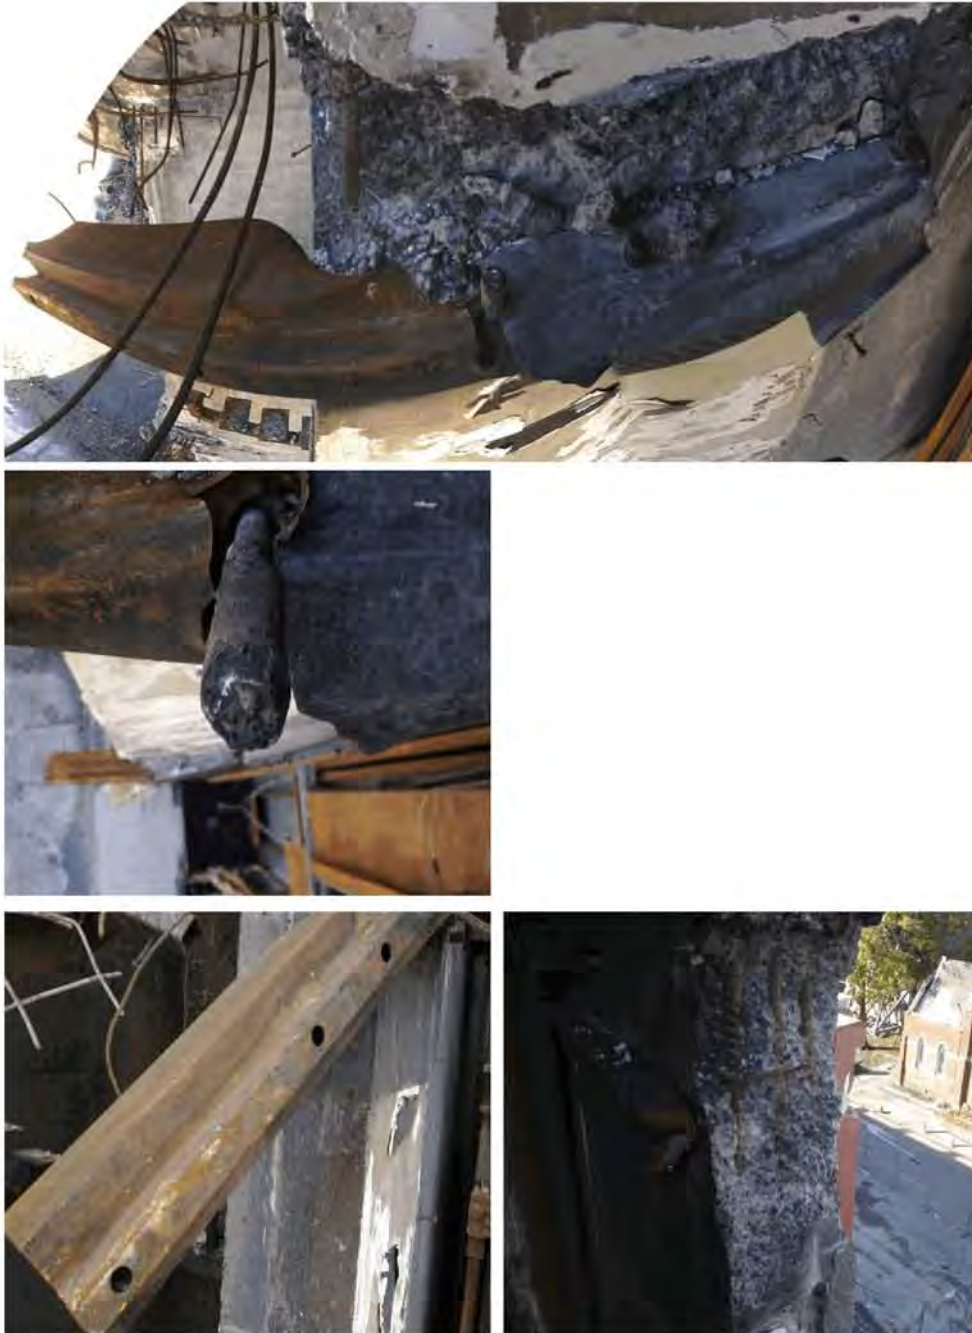
The Drag Bars on both the west and east wing walls had partially fractured in bending and tension. The epoxy grouted 20 mm threaded rods that were fixed vertically into the slab and into the Drag Bar on the west wall appeared to have pulled out in tension. This occurred as the slab between Lines D and D/E rotated downwards, pivoting about its Drag Bar supports at the ends of the lift shaft walls.

The 20 mm diameter Drag Bar threaded rods were hardness tested by MTL and found to have Rockwell Hardness HRB. This conformed with the minimum requirements of AS 4291.1:2000 (SAA 2000) for Property Class 5.8 threaded rods.

Figure 115 - Level 5 Lift Well Wing Walls Grid D and D/E (anti-clockwise from top) (a) the Drag Bar consisted of a 150x150x10 L steel angle with a 51 x 3.2 SHS welded to it; 4-M24 anchors were epoxied into the wall and 6-M20 threaded anchor rods 350 mm long were epoxied into the slab at the profiled metal deck rib. 3-M20 threaded rods remained upright on the Grid D Drag Bar. The 51x3.2 SHS had fractured in bending and tension at the bolt hole adjacent to last bolt into wall and twisted with the slab; This shows that the slab that had been fixed to the Drag Bar had rotated downwards as the column on Line 4 D/E collapsed, (b) Epoxy grout can be seen around the threaded anchor rod that had been in the slab; (c) The Drag Bar is bent downwards and holes where 3-M20 threaded anchor rods had been can be seen; d) On Wall D/E a 150x75x10 L steel Drag Bar was still fixed into the wall D/E with 5-M24 threaded rod anchors. The end of the Drag Bar had been gas cut during deconstruction.

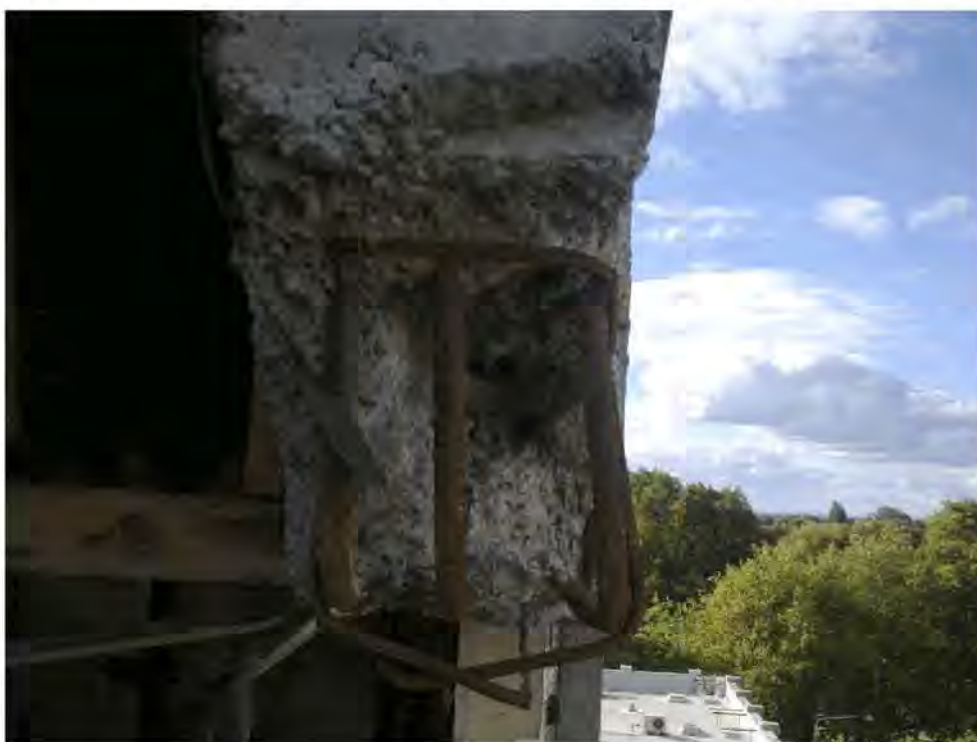
The column had pulled away from its connection to the North Core wall D/E. Four H20 bars were specified on the drawings to be bent into the wall (Figure 116). However only three 20 to 24 mm diameter holes were found in the location where the column bars had pulled out. This indicates that one bar had not been placed as specified. Though not considered to have initiated the collapse, if all these bars had been present they may have prevented the collapse of column D/E 4. Even so this would not have prevented the collapse of the other columns in the building.

Figure 116 - Lift Well Wing Wall D/E: Column D/E 4 Connection (DENG Dwg S14); 3 x 20 to 24 mm diameter holes can be seen where reinforcing bars from column have pulled out. The drawing shows that 4-H20 bars were required to be bent in to the wall.

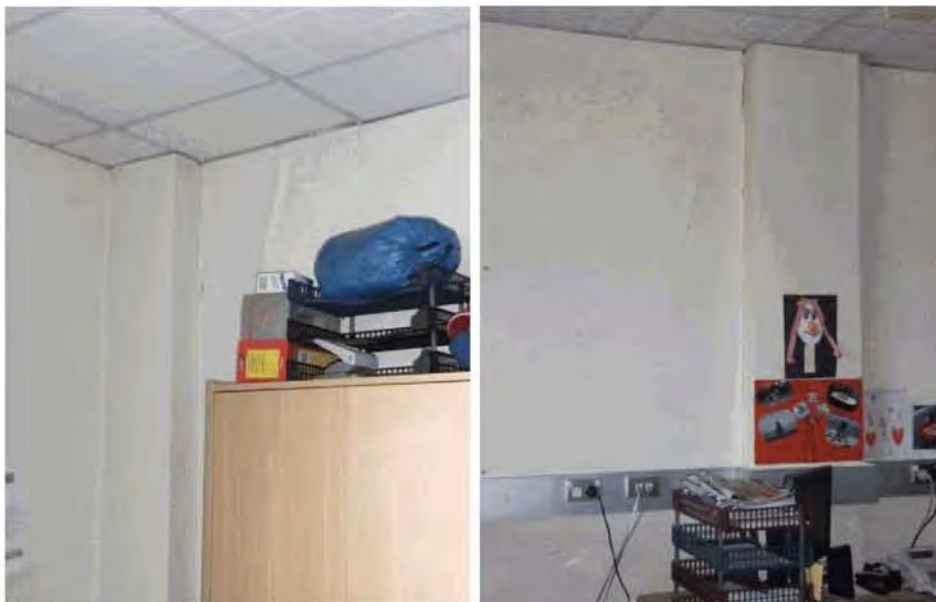
Figure 152 - Inside of the west wall at Level 2 after the 4 September 2010 Earthquake shows some damage to the linings.

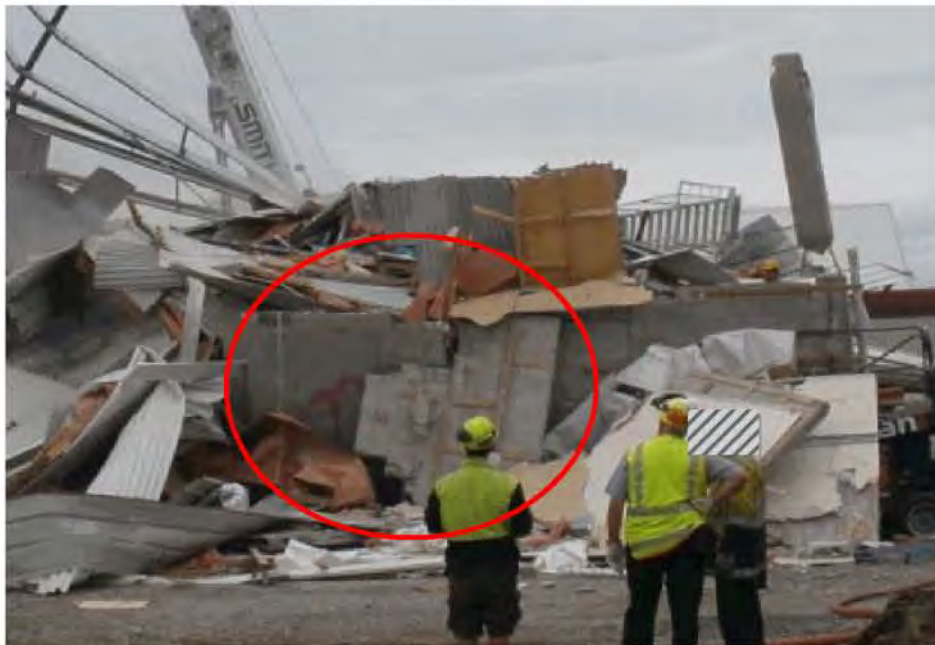
Figure 154 - West wall shortly after collapse. The corner Grid 1/A column is still standing and the wall panels have broken free in panel sections in places. The edges of the panel section are square consistent with the design drawings. Diagonal fracture of the masonry infill that has fallen outwards from level 2 is highlighted. This indicates that the infill masonry above Level 2 fully developed its shear capacity prior to the collapse and therefore affected the response of the structure to the February Aftershock.

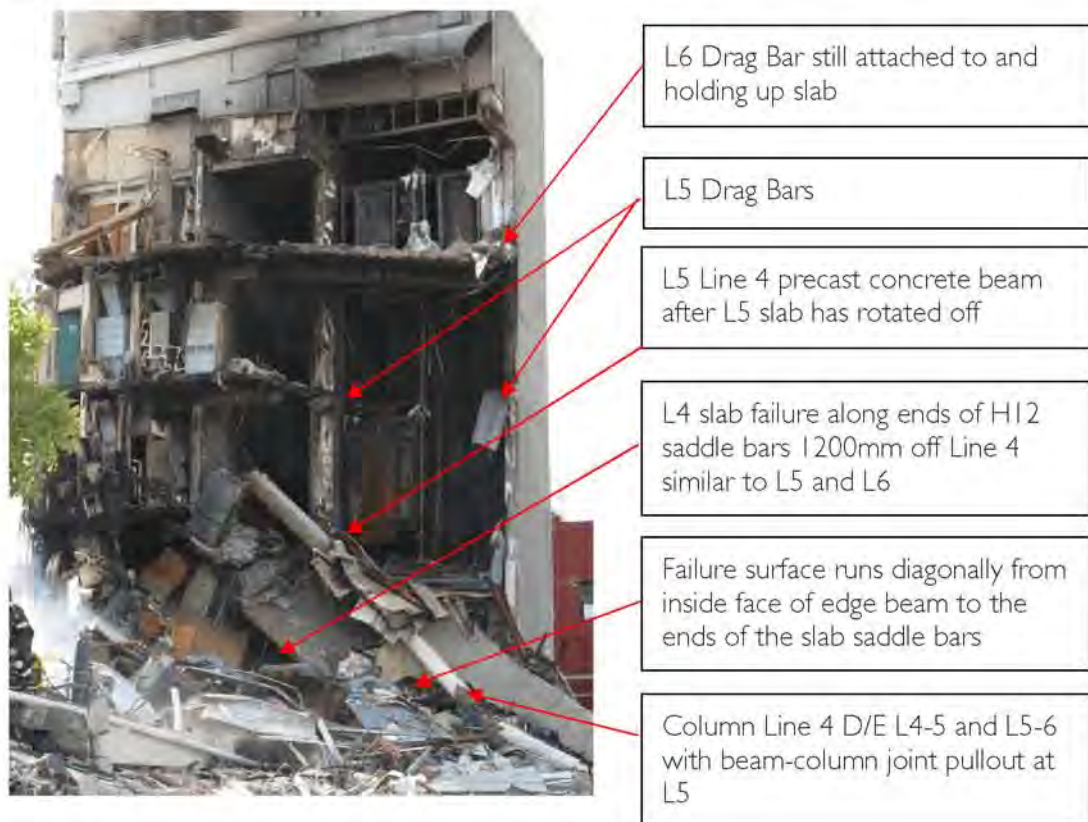
Figure 163 - Failure of slab adjacent to North Core.

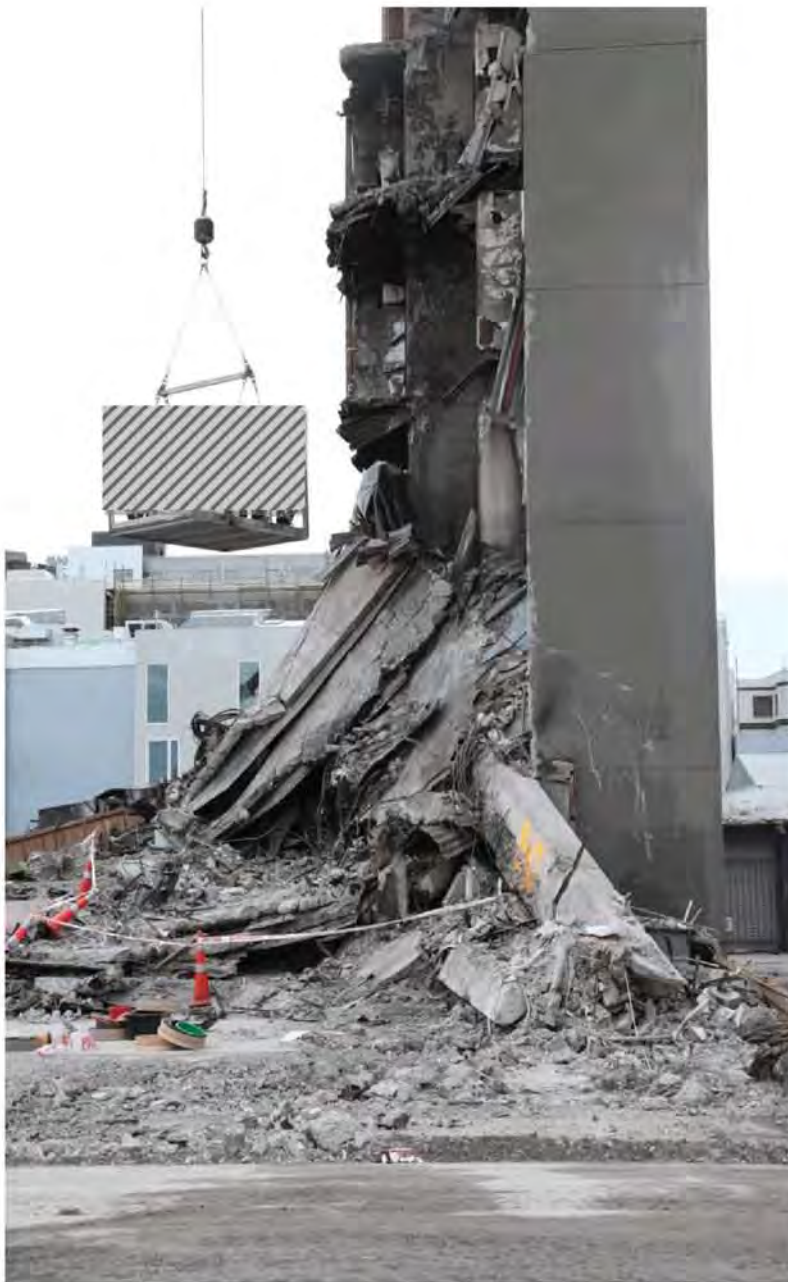
Figure 165 - North Core slabs leaning against the North Core showing that their collapse occurred after collapse of the Line 3 frame

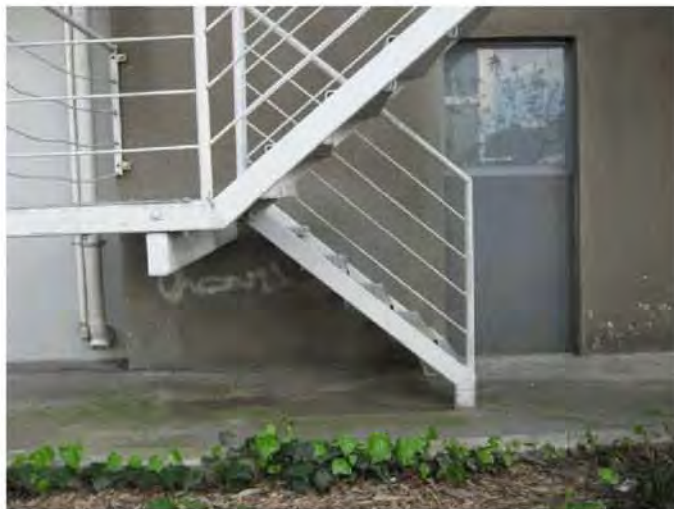
Photo 2 Cracking in south shear wall (not visible in photo) under fire escape landing

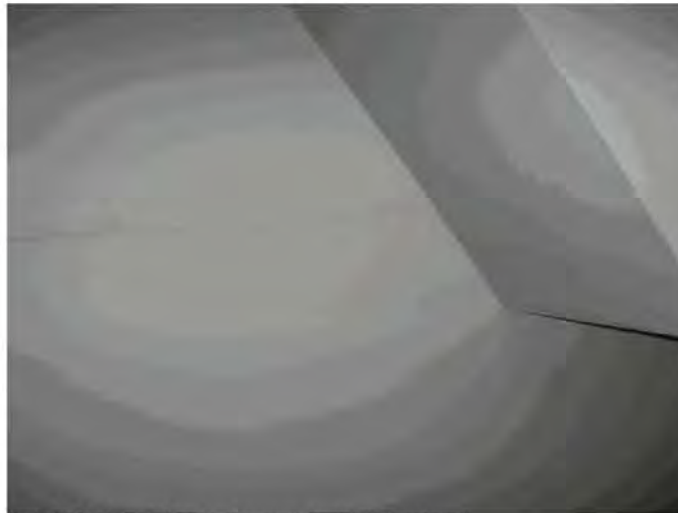
Photo 3 Cracking in floor level construction joints in stair well

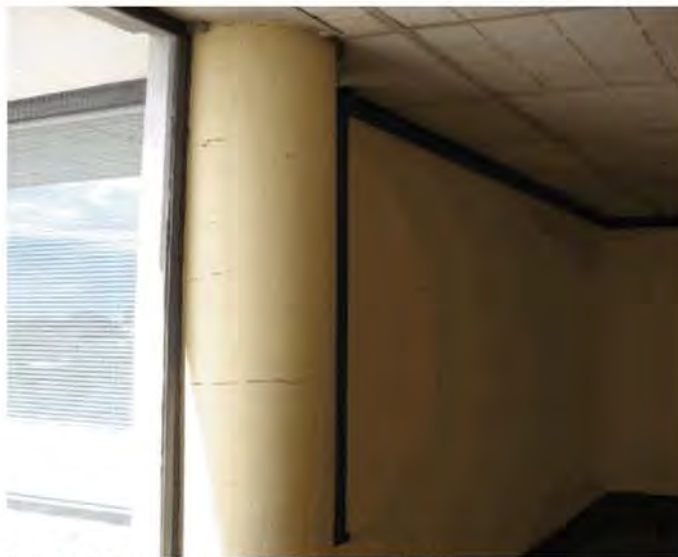
Photo 4 Cracking in top storey column adjacent to lift lobby.

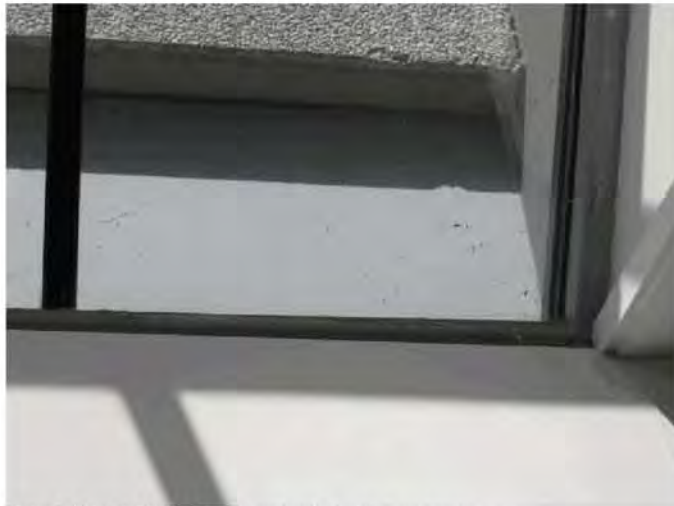
Photo 5 Cracking in first floor beam north elevation over entry.
