CTV BUILDING

CTV BUILDING COLLAPSE INVESTIGATION
FOR DEPARTMENT OF BUILDING AND HOUSING
25TH JANUARY 2012

Part 3 of 3

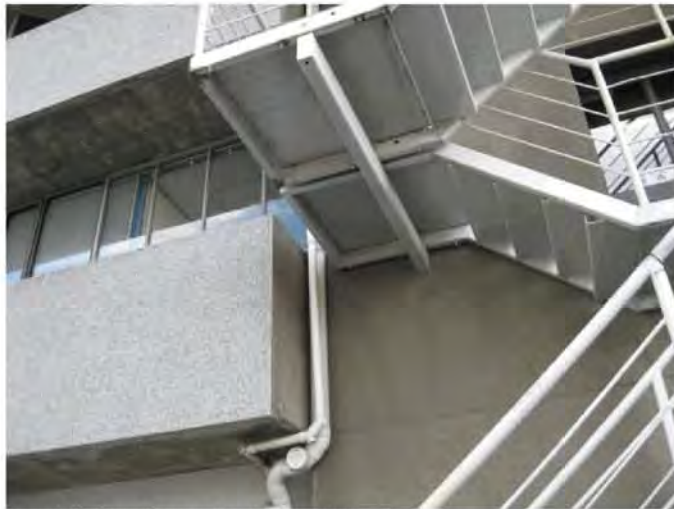
Photo 6 Spalling of plaster off ends of spandrel panels.

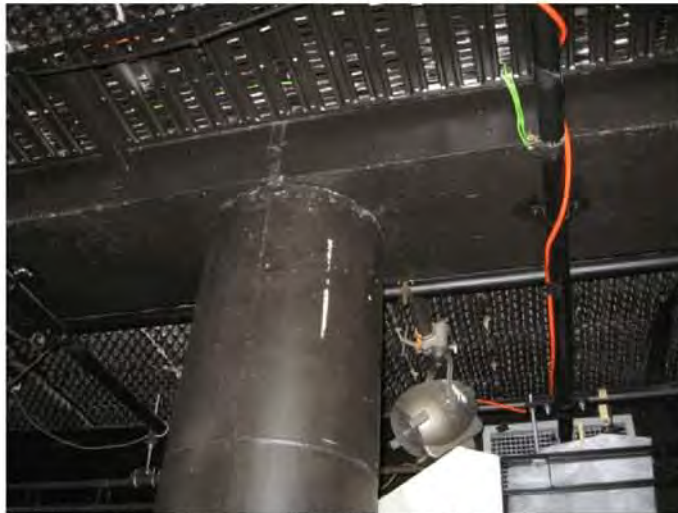
Photo 7 Internal beam column joint under first floor – no evidence of damage.

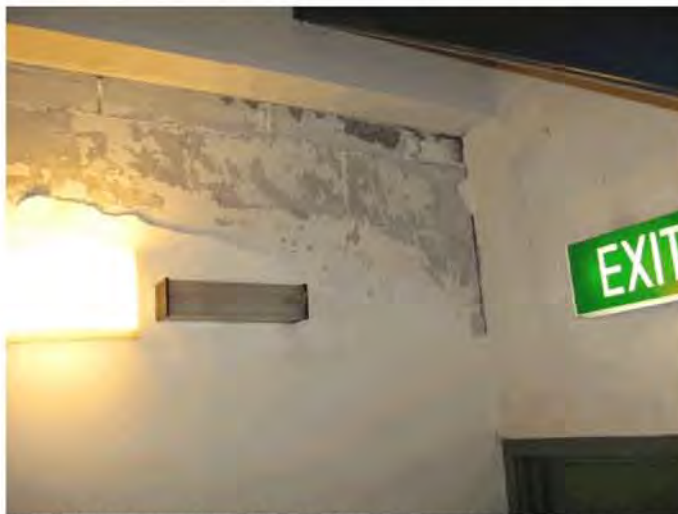
Photo 8 Spalling gypsum plaster off non-load bearing concrete block wall in stairwell.

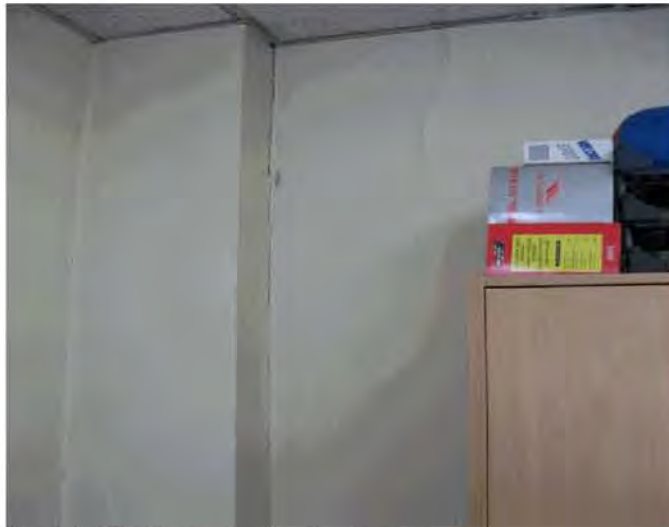
Photo 9 Partition lining damaged at junction with concrete column.

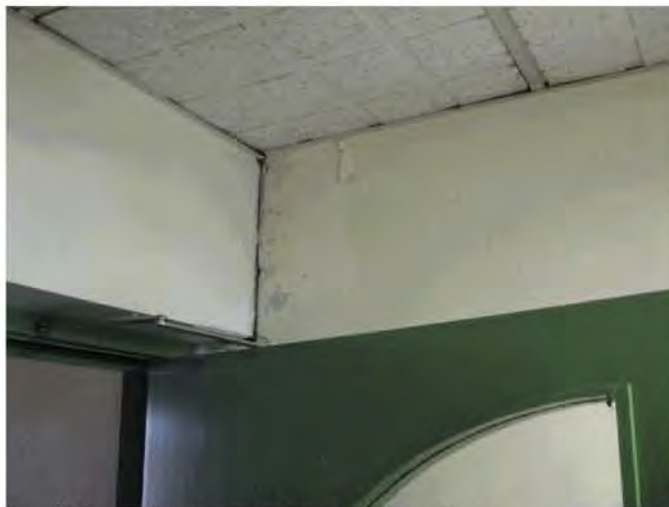
Photo 10 Partition lining damaged at junction with concrete beam.

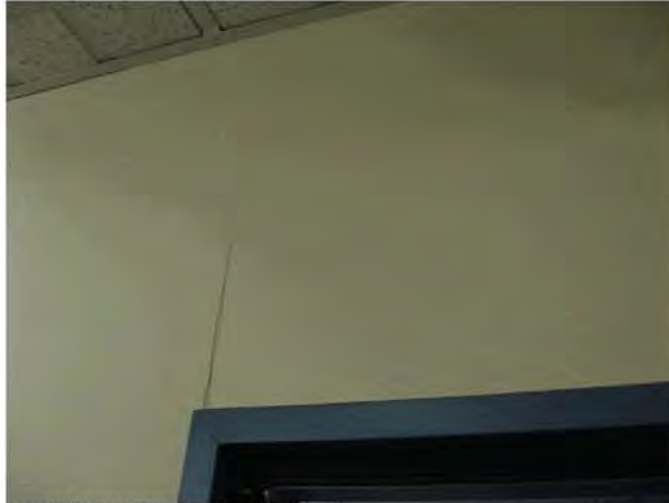
Photo 11 Cracking in linings over door head

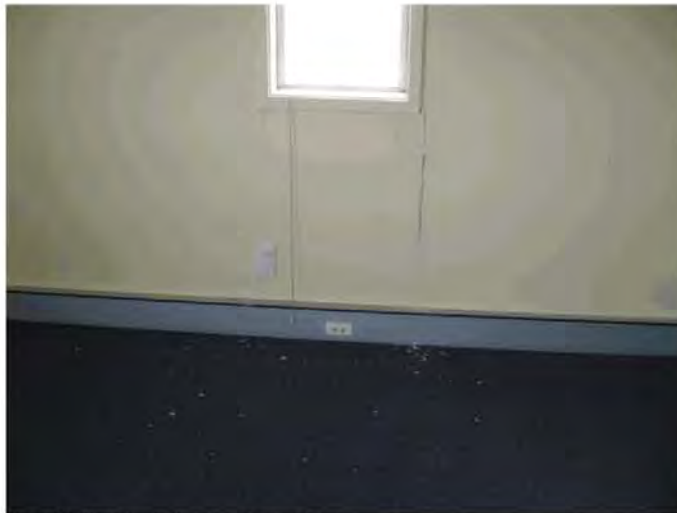
Photo 12 Cracking in linings under window.

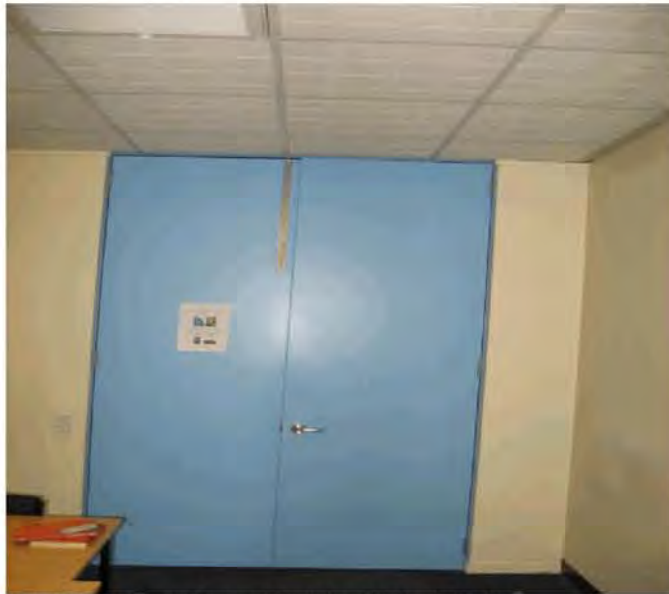
Photo 13 Racked second floor partition wall and binding double doors.

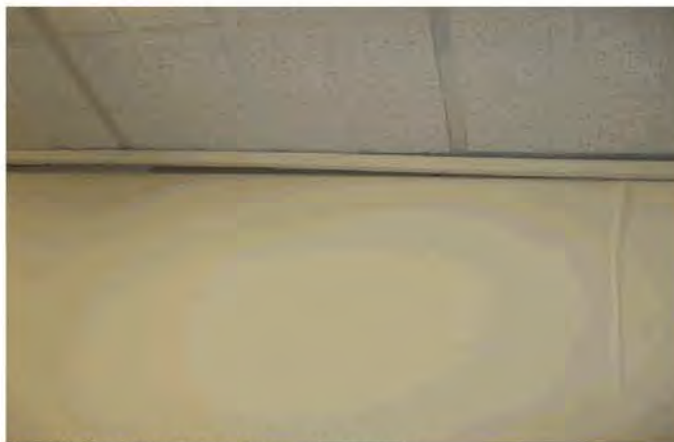
Photo 14 Cracked wall lining and damaged ceiling coving.

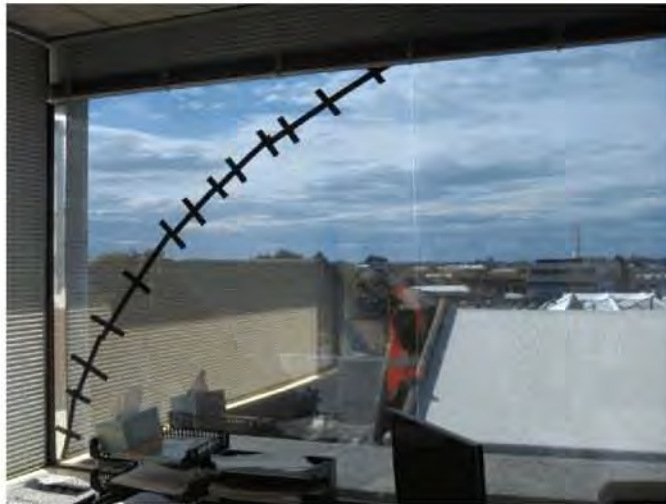
Photo 15 Broken window.
