# CTV BUILDING

CTV BUILDING COLLAPSE INVESTIGATION  
FOR DEPARTMENT OF BUILDING AND HOUSING  
25TH JANUARY 2012

Part 2 of 3

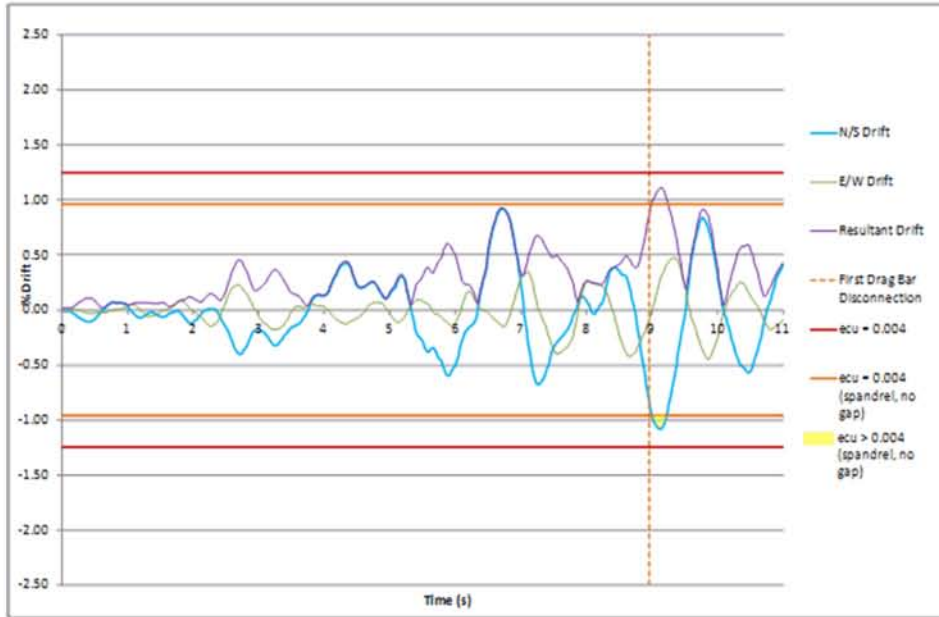
Figure 50 - Comparison of drift demand and capacity – column F2 Level 3 - CBGS, 4 September Darfield Earthquake, no masonry.

The horizontal lines represent the estimated capacity of this column to sustain the drift without failing according to various criteria (assuming expected concrete strength and without vertical earthquake effects). The band between the horizontal lines in Figure 12 and Figure 13 reflects the difference between “no interaction with the spandrels” (higher value) and “full interaction with the spandrels”. The areas where the drift had exceeded the estimated capacity are shown shaded. The band showing the range of capacities would be wider if allowance was made for the effect of variable concrete strength and vertical earthquake forces in the column.

An important feature of this analysis was that for heavily loaded columns, the displacement to cause yielding of the main column bars was close to the displacement to cause failure. This is significant because it indicates that significant displacements, such as occurred on 4 September 2010, could be sustained with little evidence of distress, yet collapse could occur due to a relatively small additional displacement.

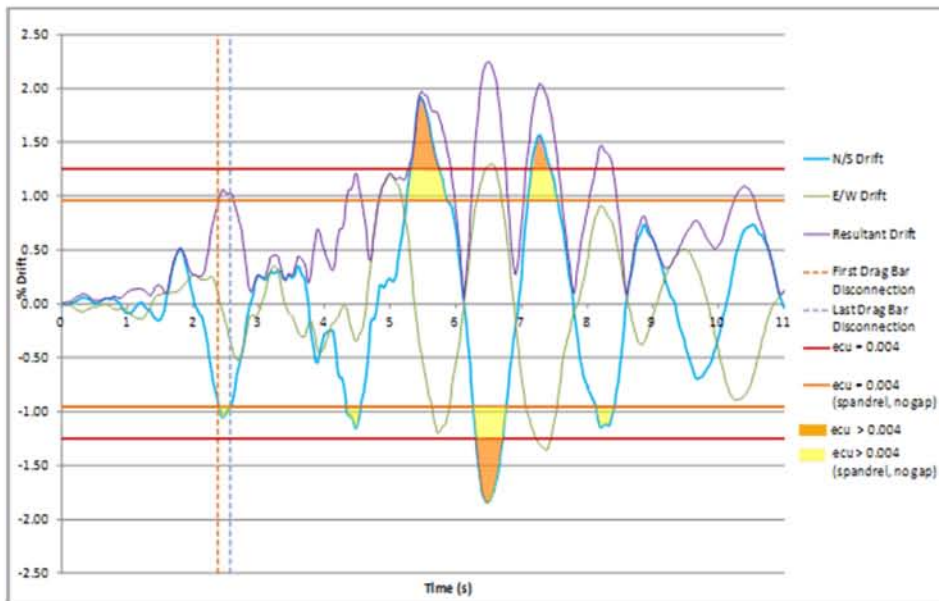
Figure 51 - Comparison of drift demand and capacity – column F2 Level 3 - CBGS, February Aftershock, no masonry.

These comparisons give some indication of the challenges of determining which column or mechanism initiated failure. However, the plots indicate clearly that there is a strong likelihood that the demands of the February Aftershock were enough to cause column failure, whereas the demands of the September Earthquake were much less.

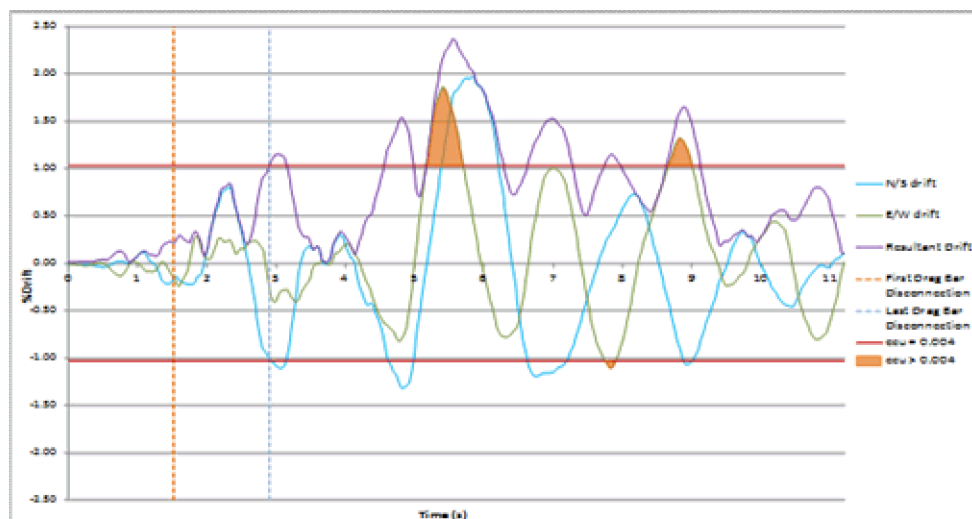
Figure 52 - Comparison of drift demand and capacity – column D2 Level 3 - CHHC, 22 February Lyttelton Aftershock, no masonry.

The axial forces in column D2, from the NTHA with vertical accelerations, were found to fluctuate at much higher frequency than the lateral modes of vibration. There was therefore significant variation in the axial force for any given cycle of lateral drift, with an increase in axial force being detrimental and a reduction in axial force being beneficial to the column drift capacity at any particular time step.

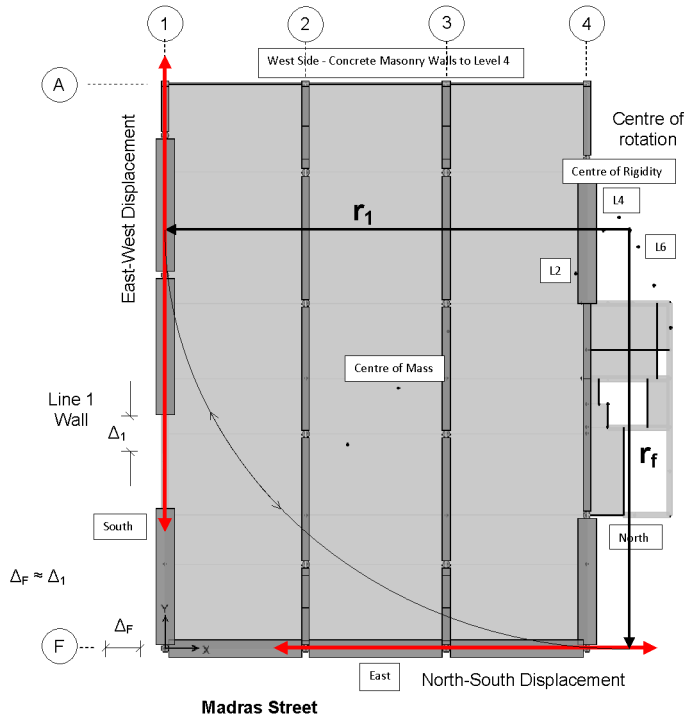
Figure 53 – ERSA indicated that torsional behaviour of the building increased if the masonry infill wall on Line A was not adequately separated from the frame. This shows that in that case the building would have had a tendency to twist about the centre of rigidity that was moved towards the Line A wall because of its stiffness. The centre of rigidity was furthest west at Level 4. This may have resulted in the columns along Line I and F experiencing similar and the highest levels of inter-storey drift as the building responded to the September Earthquake and February Aftershock. This could have made the columns on these lines more susceptible to being damaged and initiating collapse during the February Aftershock. Line I is thought to have had more protection against progressive collapse occurring due to some of the beams also being supported off the South Wall which was observed to have collapsed after the rest of the building.

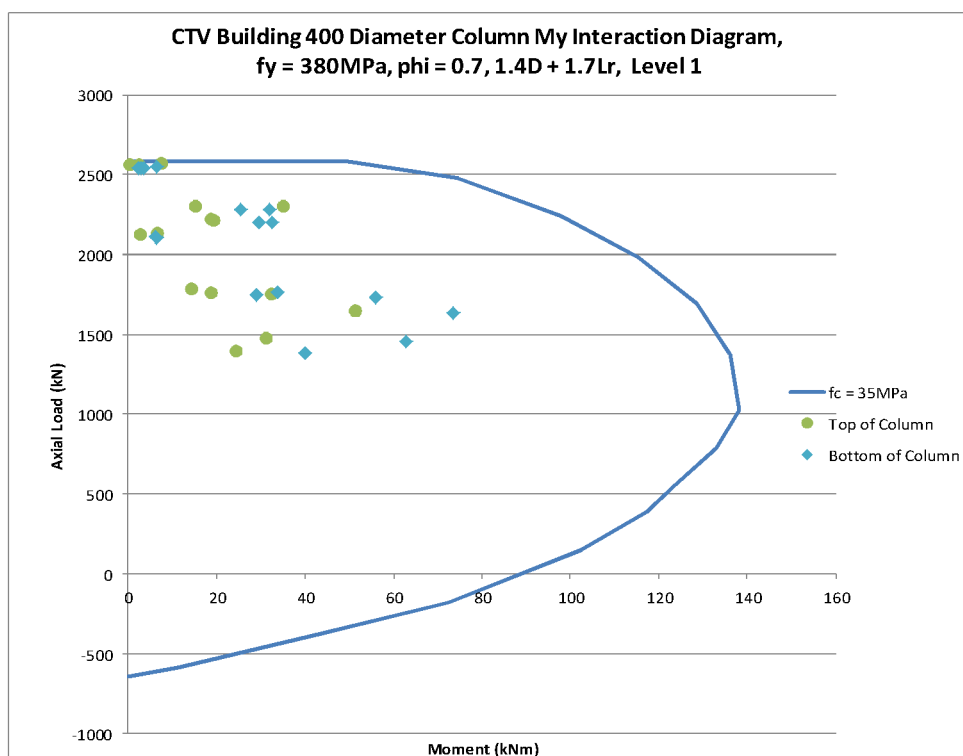
Figure 54 - Column Chart for factored design Gravity Load  $1.4D + 1.7L_r$  on Level 1 columns for concrete with specified 28-day strength of 35 MPa. This indicates that a number of the Level 1 columns were getting close to the blue line and nearing the standard axial load design limit. The phi factor of 0.7 down rates the column strength to 70% of its nominal capacity and the load factors of 1.4 and 1.7 on the dead and live loads respectively factor up the expected loads as required in the Standards. For the condition used in the collapse scenarios these safety factors have been reduced to 1.0 to better reflect actual loading conditions and expected strength at the time of the collapse.

However the testing of column remnants found the concrete to have lower 5 percentile strength of 17.3 MPa (when adjusted for possible testing orientation effects). This was significantly less than the lowest 28-day strength concrete specified for columns in the CTV Building. For this reason lower than specified concrete strength was considered in the column collapse scenarios.

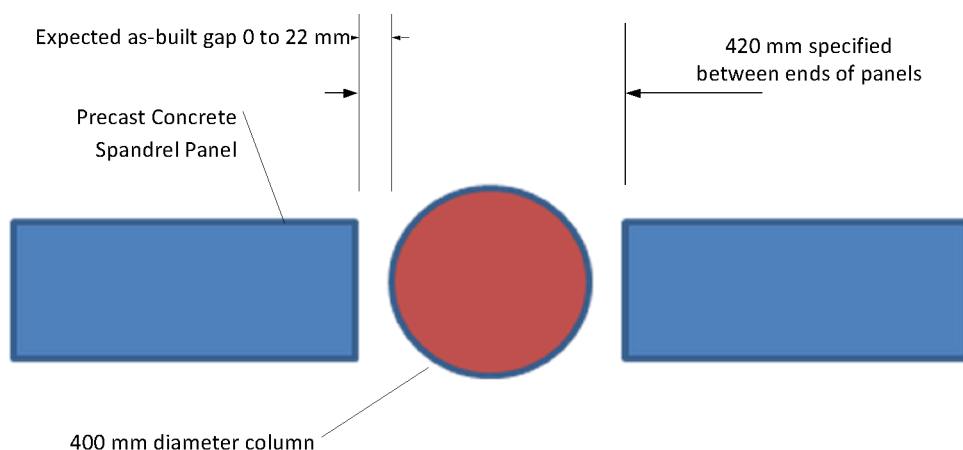
Some of the columns may therefore have had little gap between them and the pre-cast panels. It was found from the displacement compatibility and push over analyses that the potential effect of the Spandrel Panels interfering with the movement of the columns was to accelerate critical column head flexural/compressive damage.

Figure 55 - Expected gaps achieved between Spandrel Panels and columns to achieve a specified gap of 420 mm between ends of panels. This based on BS 5606:1990 guidelines on construction tolerances.

No minimum seismic gap was specified.

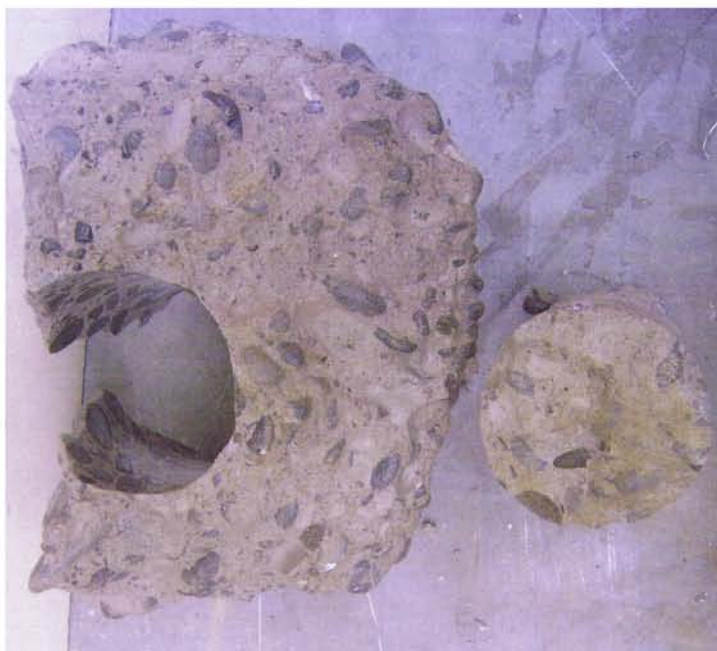
Concrete strength is known to be influenced by the manner in which it is placed. In this case it was reported that the concrete columns were formed using steel shutters which tend to provide a good environment for concrete placement as water and cement paste is less likely to leak out. A curing membrane was reportedly sprayed on to the column surfaces after the shutters were removed, so curing may have been adequate. No areas of "bony" concrete, where the aggregate lacked adequate cement, were found in the columns examined.

Figure 56 - Concrete from column on Line 4-D/E (C18) showing possible discolouration from silt.

Cores taken from the Line 4-D/E column were however found to have some discolouration that may or may not have been due to silt, had low density and did
