EXPERT PANEL REPORT

Structural Performance of Christchurch CBD Buildings in the 22 February 2011 Aftershock

February 2012

**Report of an Expert Panel
appointed by the New Zealand Department of Building and Housing**

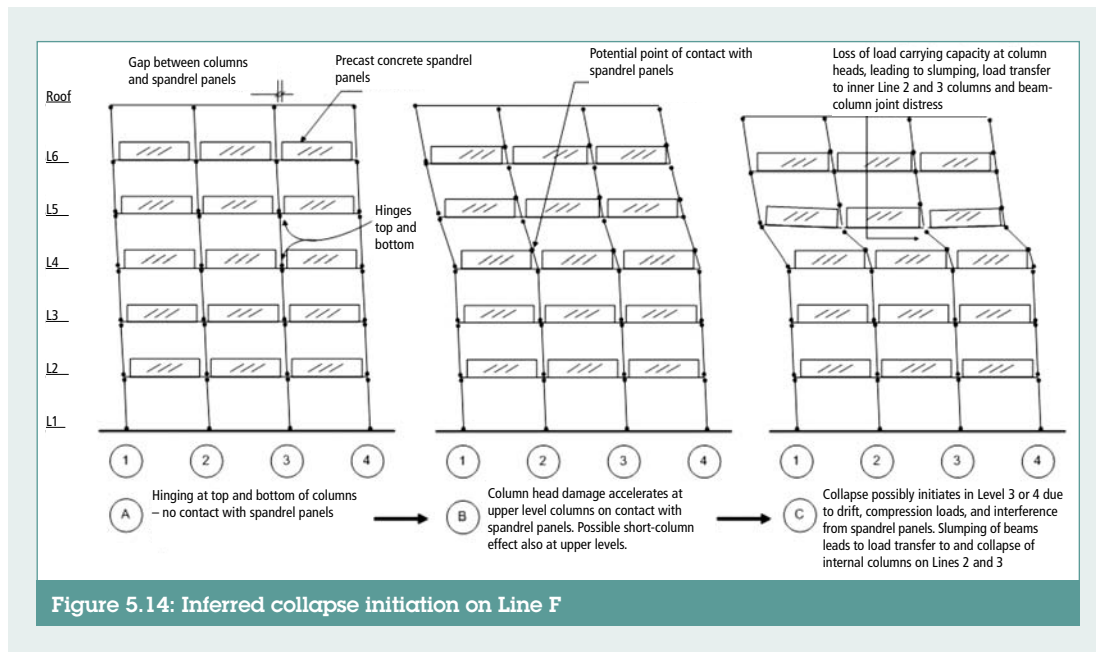
Figure 5.14: Inferred collapse initiation on Line F

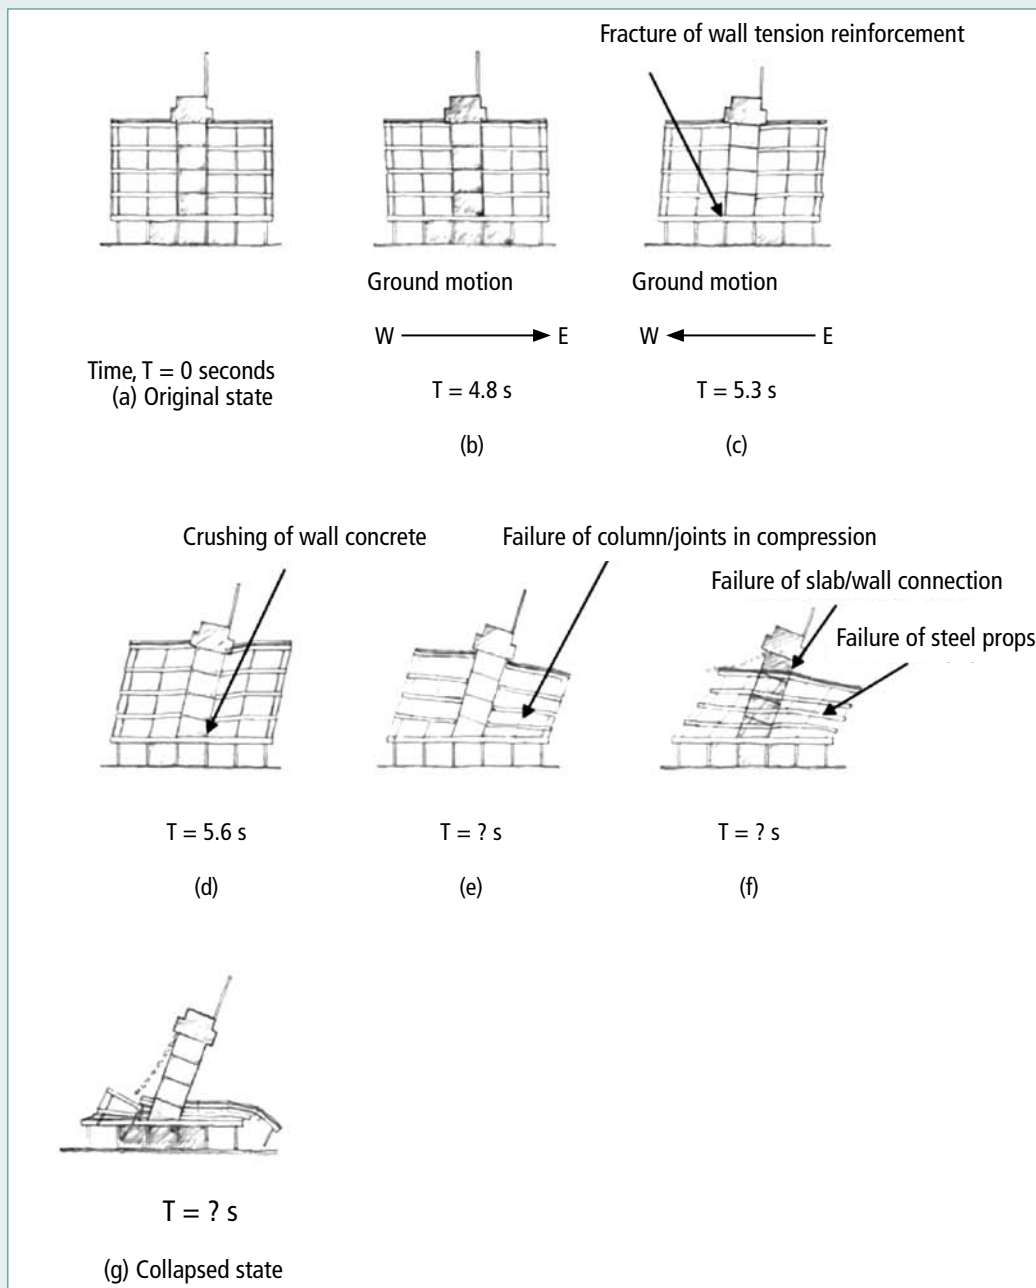
Figure 6.5: Inferred collapse sequence

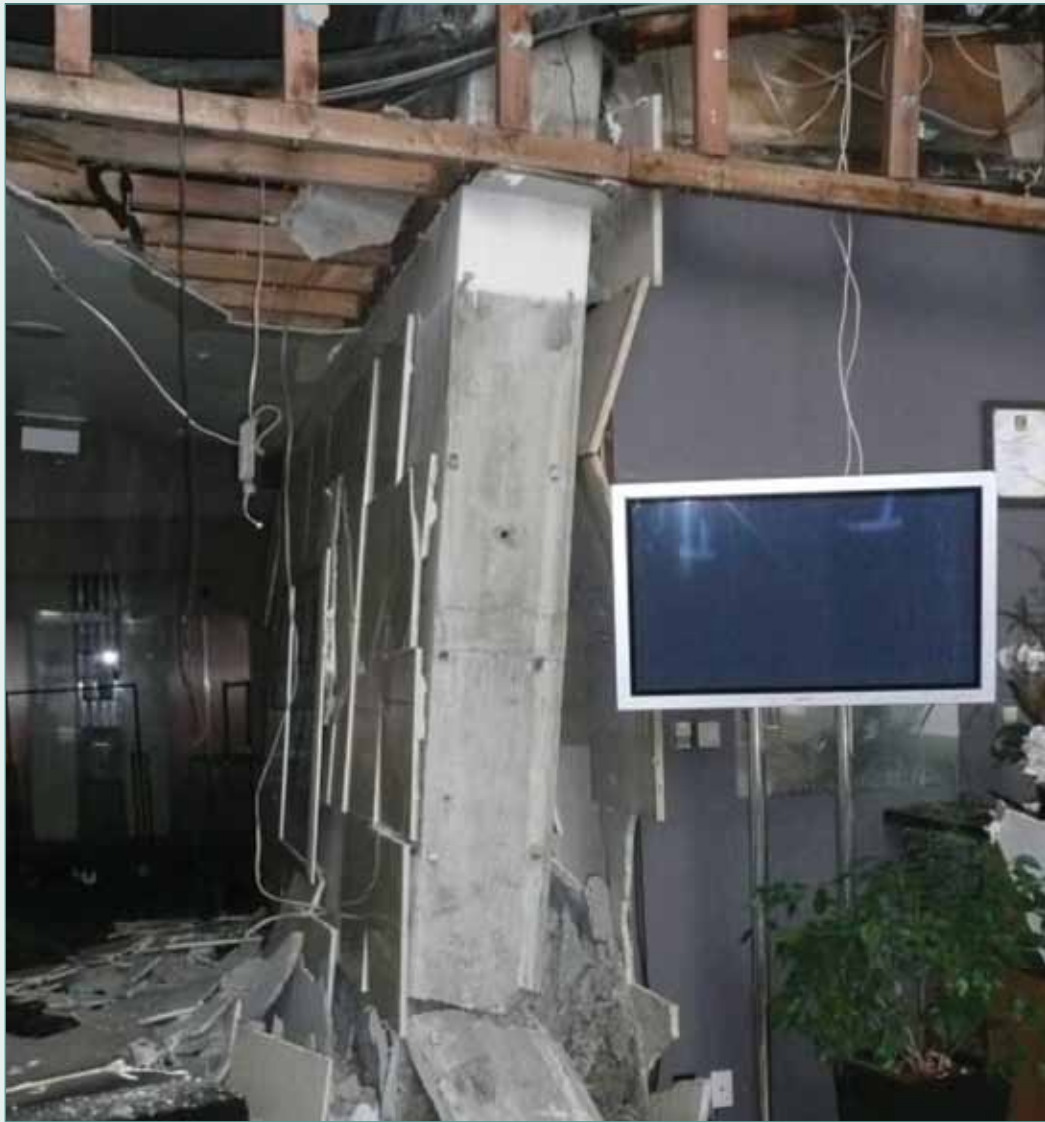
Figure 7.4: Shear wall D5-6 base failure (in the hotel foyer)

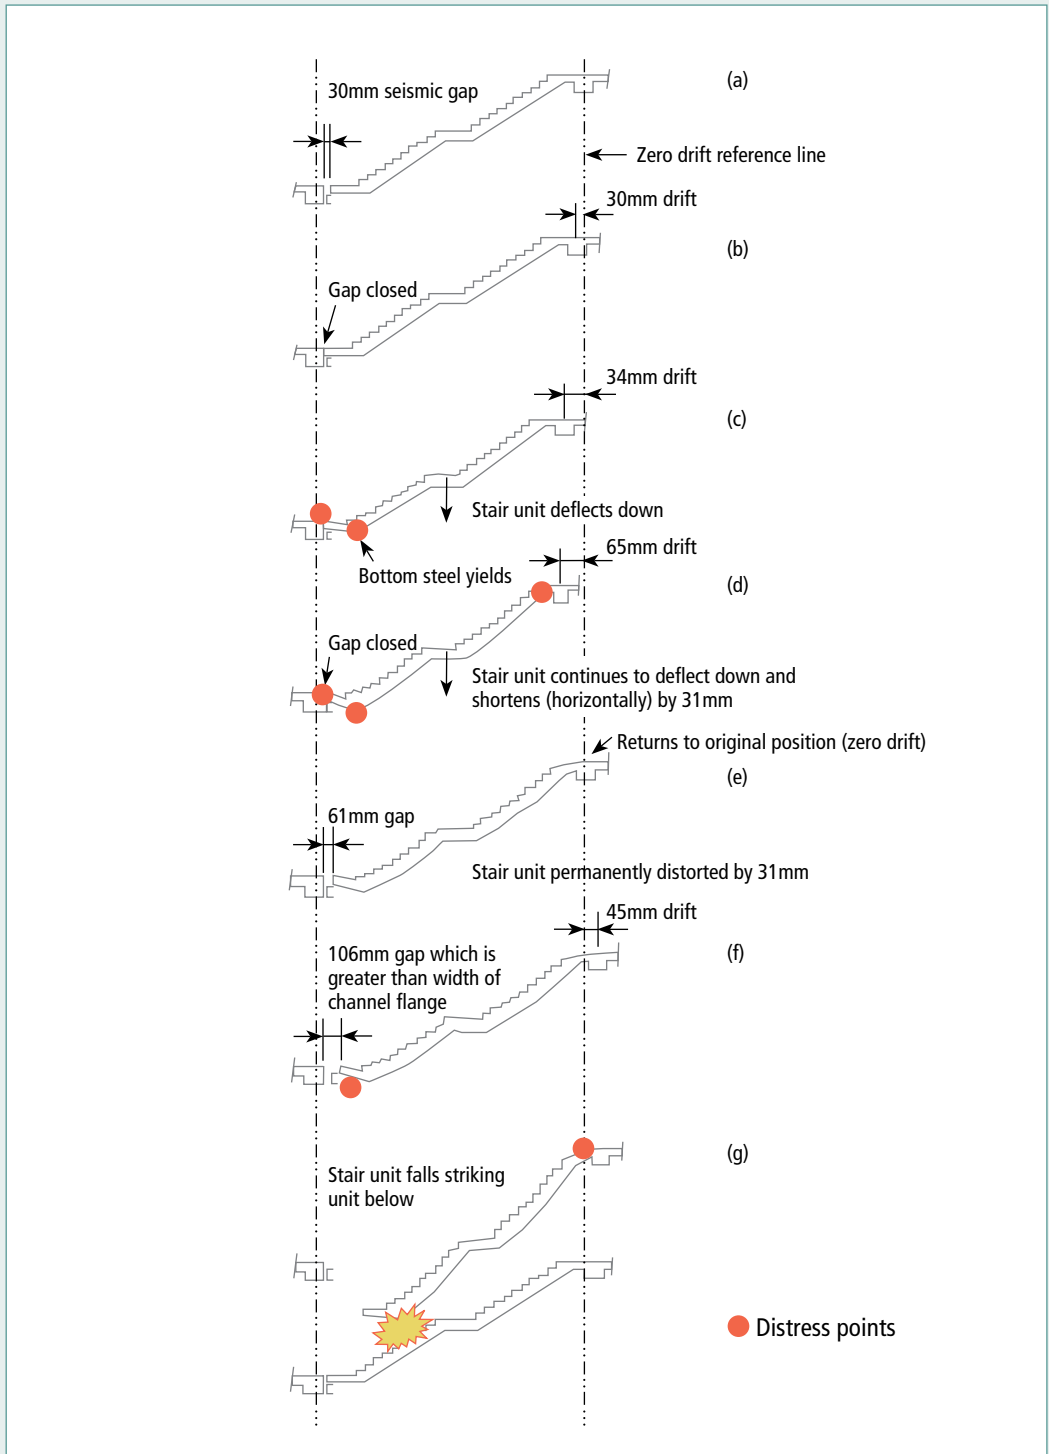
Figure 8.5: Inferred collapse sequence

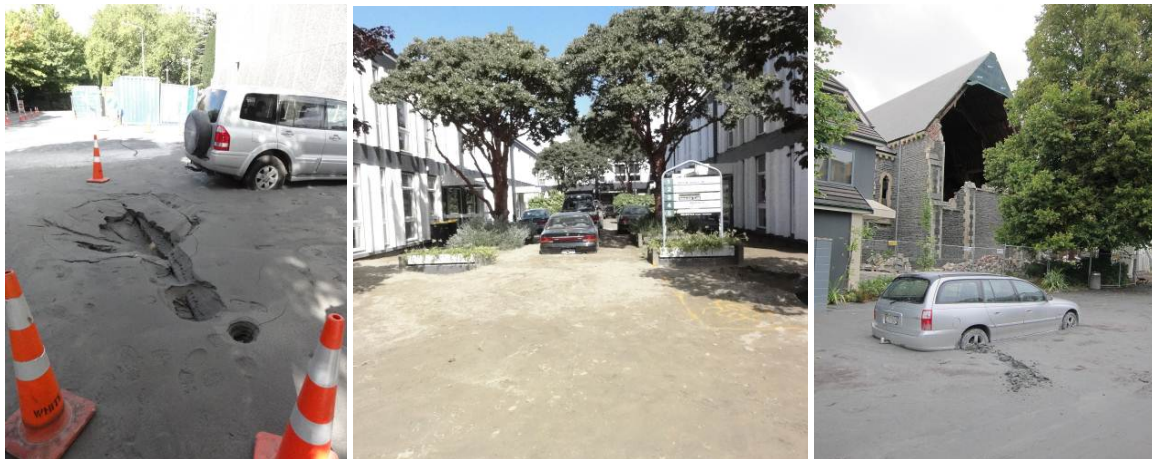
Figure 19: Liquefaction damage within the Christchurch CBD:
a) Kilmore Street ; b) Armagh Street ; c) Manchester Street

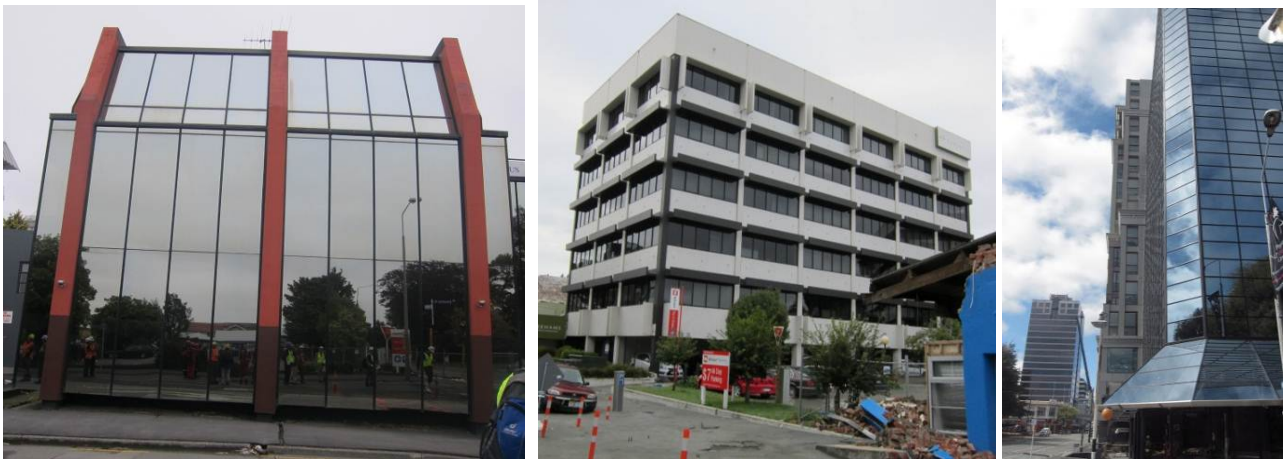
Figure 20: Liquefaction induced differential settlement resulting in significant tilting of mid- to high-rise buildings of various foundation and soil details: a) Four-storey with shallow foundation; b) Six-storey with piled foundation; c) Three high-rise buildings with substantial differential settlement and tilting.

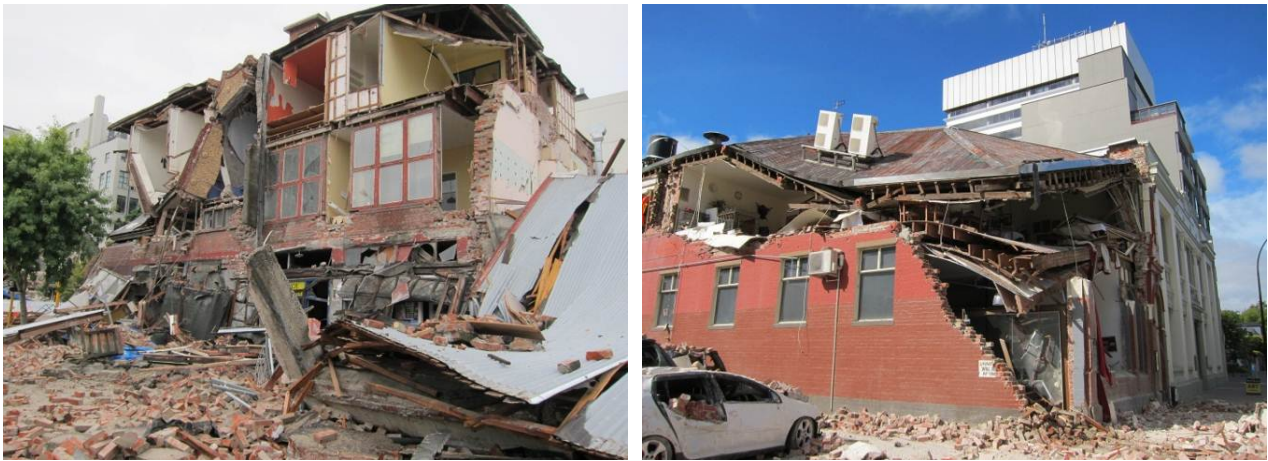
Figure 29: Unreinforced masonry buildings collapse/damage patterns: Mixed of in-plane and out-of-plane failure modes

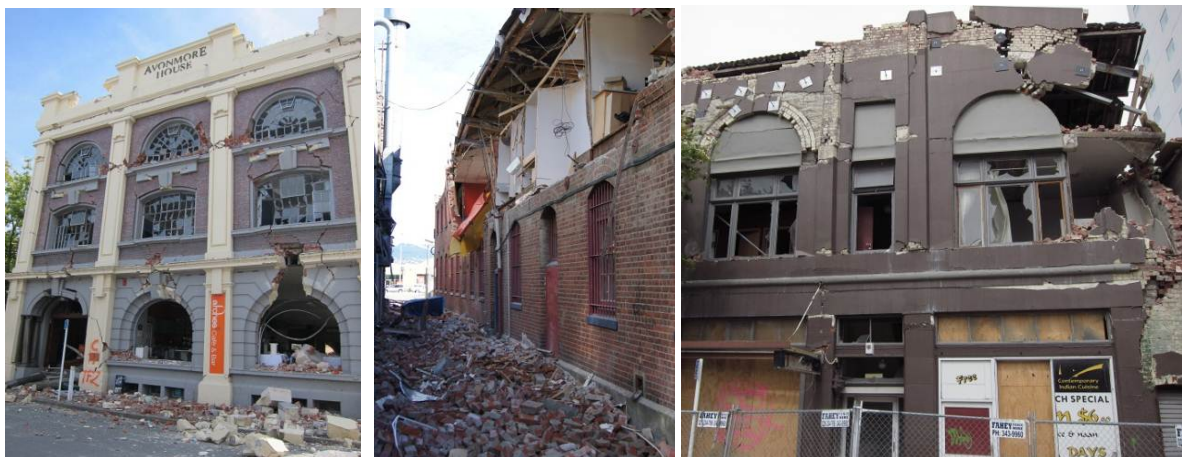
Figure 30: Unreinforced masonry buildings collapse/damage patterns: Mixed of in-plane and out-of-plane failure modes

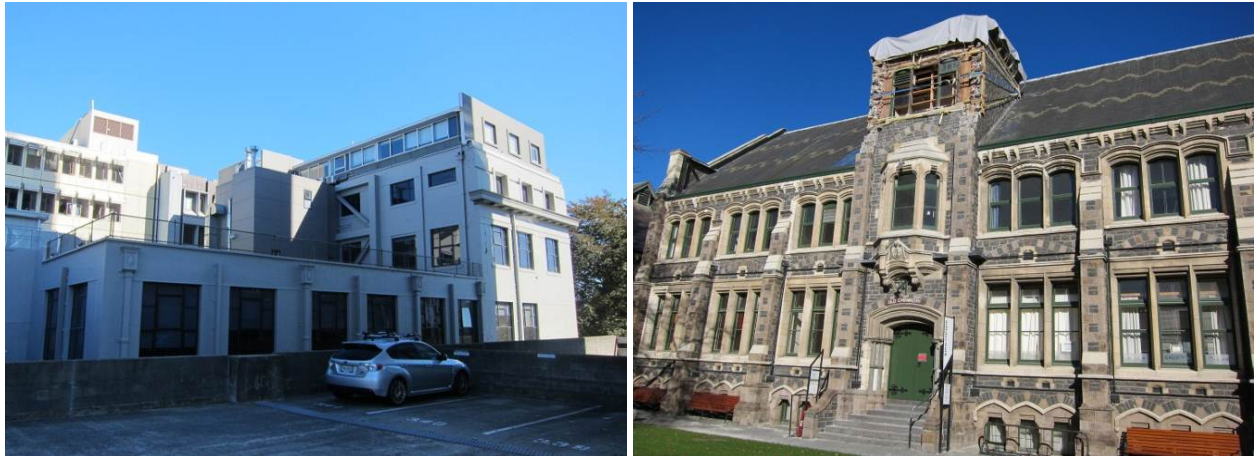
Figure 31: Good performance of seismic retrofitted unreinforced masonry and brick buildings: a) Public Trust Building; additional external steel braces and internal RC walls; b) Art Centre’s Old Chemistry Building; external horizontal and vertical post-tensioning, with closely spaced tie-in rose anchors

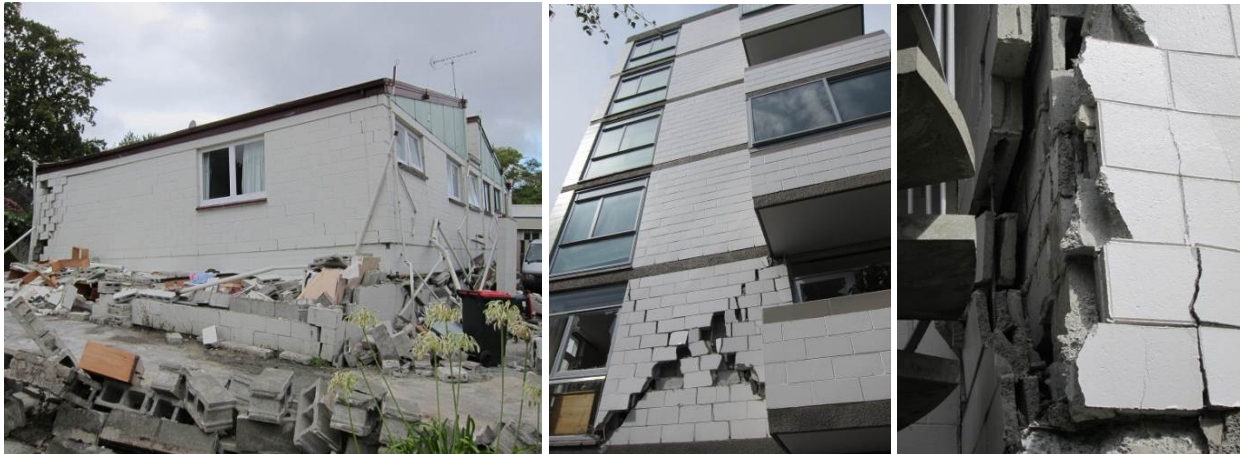
Figure 33: Reinforced concrete masonry buildings collapse/damage patterns: a) two-storey residential building with complete soft-storey collapse of the first floor; b-c) Shear failure of the 2nd floor RCM walls of a six-storey residential apartment built in the 1960s

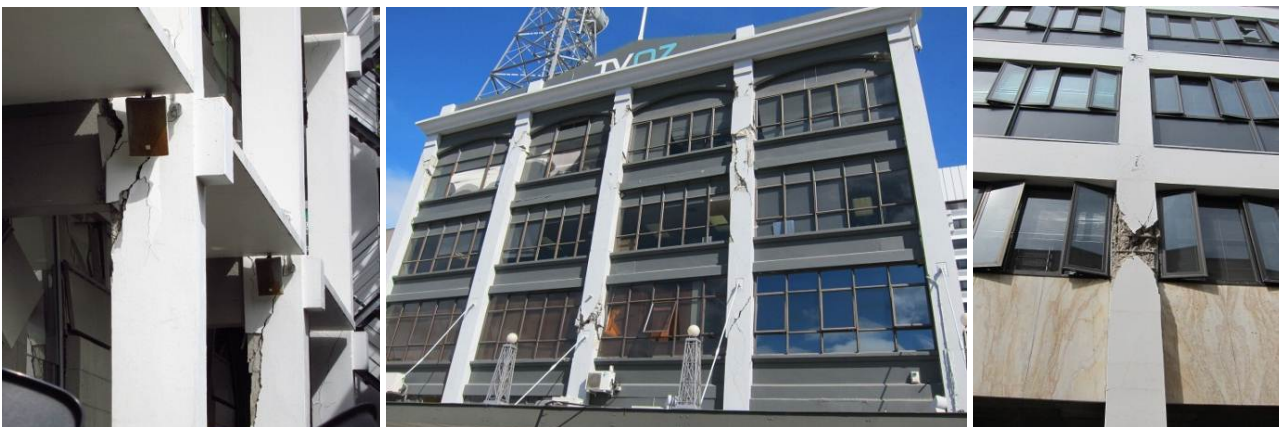
Figure 35: Pre-1970s reinforced concrete moment-resisting frame buildings collapse/damage patterns

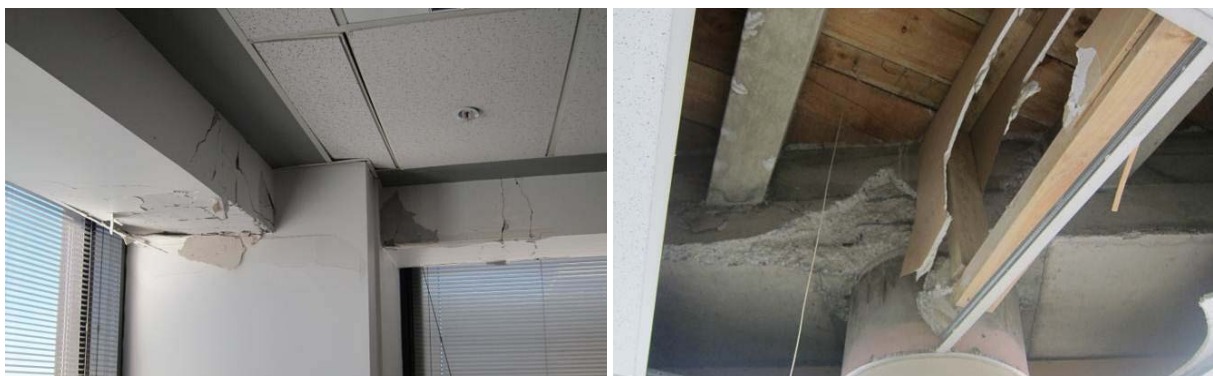
Figure 36: Post-1970s reinforced concrete moment-resisting frame buildings collapse/damage patterns: a) Two-way plastic hinging on 5th floor of a 22-storey office tower; b) 2nd floor beam-column connection in a five-storey office building

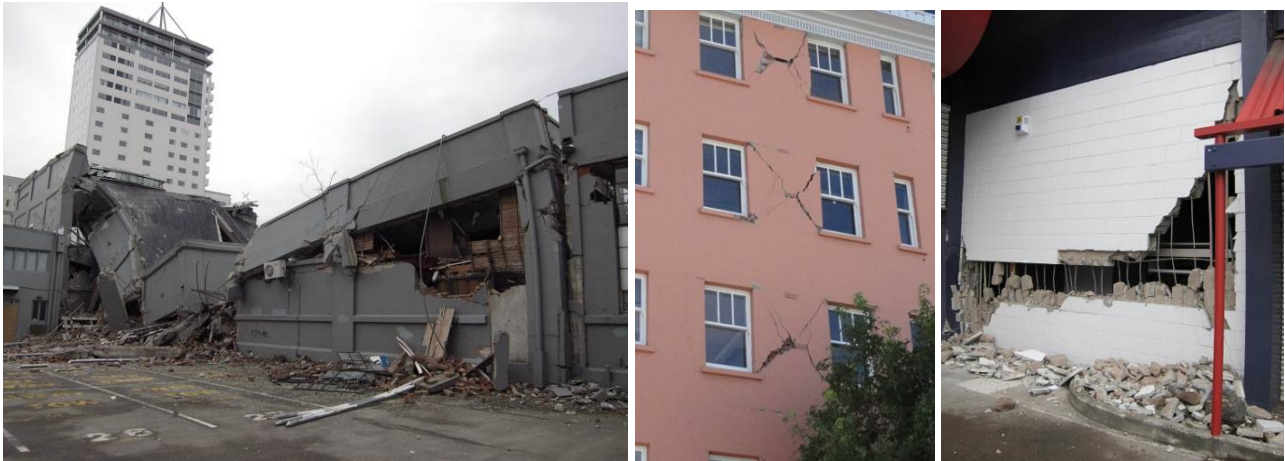
Figure 38: Reinforced concrete frame buildings collapse/damage patterns: a) 1930s three-storey RC frame with masonry infill collapsed after the 13th June M_w 6.2 aftershock; b) 1935 seven-storey RC frame with masonry infill and veneers; c) 1970s two-storey RC frame with reinforced concrete masonry blocks

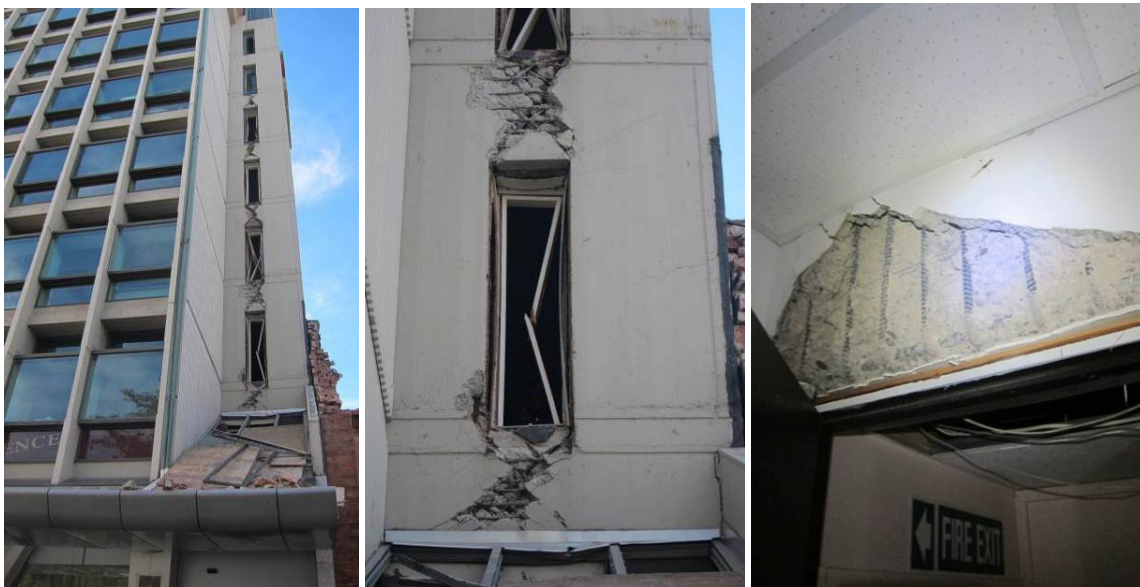
Figure 40: Pre-1970s reinforced concrete structural wall buildings collapse/damage patterns: a-b) Seven-storey 1960s coupled-RC walls building with significant damage on the coupling beams. Plain bars and diagonal reinforcements were used on the coupling beams; c) Six-storey 1950s RC walls building with moderate damage to the coupling beams

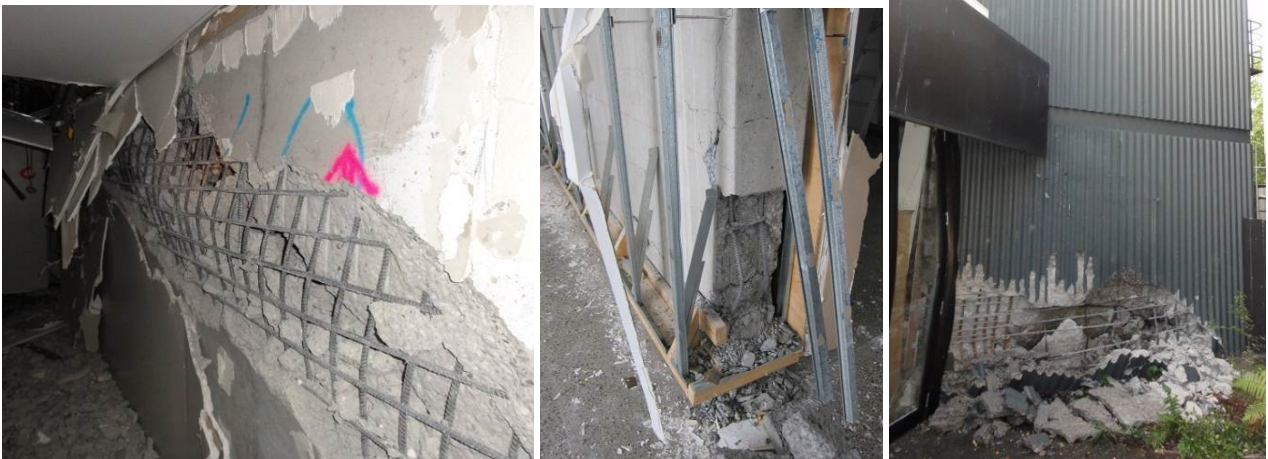
Figure 41: Post-1970s reinforced concrete structural wall buildings collapse/damage patterns: a) Nine-storey residential apartment built in 2000-2010 with severe shear failure of the long slender wall (photo courtesy of Ken Elwood); b) 14-storey residential apartment built in 2007 with buckling of the boundary reinforcements; c) Seven-storey 1980s office block with significant compression failure of the V-shaped RC shear wall

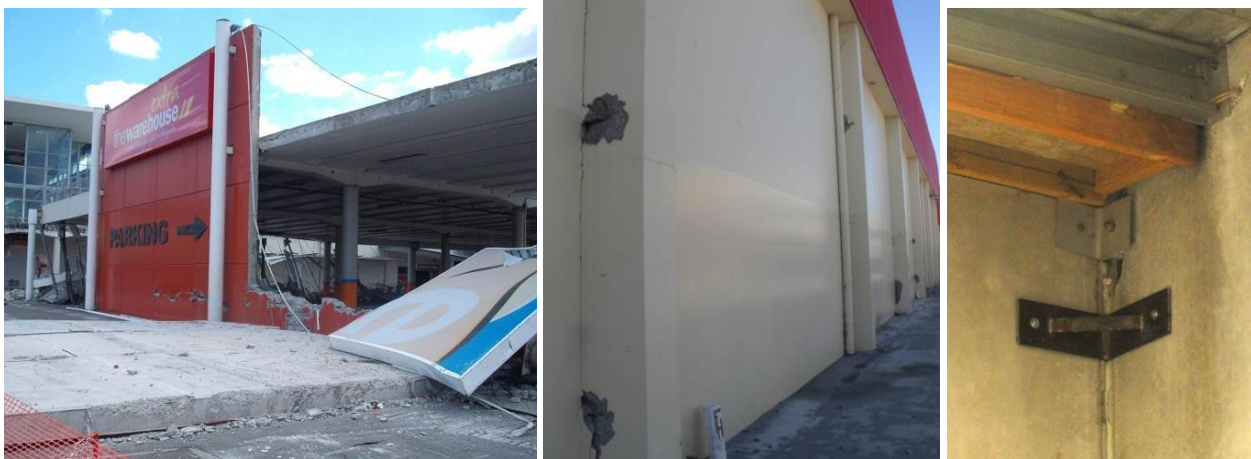
Figure 43: Tilt-up concrete wall buildings collapse/damage patterns: a) Failure of the spliced-connection of the tilt-up panel walls (photo courtesy of John Marshall); b) Tilt-up panels with encased steel portal frame; c) Steel angle connection damaged in the 4th Sept earthquake, repaired with a supplementary bolted steel angle

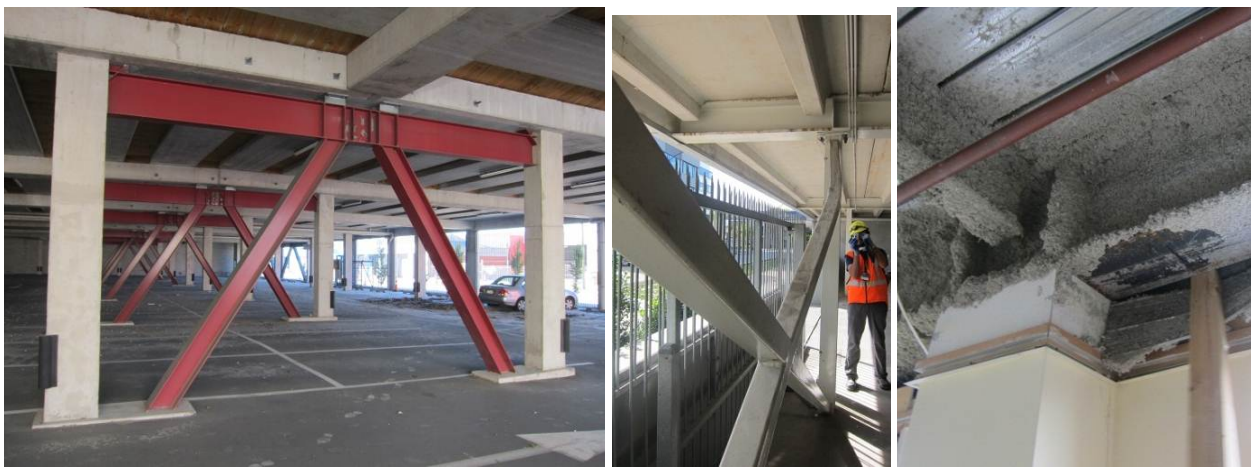
Figure 45: Steel frame and steel-braced buildings. collapse/damage patterns: a) Yielding and fracture of the shear-link of eccentric-braced frame with composite gravity frame; b) buckling and fracture of diagonal steel braces; c) Yield lines on steel-frame

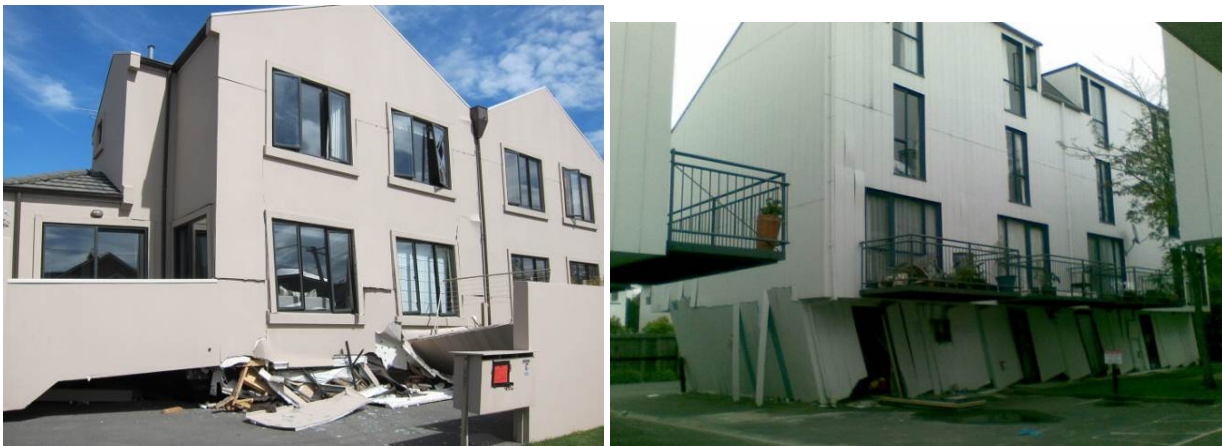
Figure 47: Timber buildings collapse/damage patterns: a) Soft-storey collapse of a relatively modern residential apartment; b) Soft-storey collapse of a four-storey residential apartment (Photo courtesy of Julian Ramsay)

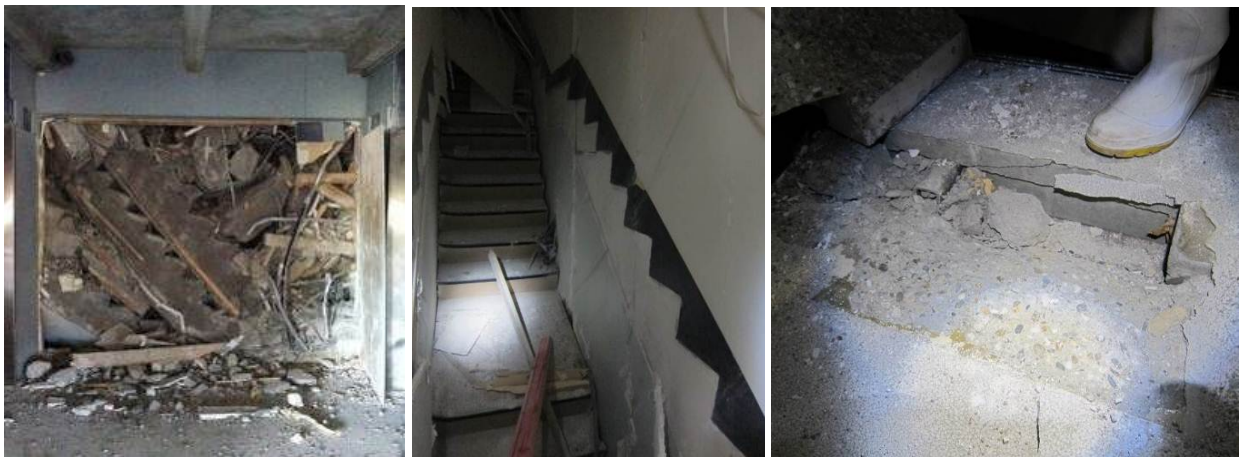
Figure 49: Collapse (a-b) and top landing damage (c) of precast concrete staircase in multi-storey buildings

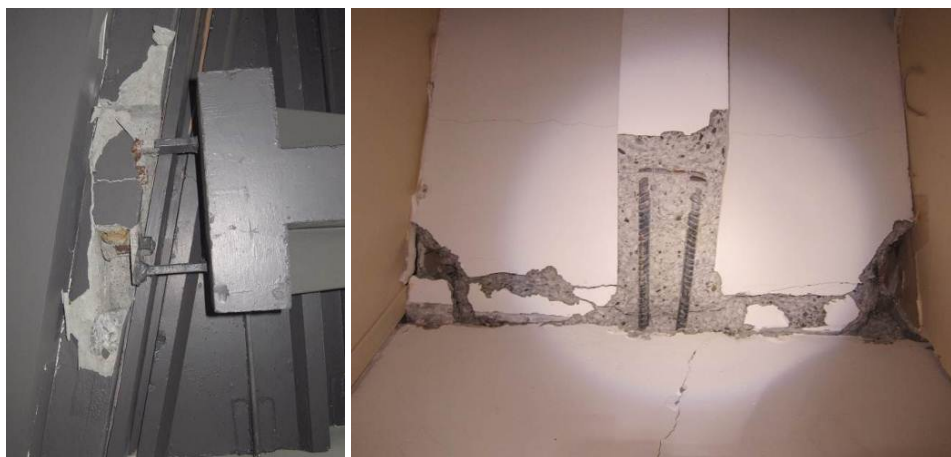
Figure 50: Bottom landing damage of precast concrete staircase in multi-storey buildings

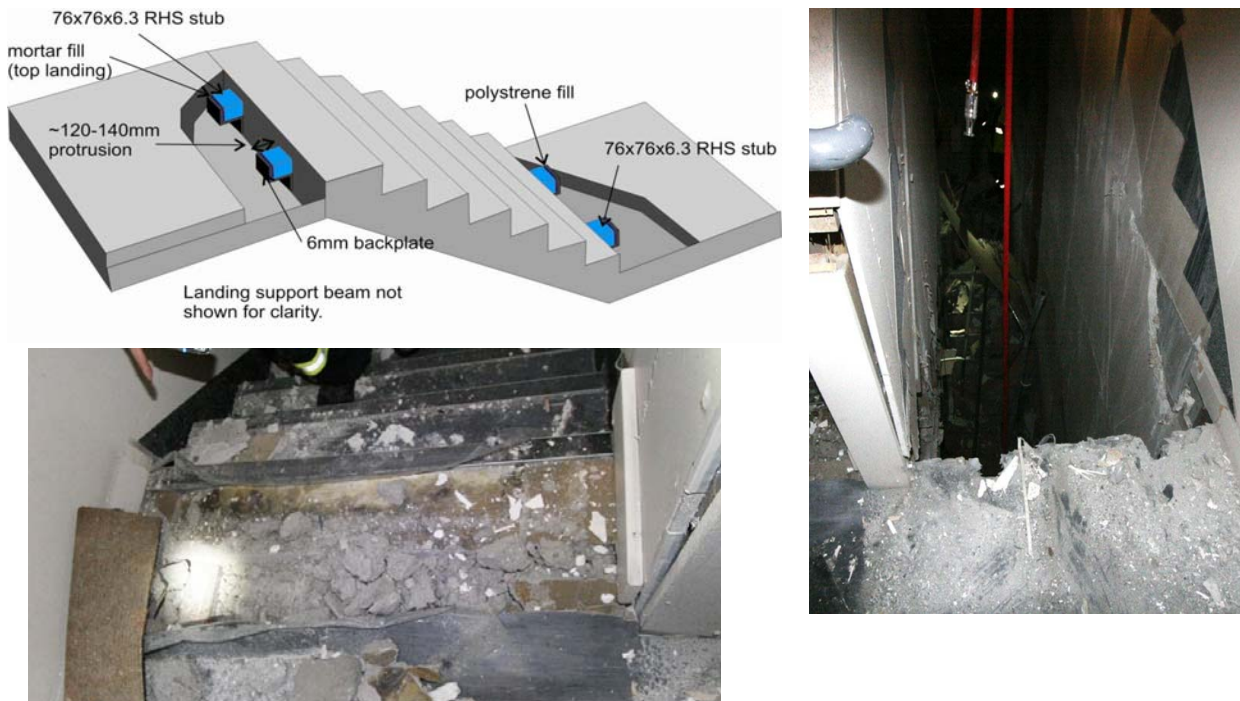
Figure 52: Alternative typical detailing of staircase- Type A - Pinned-slide connections with RHS shear keys on both ends and observed failures. (Damage photographs are courtesy of USAR teams)

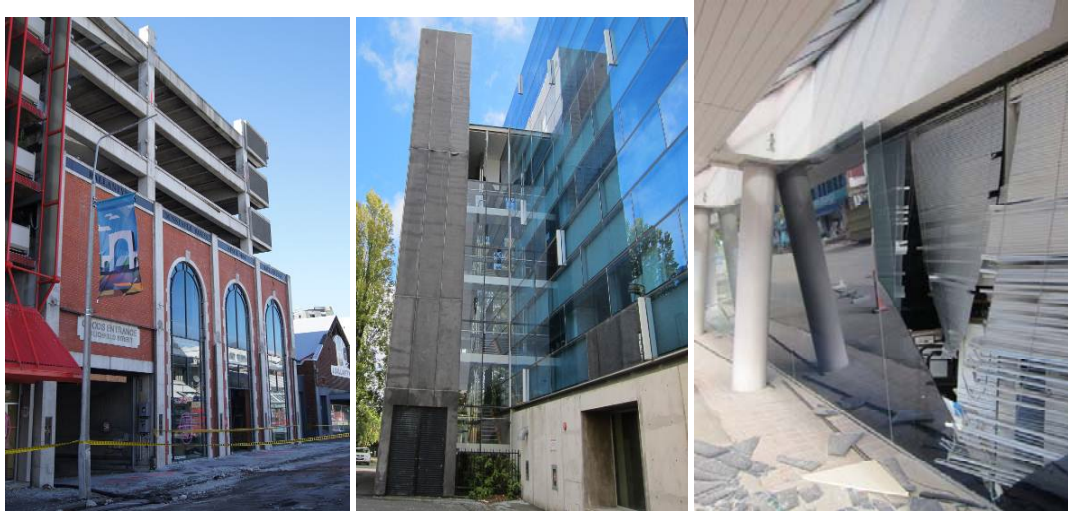
Figure 53: Damage and collapse of vertical “non-structural elements”: a) Collapse of heavy precast concrete panels due to failure of the connecting bolted-plates; b) The failure of the inter-panel shear connection of an external lift-shaft located next to the only safety egress for the building; c) Shattered glass façade at street retail level

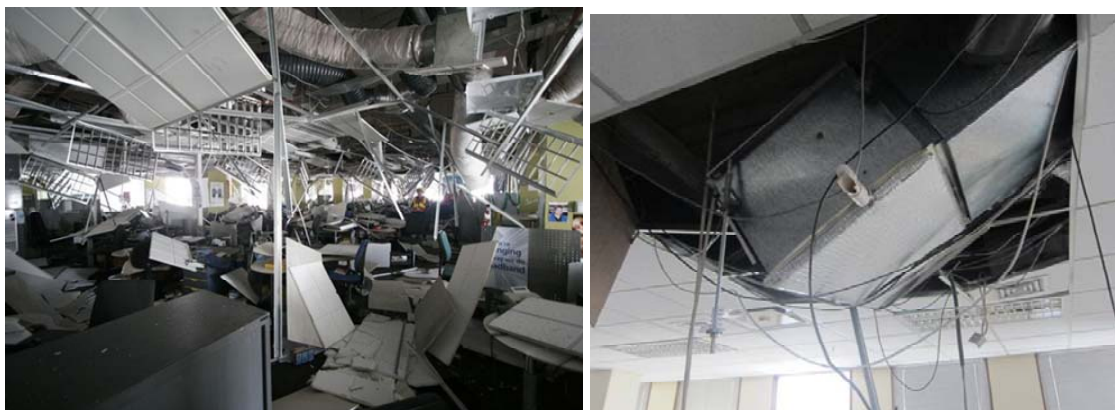
Figure 54: Damage and collapse of horizontal “non-structural elements”: a) Collapse of heavy ceiling tiles and services b) Near collapse of a HVAC unit due to anchorage failure

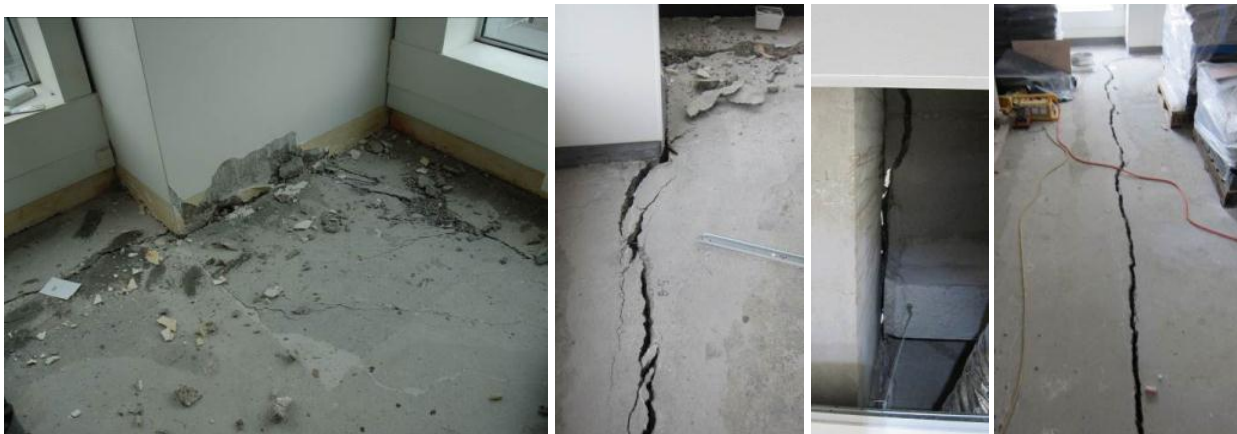
Figure 55: Extensive damage of floor diaphragm and loss of floor support due to the beam-elongation effects of concrete frame inelastic response

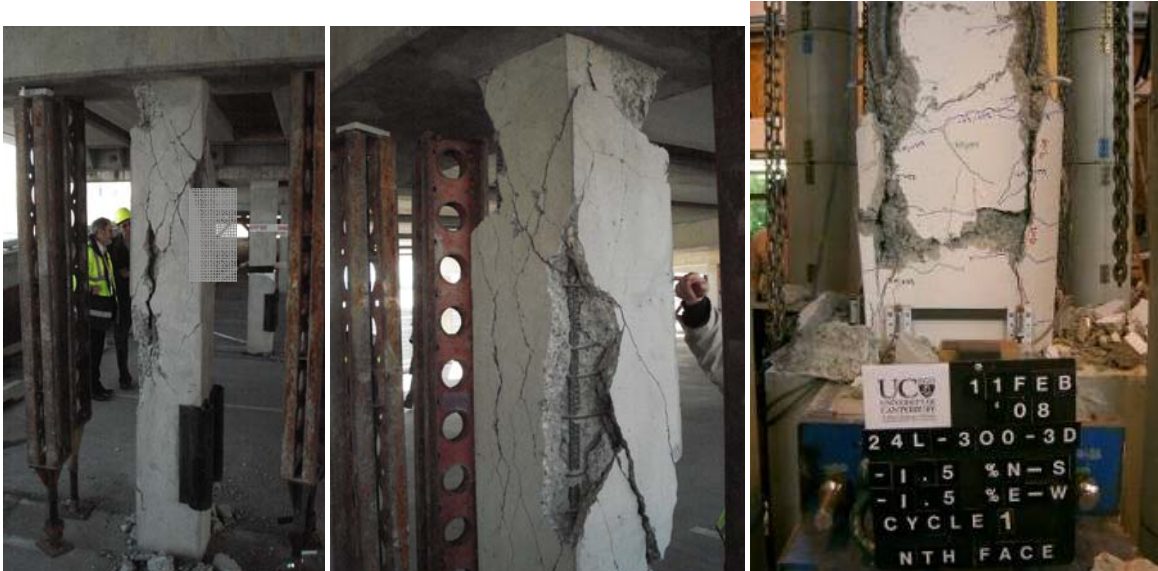
Figure 56: Severe damage with loss of vertical load-bearing capacity in columns with inadequate transverse reinforcement as part of the “gravity-load systems” due to displacement compatibility with the lateral load resisting systems (Left: damage observed after the 4 Sept earthquake; Right: experimental tests carried out years before on typical pre-1995 gravity-load columns subjected to bidirectional cyclic loading)
