Estimating the Risk to Life Safety during Earthquakes from Non-Structural Elements in Commercial Buildings in New Zealand

Prepared for Ministry of Business, Innovation and Employment (MBIE)

Prepared by Beca Ltd (Beca)

28 October 2016

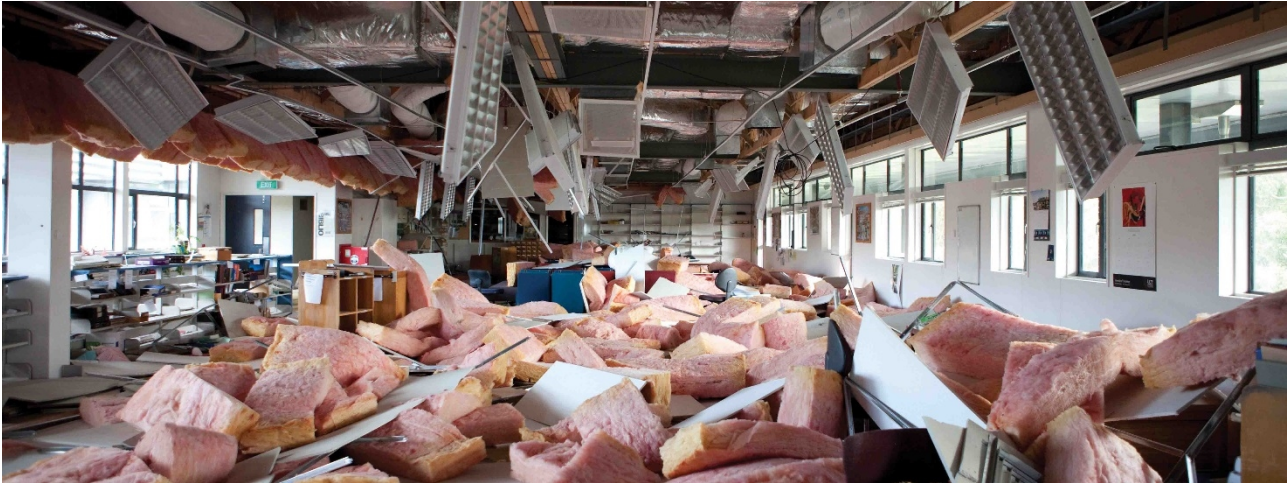
Figure 1: Non-structural damage following the Mw 6.1 2011 Christchurch earthquake

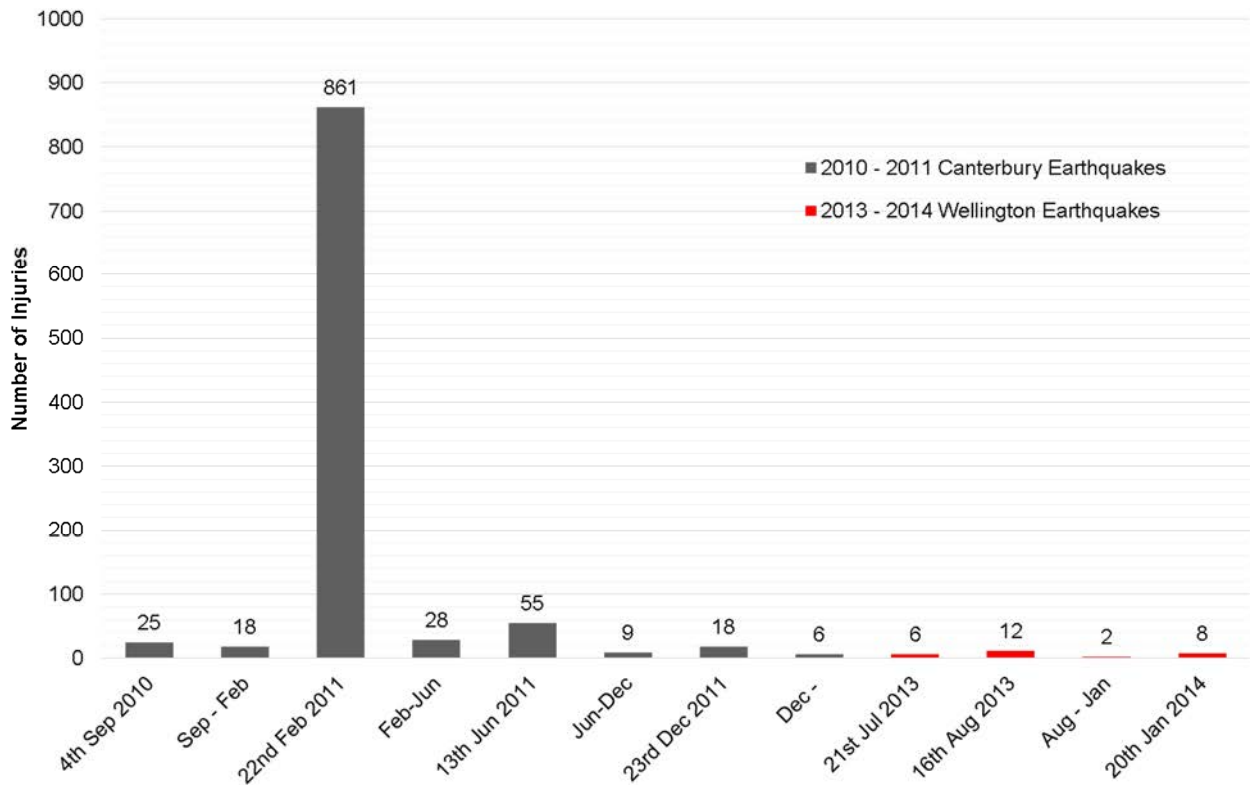
A total of 1,048 injuries were directly attributable to earthquake building damage, according to the earthquake events as shown in Figure 3 below. The injuries have been either attributed to the seven major earthquake events defined in the previous section, or to the time period between these major events. The time periods between major events include numerous aftershocks since no single aftershock event caused a significant number of injuries.

Figure 3: Total number of injuries for each earthquake event

The earthquake on 22nd February 2011 generated by far the most number of injuries. Overall injury statistics subsequently presented in this report are consequently distorted by this single earthquake event. The number of injuries in the 4th September 2010 earthquake was comparatively low for the magnitude of this earthquake. This is likely due to the earthquake occurring at 4:35am, when it would be expected that the majority of commercial buildings are unoccupied.

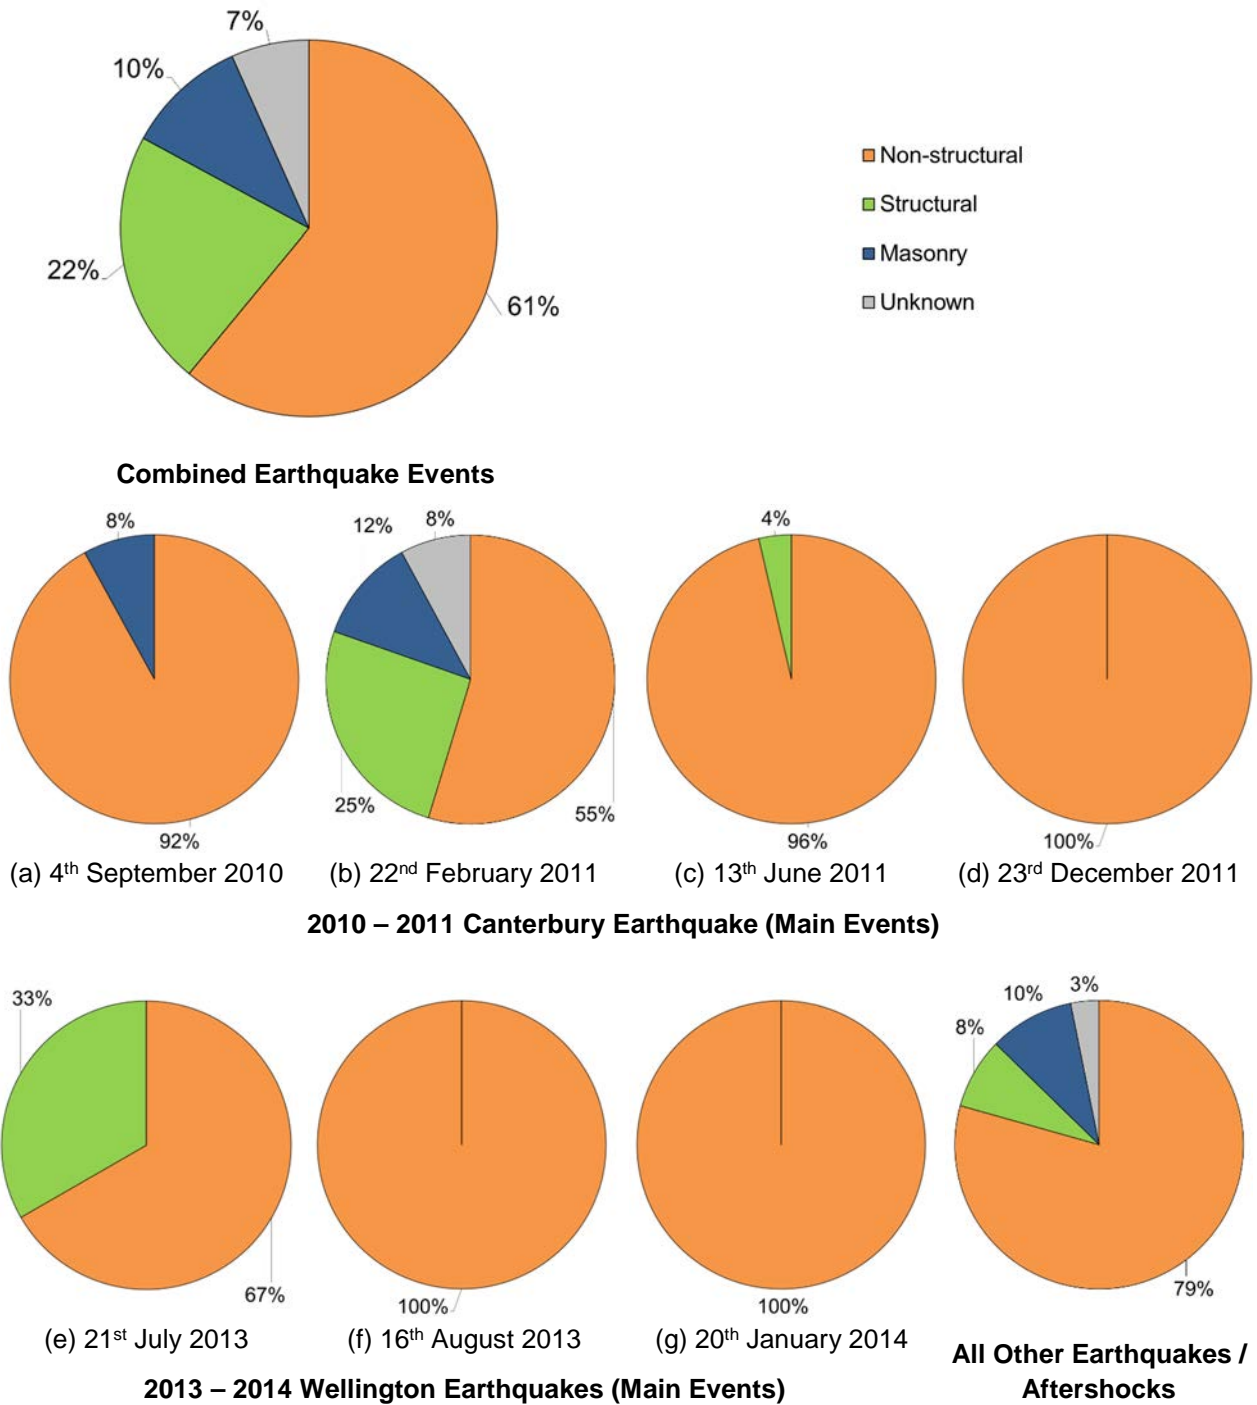
A breakdown of the cause of injury between the following categories: non-structural, structural, masonry and unknown, for the total 1048 identified injuries in the RHISE database for the earthquake events from 4 September 2010 is shown in Figure 4. Non-structural damage is the main contributor to earthquake injury, being the cause of 61% of all injuries.

Figure 4: Cause of injuries by building component

The contribution of structural and masonry damage to injuries was most noticeable in the 22nd February 2011 earthquake, with a significant number of injuries being attributed to the two reinforced concrete building collapses and the numerous unreinforced masonry failures (CERC, 2012a). This may have also been attributed to the instatement of the Central City Red Zone cordon which was a public exclusion zone established in the Christchurch CBD following the 22 February 2011 earthquake.

The previous section demonstrated that non-structural elements caused the greatest number of injuries, however Figure 6 reveals that 90% of these non-structural injuries were at the lowest injury severity level. There were also no fatalities from damage to non-structural elements in commercial buildings, though there were recorded fatalities which occurred in residential buildings and from the failure of secondary structural elements (CERC, 2012b). The majority of injuries requiring ED treatment, or hospitalisation were also due to non-structural damage, which highlights the large proportion of overall injuries due to non-structural damage causes, as shown earlier in Figure 4.

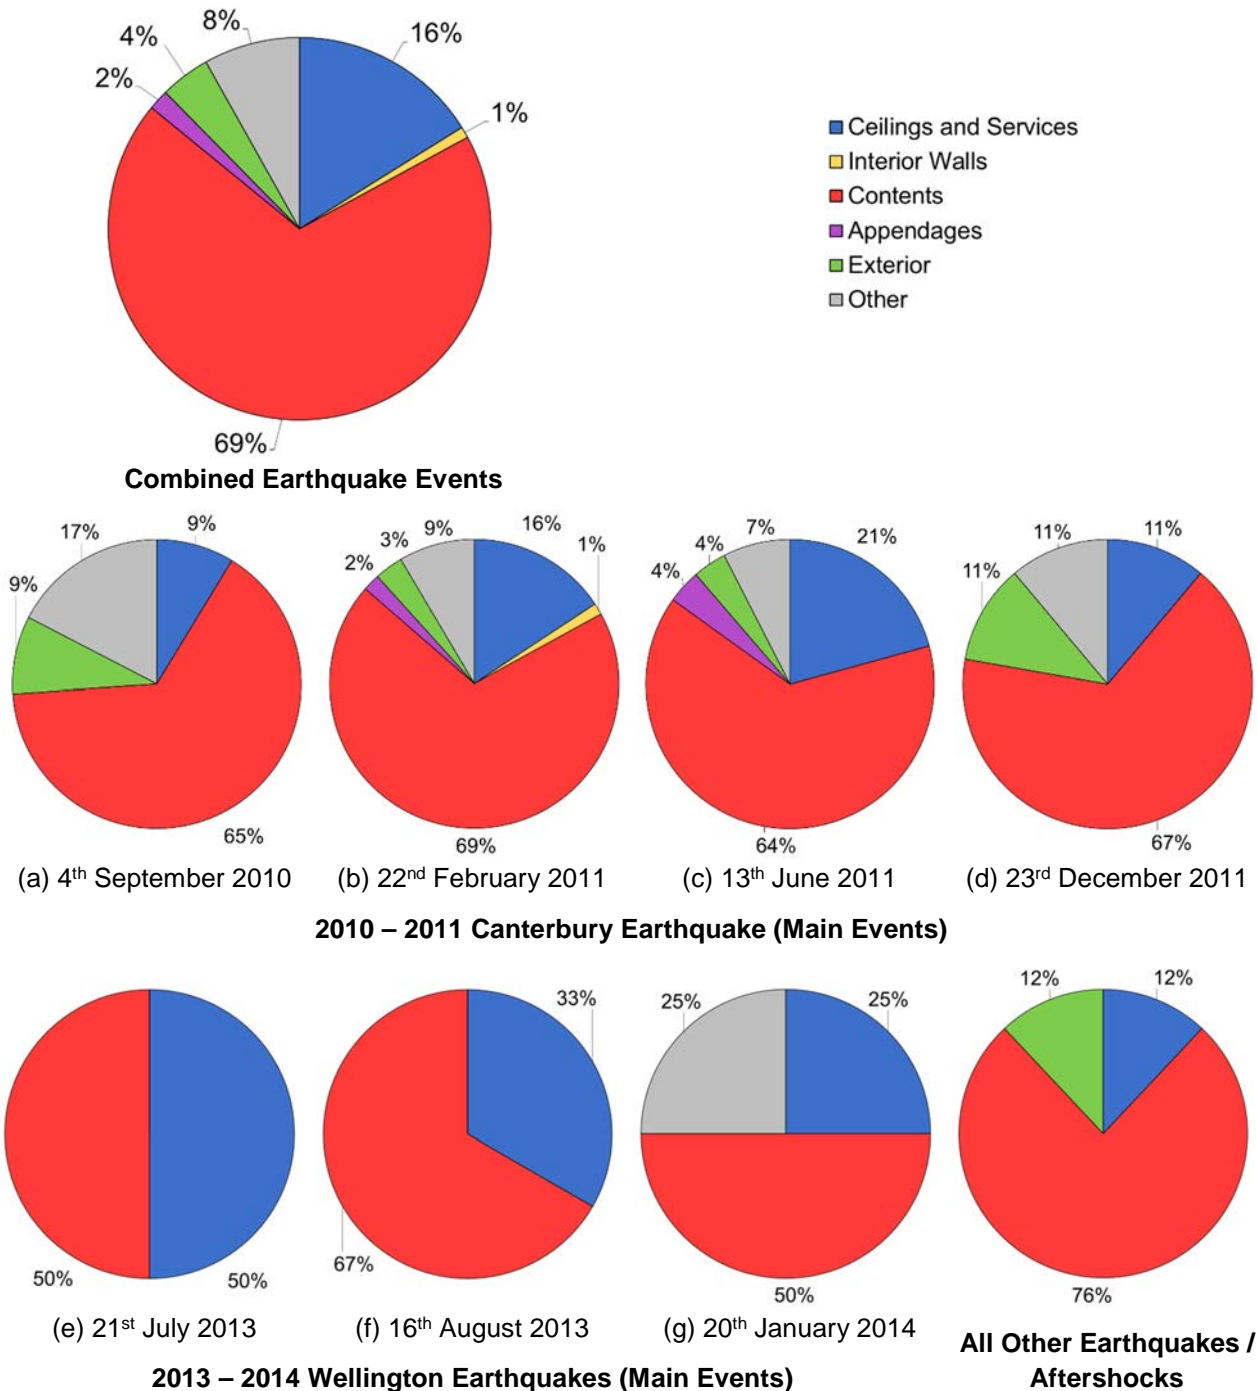
A breakdown of the cause of injury by non-structural elements for the earthquake events from 4 September 2010 is shown in Figure 5.

Figure 5: Cause of non-structural element related injuries

Contents related injuries were the dominant cause of injuries, making up 69% of all non-structural injuries (or 42% of all building related injuries overall). The proportions of injuries between the different non-structural categories was relatively consistent for all earthquake events, with contents always being the dominant

contributor. Ceilings and services were the second largest injury contributor. Appendages, exterior elements and other non-structural elements made a minor contribution to total injuries. Interior walls caused very few injuries, as damage to these elements rarely resulted in fall-out of the interior wall, hence not posing a significant injury hazard.

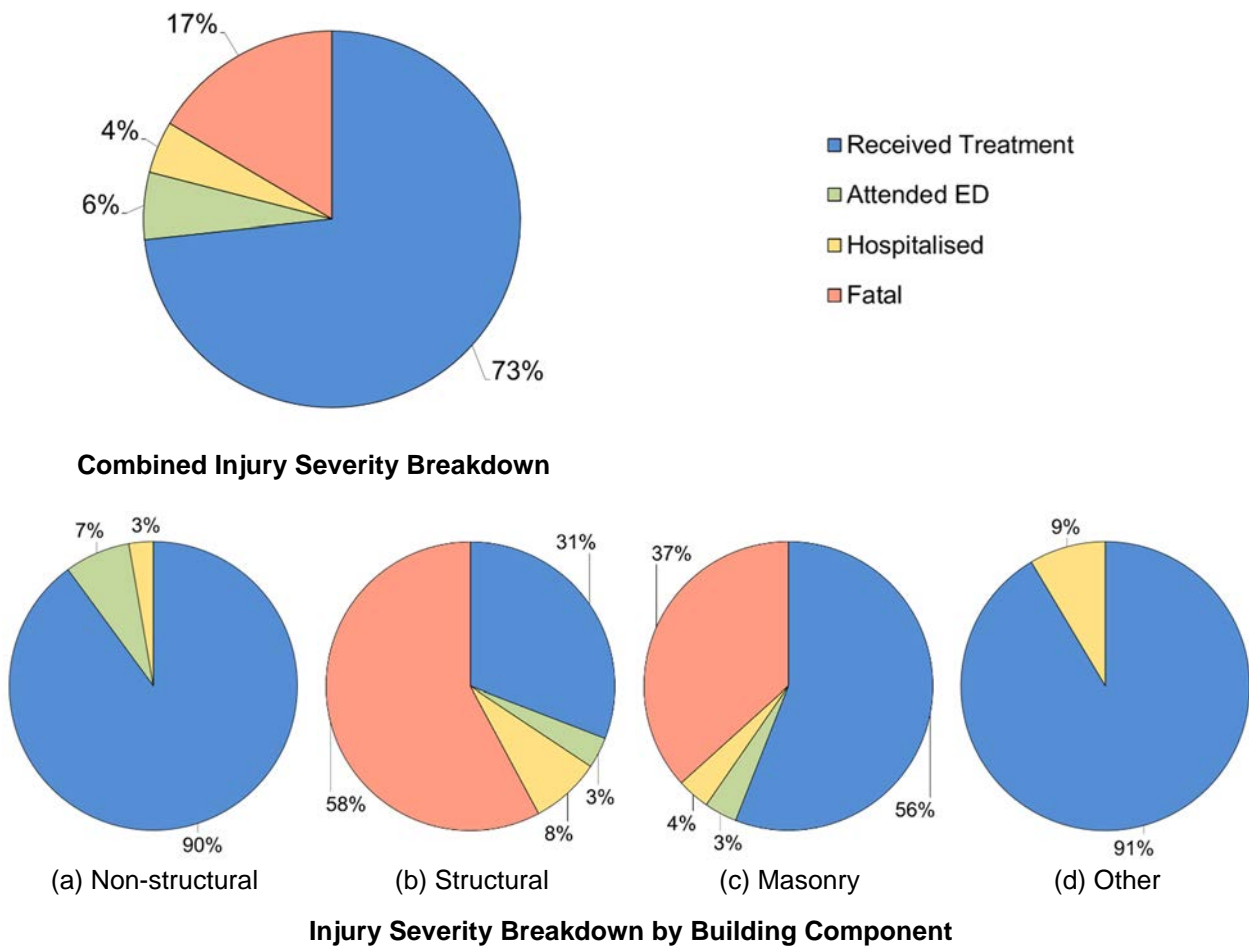
The severity of injuries due to damage from all building components (structural and non-structural) for all earthquake events considered is shown below in Figure 6. As would be expected, the majority of injuries were more minor in nature, with injuries receiving treatment outside of hospital contributing to 73% of injuries within the research scope. Since self-reported injuries (i.e. people who were injured but did not seek any form of treatment) are not represented in the data, it is likely that minor injuries are under reported. Fatal injuries comprise the second highest number of injuries, totalling 173. This can be attributed to the deaths that resulted from the two building collapses and the numerous unreinforced masonry failures the 22nd February 2011 earthquake.

Figure 6: Breakdown of injury severity by building component

It is shown in Figure 6b that the majority (58%) of structural building component related injuries were fatal. All of the fatalities resulting from structural damage were a result of the two building collapses that occurred on the 22nd February 2011. Of the non-fatal injuries caused by structural damage, many of these injuries could also be attributed to the collapse of these two buildings. This emphasises the critical role that structural collapse prevention plays in life-safety protection. A large proportion of masonry related injuries also resulted in fatalities, demonstrating that this also poses a significant life-safety hazard.

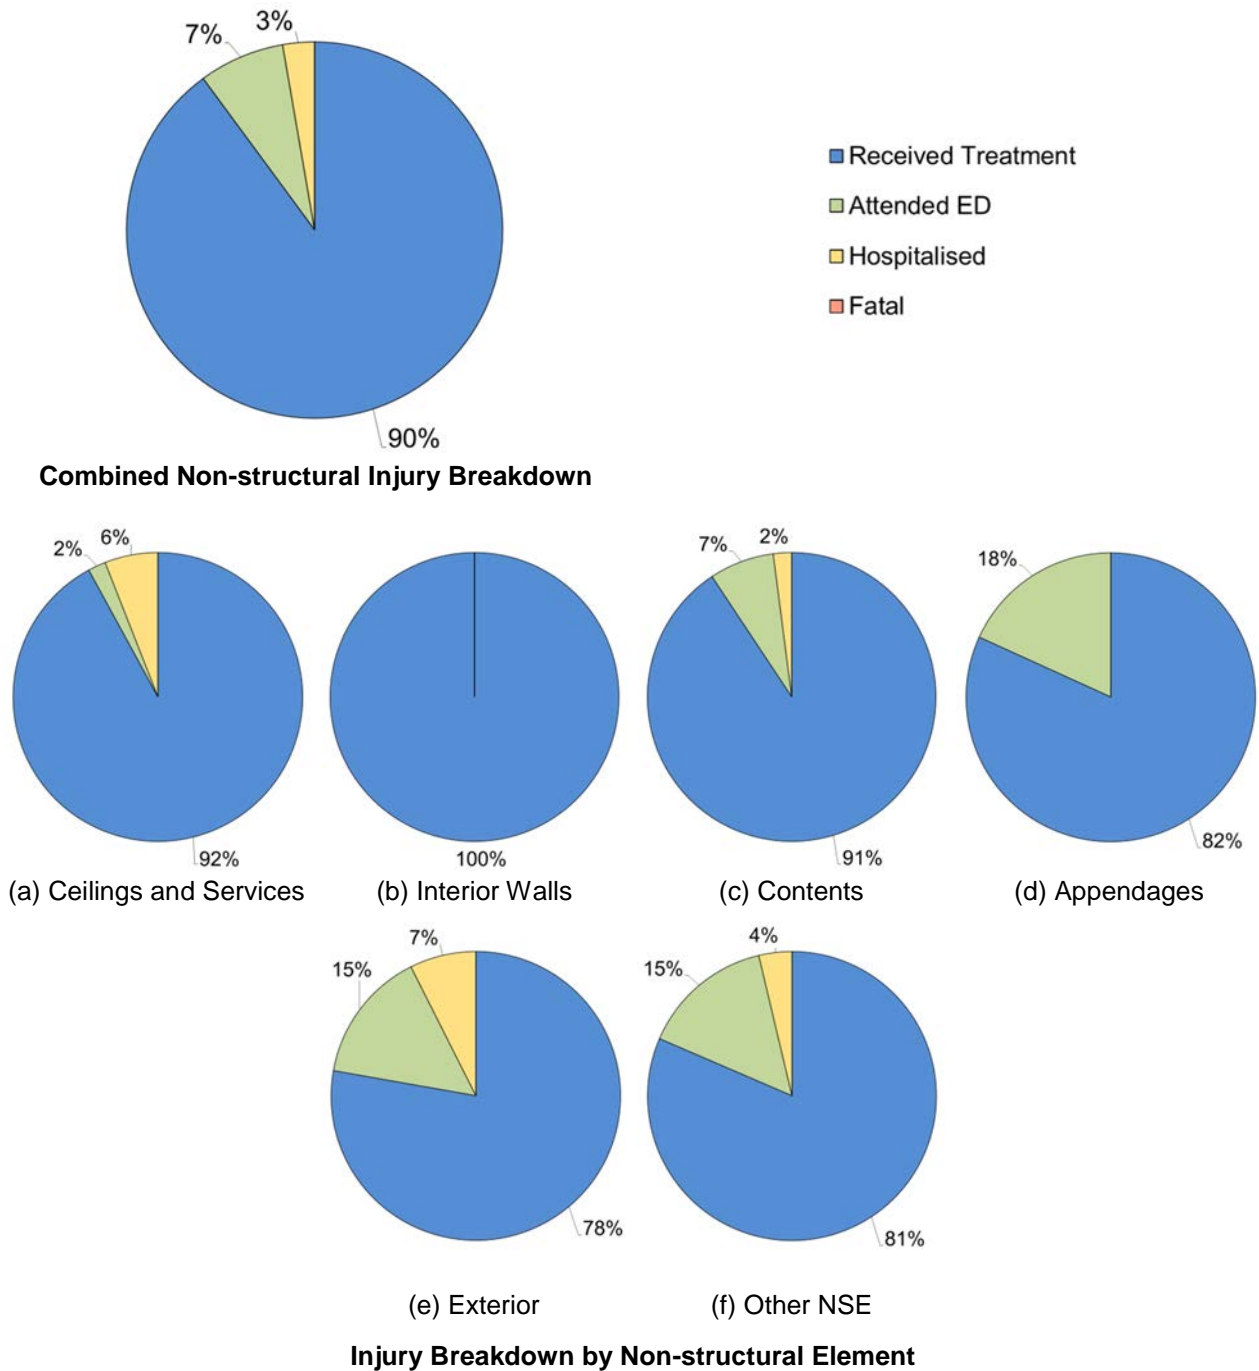
The proportion of injury severity can be further broken down by non-structural element type, as presented in Figure 7. The proportions are generally similar for each type, and since contents are the dominant injury cause, the breakdown of content injuries is nearly identical to that of the combined non-structural injury breakdown.

Figure 7: Injury Breakdown by Non-structural Element Type

It can be seen in Figure 7 that exterior elements caused the greatest proportion of injuries that required emergency department treatment, or admission to hospital. Such injuries are likely attributable to glass falling from height, which was widely reported following the Canterbury earthquakes (Baird et al., 2011).

Appendages also caused several injuries requiring emergency department treatment, which is likely related to being heavy non-structural elements falling from height similarly to exterior elements. Injuries attributed to interior walls were rare, and also only ever minor in severity. Such elements evidently do not present a significant issue from a life-safety viewpoint based on the research data.

Ceilings/services injuries and contents injuries had a similar proportion of injuries that required emergency department treatment or hospitalisation. However, contents had a greater number of injuries overall, so the number of contents related injuries requiring treatment is greater. Based on the data we can conclude that if an occupant of a commercial building in New Zealand is injured in an earthquake, the most likely cause of the injury is building contents, however, the severity of the injury is most likely to be minor.

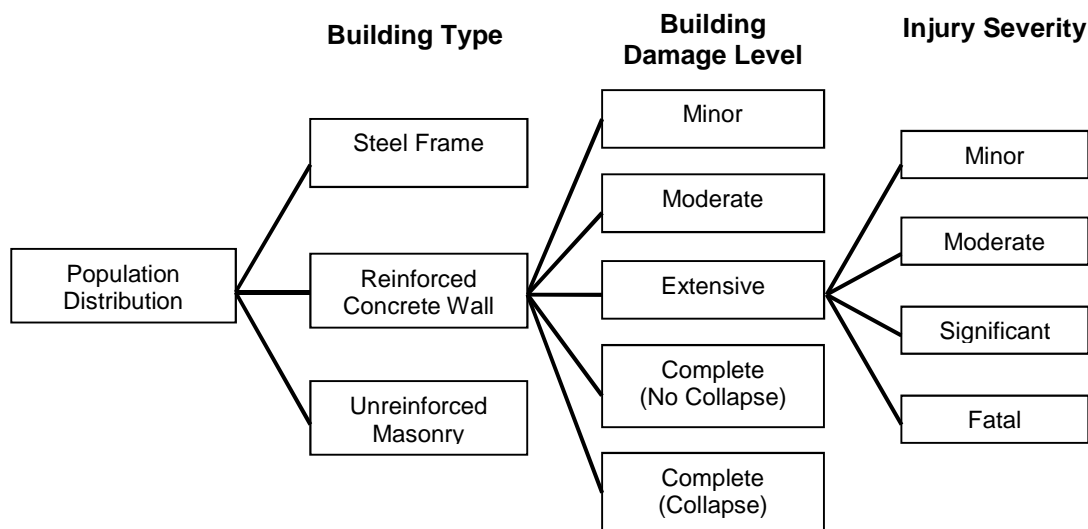
The most commonly used event-tree approach is shown in Figure 8; where (i) the population present within each building type are estimated, (ii) the global damage level for each building type is predicted, and (iii) injury rates are assigned for each damage level. Examples of models which follows this approach include the Cambridge University Casualty Model (Coburn et al., 1992), HAZUS® (FEMA, 2015), and Mitrani-Reiser (Mitrani-Reiser, 2007). While this approach may be adapted to consider non-structural element failure rather than the building’s damage level, no studies exists linking non-structural element failure to injury severity.

Figure 8. Event tree model for indoor casualty prediction HAZUS® (FEMA, 2015)

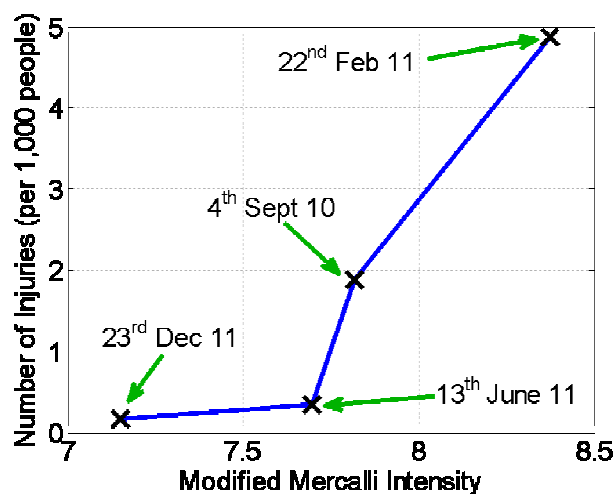
The non-structural injury model represents the relationship between the ground shaking intensity with the injury rate. It consists of a data point that relates these two variables for each earthquake event considered, as shown in Figure 9. The injury model presented in Figure 9 considers injuries from all non-structural elements. The relationship shows that the injury rate increases with ground shaking intensity which is reasonable. The injury rate varied between 0.1 and 4.9 injuries attributable to non-structural damage per 1,000 people, depending on the intensity of ground shaking.

Figure 9: Non-structural element injury rate versus ground shaking

The two lowest injury rates were the last two significant events of the four Canterbury earthquake sequence events considered. It is likely that these injury rates may have been higher had they had not followed larger

previous earthquake events which we surmise would have damaged the most vulnerable non-structural elements and which may not have been repaired by the time these later significant events in the Canterbury earthquake sequence occurred.

This injury model can be used as a tool for estimating the number of injuries in other earthquakes. However, the model is implicitly Christchurch specific, meaning that the factors linking MMI to injury severity, such as soil type, building typology, non-structural element types, building populations, etc., are representative of Christchurch in the years 2010-2011. Any further application therefore assumes that these ‘filters’ are an appropriate representation of the place that they wish to estimate injuries for. That’s not to say that such a model is unusable, as it will likely provide a better estimate of possible injury numbers compared to equivalent models developed outside of New Zealand, which have been passed through their own local filter. Further data will help in improving the validity of the model and widen its application.

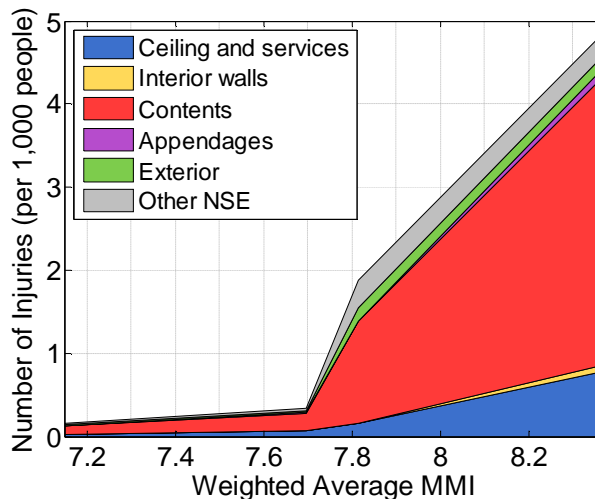
The injury rate can also be broken down to show the individual contribution of each non-structural element type considered, as shown in Figure 10. As would be expected, contents injuries are the main contributor to the overall non-structural injury rate. The contribution of each non-structural component to the overall injury rate appears to be relatively consistent for different levels of ground shaking. It appears that interior wall and appendage injuries only register under large shaking.

Figure 10: Breakdown of non-structural element injury rate versus ground shaking

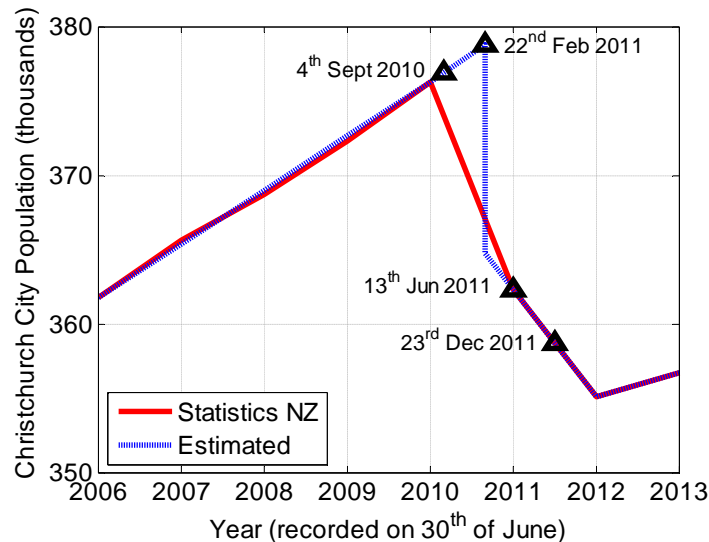
Figure 12. Dwelling population trends from 2006 to 2013 (Statistics New Zealand)

Based on these assumptions, F_1 is estimated by dividing the estimated dwelling population at the time of each event by the dwelling population from either 2006 or 2013. Since many businesses during the 22nd of February 2011 event were forced to relocate, the working population distribution for events after the 22nd of

February 2011 is likely to be more consistent with the 2013 census data. In contrast, the working population distribution up until the 22nd of February 2011 event is likely to be more consistent with the 2006 census data. As such, the 2006 dwelling population was used to estimate F_1 for 4th September 2010 and 22nd February 2011 events, while the 2013 dwelling population was used for the other two events.
