Technical investigation into the collapse of the Stadium Southland roof

**DEPARTMENT REPORT TO THE MINISTER FOR BUILDING
AND CONSTRUCTION**

May 2012

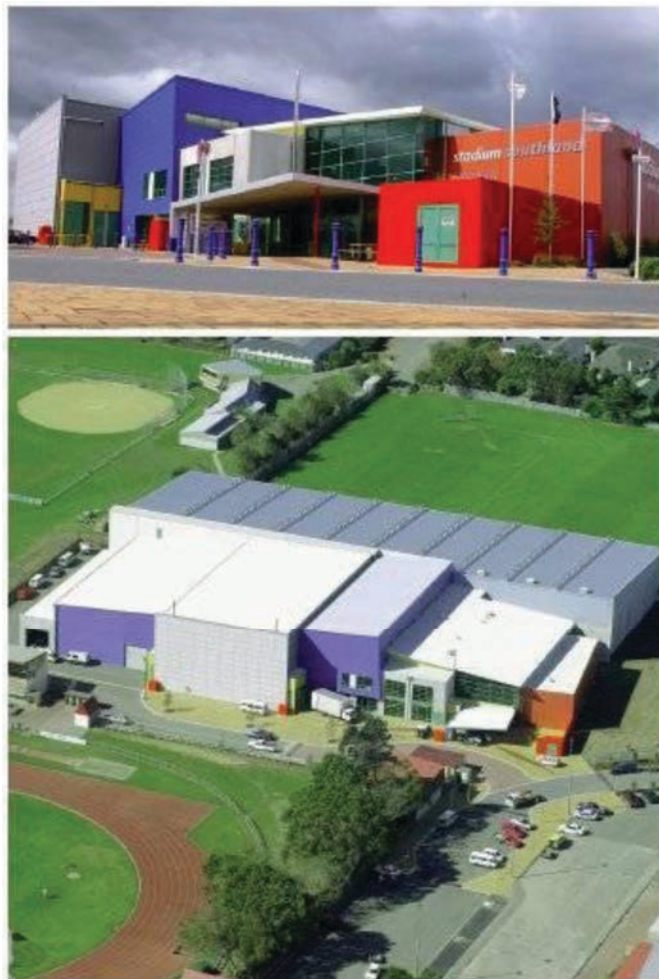
Figure 1. Stadium Southland prior to collapse (the builder's website)

In November 1999, during construction of the stadium, excessive deflections were observed in the roof trusses that had been erected above the community courts area. Remedial works were necessary to address the deflections. A revised building consent was obtained for the revisions involved in the remedial works. The building opened in 2000.
