# Investigation into the Collapse of the Forsyth Barr Building Stairs on 22<sup>nd</sup> February 2011

Prepared for Department of Building and Housing (DBH)

By Beca Carter Hollings & Ferner Ltd (Beca)

26<sup>th</sup> September 2011

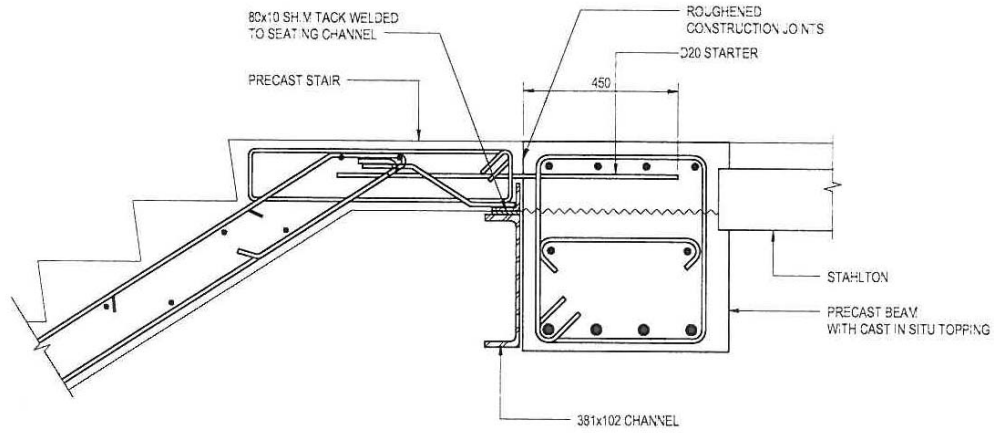
Figure 4.4 : Typical Stair Top Support Detail

The majority of the stair flights were precast concrete units (cast as a single unit, not as separate flights connected by a cast in-situ slab as shown on the drawings) cast into the supporting concrete beam at the top landing (refer to Figure 4.4 for the detail). At their lower end, they were seated on a steel channel with a horizontal gap specified to be 30 mm wide (refer to Figure 4.5 for the detail). The steel channels also support the ‘toilet’ slab.

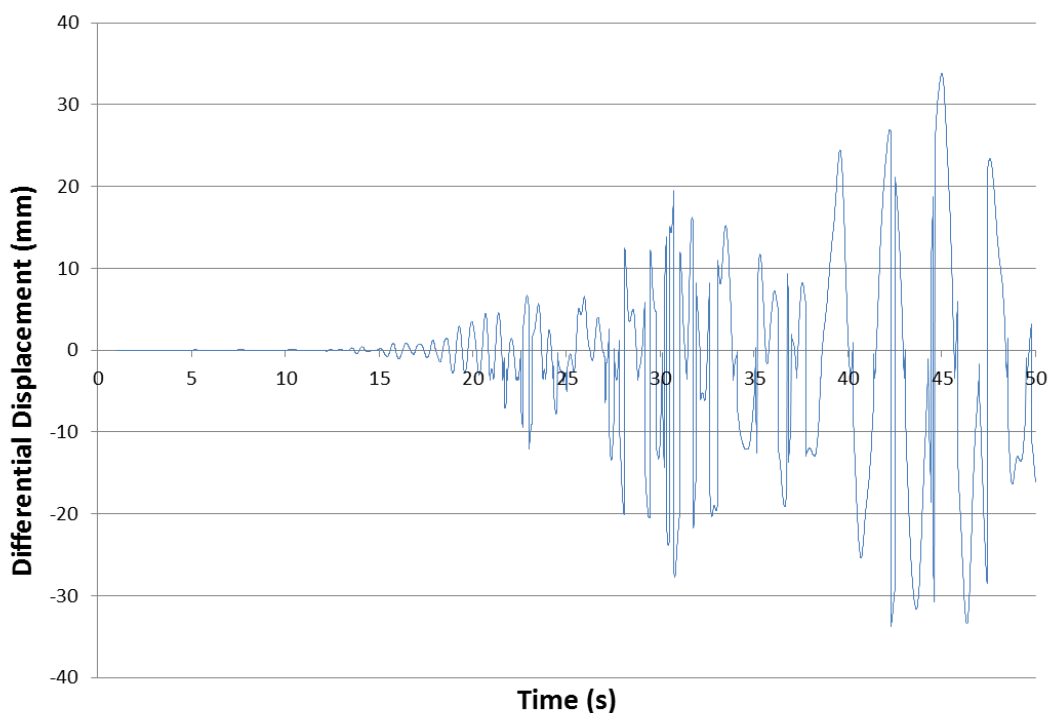
**Figure 5.6 :** Predicted Variation with Time of the Inter-storey Drift between Levels 13 and 14 during the 4<sup>th</sup> September 2010 Earthquake Obtained from Time-History Analyses Using the REHS Strong-Motion Record

A plot of the inter-storey drift (relative horizontal displacement between adjacent levels) with time for Levels 13 to 14, for the 4<sup>th</sup> September earthquake, is shown in Figure 5.6. The drift between these two levels was the largest in the building of the analyses that were carried out. The drift shown was calculated at the stair location for the direction parallel to the stair flights.

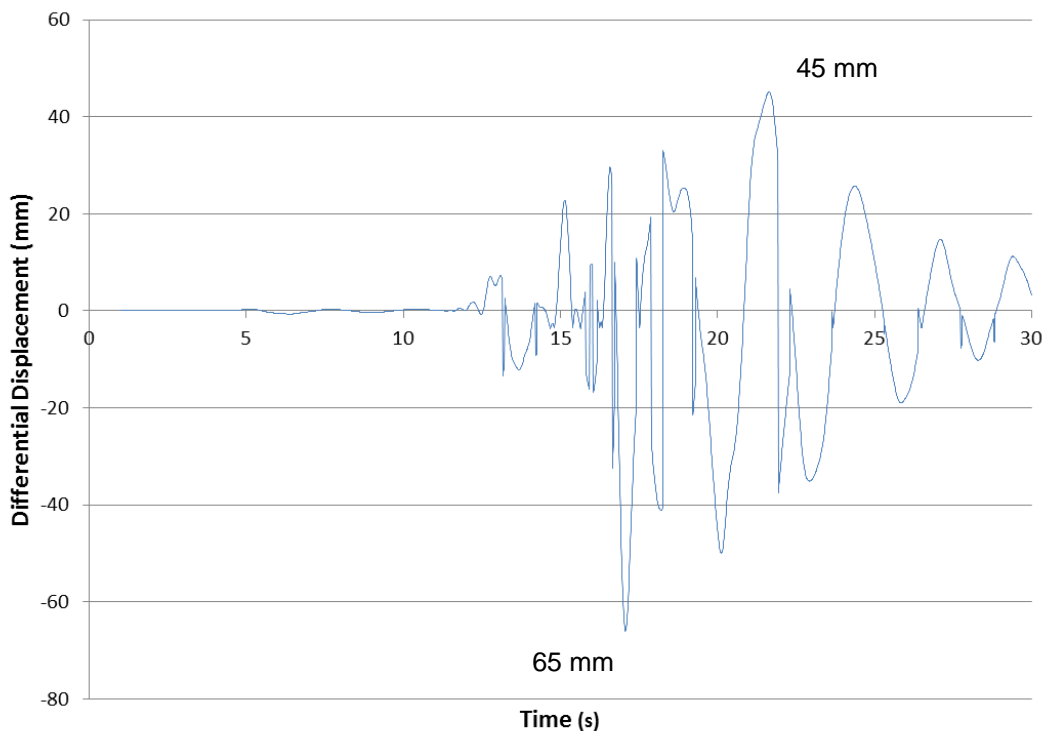
**Figure 8.1 :** Predicted Variation with Time of the Inter-Storey Drift between Levels 13 and 14 during the 22<sup>nd</sup> February 2011 Earthquake Obtained from Time-History Analyses Using the REHS Strong-Motion Record.

Our analyses predicted the changes in inter-storey drift (relative horizontal displacement between adjacent levels) with time for Levels 13 to 14 for the 22<sup>nd</sup> February earthquake that are shown in Figure 8.1. The drifts between these two levels were the largest in the building for the analyses that were carried out. It can be seen that the maximum drift predicted for this earthquake was of the order of twice that for the 4<sup>th</sup> September 2010 earthquake (refer to Figure 5.5), although the number of cycles during the September event was greater.

The level of drift predicted by these analyses (65 mm) is greater than we determined was required to be considered for design (34 mm) in accordance with NZS 4203 by a factor of nearly two. When compared with the clearances and seatings provided it also exceeded the seismic gap by a factor of two, but was less than the seating length that had been detailed (72 mm, assuming this had not been eroded by construction tolerances). The level of drift in this earthquake also exceeded the drift requirements of the current code, NZS1170.5, which have been estimated at 40 mm.
