PYNE GOULD CORPORATION BUILDING  
SITE EXAMINATION AND MATERIALS TESTS  
FOR DEPARTMENT OF BUILDING AND HOUSING  
17TH SEPTEMBER 2011

REPORT PREPARED FOR:  
**DEPARTMENT OF BUILDING AND HOUSING**

**DR CLARK HYLAND**

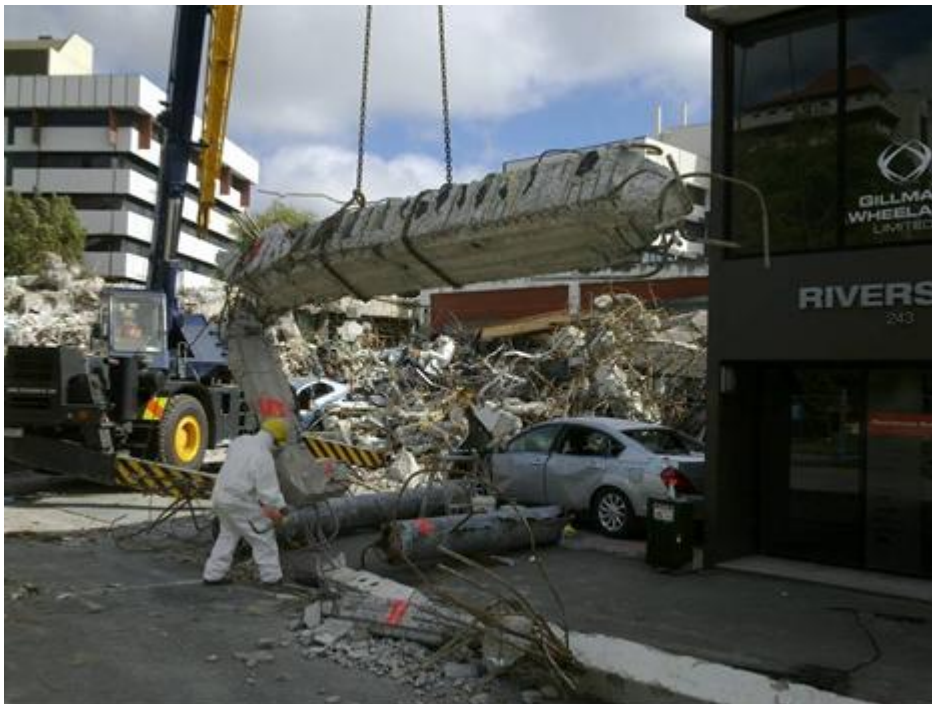
The site was identified as containing asbestos which required the wearing of asbestos personal protection (Figure 1).

Figure 1 – Structural concrete beam remnant being moved by mobile crane and site crew wearing personal protection equipment due to presence of asbestos.

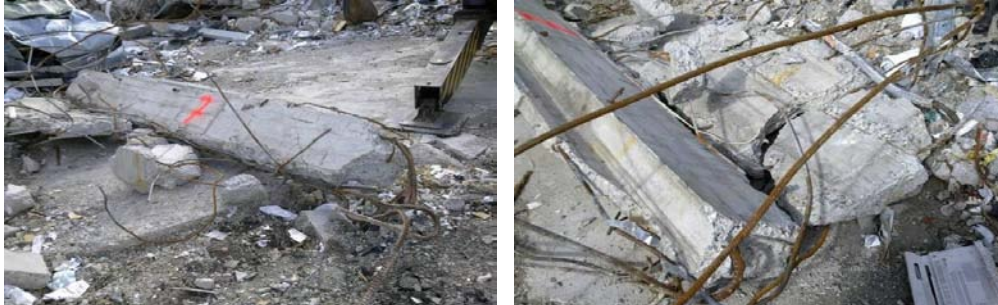
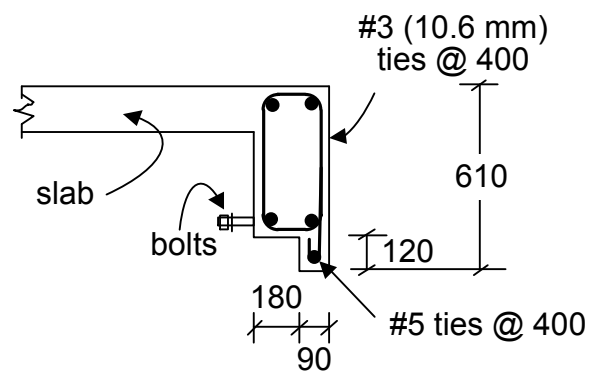
Figure 9 - Item 7 - 610 x 270 mm Concrete Spandrel Beam (photos clockwise from top left): a) Right hand end; b) Left end with slab remnant

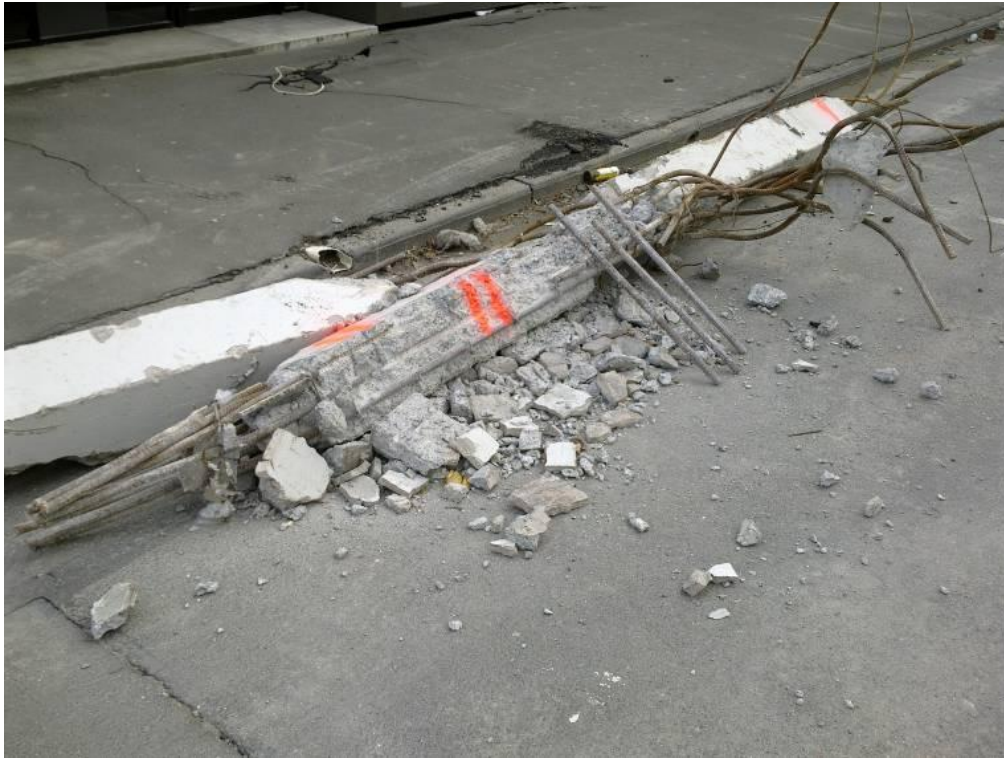
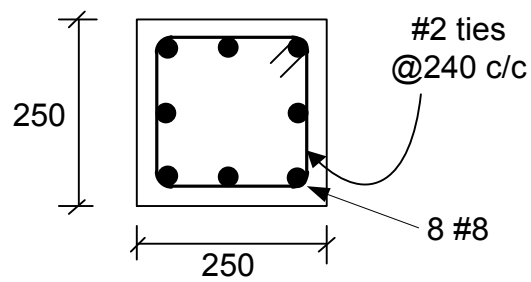
Bars were extracted from this column for tensile testing by SAI Global ( NZ) Ltd and chemical analysis by Pacific Steel Group.

Figure 11 - Item 11 - 250 x 250 mm 8 bar Concrete Column with bars removed for tensile testing

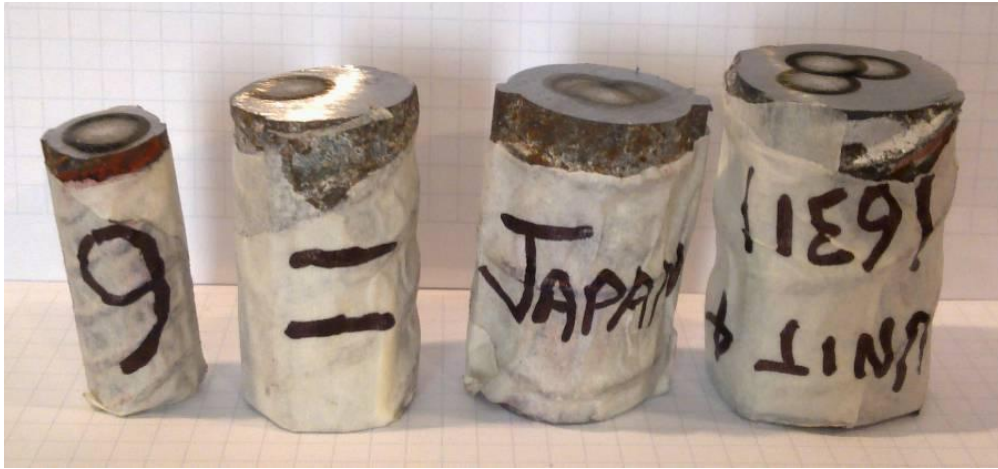
The #5D (PGC-6) bar conforms comfortably with NZS 1693:1962

Figure 14 - PGC bar samples after chemical analysis

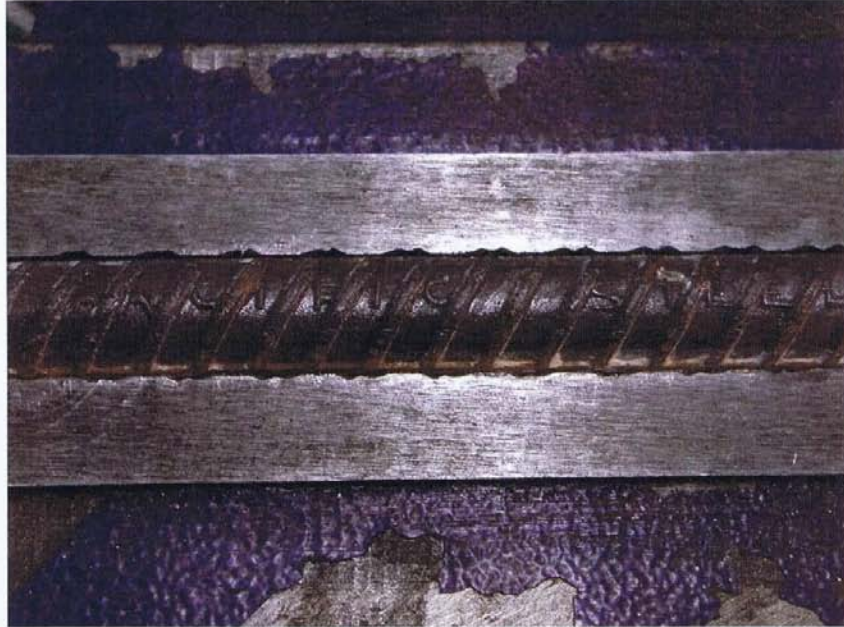
Figure 1 - #4D and #5D

The sample markings on the reinforcing bars supplied are shown in figures 1 and 2. The #4D and #5D samples were marked with Pacific Steel and shown in figure 1. The #8D Bamboo samples were marked with JAPAN and are shown in figure 2. All the other samples had the same markings and are shown in figure 3.
