Investigation into the Collapse of the Pyne Gould Corporation Building on 22nd February 2011

Prepared for Department of Building and Housing (DBH)

By Beca Carter Hollings & Ferner Ltd (Beca)

26th September 2011

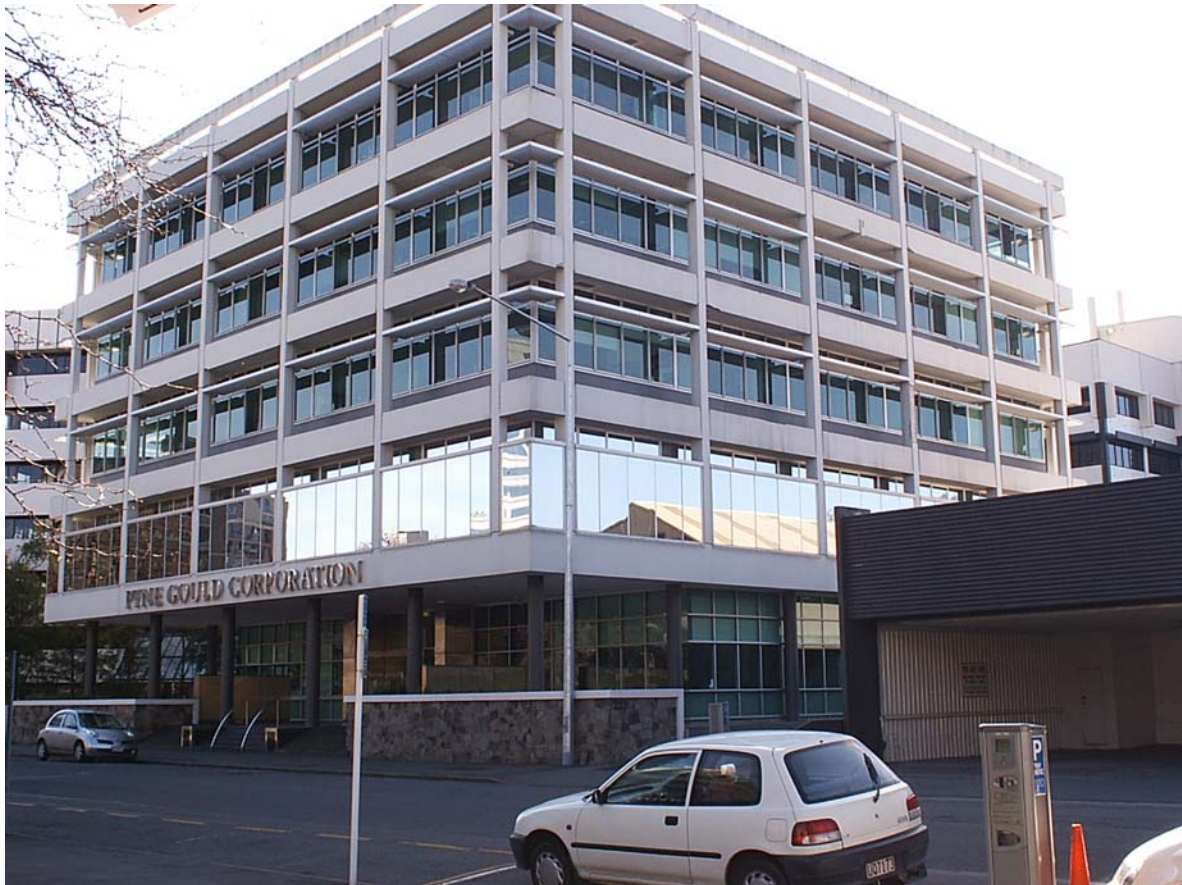
The perimeter columns above Level One were supported on the ends of beams cantilevering out past the line of the Ground Level columns. Refer to Figure 4.1.

Figure 4.1 : 2010 Photo of Building taken from South-East
