Christchurch Earthquake

**Report on the Structural Performance
of the
Hotel Grand Chancellor
in the
Earthquake of 22 February 2011**

Prepared By:
Dunning Thornton Consultants Ltd

Final: 26 September 2011

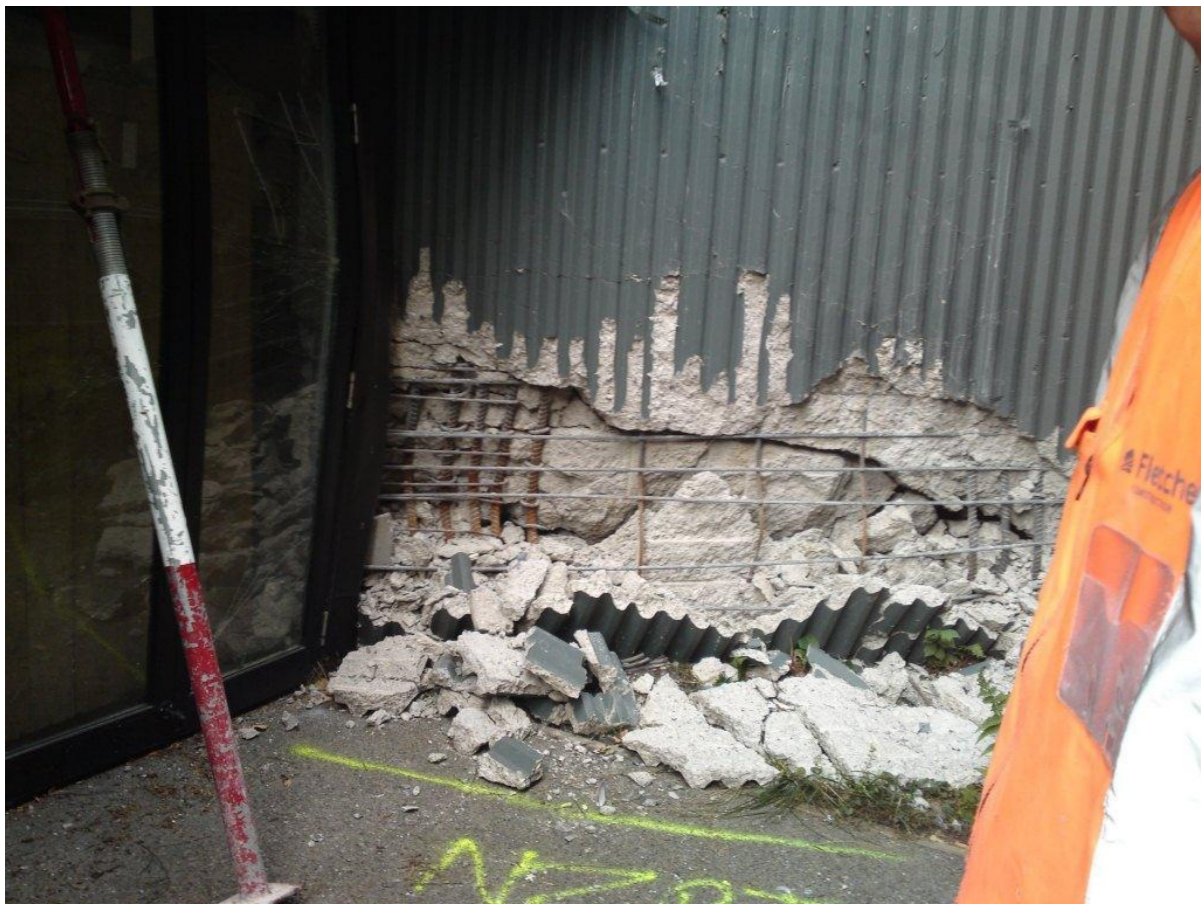
Photo 11 - Similar Shearwall Failure
Not the Hotel Grand Chancellor

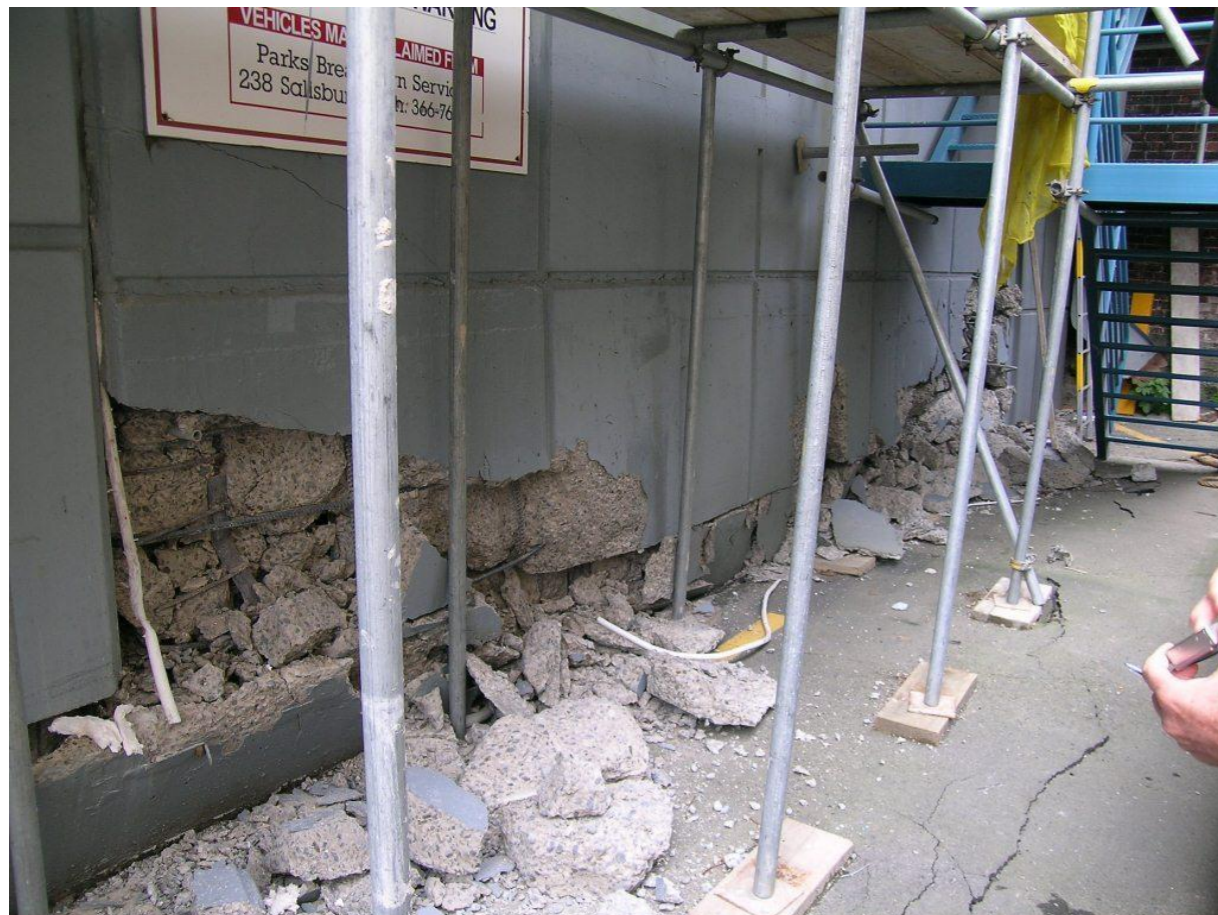
Photo 12 - Similar Shearwall Failure
Not the Hotel Grand Chancellor
