CTV BUILDING

CTV BUILDING SITE EXAMINATION
AND MATERIALS TESTS
FOR DEPARTMENT OF BUILDING AND HOUSING
16TH JANUARY 2012

DR CLARK HYLAND

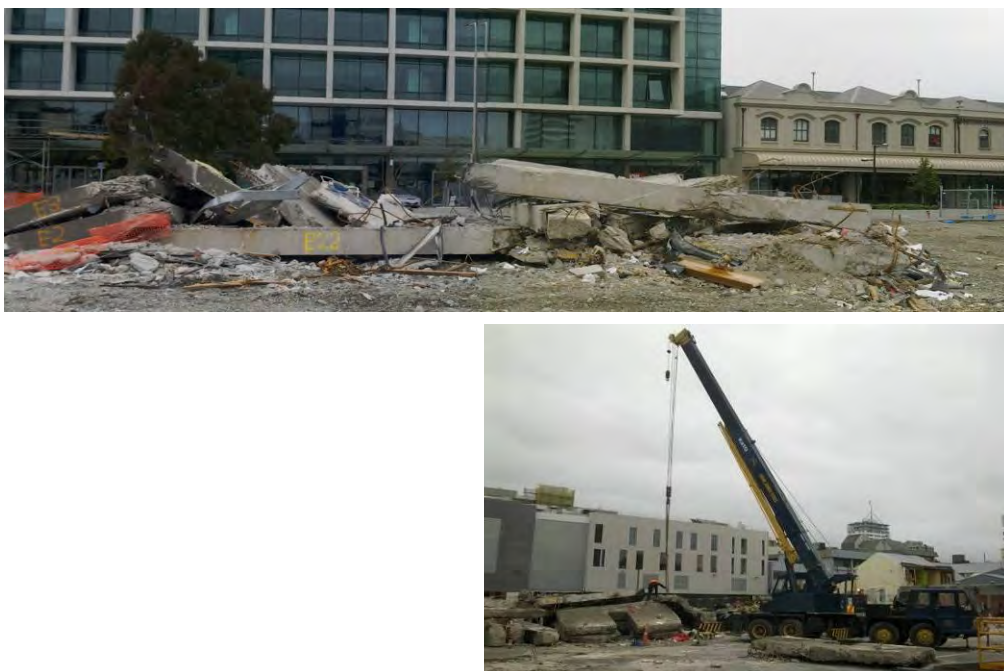
The examination of structural remnants was undertaken by the author and a DBH Engineer, on Saturday 12 March, 2011 (Figure 3). It was then visited again with an engineer from Structuresmith Ltd on 5 April, 2011.

Figure 3 – Structural debris pile on CTV site (top to bottom) (a) At start of Site Examination; (b) Crane used to move debris remnants for examination

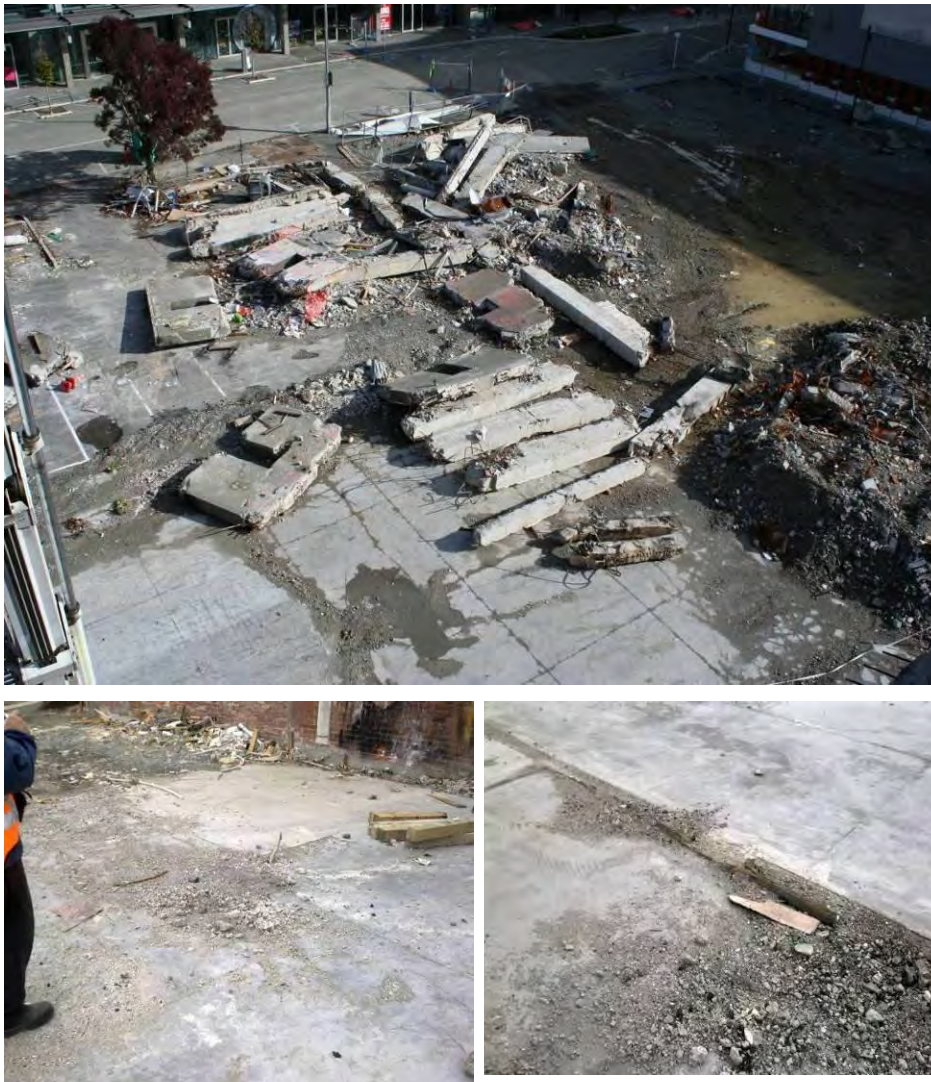
The ground floor slab had a concrete overlay that measured on average 89 mm thick over the eastern half of the floor (Table 5). This ramped up from the original slab adjacent to the lift core (Figure 4).

The slab appeared to be in reasonable condition and there weren't any obvious heave or localised damage at column or shear wall locations. A "levels and positional survey" was undertaken to check for signs of settlement and lift core rotation and is reported in Section 3.

Figure 4 - Ground floor Level I slab on grade (clockwise from top) (a) View from snorkel of debris and western portion of Level I slab on grade; (b) Slab in northwest corner with column reinforcing protruding; (c) Ramp formed in concrete overlay in front of Line 4 lift core walls.

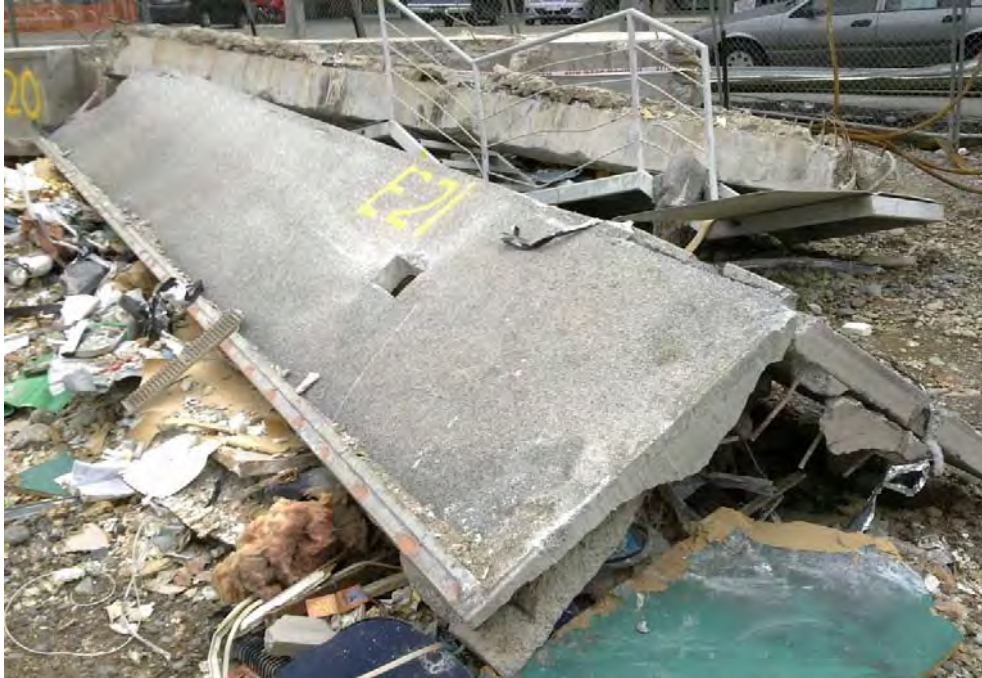
Figure 5 - Pre-cast spandrel panel Item E21 (DENG Dwg S25 (Figure 65))

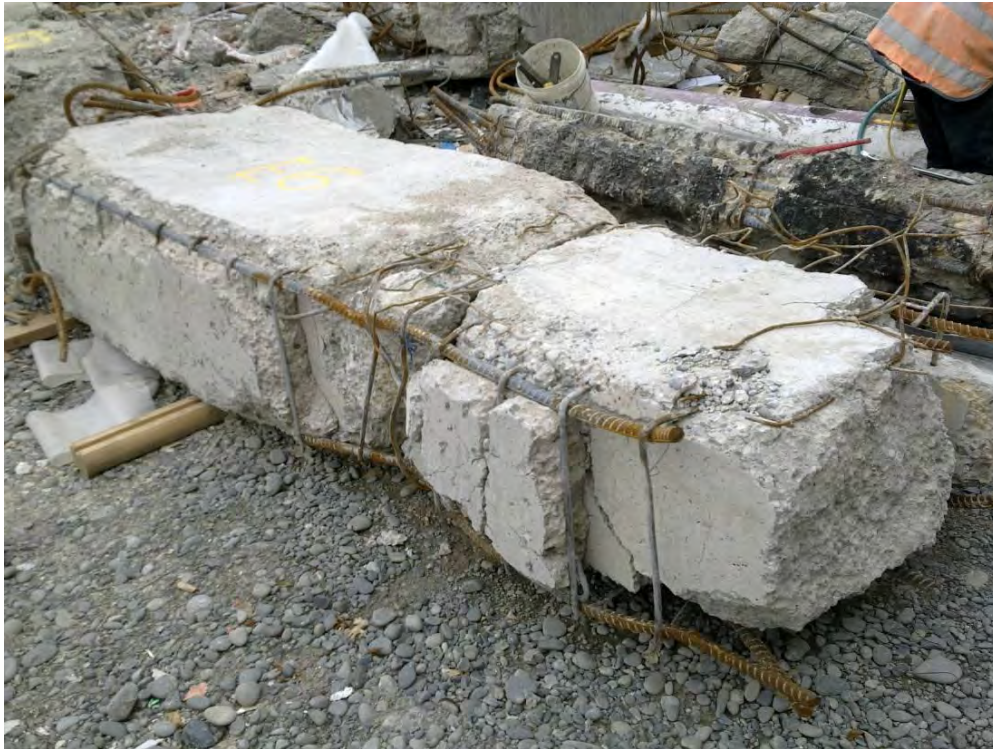
Figure 6 - Edge shell beam Item E6 showing unreinforced concrete infill and smooth interface between shell beam and in-fill. The DENG Specification Precast Concrete cl 3.12 required roughened interface surfaces (Figure 77).

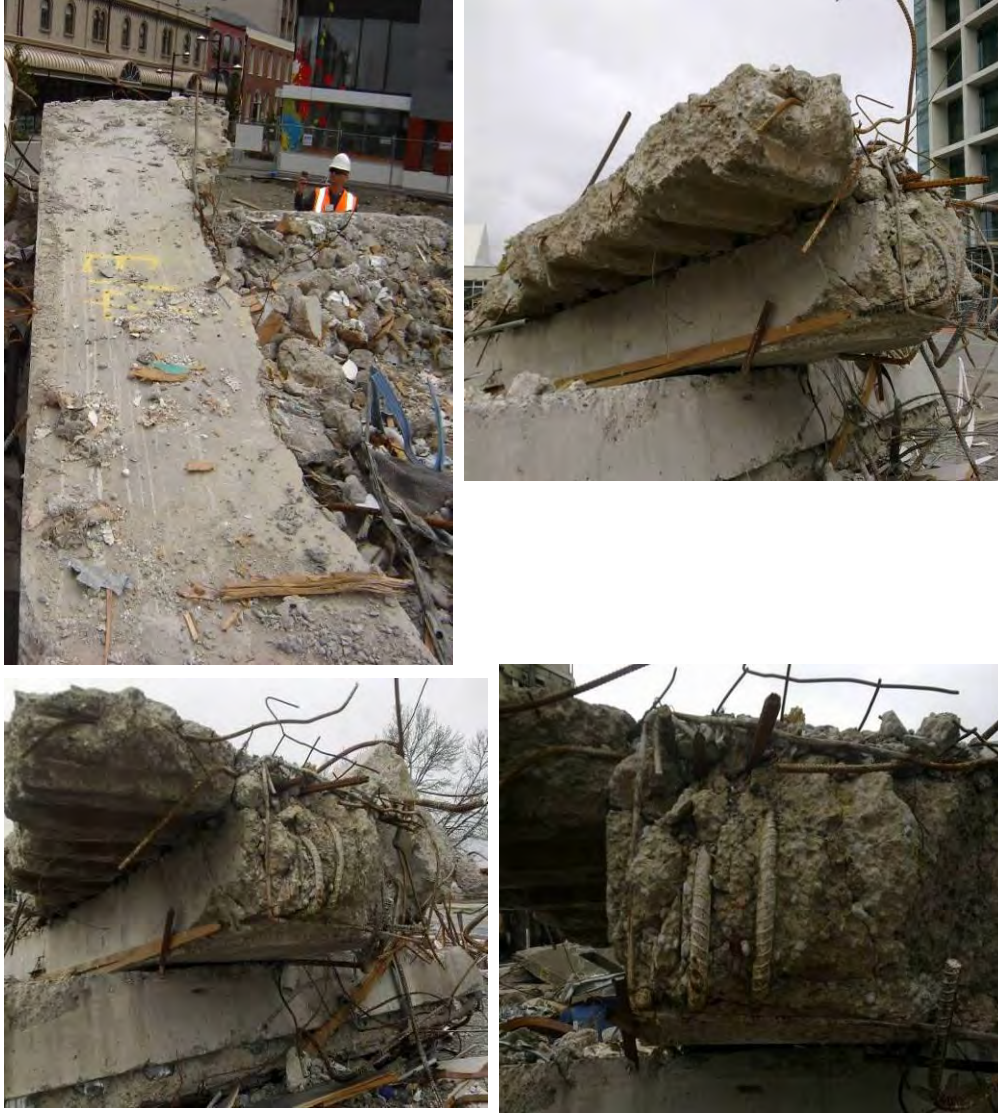
The bottom reinforcing steel in the shell beams had not been developed fully into the Grid C core wall on Line 4 as specified except at Level 2. The bars had been bent back into the concrete infill in the shell beam (Figure 7).

Figure 7 - Pre-cast shell beam (Item E14) from northern face Grid 4, west side of lift core (DENG B23 Dwg S18 (Figure 67)). (clockwise from top left) (a) Top face with slab fracture along edge of shell beam, extending out further at far end adjacent to lift core attachment; (b) to (d) Fractured slab outstand remnant at east end from which slab concrete cores were extracted. The bottom H24 bars from shell beam have been turned back into the concrete infill rather than embedded in shear wall as specified (DENG Detail 5 Dwg S19). Refer also bar imprint on wall at the connection seen in Figure 29 at Level 4 and Figure 30 at Level 3.

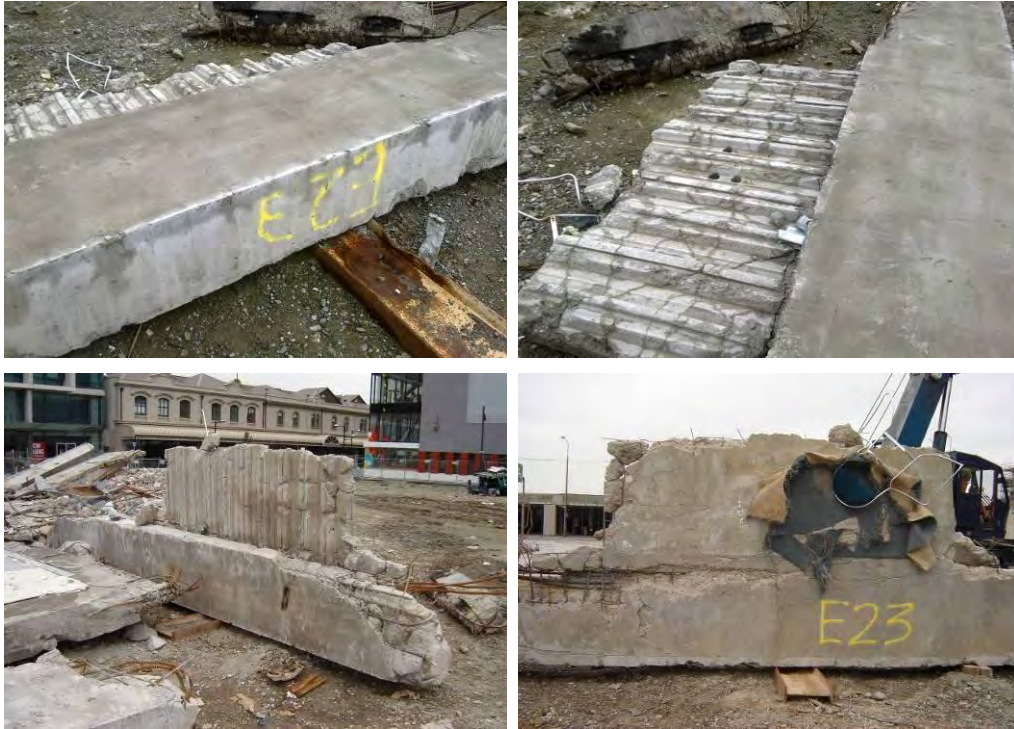
Figure 8 - Edge Shell Beam (Item E23) from Line 1 or 5. (Clockwise from top left) (a) Underside and outer face; (b) Underside showing 1200 mm slab outstand with metal decking pulled away and diagonal cracking indicating shear in diaphragm; Holes are where concrete cores were taken for testing; (c) Carpet remnant on top of slab; (d) Damaged shell beam.

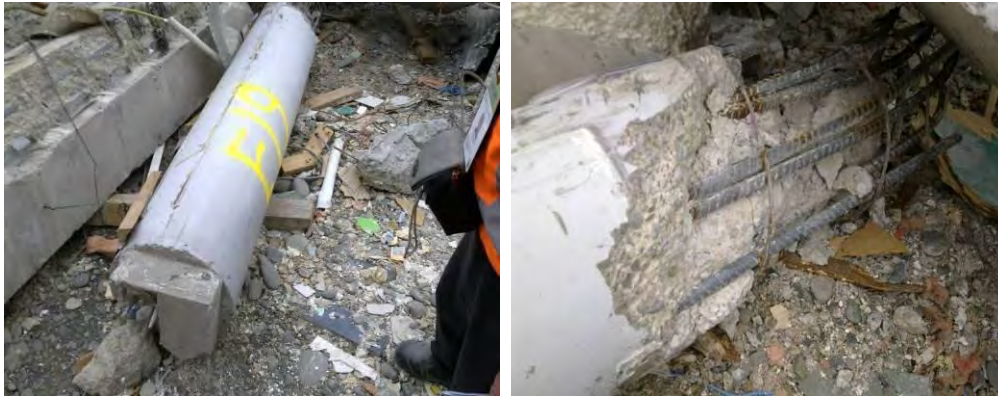
Figure 9 - 400 mm diameter column Item E19. (Left to right) a) Level 6 to Roof, likely location Grid F (Figure 65) based on roof steelwork hold down attachment detail; b) Flexural fracture at base in lap zone of vertical reinforcing steel. R6 spirals at 250 centres can be seen (Figure 69).

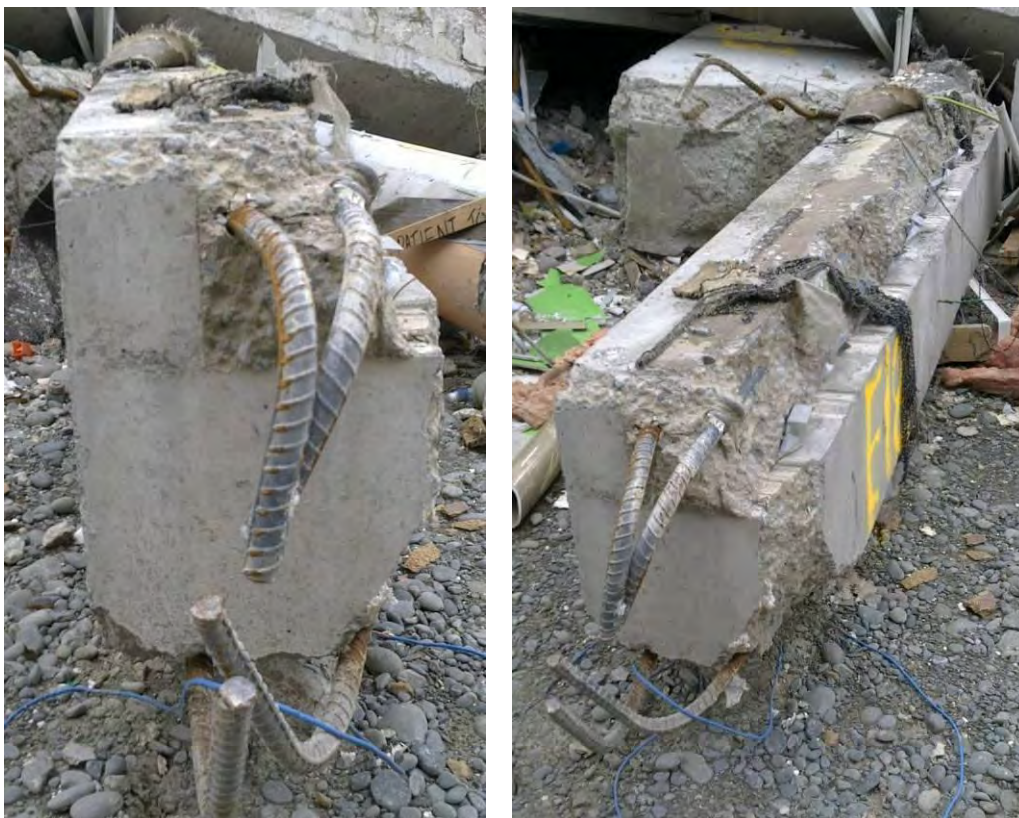
No starter bars connected the log beam into the 200 mm slab that was supported on the shell beams (Figure 13).

Figure 13 - Item E18 Pre-cast edge beam north-west corner (DENG B22 Dwg S18 (Figure 67) (from left to right) (a) Smooth form finish at attachment to column 4A (DENG Detail I Dwg S19 (Figure 70)); (b) No starter bar reinforcing steel extended from this pre-cast beam into slab. This was consistent with what was shown on the Drawings (DENG Section 4 Dwg S15 (Figure 66).

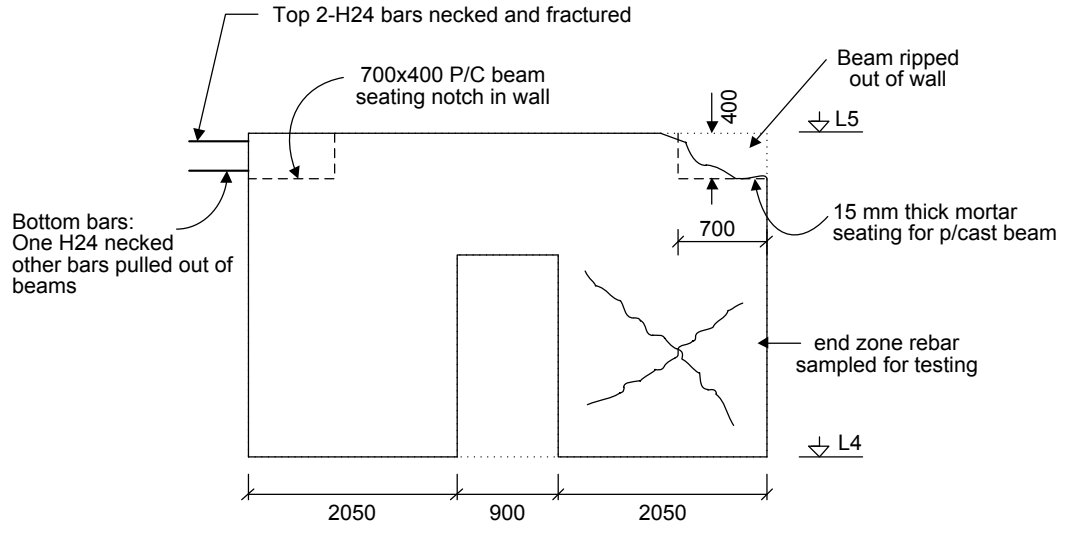
Severe two-way diagonal shear cracking in east pier and loss of cover to vertical reinforcing steel on east edge.

Smooth mortar construction joints rather than roughened at junctions with pre-cast shell beams B15 and B16 (Figure 67).

Figure 21 - South Wall Item E4 schematic of damage observed.

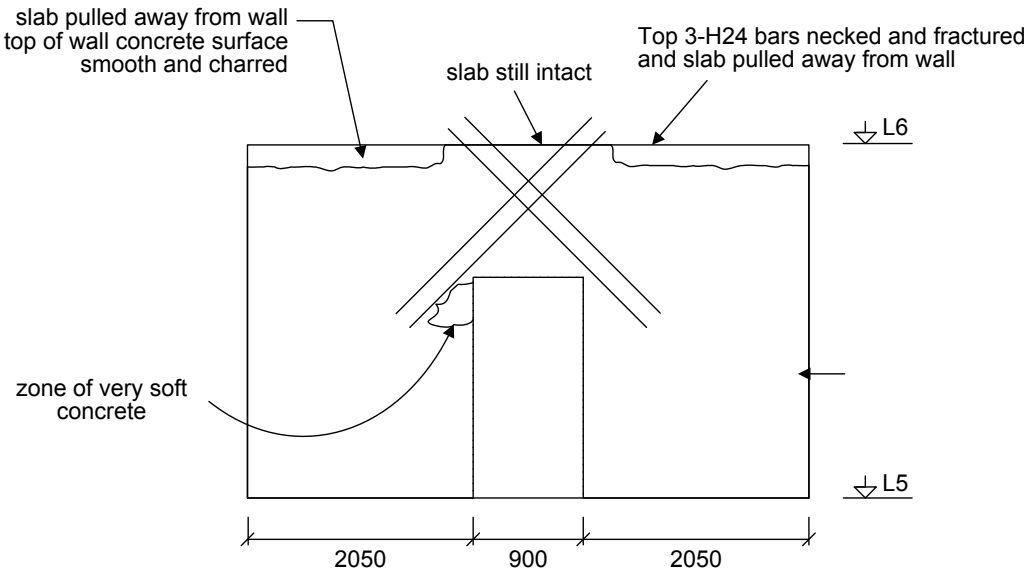
Weak concrete in west pier adjacent to top of doorway that was able to be dislodged by boot (Figure 22).

Figure 23 - South Wall Item E5 schematic of damage observed.

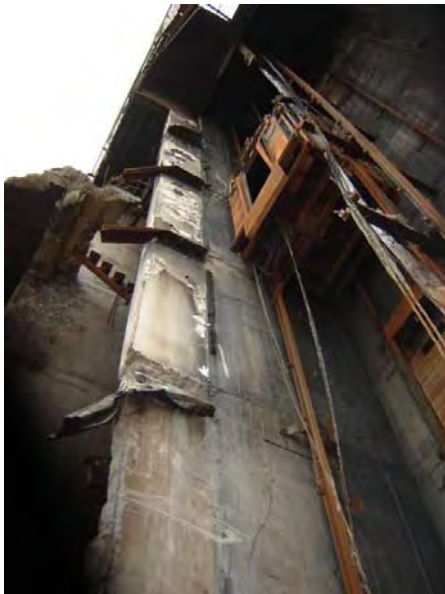
Drag Bars had been fixed into the slab and into the shear walls at Levels 4, 5 and 6 with epoxy grouted threaded anchors after the original construction had been completed (Figure 33).

The profiled metal deck floor slab at Level 4, 5 and 6 had additional Drag Bars connecting it to the north-south wing walls, ("the Drag Bars") on either side of the lift well, sometime after the original construction was completed. Threaded rods had been fixed into the slab with what appeared to be epoxy grout and bolted to the underside of the Drag Bars, as seen in Figure 36 to Figure 40.

Figure 33 - Drag Bar connections at Levels 6, 5 and 4 on lift well west wing wall on Grid D. No Drag Bar at Level 3 or 2 (Figure 32)

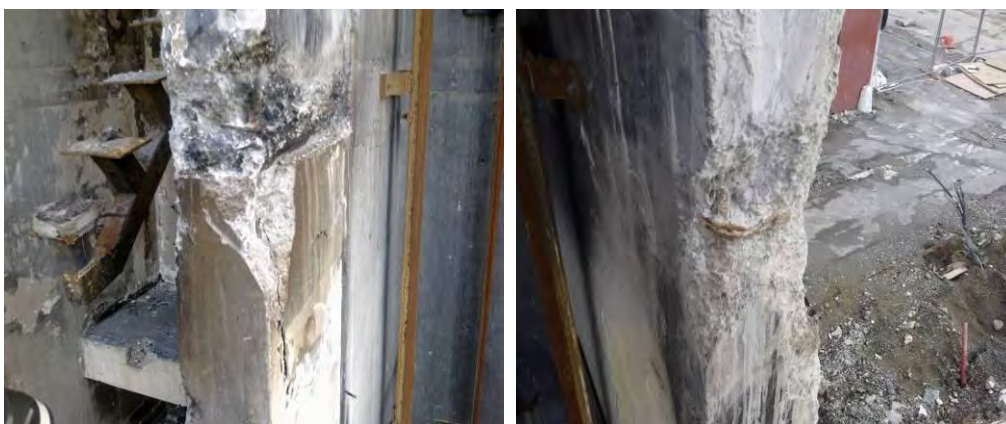
A 20 mm hole was found in the west wing wall D where a reinforcing bar had pulled out (Figure 34).

Figure 34 - Level 2 Lift Well Wing Walls Grid D and D/E (left to right) (a) 20 mm hole in end where a reinforcing bar has pulled out of wall. 200 mm thick construction joints in wall at slab level; (b) No reinforcing steel attachment into the east wing wall at Level 2

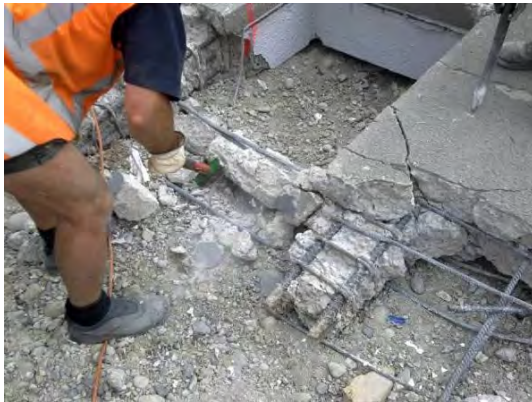
Figure 42 - Line 1 South Wall Item E1 H16 bars from masonry door infill.

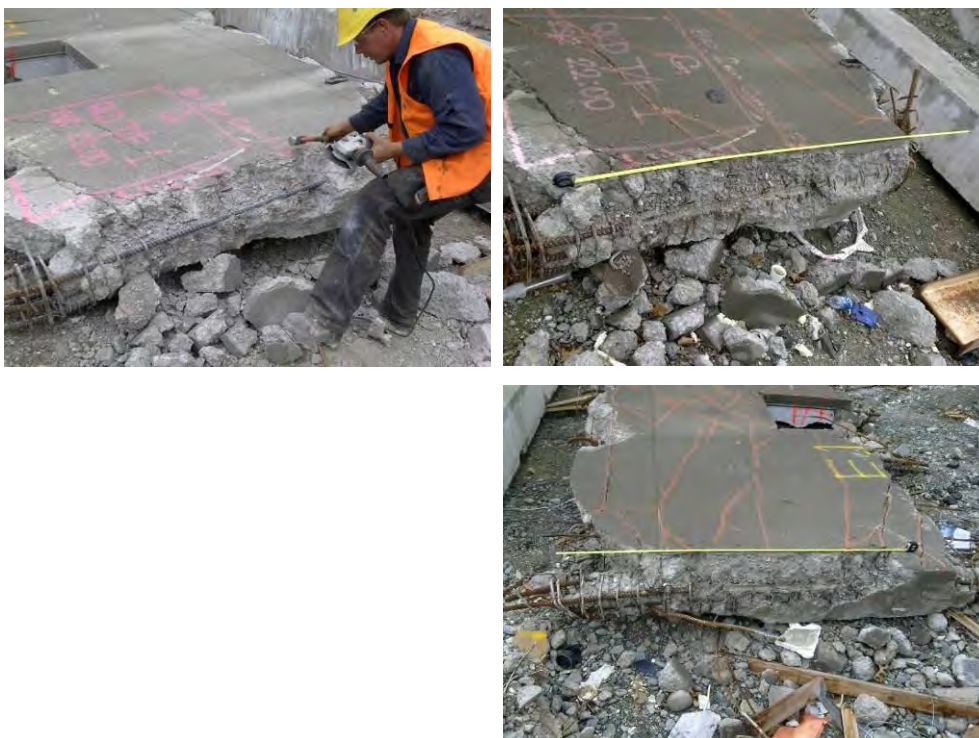
Reinforcing steel taken from the east end of the wall was found to have yielded and elongated prior to the collapse of the building (page 55).

Figure 43 - H28 from east and west end of Line I South Wall Item E1 (clockwise from top left) (a) H28 about to be cut from east end (EIE); (b) Top of 1000 mm long EIE sample 1300 mm from top of L2 slab; (c) Top of 1000 mm long EIW sample from west end 750 mm from top of L2 slab. Coupling beam depth was 1700 mm.

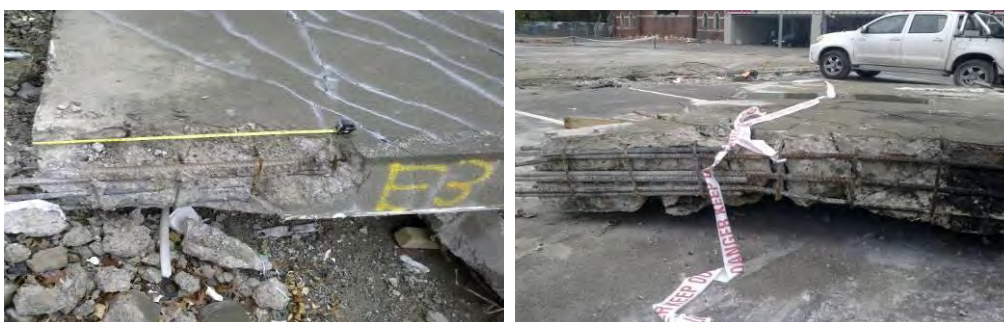
Figure 44 - Locations of H24 reinforcing bar samples (left to right) (a) East end of Line I South Wall item E3, one cut from lower 1050 mm of wall; (b) Two lapping bars from lower E3 wall item taken from east end of wall item E4

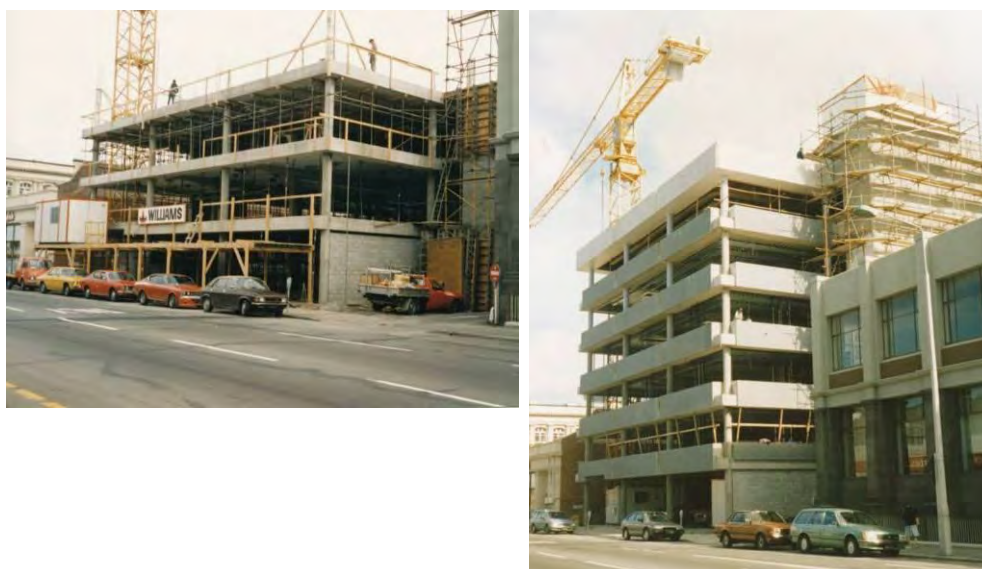
The specified concrete 28-day strength for these two Level 1 columns was 35 MPa at 28 days according to the Specification. However the mean strength was 24.9 MPa (26.9 MPa when adjusted for test orientation) based on the Rebound Hammer tests, so appeared to have not complied with the requirements for 35 MPa concrete. Photos, taken by a member of the public during construction, show that these columns were not cast at the same time as the other Level 1 columns (Figure 45).

Figure 45 - CTV Building under construction (left to right) (a) May 1987 with floors cast up to Level 4; (b) October 1987 with roof on and pre-cast spandrel panels attached; Columns C21 to C23 had not been built at that time in the northeast corner closest to camera.

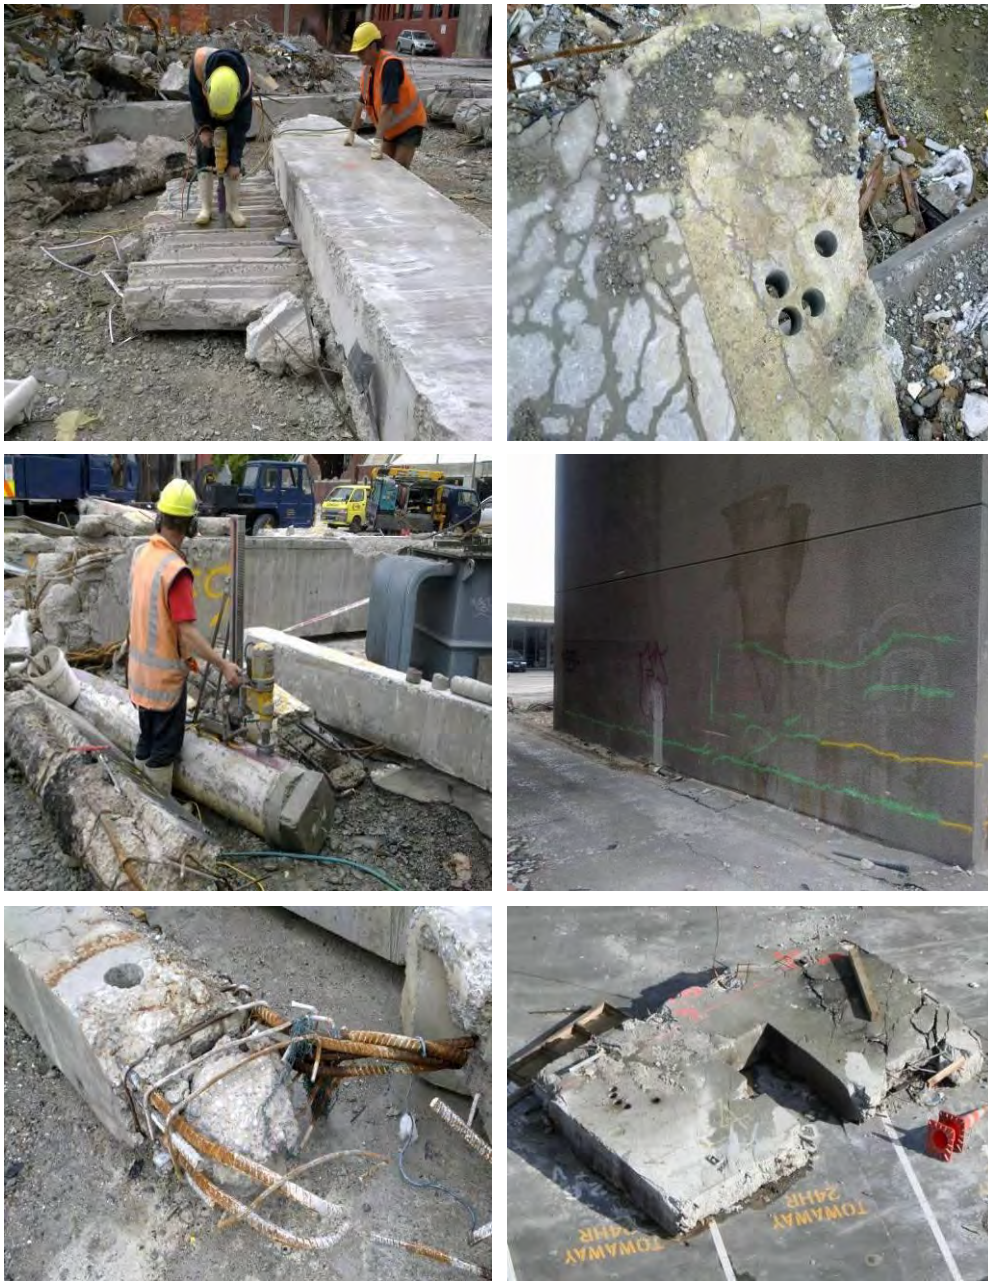
Cores were extracted from columns, beams, slabs and walls for compressive strength testing (Figure 46). The chord modulus of elasticity was also determined for the South Wall and North Core concrete.

Figure 46 – Locations of concrete cores taken for testing (clock-wise from top left) (a) Slab attached to Line 1 or 4 perimeter shell beam (Item E23) (b) Slab attached to Line 4 perimeter shell beam (Item E14); (c) Line 5 shear wall through stair well at Level 1; (d) Line 1 South wall Level 4 to 5 (Item E4); (e) Pre-cast log beam from Line 2 or 3; (f) Level 6 400 mm diameter column (Item E25)

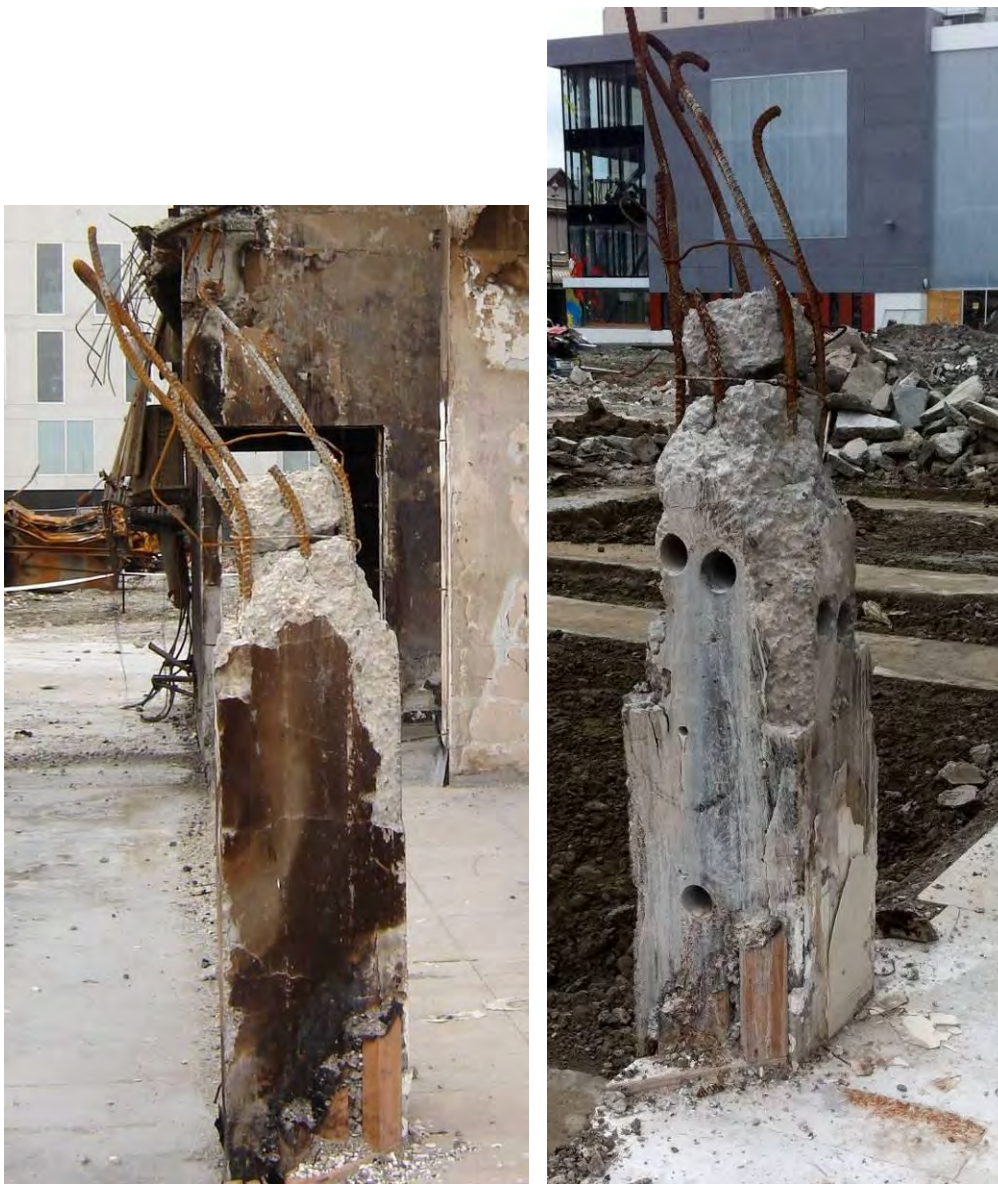
All the concrete columns had been removed to floor slab level except for a 400 mm square column stub C18 stub adjacent to the east end of the lift core walls (Figure 47).

Figure 47 – Locations of concrete cores taken on site for testing on column C18 on Line 4, adjacent to wall D/E

Opus pointed out areas of possible silt contamination in the samples of column C18.

In conclusion, at the time of the tests, subject to there being no detrimental effects on the concrete test samples from heat from the post-collapse fire, the Level 1 400 mm square column concrete would not have complied with the requirements of concrete with the specified 28-day strength of 35 MPa nor 15 MPa. However it is recognised that this remnant had been affected by heat and collapse damage.

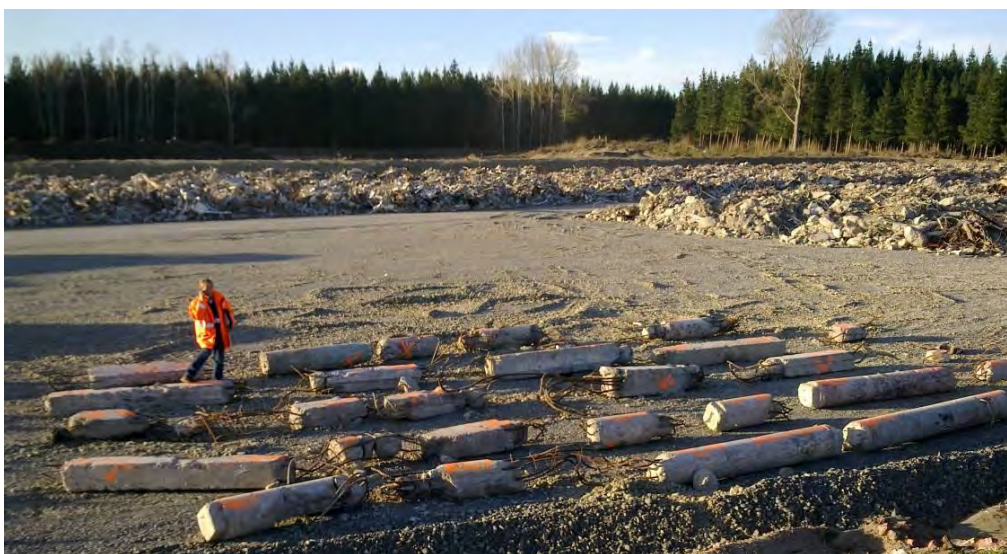
Figure 48 - CTV Columns remnants extracted from the Burwood Landfill CTV debris (at right) for Schmidt Hammer testing and coring. Full height and partial height remnants can be seen.

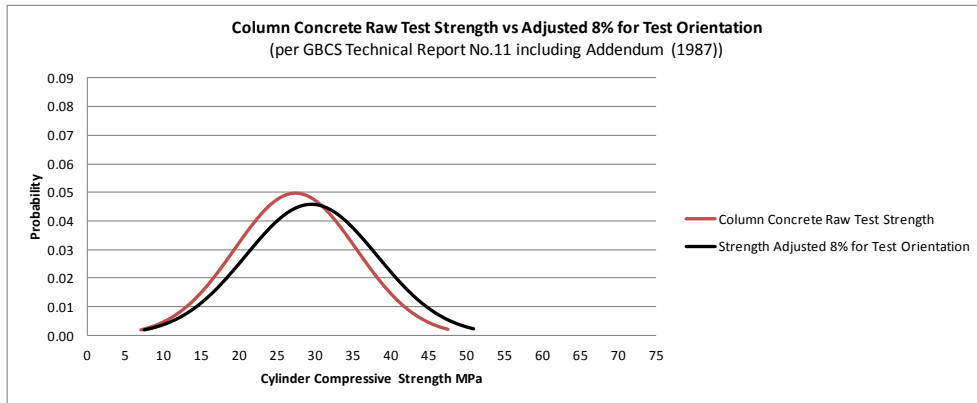
Figure 50 Column concrete test strengths compared to strengths adjusted 8% for test orientation being transverse to direction of concrete casting. This adjustment in test strength was recommended by the Concrete Society Technical Report 11 “Concrete Core Testing for Strength”.

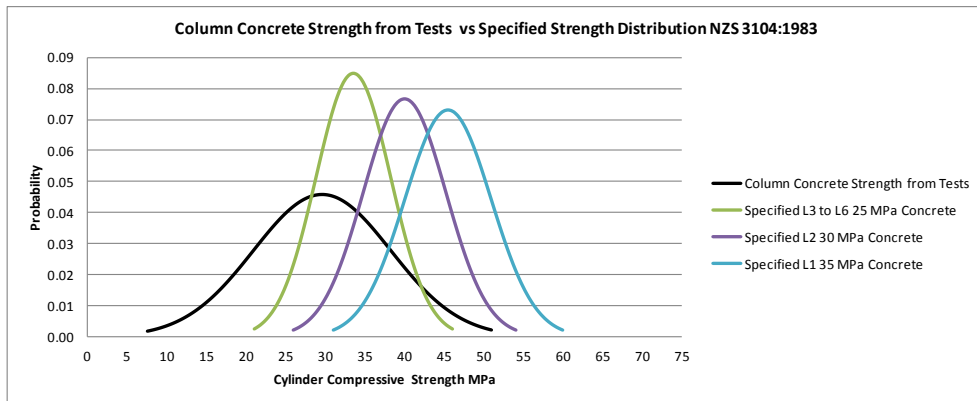
Figure 51 Column strengths from tests adjusted 8% for test orientation vs 28-day concrete strength distribution according to NZS3104:1983

This indicates that at the time of the testing the column remnants from Levels 1 to 6 had mean concrete strength consistent with that of concrete with specified 28-day strength of 20 MPa (Figure 51 and Figure 52). This is less than the minimum specified concrete 28-day strength of 35 MPa for columns at Level 1; 30 MPa for columns at Level 2; and 25 MPa for columns from Level 3 to Level 6.

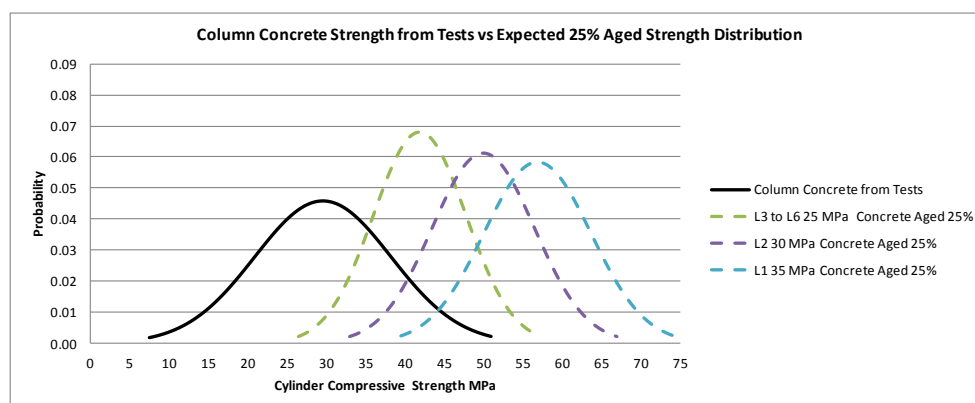
Figure 52 Column test strengths adjusted 8% for test orientation vs 28-day concrete strength distribution according to NZS 3014:1983 strength-aged by 25%

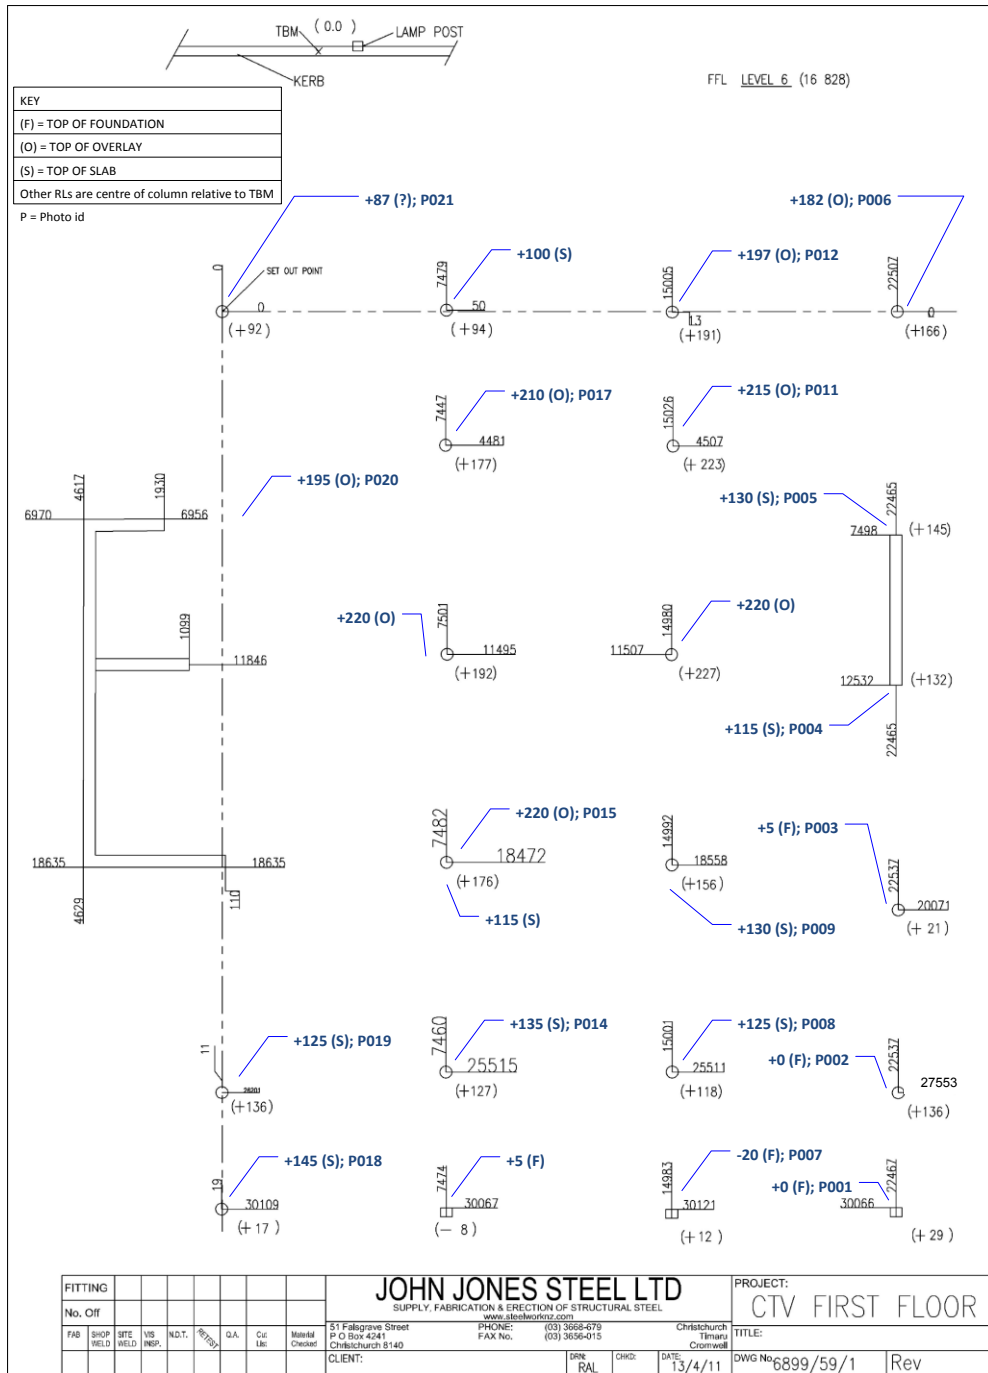
Shots were initially taken on 14 April, 2010 to the approximate centres of the demolished remains of the concrete columns (Figure 58).

Figure 58 - JJS Dwg 1: Locations and levels at centres of demolished columns, annotated with levels on adjacent concrete identified as 100mm overlay (O), 125mm slab (S) or foundation beam (F). Photo locations are designated P####.

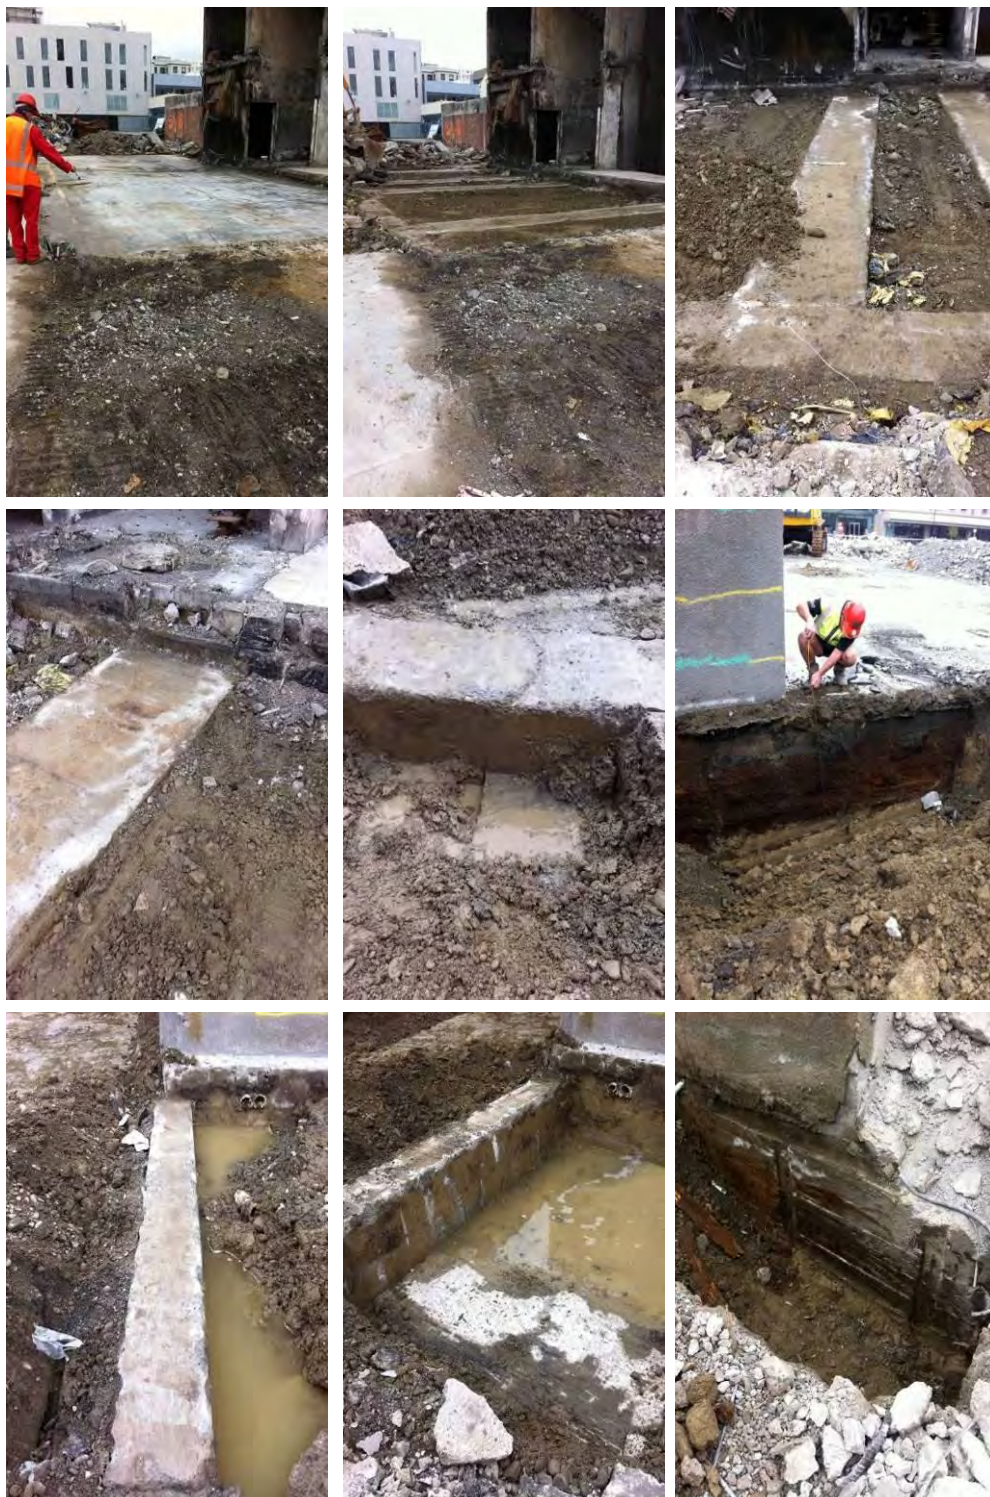
- P964 NW corner finger beam top surface. No damage evident. Chips are from excavator bucket.
- P919 Excavated south side of the finger beam showing the base slab. Water entered from a broken pipe in the side of the tower foundation. The base slab is about 650 below top of the beam.

- P993 North side of the excavation at the northwest corner showing side of the finger beam shown in P903 after demolition of the core. The rotted boxing timber in P903 on the side of the footing has been removed.

Figure 60 - Foundation Inspection (From left to right in rows from top) (a) P947; (b) P948; (c) P968; (d) P971; (e) P960; (f) P903; (g) P964; (h) P919; (i) P993

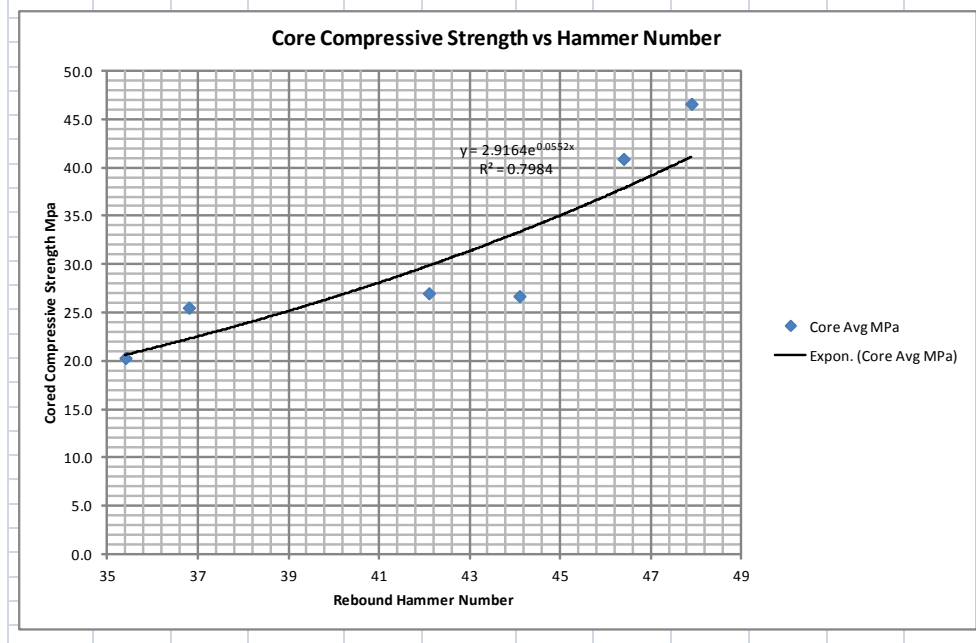
Figure 61 - Core strength to rebound hammer tests correlation curve.

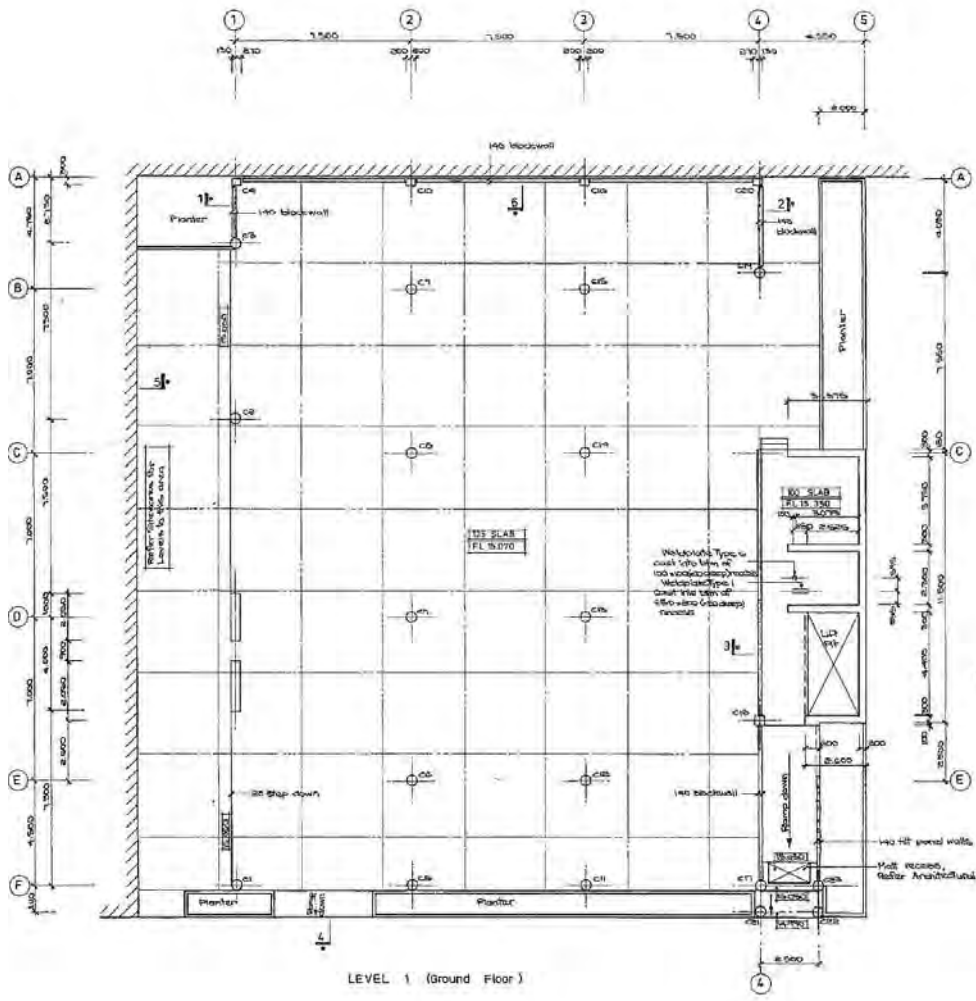
Figure 64 - Level 1 ground floor slab layout (extract DENG Dwg S9)

The average RL of top of slab, which was cast directly on the top surface of the foundation beams was +120 mm with sample standard deviation of 12 mm from 12 shots. The nominal thickness of the slab specified was 125 mm cast to Finished Floor Level of 15.070 m (DENG Dwg S9 (Figure 64)). The average slab thickness calculated from the difference in the average RL of the slab and the foundation beams was 117 mm.

Average compressive strength from the six cores tested (n=6) for the Level 1 square column C18 (DENG Dwg S9 (Figure 64) and S14 (Figure 68 and Figure 69)) was

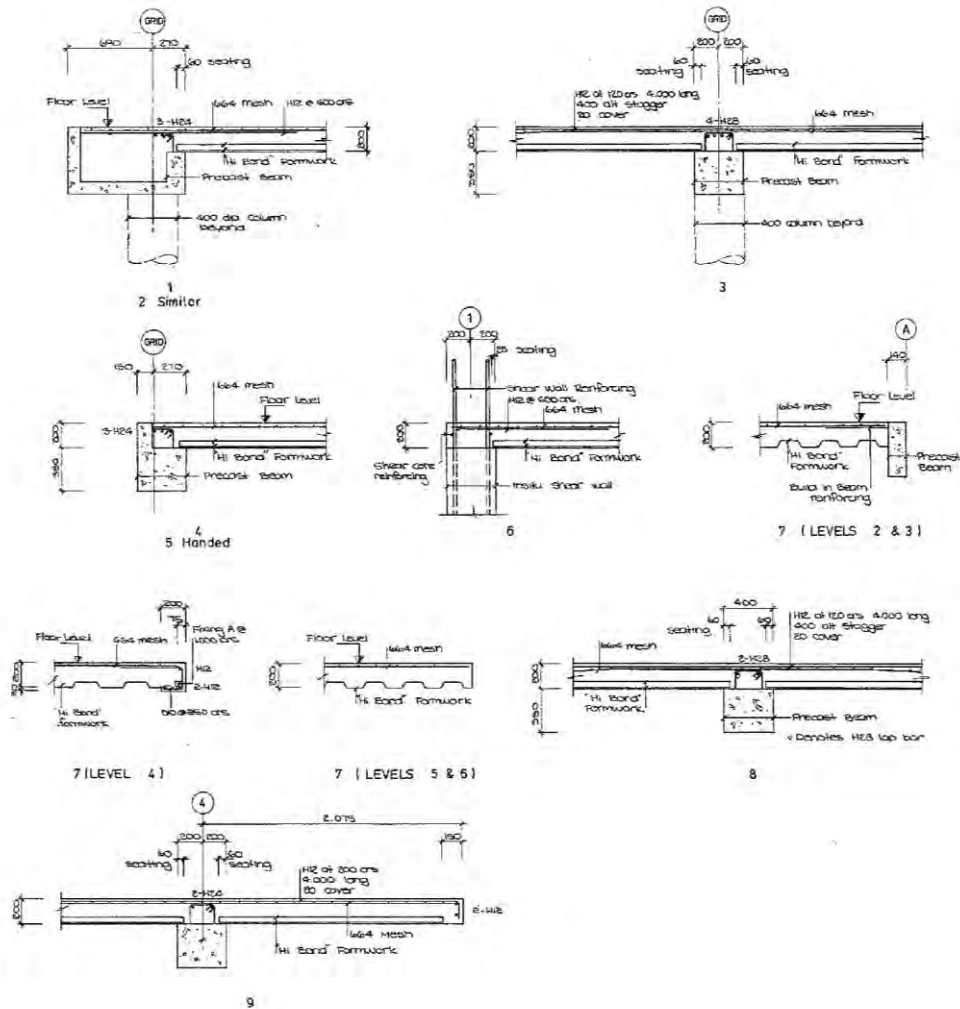
Figure 66 - Level 2 to 6 floor slab details (Extract from DENG Dwg S15)

Figure 11 - Interior Pre-cast Log Beam from Line 2 and 3 (DENG Section 3 Dwg S15 (Figure 66)) (left to right) (a) Diagonal shear damage at end and smooth formed surface at beam-column joint; (b) Mid-portion of beam concrete has broken away and stirrups are pulled apart.
