CTV BUILDING

CTV BUILDING SITE EXAMINATION
AND MATERIALS TESTS
FOR DEPARTMENT OF BUILDING AND HOUSING
16TH JANUARY 2012

DR CLARK HYLAND

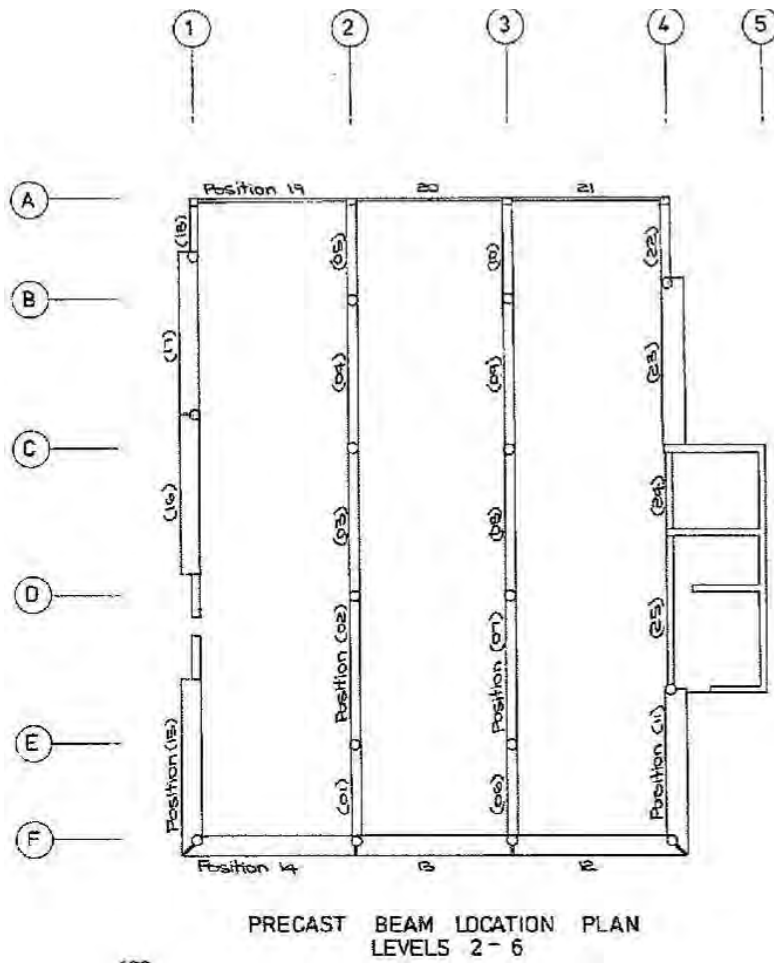
Figure 67 - Precast beam layout drawings (Extract DENG Dwg S18)

Figure 29 - Line 4 North Core Walls Level 4 slab remnants (top to bottom) (a) Connection of shell beam to wall with two fractured H24 top bars and two de-bonded top bars. No bottom bars from shell beam embedded in wall but imprints from bars evident (DENG B23 Dwg S18 (Figure 67), Detail 5 S19 (Figure 71)), corresponding to the bent back bottom steel in shell beam Item E23 (Figure 8); (b) Fractured vertical face of slab at stairwell wall, with fractured slab support beam (DENG B25 Dwg S18 (Figure 67)) top bar and charred fracture surface; (c) Torn profiled metal deck sheeting de-bonded from slab but still fixed in at pre-cast beam support.

Figure 30 - Line 4 North Core Walls Level 3 slab remnants (clockwise from top left) (a) Connection of shell beam to wall with two fractured H24 top bars and two de-bonded top bars. No bottom bars from shell beam embedded in wall but imprints from bars evident (DENG B23 Dwg S18 (Figure 67), Detail 5 S19 (Figure 71)), corresponding to the bent back bottom steel in shell beam Item E23 (Figure 8); (b) Ash on slab; Cored holes at fractured edge; (c) Torn profiled metal deck sheeting de-bonded from slab but still fixed in at pre-cast beam support (DENG B24 Dwg S18 (Figure 67)); (d) Profiled metal deck and slab from below supported on beam B24.

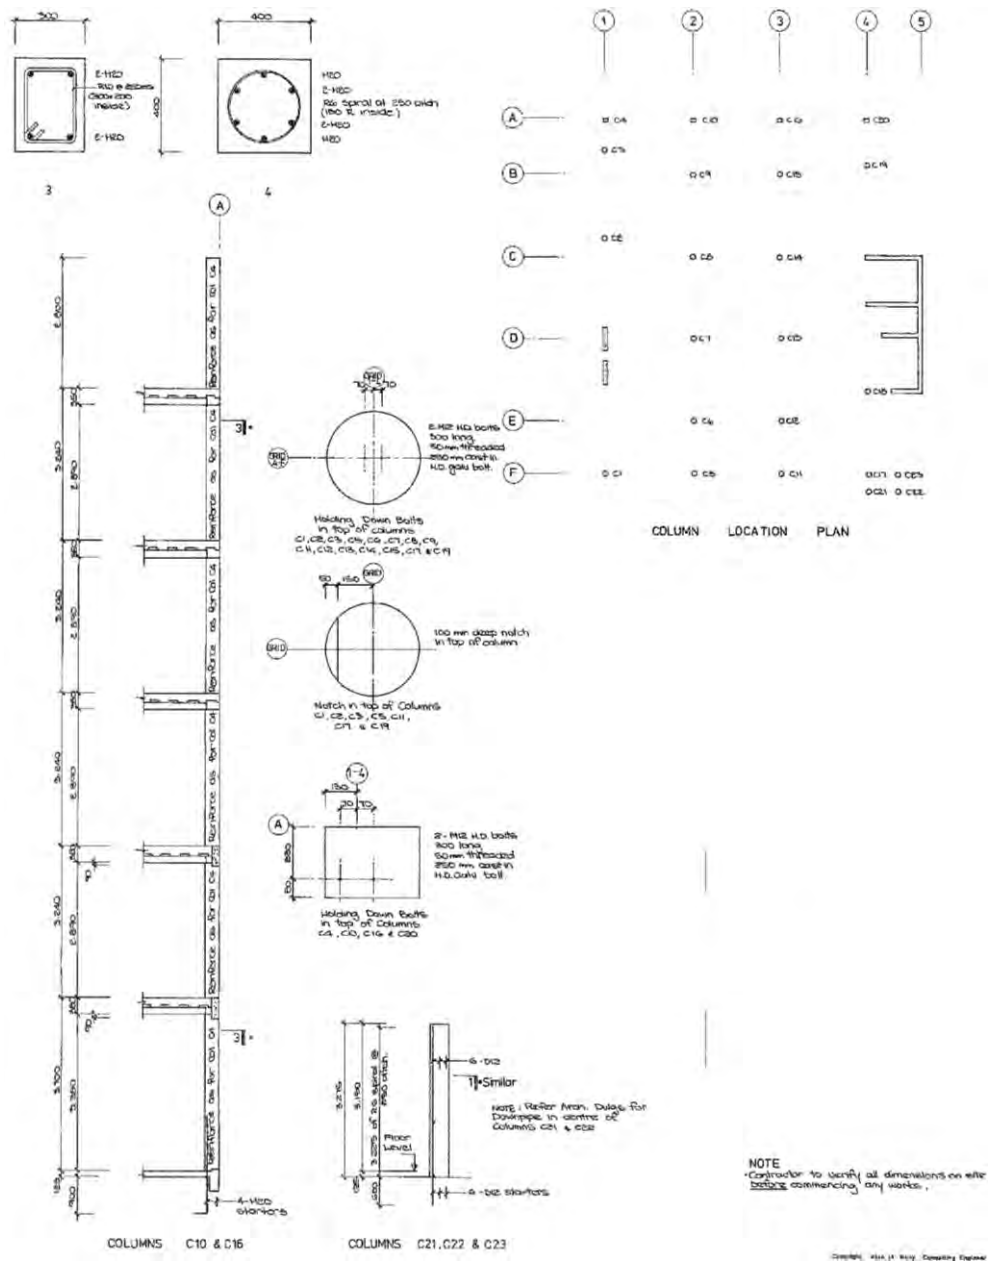
Figure 68 - Columns (Extract DENG Dwg SI4)

Average compressive strength from the six cores tested (n=6) for the Level 1 square column C18 (DENG Dwg S9 (Figure 64) and S14 (Figure 68 and Figure 69)) was

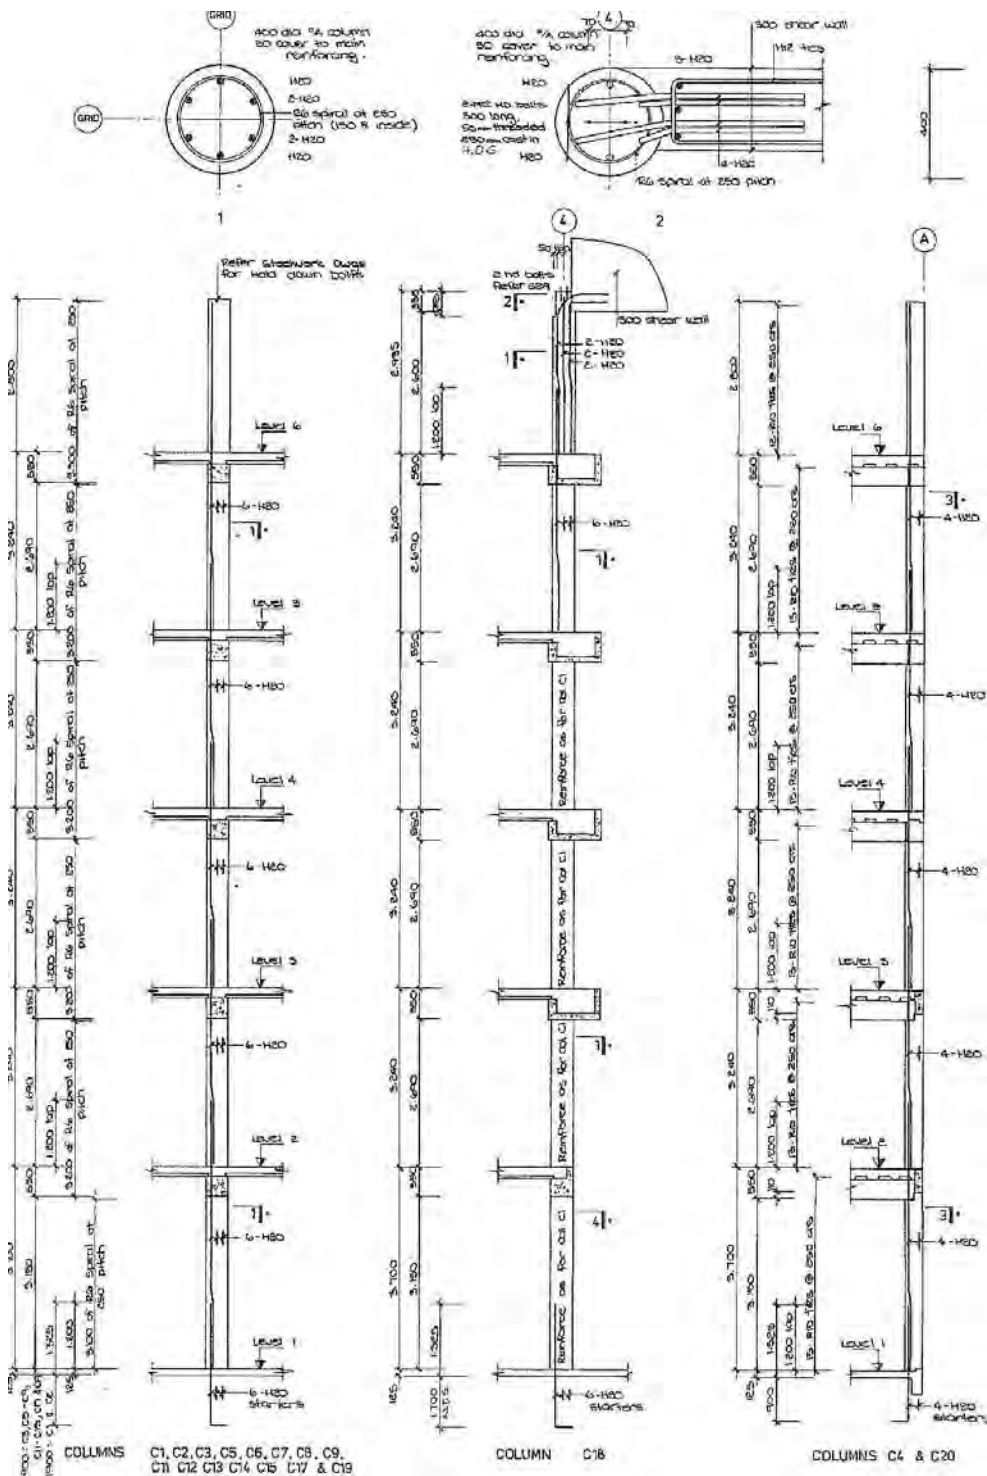
Figure 69 - Columns (Extract DENG Dwg S14)

Figure 41 - Lift Well Wing Wall D/E: Column D/E 4 Connection (DENG Dwg S14 (Figure 69); 3 x 20 to 24 mm diameter holes could be seen where reinforcing bars from the column had pulled out. The drawing shows that 4-H20 bars were required to be bent into the wall.

Circular column remnants test Items tC7, tC8, tC9, tC11, tC12 and tC13 had flexural hinging zones at their bases around the lapping bars and hinging failure similar to that seen in Item 33 which was a perimeter column (Figure 53) and Figure 10). In that case spear head style fracture commenced approximately 1350 mm above the base and terminated at around 1600 mm. This may have coincided with the end of the column lap bars, which were specified to be 1200mm long (DENG Dwg S14 Figure 69).

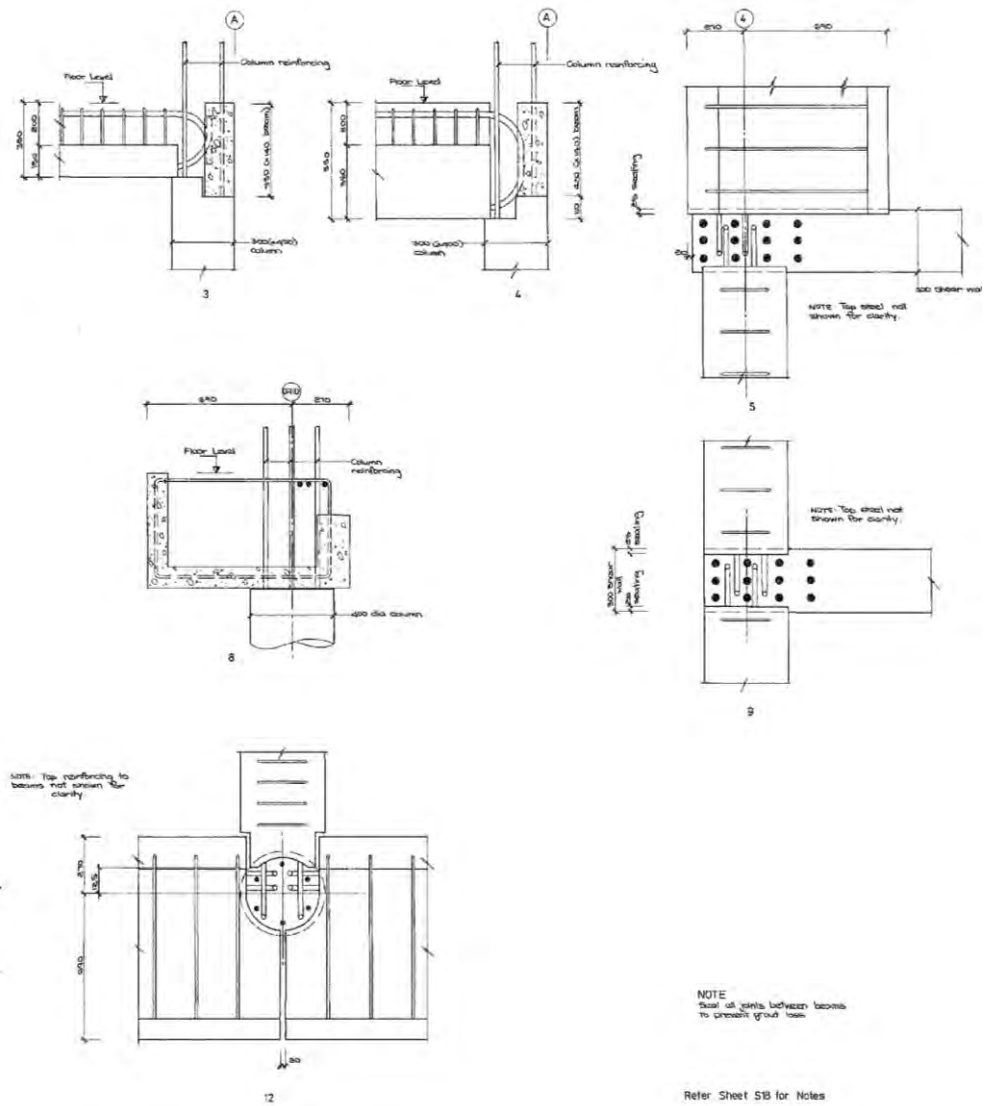
Figure 71 - Beam-Column Joints (Extract DENG Dwg S19)

Figure 31 - Line 4 North Core Walls Level 2 slab remnants (clockwise from top left) (a) Slab edge broken back during de-construction adjacent to stairwell wall; (b) Broken back slab with H12 saddle bars exposed. Masonry wall with separation along top course; (c) Switch room under Level 2 slab; (d) Connection of shell beam to wall with two fractured H24 top bars and one de-bonded top bars. Bottom bars from shell beam have been embedded in wall as specified (DENG B23 Dwg S18 (Figure 67), Detail 5 S19 (Figure 71)). Some diagonal beam-wall joint zone shear cracking can be seen in the wall end..

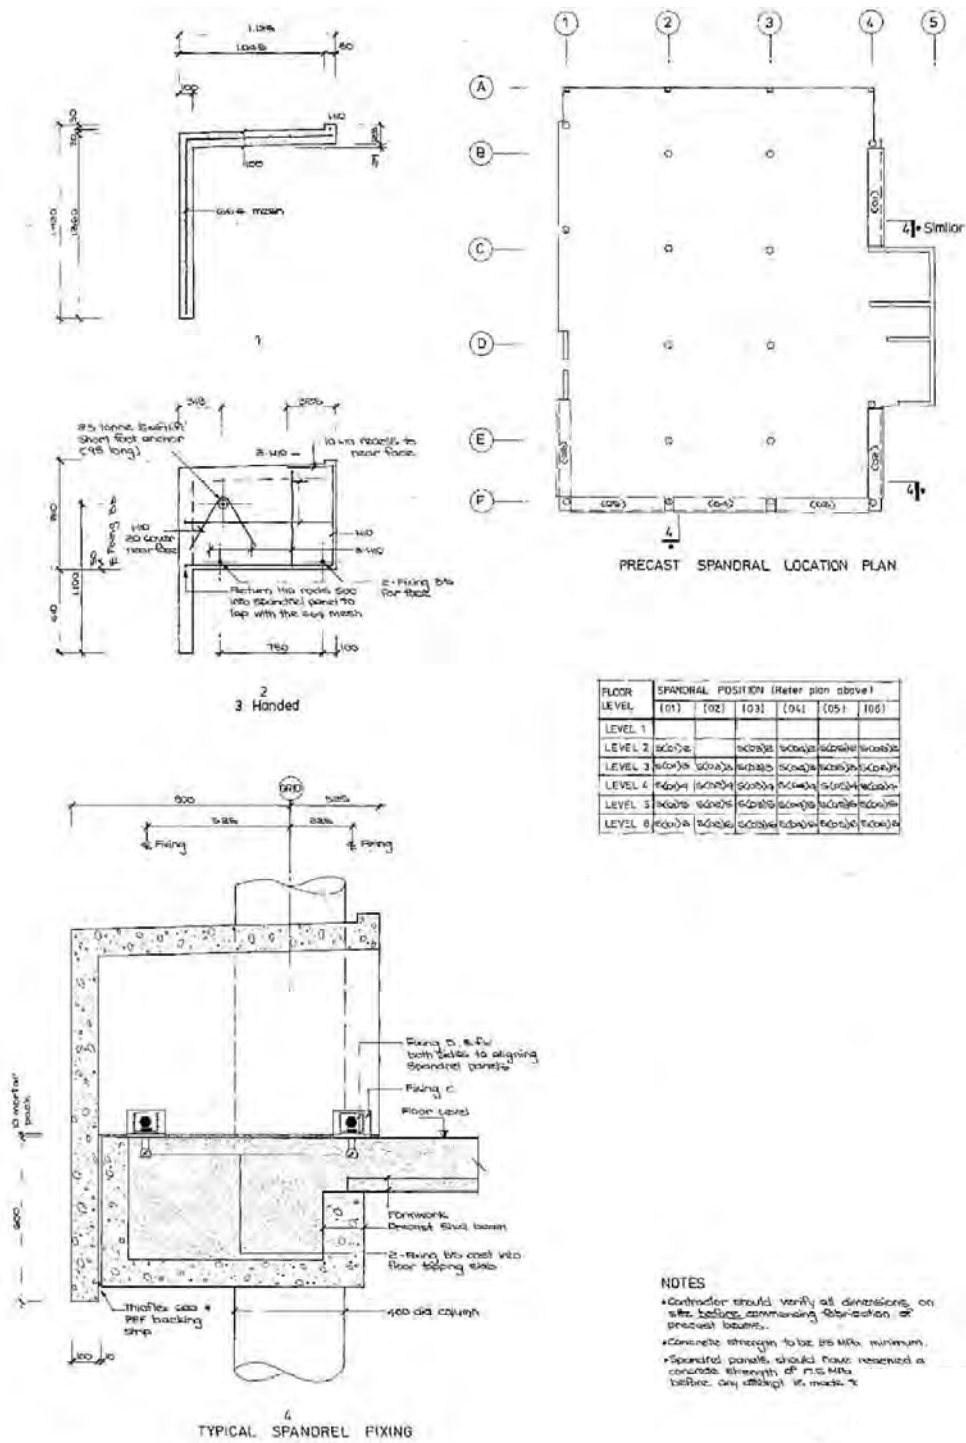
Figure 72 - Pre-cast spandrel panels (Extract from DENG Drawing S25)

The pre-cast spandrel panels may have had some influence on the mid-height failures by inducing short column effects (Figure 5 and Figure 72). The 400 mm diameter columns that suffered the mid-height failures may therefore have been from Grids I, 4 and F like Item 33.
