CTV BUILDING

CTV BUILDING COLLAPSE INVESTIGATION
FOR DEPARTMENT OF BUILDING AND HOUSING
25TH JANUARY 2012

Part 3 of 3

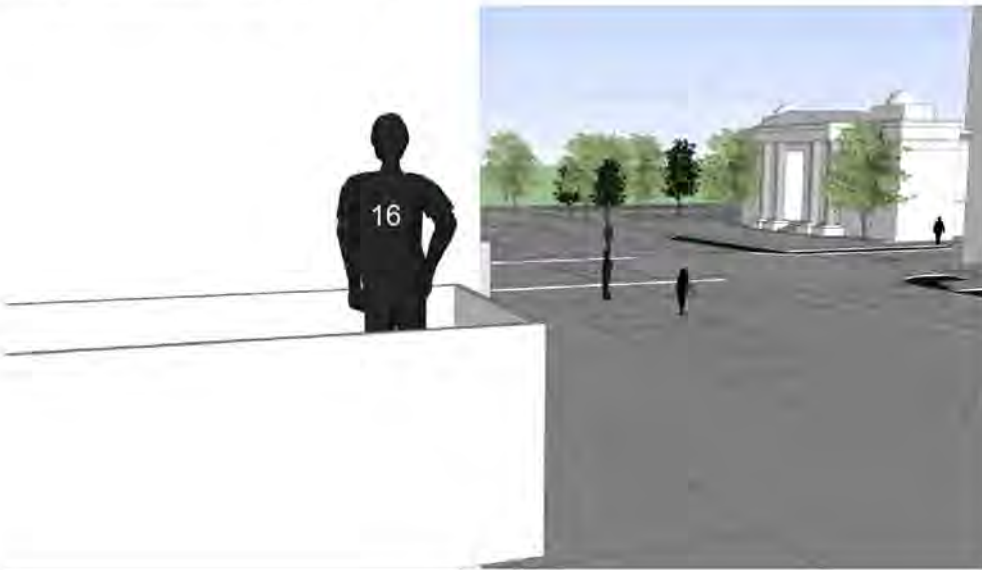
Figure 70 - Perspective of Eyewitness 16 from the elevated work platform at the southeast corner of the CTV Building.

He described seeing the column fracture. “It buckled out. It had cracked and the two bits held still by the steel had spat out, and obviously as the weight got too much, it broke and came down. This was in the middle of the column, between floors. It ‘kicked out’ in the direction of Les Mills. I remember I was still looking at the corner of the building at that time - it looked like the like the block in front of me came up and back down again. I turned away to the right to throw my workmate off the end of the machine, then I turned back to make sure nothing else was coming and that is when I saw the corner – sticking out around 300mm. It let go – and came down when I was jumping out.”

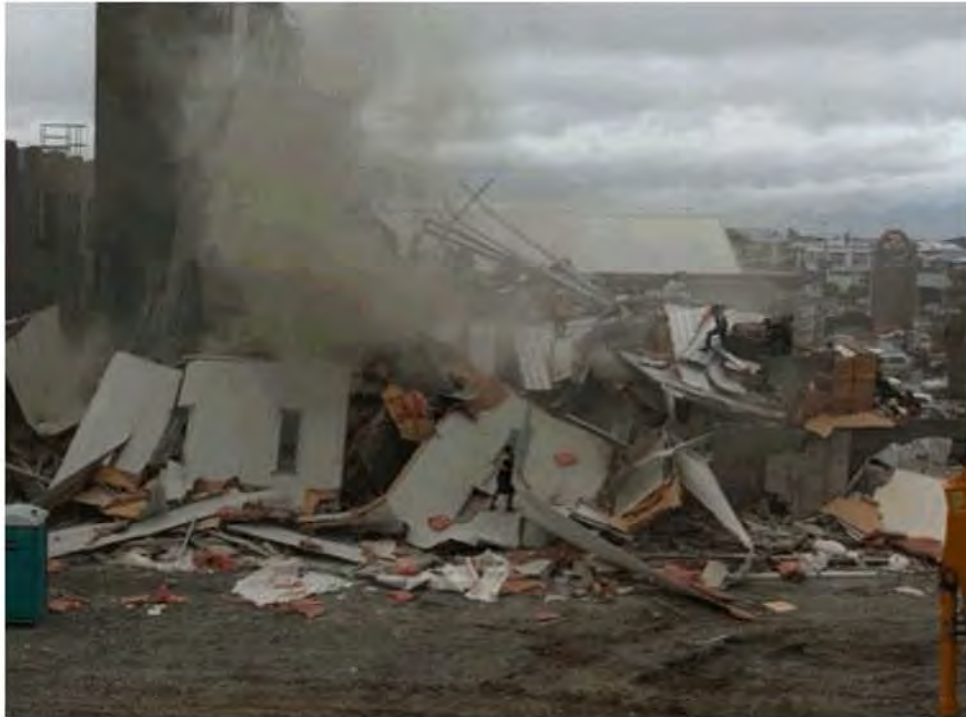
Figure 71 - West side of building with North Core partially obscured by smoke, prior to heavy machinery removing debris. No liquefaction evident.

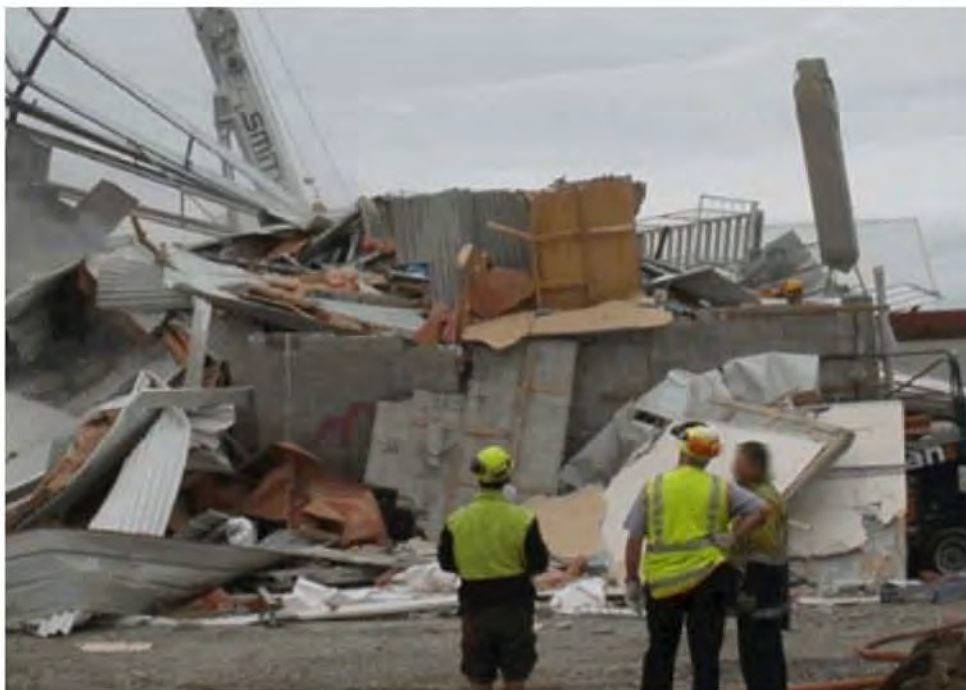
Figure 72 - Southwest corner (Grid A/1) with corner column still standing. Collapsed work platform under wall panels can be seen at the right on which Eyewitness 16 was working.

Severe diagonal fracture of what appears to be Level 2 wall panels was observed in photos of the debris immediately after the collapse (Figure 72).

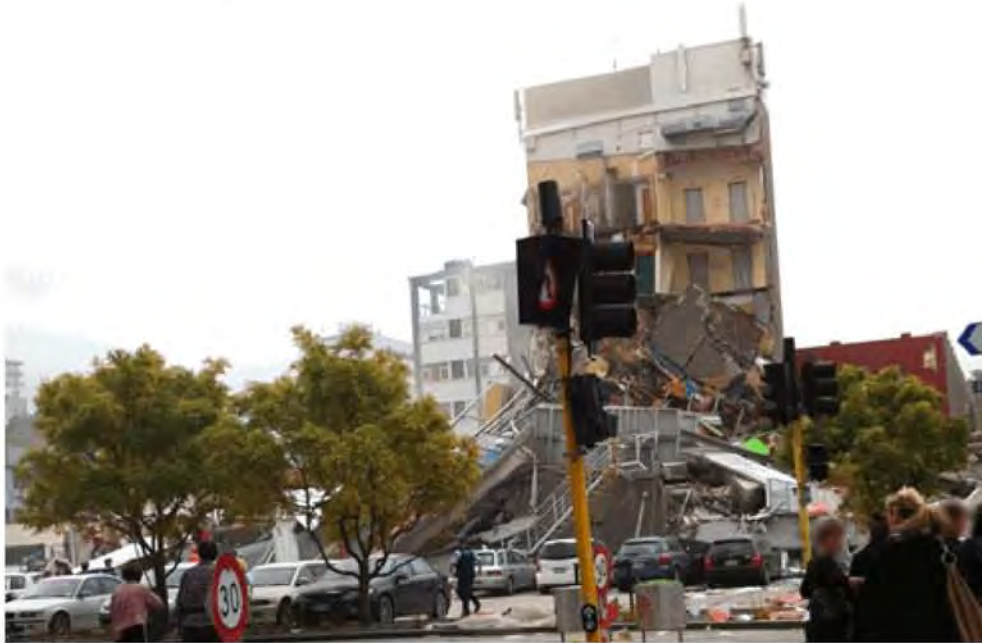
Figure 73 - Cashel St. face with North Core tower in background prior to fire starting.

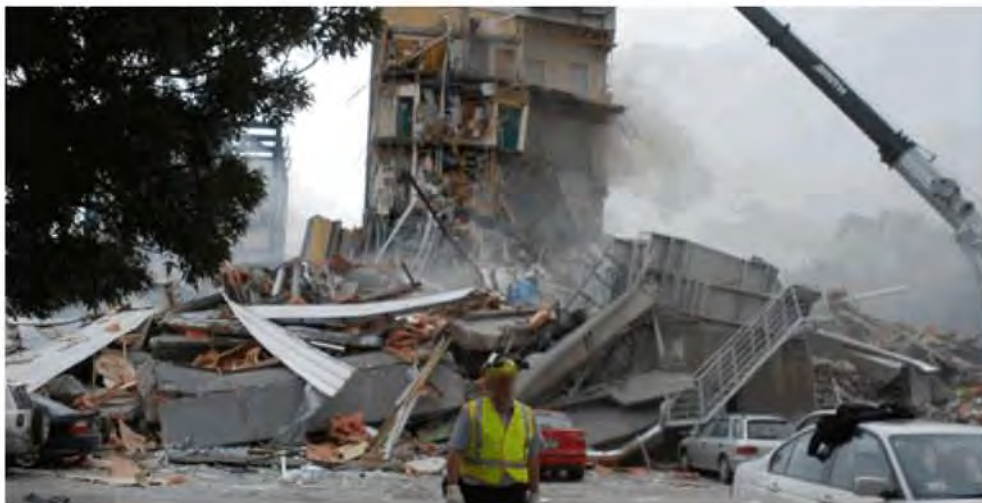
Figure 74 - Western end of south face (Line 1). Collapsed Line shear wall with escape stair to the right.

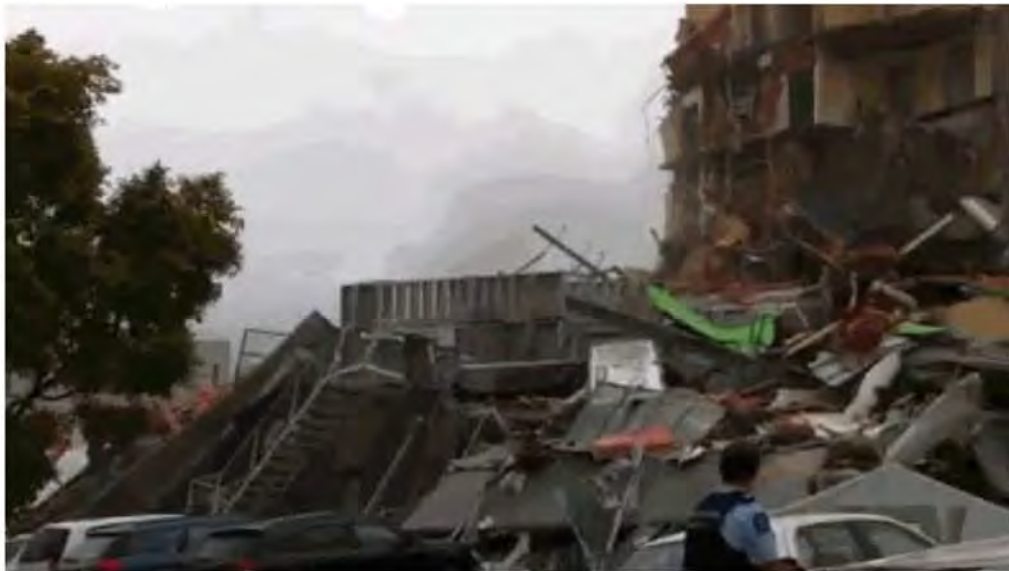
Figure 75 – View southeast corner of the CTV Building looking northwest. The South Wall collapsed onto the top of the debris from Level 2 can be seen, identifiable by the white fire escape stair still attached to it.

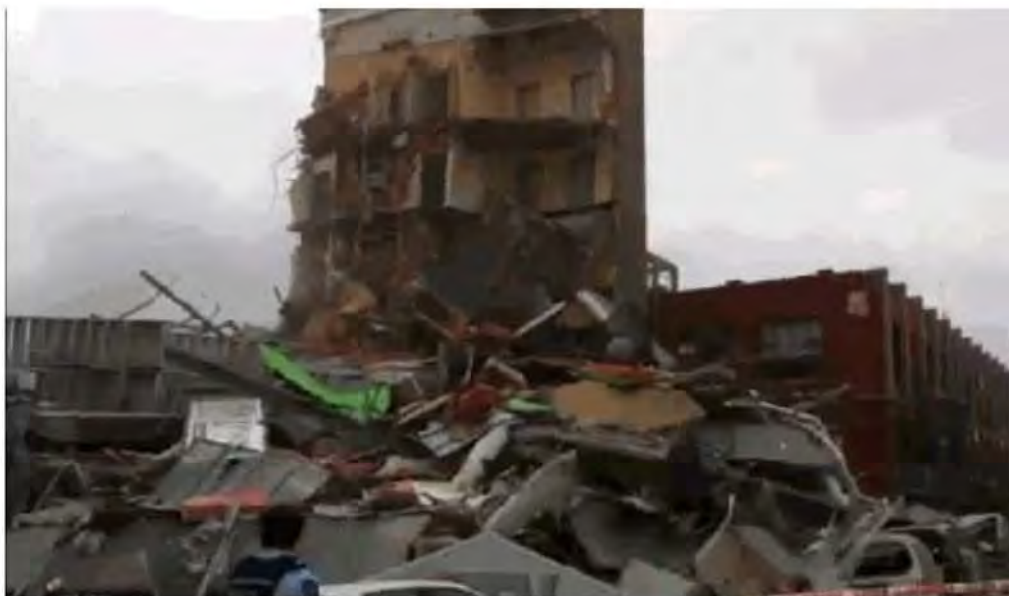
Figure 76 Madras St with precast Spandrel Panels fallen onto cars.

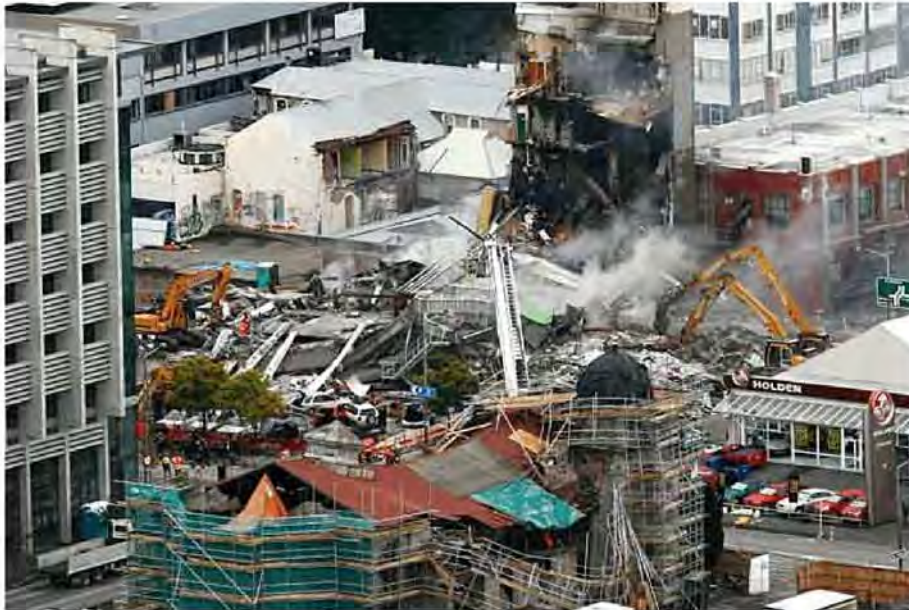
Figure 80 - Aerial view from southeast with debris being removed by heavy machinery. Fire has blackened the North Core. The Samoan church is damaged in the foreground (Dominion Post).

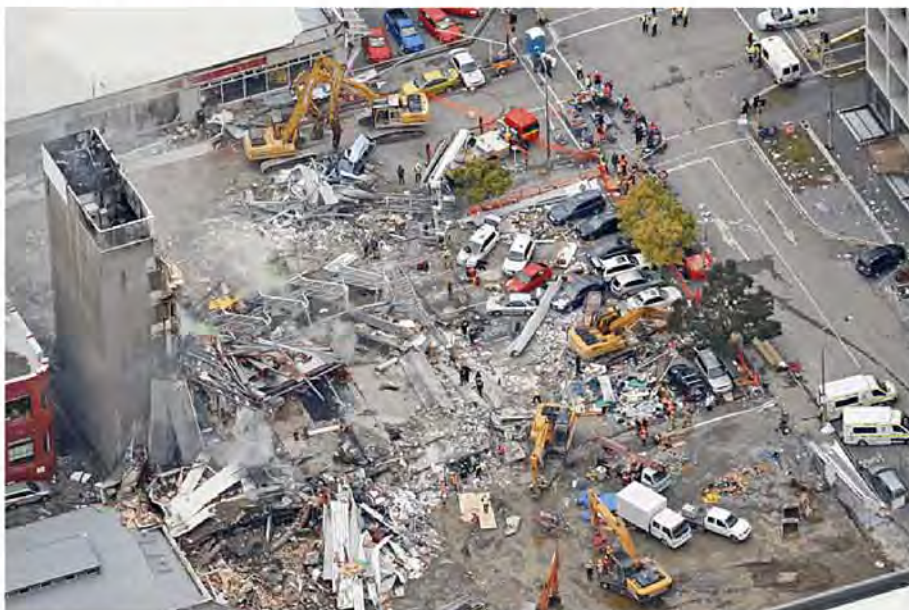
Figure 81 - Aerial view from northwest with heavy machinery removing debris. Water puddles on the vacant site may be due to fire fighting based on comparison with Figure 71 which showed no surface water immediately after the collapse (NZ Herald).

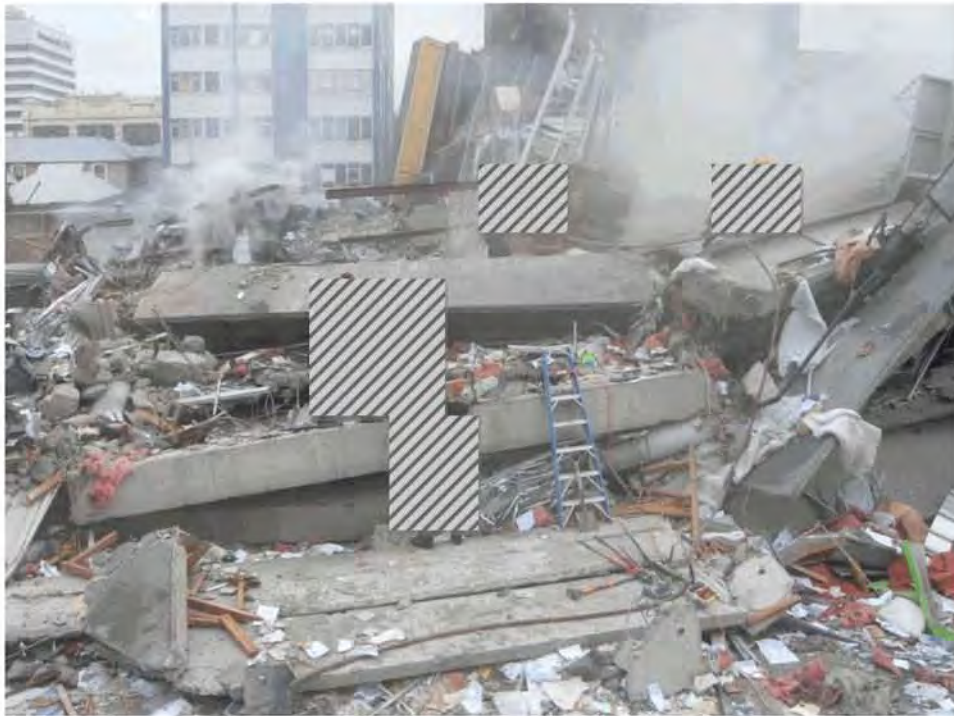
Figure 83 - Concrete Spandrel Panels, perimeter beams and columns on Cashel Street face (Line 1 / B-D).

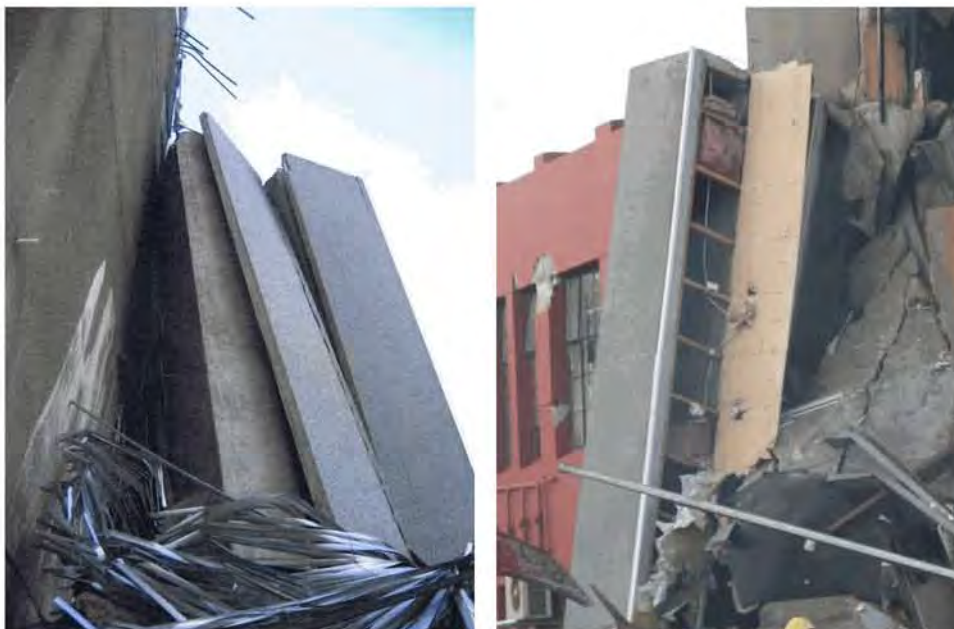
Figure 84 - Line 4 / B-C Spandrel Panels against tower wall, showing (left to right) a) View from north face; b) View from west showing timber framing for wall linings.

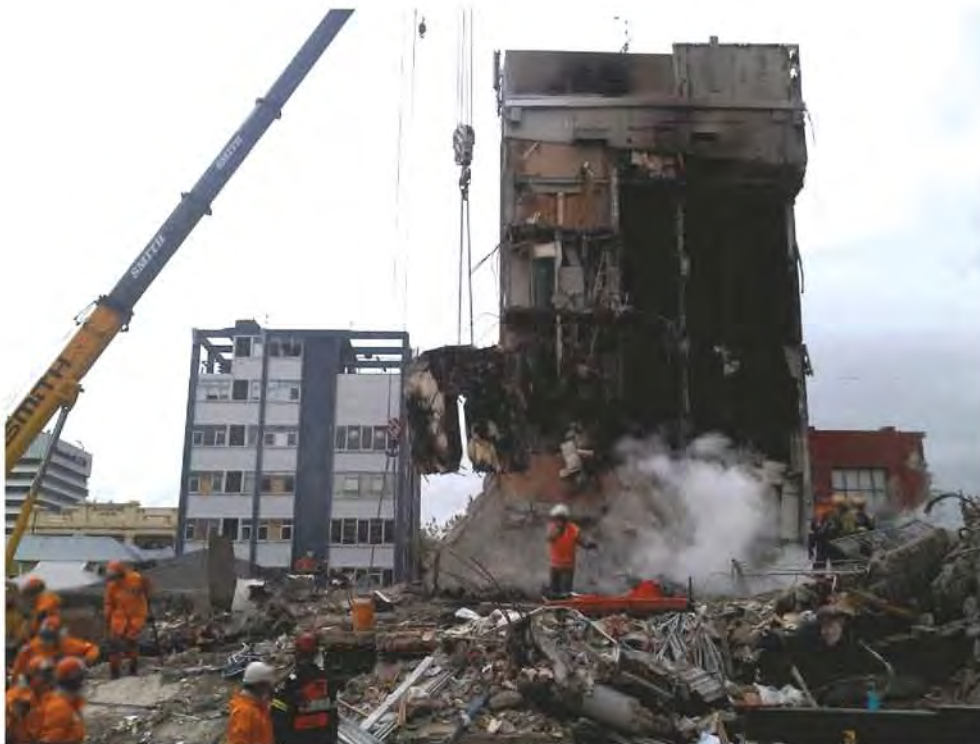
Figure 91 - Portion of Line 1 South Wall being lifted out by crane.. The Level 6 slab in front of North Core has been removed for safety reasons.

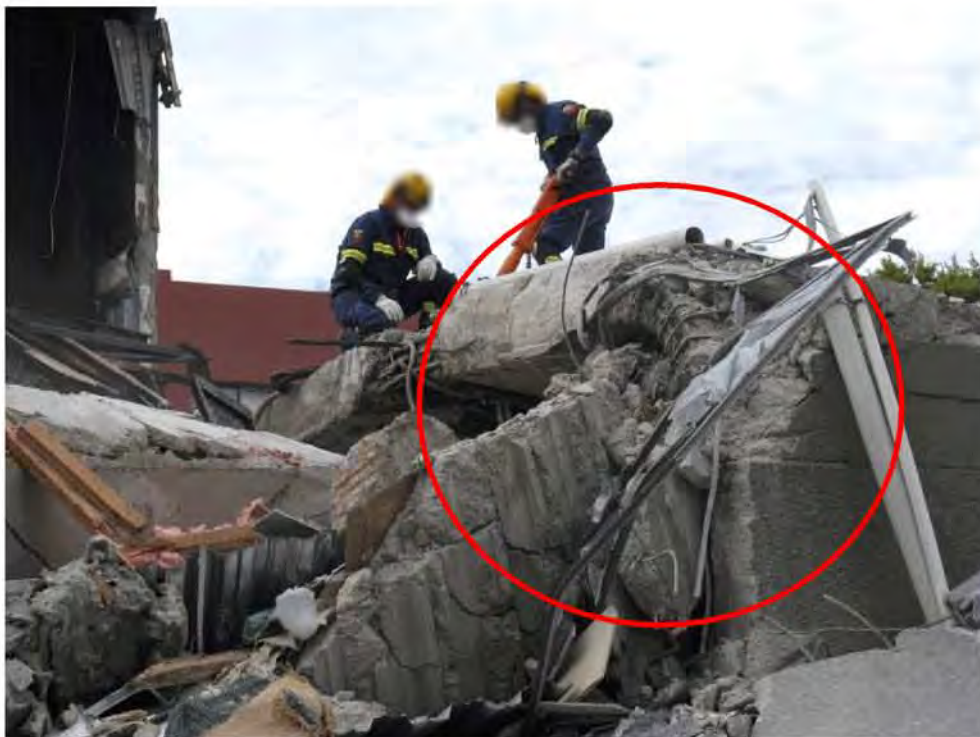
Figure 92 – Upper portion of South Wall being prepared for removal. A portion of slab can be seen highlighted in the foreground in contact with the South Wall on this side at Level 2. It may have forced the wall to pivot against it, preventing it breaking over at its base at Level 1.

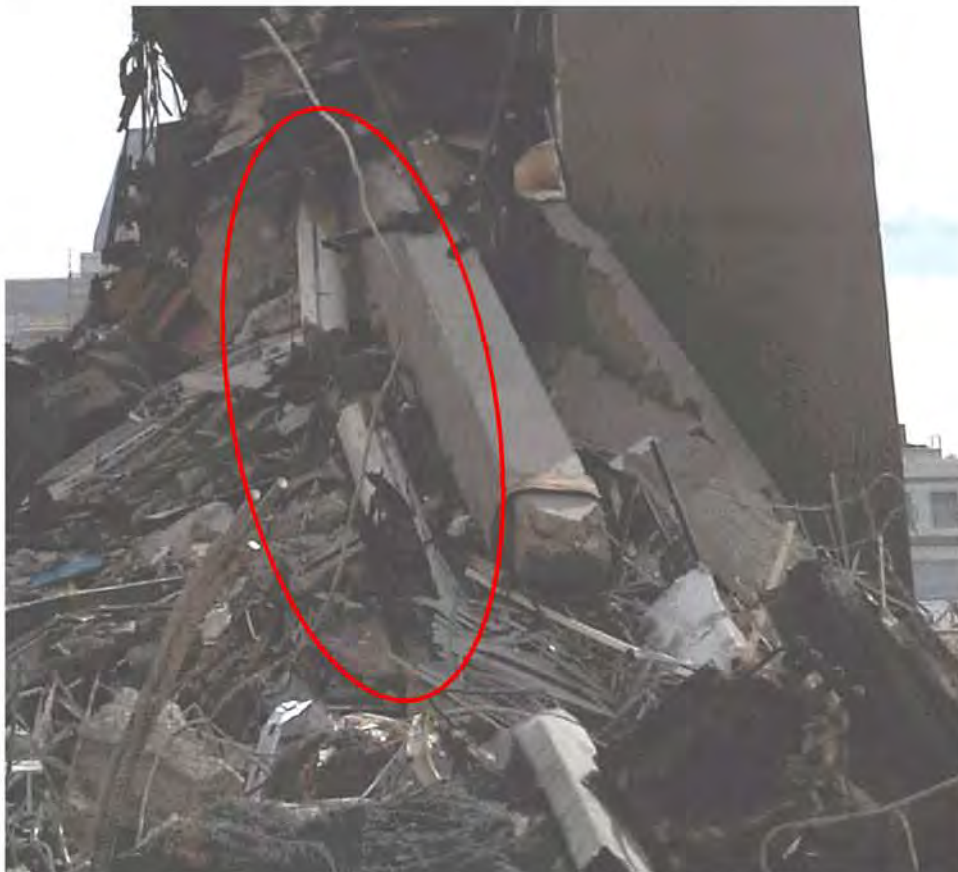
Figure 96 - North Core column 4 D/E highlighted amongst the debris. Hinging can be seen above and below the beam column joint.

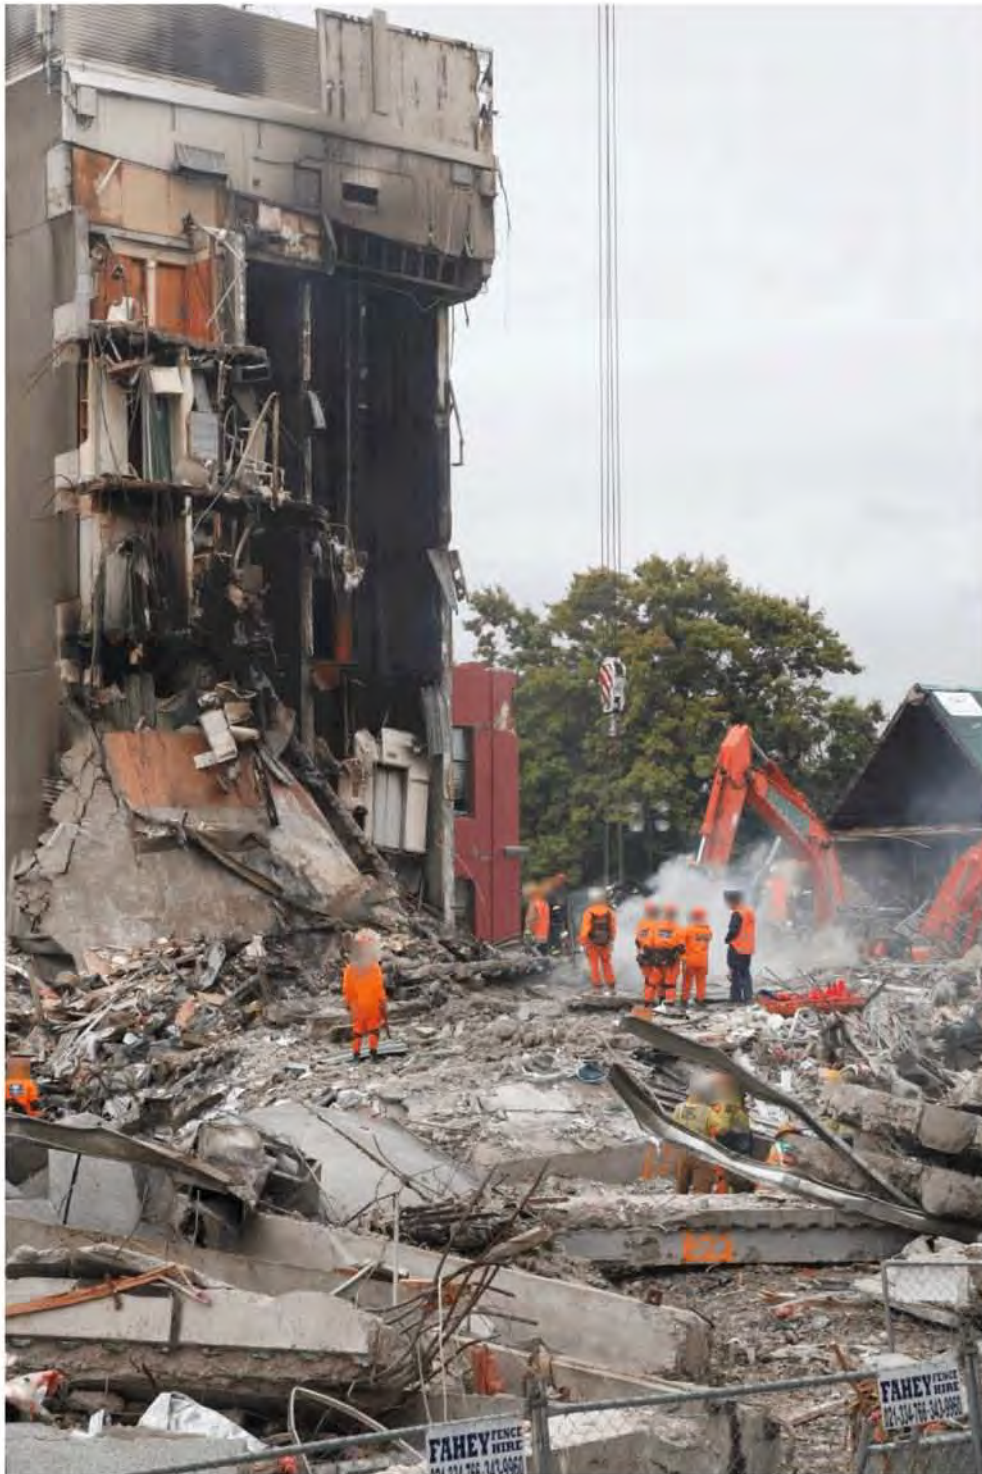
Figure 97 – View from southwest of North Core. The Level 4 slab can be seen lying diagonally against the North Core.

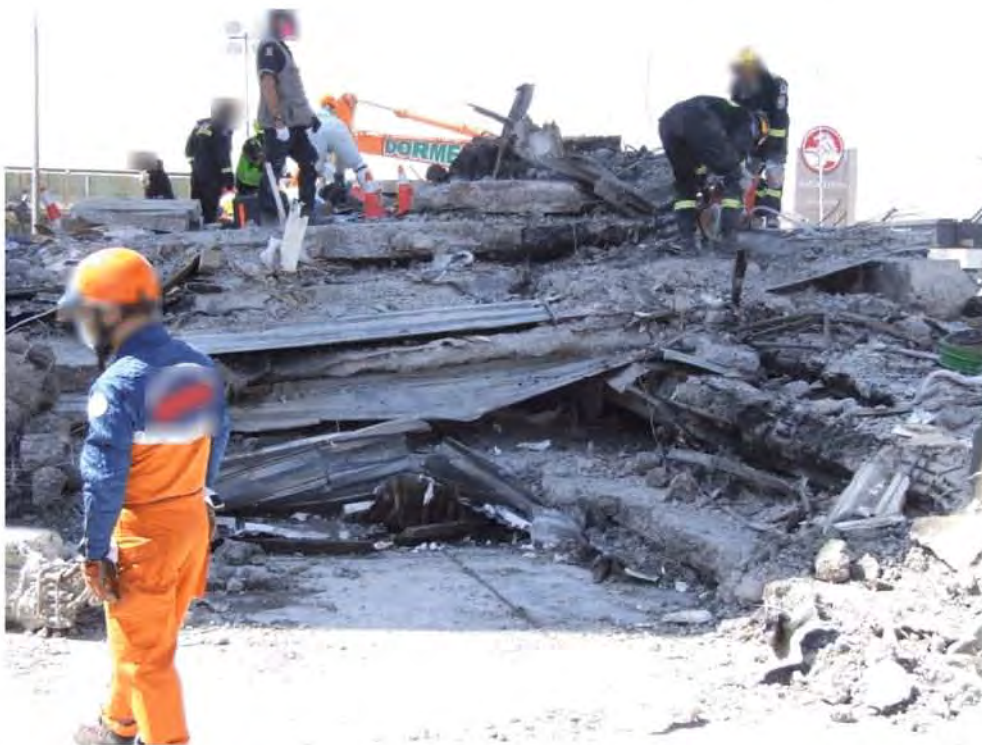
Figure 98 - Line 2 beams lying rotated northwards.

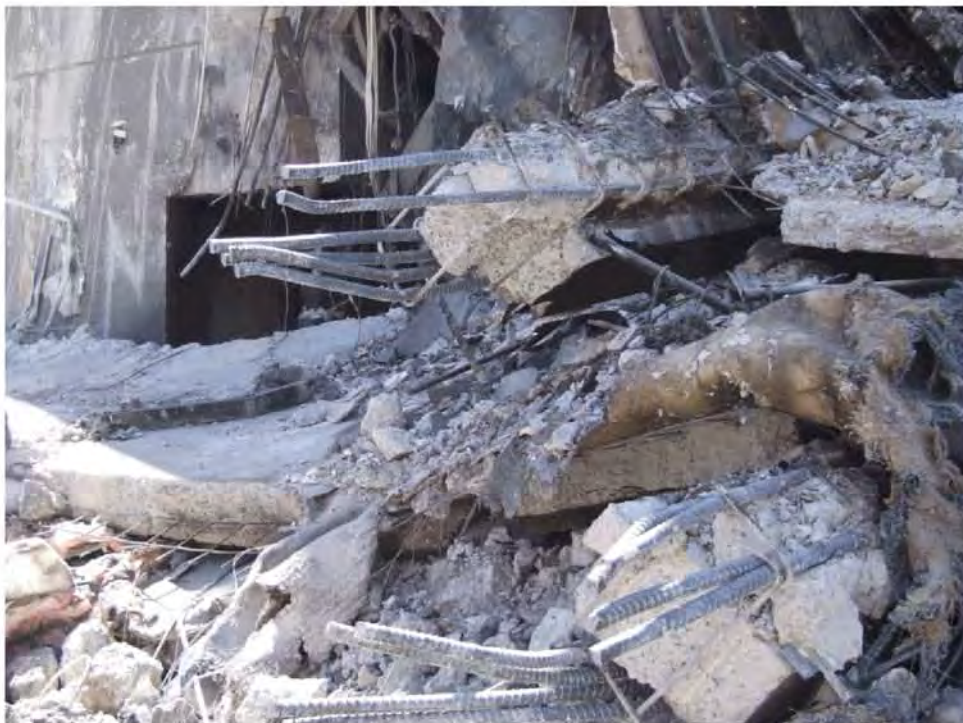
Figure 99 - Line 3 beams lying rotated southwards

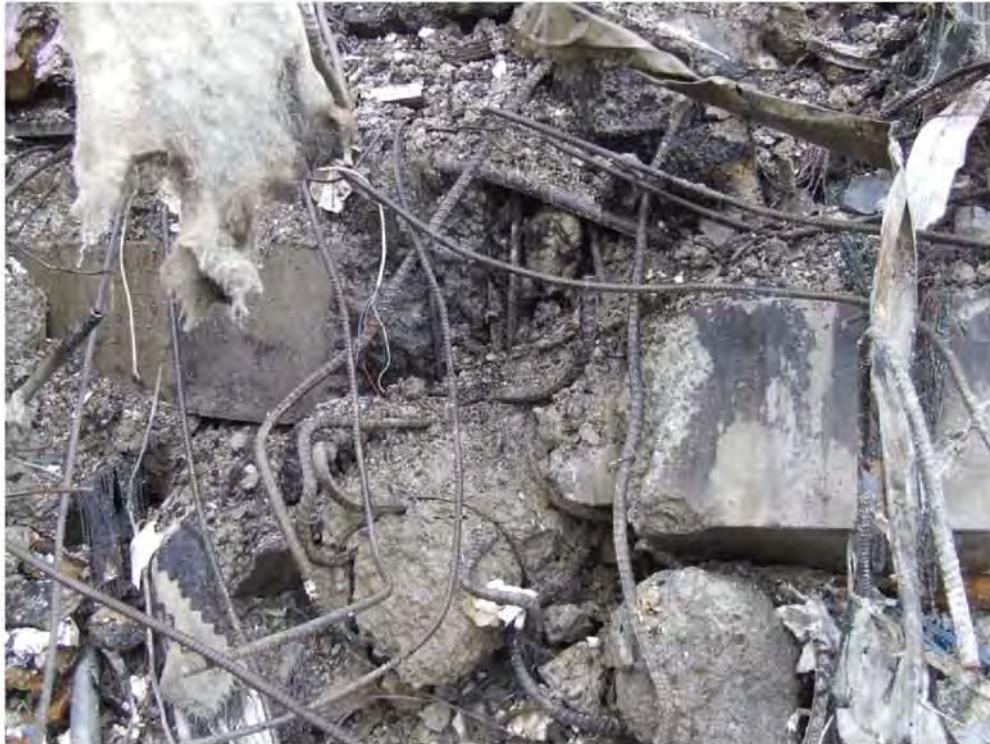
Figure 100 - Perimeter columns at beam-column joint with shell beam on right side.

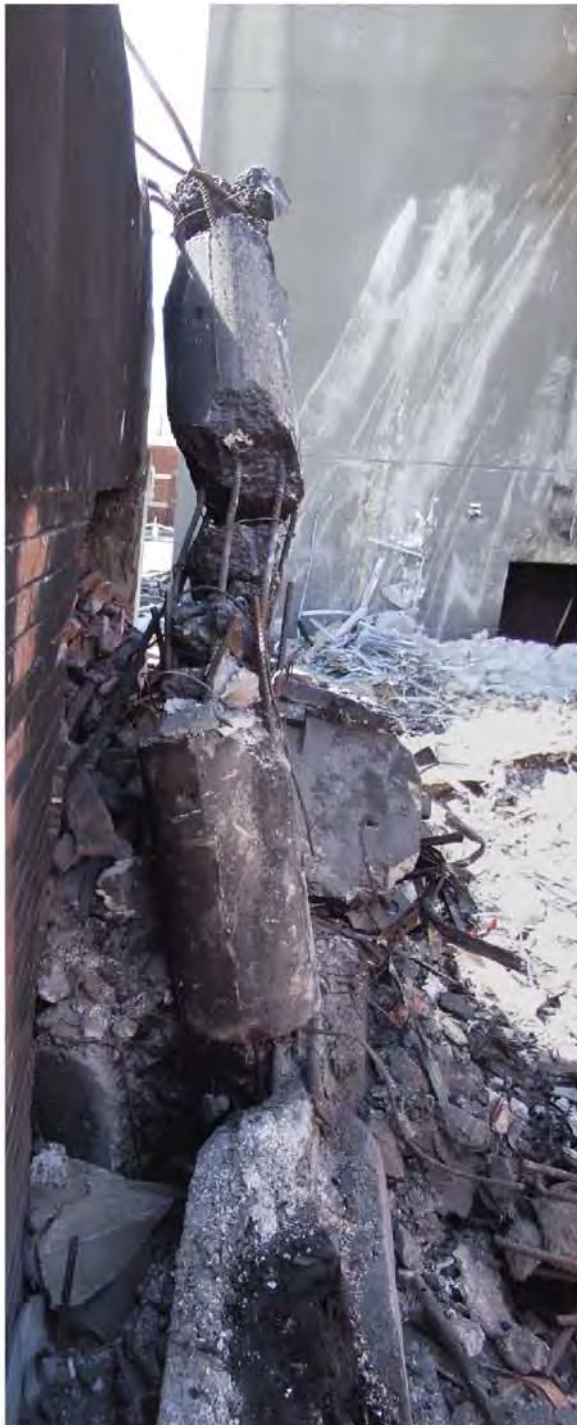
Figure 101 - Line 4 / B column with B22 precast log beam in foreground and B23 shell beam at rear. No hinging is apparent at the base of the column compared to the perimeter column Item E33.

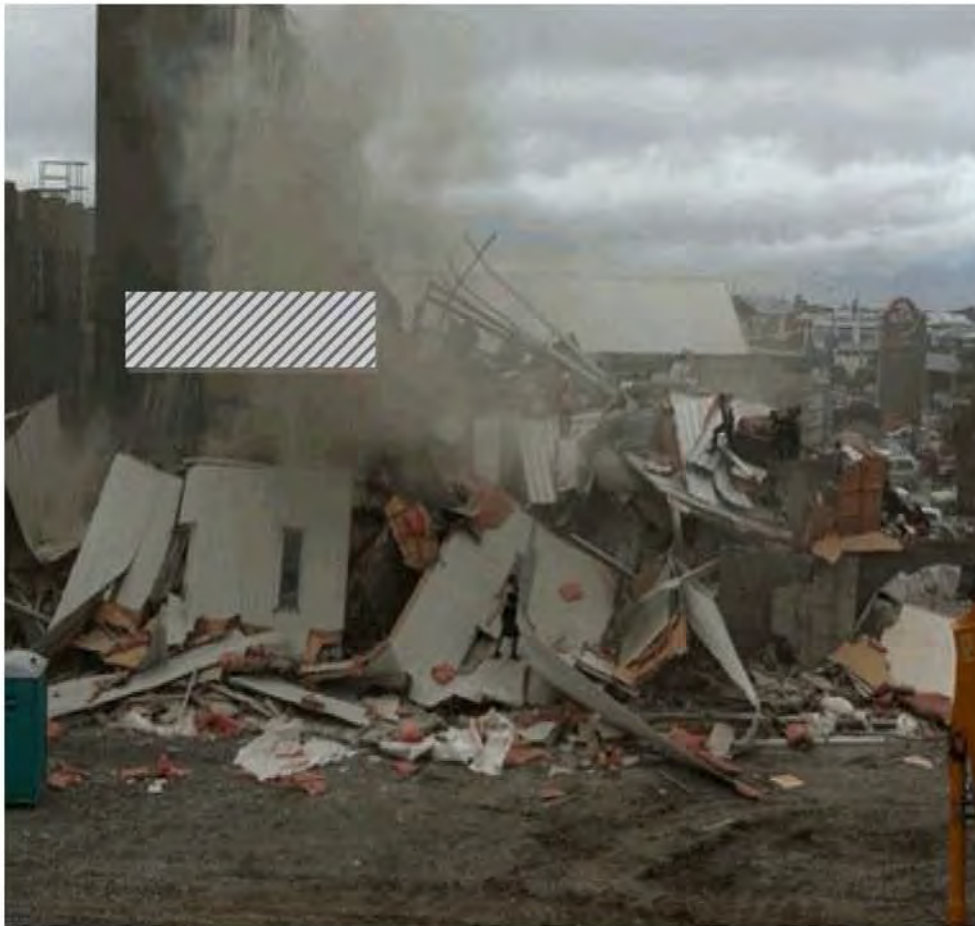
Figure 102 - North Core slabs remaining to be removed.

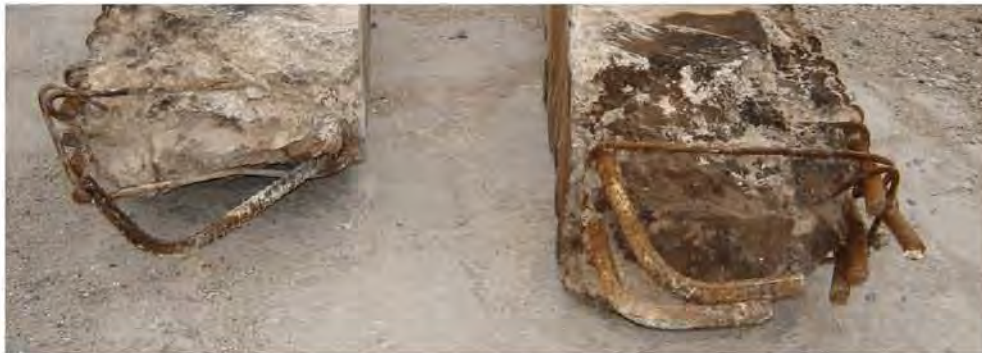
The ends of the pre-cast internal log beams that supported the 200 mm thick profiled metal deck slab, had smooth formed un-roughened ends at the interface with the beam-column joint zone. This would have reduced beam-column joint shear capacity weakening its ability to hold together during earthquakes (Figure 107).

Figure 107 - Interior Pre-cast Log Beams from Line 2 and 3 (DENG Section 3 Dwg S15) showing smooth concrete formed for beam-column joint, and bottom hooked bars that have pulled out of beam-column joints without any obvious straightening;

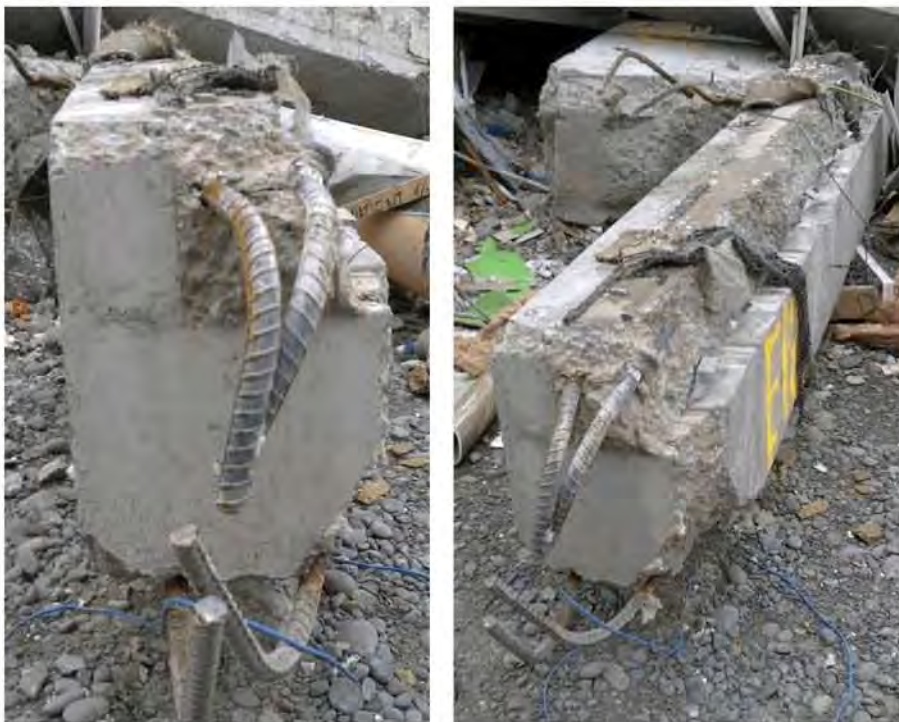
The ends of the pre-cast log beams supported by the corner columns on Grid A had a smooth un-roughened end where it connected into the columns. This would have reduced the beam-column joint shear capacity weakening its ability to hold together during earthquakes.

No starter bars connected the log beam into the 200 mm slab that was supported on the shell beams. This is not considered to be usual design practice (Figure 108).

Figure 108 - Item E18 Pre-cast edge beam north-west corner (DENG B22 Dwg S18 (from left to right) (a) Smooth form finish at attachment to column 4A (DENG Detail 1 Dwg S19); (b) No starters (reinforcing bars) from pre-cast beam into slab to prevent the profiled metal deck slab pulling away (DENG Section 4 Dwg S15). If roughened these joints may have slowed down development of progressive collapse.

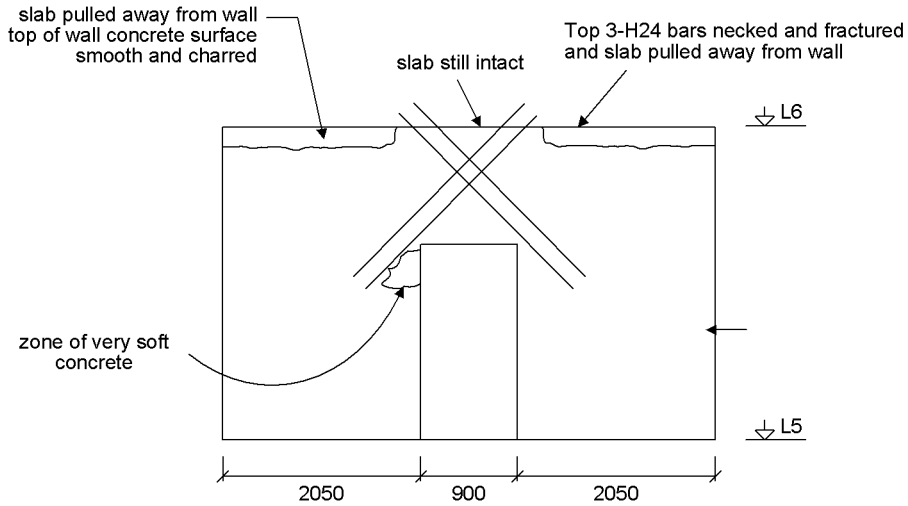
E5

Figure III - Line I South Wall remnants E4 Level 4 to 5 and E4 level 5 to 6.

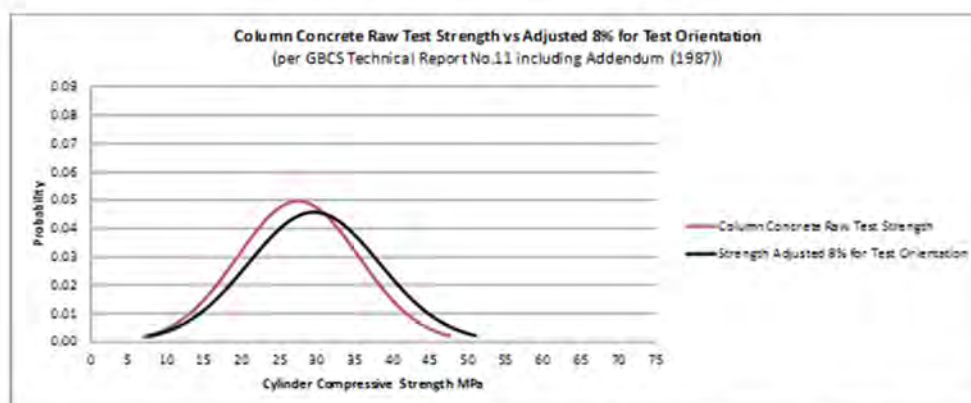
The sample means of the test results for a particular member were adjusted up by a factor of 8% where required, to allow for test orientation effects where testing had been done transverse to the direction of casting (Figure 117). This was in accordance with the recommendations of the Concrete Society Technical Report 11 (GBCS 1987).

Figure 117 - Column concrete test strengths compared to strengths adjusted 8% for test orientation being transverse to direction of concrete casting. This adjustment in test strength was recommended by the Concrete Society Technical Report 11 “Concrete Core Testing for Strength”.

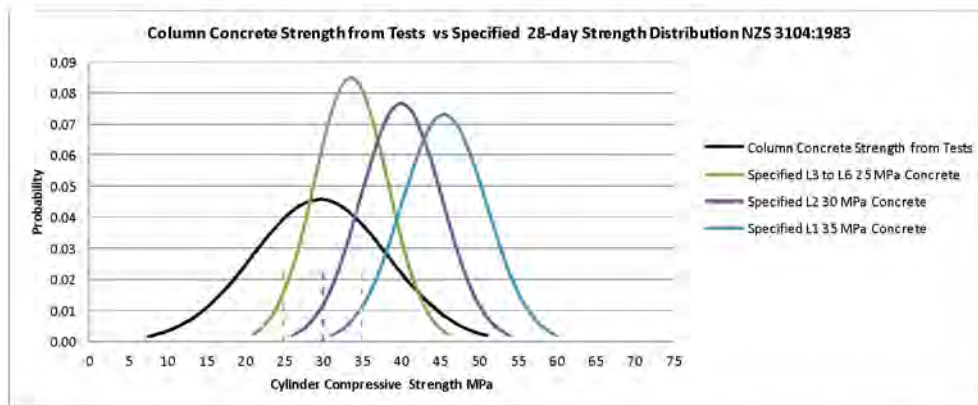
Figure 118 – Column concrete test strengths adjusted for test orientation vs 28-day concrete strength distribution according to NZS3104:1983. This indicates that the concrete in a significant proportion of the columns may have had strengths less than the minimum specified.

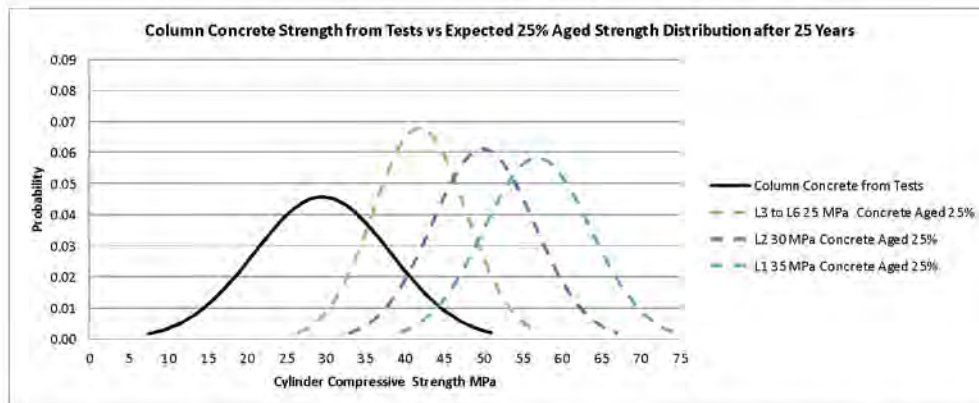
Figure 119 – Column concrete test strengths adjusted for test orientation vs 28-day concrete strength distribution according to NZS 3014:1983 strength-aged by 25%. This indicates that the concrete in the column remnants may have had a significantly lower strength distribution compared to the lowest concrete strength specified, when a 25% allowance is made for the strengthening of concrete with age.

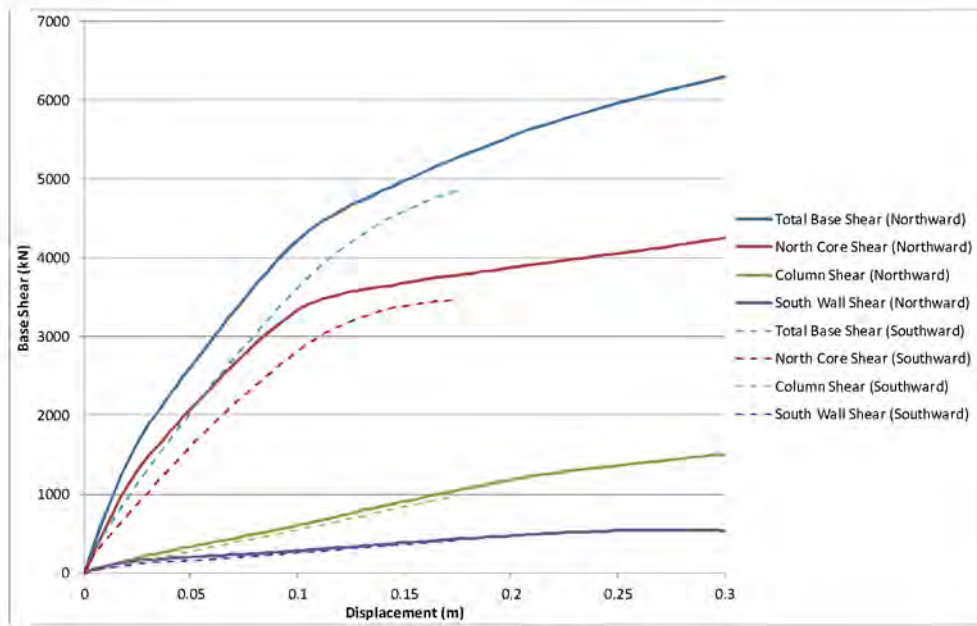
It can be seen in Figure 123 that the plots for the eastward and westward pushovers are almost identical, indicating a similar response in both these directions. By comparison in Figure 122 the initial response of the building in the northward direction is stiffer than in the southward direction, which can be attributed to the differences in foundation stiffness under the North Core.

Greater base shear is carried by the North Core for a northward push than for a southward push. This is due mainly to the mobilisation of the gravity loads on beams along gridline 4 to resist overturning as the core walls rock and move upward beneath the beams. This behaviour is not as significant in the southward direction because of the restraining effect of the foundations to downward loads on gridline 4.

Figure 122 - Pushover curves, north-south, no masonry

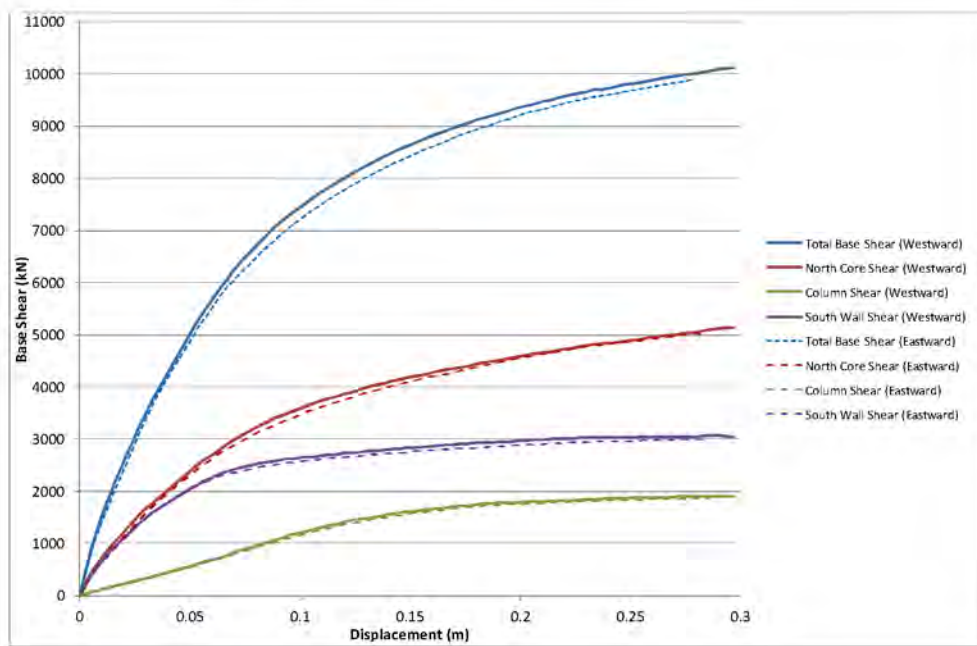
Figure 123 - Pushover curves, east-west, no masonry

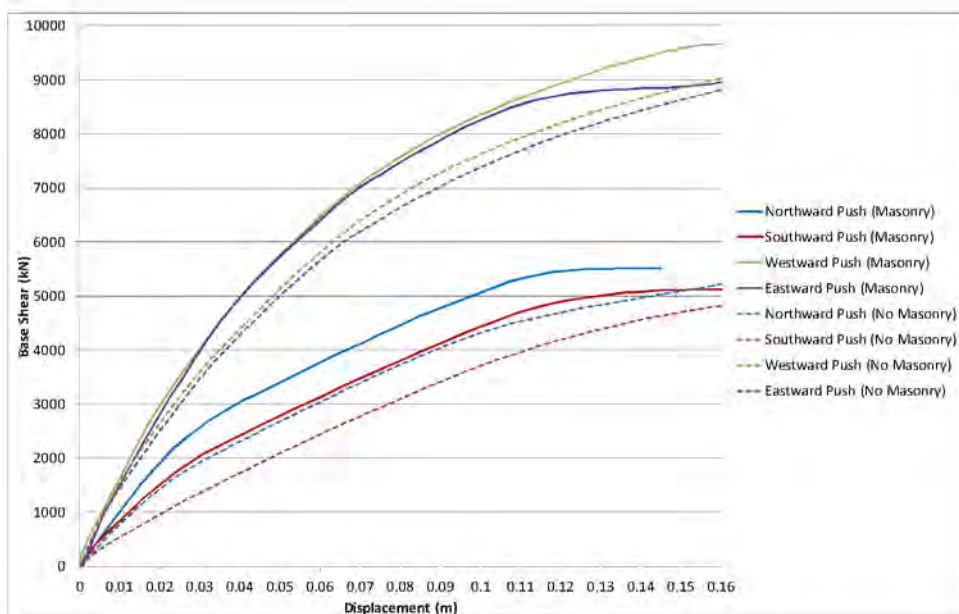
Figure 124 plots of the pushover curves for Model A (no masonry) are shown by the dashed lines and Model B (with masonry) are shown by the solid lines. The stiffening

effect of the masonry can be seen. Also, slight strength degradation of the masonry is evident in the pushover curves, where the solid and the dashed lines converge near the right-hand side

Figure 124 - Pushover curves, total base shear, with and without masonry
