CTV BUILDING

CTV BUILDING COLLAPSE INVESTIGATION
FOR DEPARTMENT OF BUILDING AND HOUSING
25TH JANUARY 2012

Part 3 of 3

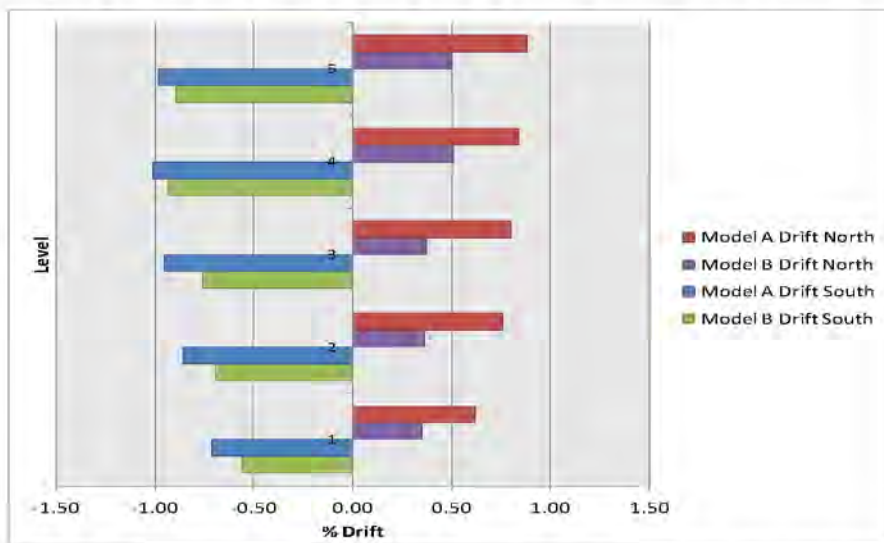
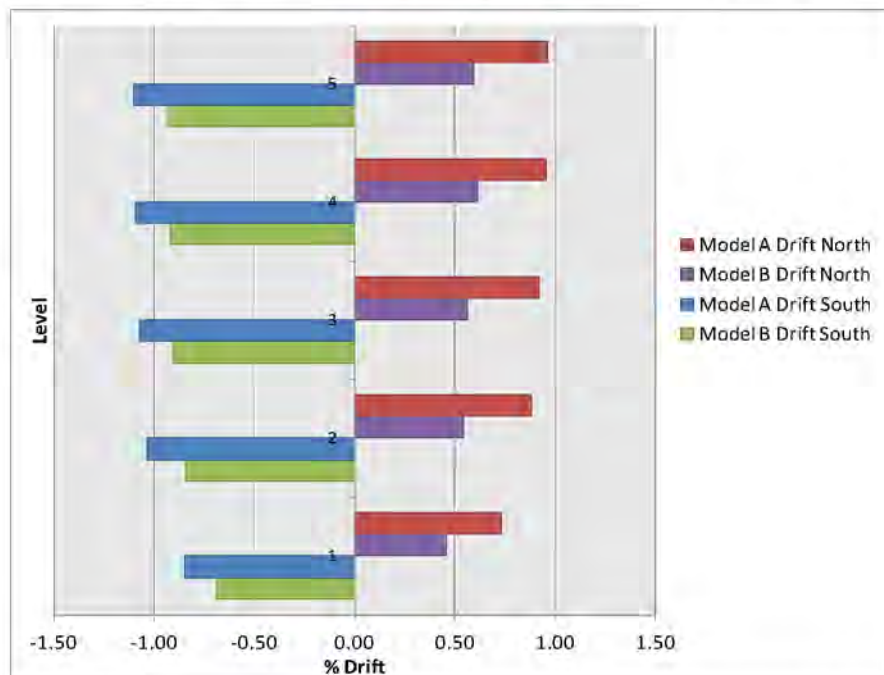
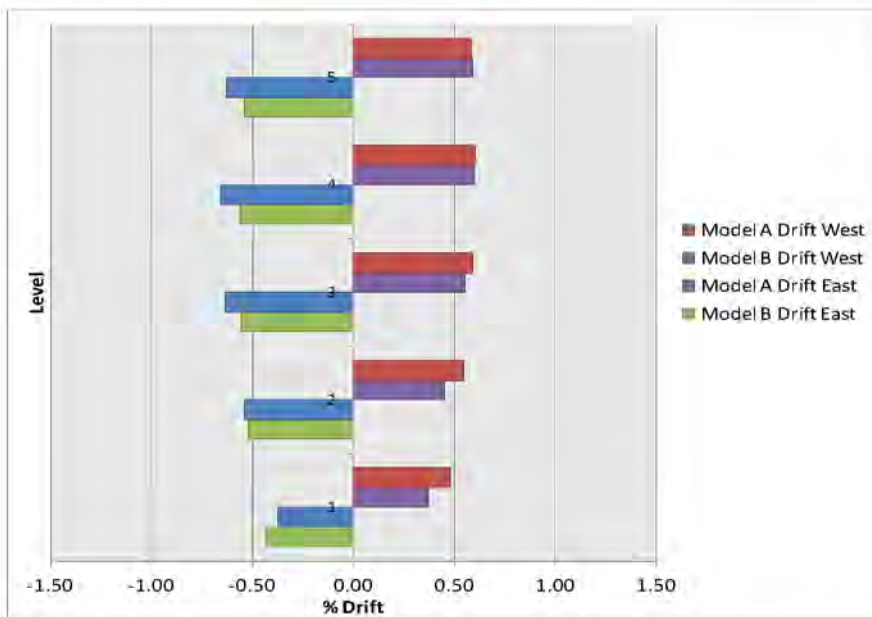
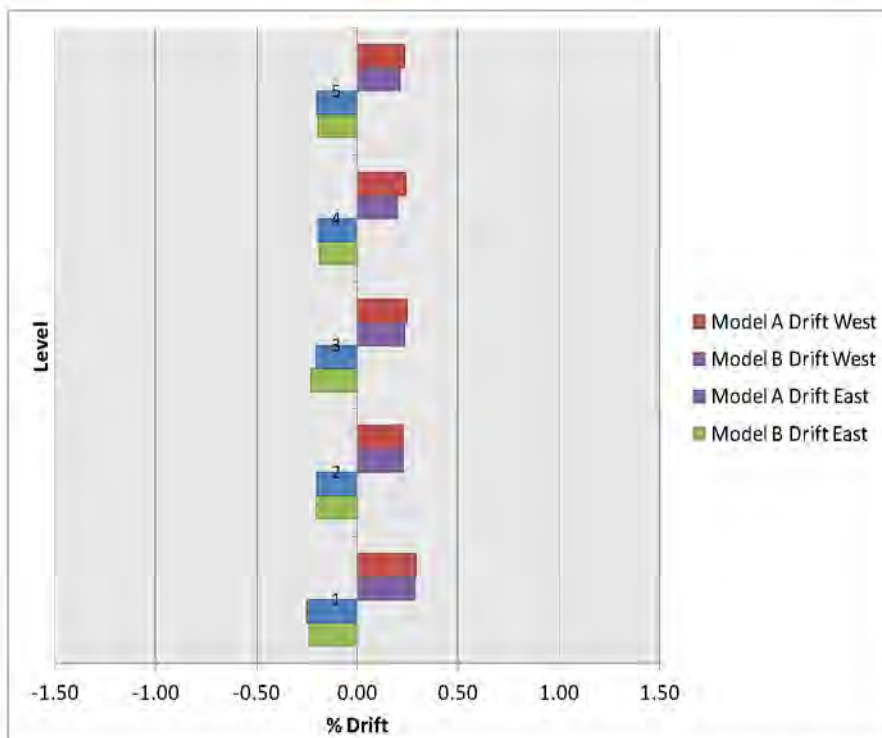
Figure 125 to Figure 128 show maximum storey drifts predicted by the NTHA for the September Earthquake are around 1.1% (+/-35mm) in the north-south direction on Line F, 0.61% (+/-21mm) in the east-west direction along grid 1 and 0.3% (+/-10mm) in the east-west direction along grid 4. Storey drifts were less along grid 4 because of the greater stiffness of the North Core in the east-west direction when compared with the South Wall. (Northward drifts are positive.)

Comparison of the results for storey drifts for the masonry and non-masonry models for the September Earthquake can also be seen in Figure 125 to Figure 128. This shows that the masonry walls have minimal effect on the drifts in the east-west direction. In the north-south direction the masonry walls had a stiffening effect, reducing the storey drifts on line A and also to a lesser extent on line F.

It has been shown in Figure 125 to Figure 128 that the masonry infill walls, if engaged with no effective separation, would generally have caused a reduction in storey drifts

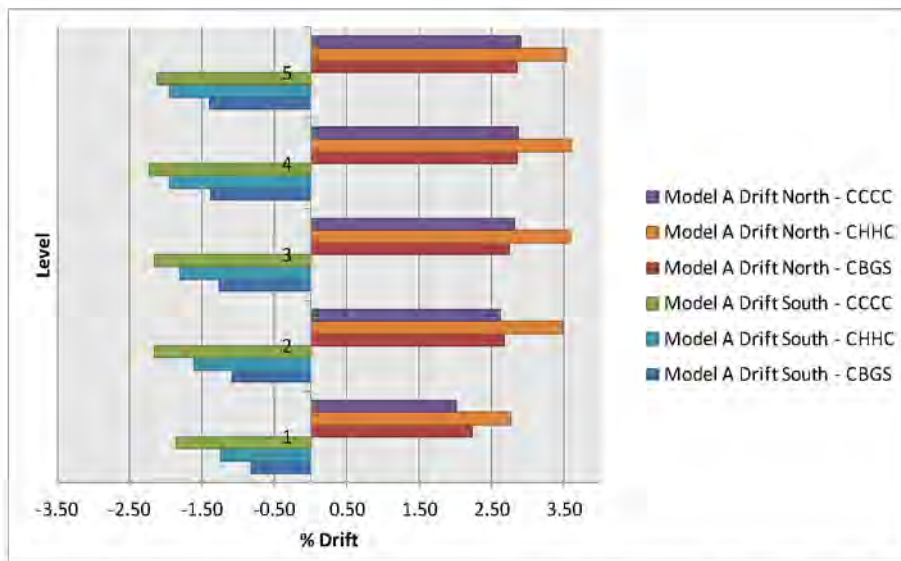
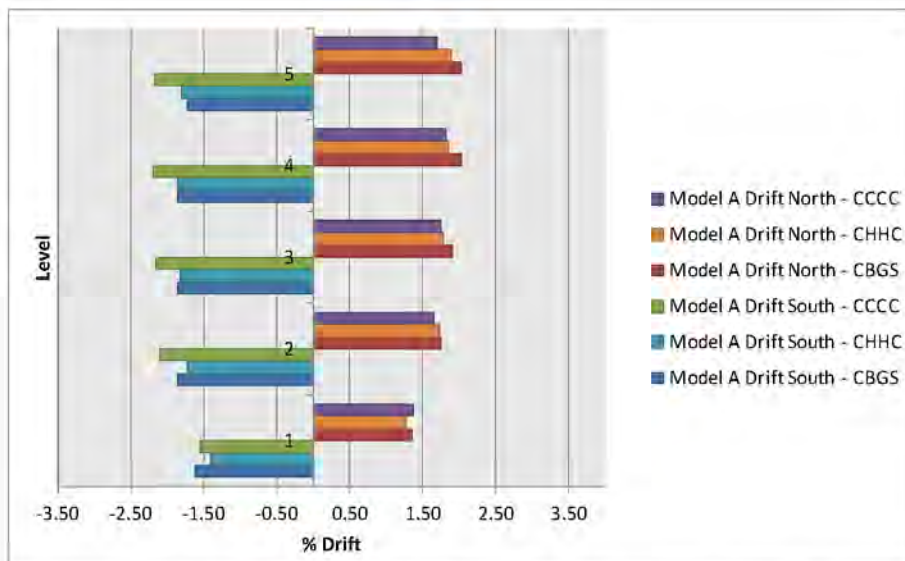
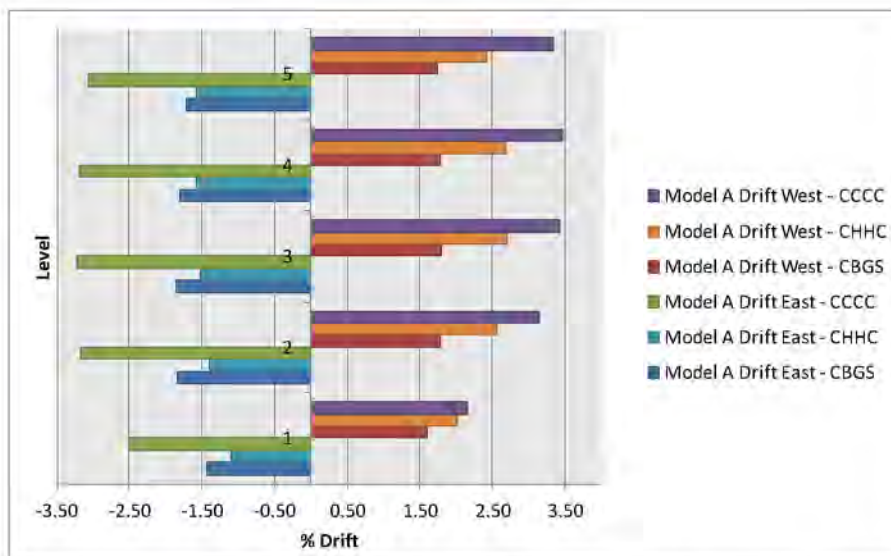
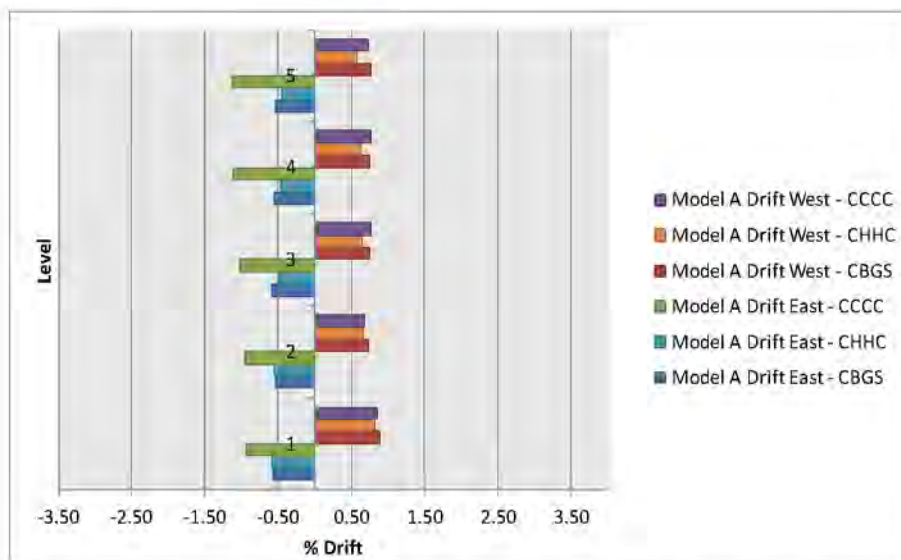
Comparison of the results for storey drifts for the three different earthquake records adopted for the February Aftershock can be seen in Figure 129 to Figure 131. Storey drifts are shown to be somewhat higher in the north-south direction for the CHHC record and higher in the east-west direction for the CCCC record. It was

For the February Aftershock maximum storey drifts predicted by the NTHA are shown in Figure 129 to Figure 132 to be up around 3% (+/-100mm) in the north-south direction and also in the east-west direction along grid 1.

In the east-west direction along grid 4 the storey drifts are predicted to be around 1% (+/-32mm). This variation in drift between grids 1 and 4 reflects the severe plan irregularity and the torsional behaviour discussed earlier:

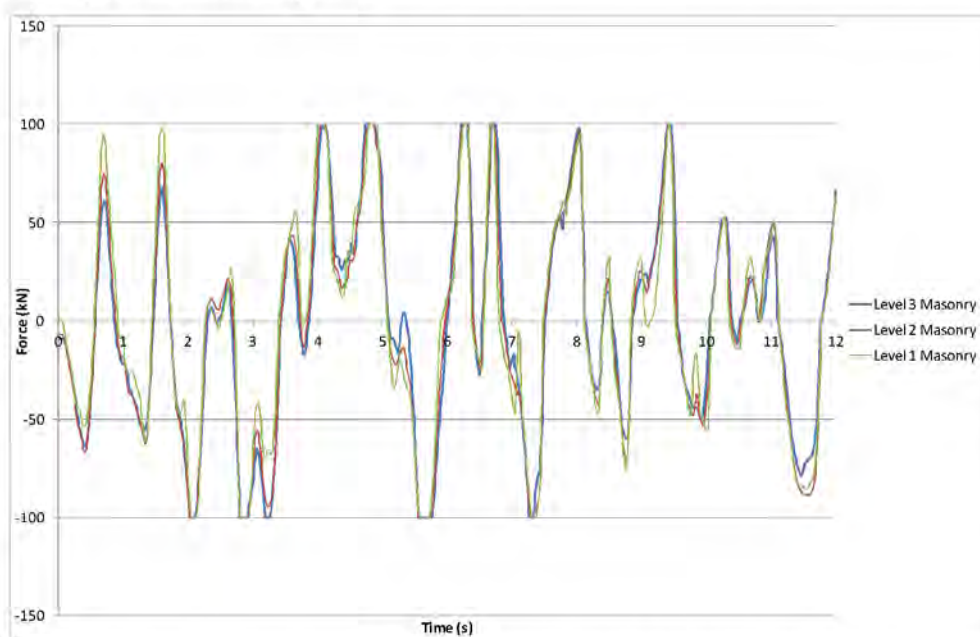
Figure 133 below is a plot showing the shear force in a typical 2.3m wide masonry infill panel over the duration of the September Earthquake CBGS record. It shows that the masonry panel, as modelled, would have reached its bending limited shear capacity of ± 100 kN in a number of cycles. There were nine masonry panels on grid A at each floor level, meaning that the total storey shear contribution from the masonry was limited to 900kN (0.027g) in the model, limited by cantilever bending capacity of the individual panels.

Figure 133 - Shear Force in typical 2.3m wide masonry infill panel, September Darfield Earthquake CBGS. This shows that the masonry panels reached their shear resistance of ± 100 kN as limited by flexural capacity on a number of cycles.

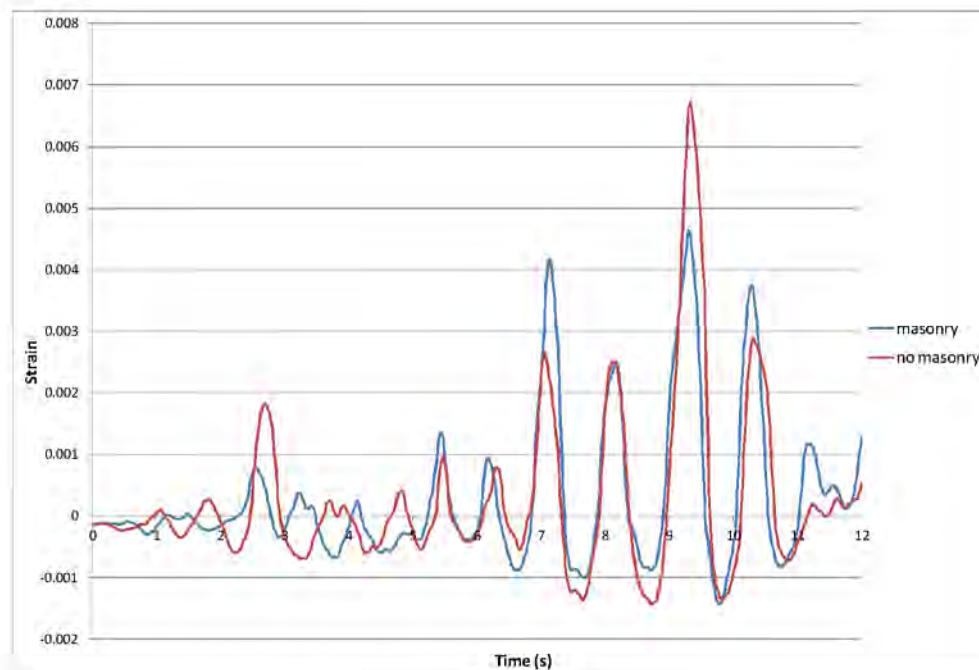
To correlate damage (crack widths) reported after the event with the NTHA results it is also instructive to review the variation in strain over time. Figure 134 below, is a plot of the strain at the base of the southern coupled shear wall at the eastern face, for Models A (no masonry) and B (with masonry). It shows the peak strains of 6.7mm/m and 4.7mm/m described above at between nine and ten seconds into the record. It also shows the variation of strain over time and indicates a much reduced strain, between 0.5mm/m and 1.3mm/m at the end of the portion of record analysed.

Figure 134 - Strain at base of South Wall at eastern face, September Darfield Earthquake CBGS

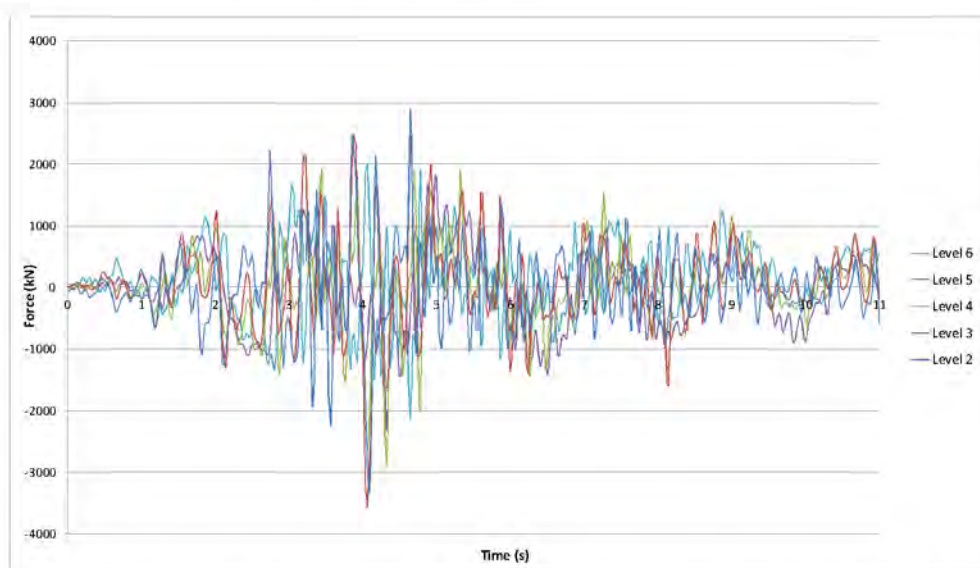
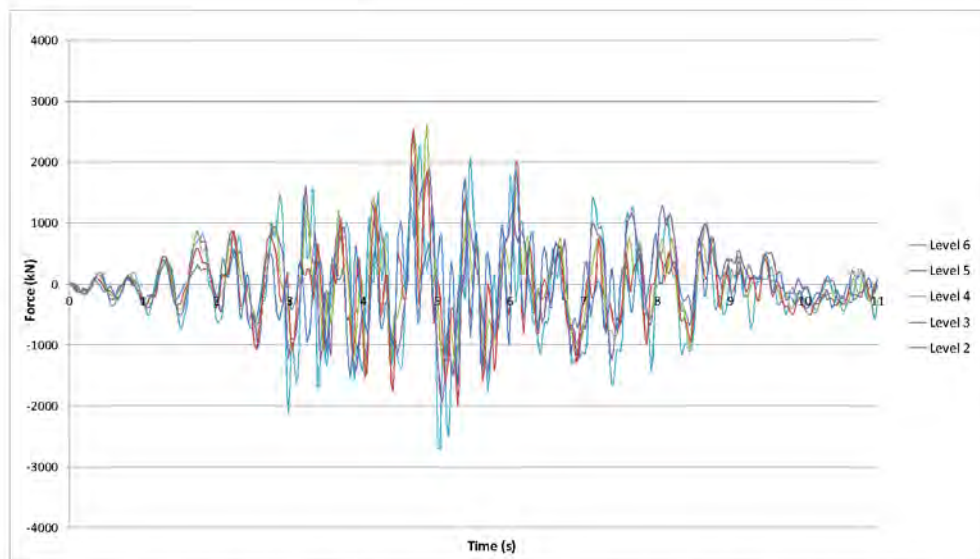
It is interesting to see in Figure 135 and Figure 136 that the maximum calculated total diaphragm connection force to the North Core exceeded 3500kN in tension (which is negative in the figures) at level 3 (0.61g) using the full record and without Line A masonry. This is nearly five times the design tension diaphragm connection force of 0.125g that would have applied for level 3 from the Loadings Standard of the day NZS4203:1984. It is also noted from the figure that the diaphragm forces fluctuate at very high frequency, much higher than the natural periods of lateral vibration that varied between 1.0 and 1.3 seconds..

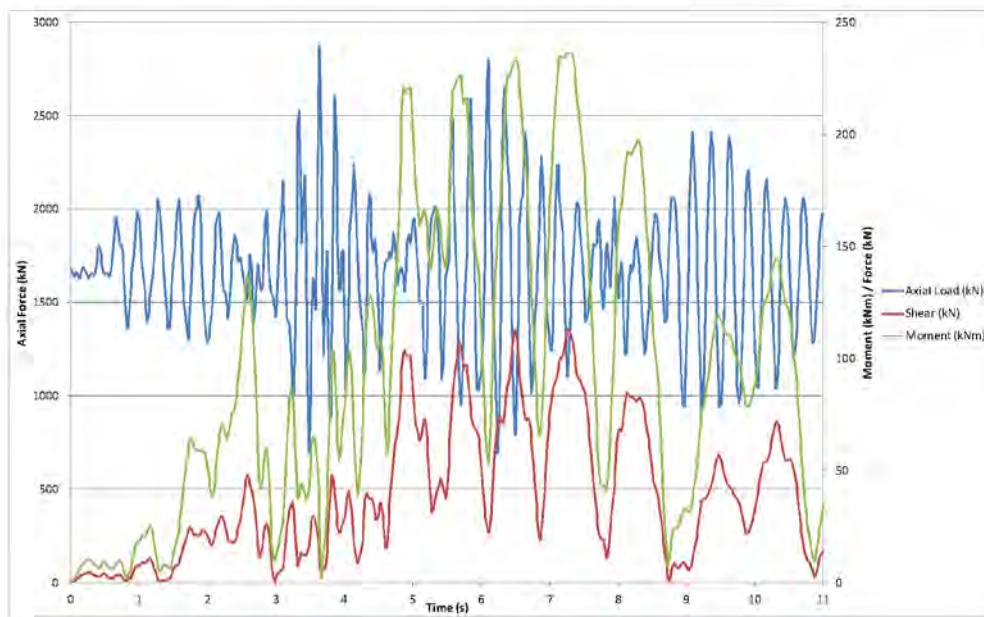
In Figure 137 below the variation of axial action, bending moment and shear force for the 22 February CBGS record is plotted over time for one of the most heavily loaded columns at grid D2 at level 1. This shows the bending moment and the shear force in phase at around one cycle per second, and the vertical component superimposed at higher frequency. The flat spots on the bending moment and shear force curves represent the times when column hinging is occurring in the model. From this plot it will be appreciated that assessing the demand on, and capacity of the column at any particular instant in time is difficult.

Figure 137 - Column Actions D2 Level 1, 22 February Lyttelton Aftershock, CBGS

Referring to Figure 137, the axial forces in column D2, from the NTHA with vertical accelerations, were seen to fluctuate at much higher frequency than the lateral modes of vibration. There was therefore significant variation in the axial force for any given cycle of lateral drift, with an increase in axial force being detrimental and a

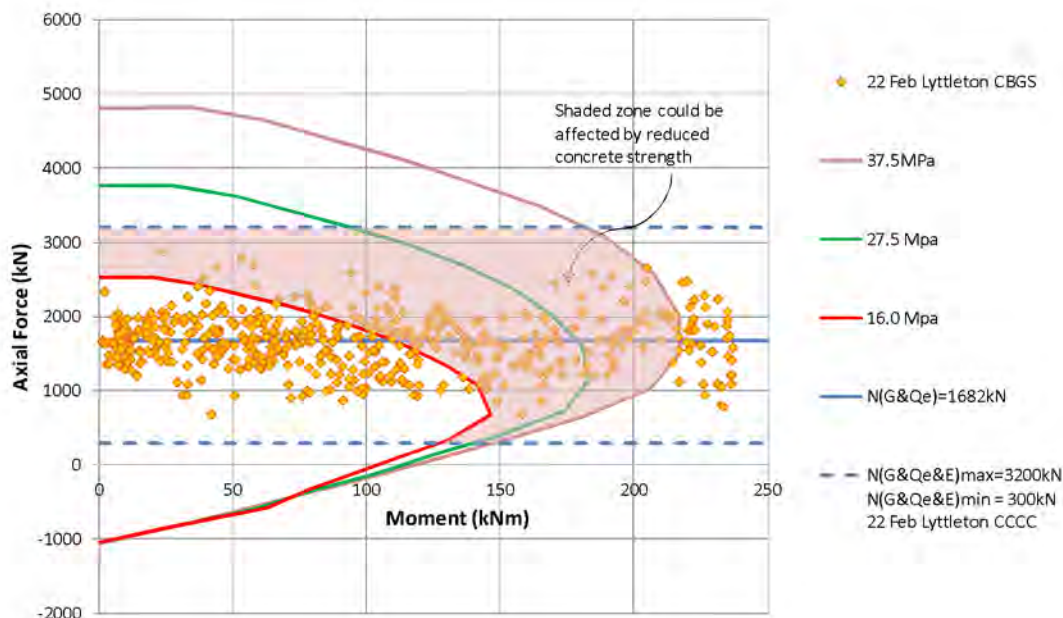
Figure 138 - Column D2 Level I M-N Interaction diagram. ($F_y=448$ MPa, $\phi=1.0$, no masonry.)

Points that can be observed from Figure 138 include:

- The M-N interaction curves have been drawn for three different concrete strengths 37.5 MPa, 27.5 MPa and 16 MPa, representing a range of concrete compression test results. The specified concrete strength for this column was 35 MPa, for which an expected strength of 37.5 MPa was used in the NTHA. The lowest strength found from material testing of column remnants was 16.0 MPa.

- The data points marked by green, red and gold diamonds are the moment and axial action in this column at each time step from the NTHA (CBGS 22 February Aftershock record) prior to, during and following the modelled disconnection of the Drag Bars. It should be noted that the data points plotted are for the column modelled, i.e. with 37.5 MPa concrete, and these

- Where the data points go outside the interaction curve at the right hand side of the chart this is mainly due to cyclic behaviour in the column hinges beyond the nominated failure criterion of $E_{cu} = 0.004$ where, due to the hinge modelling parameters chosen for the NTHA, the column moments are reported as being slightly higher than the theoretical value if failure had not occurred. Also, column hinge capacities have been based on the average gravity axial load and the hinges do not automatically take account of varying axial loads during the analysis. This does not have a significant effect on the storey response and has been taken into account in the assessment.

- The shaded area represents M-N combinations from the NTHA that would be affected by reduced concrete strength, i.e. there would be further hinging and potential column failures in this area if these reduced concrete strengths had been present.

Figure 138 indicates that vertical earthquake effects alone may not have been enough to fail the columns if they had been constructed at the specified strength. However, vertical earthquake effects in combination with column actions resulting from lateral drift are significant and may have contributed to column failures, particularly if in combination with reduced concrete strengths.

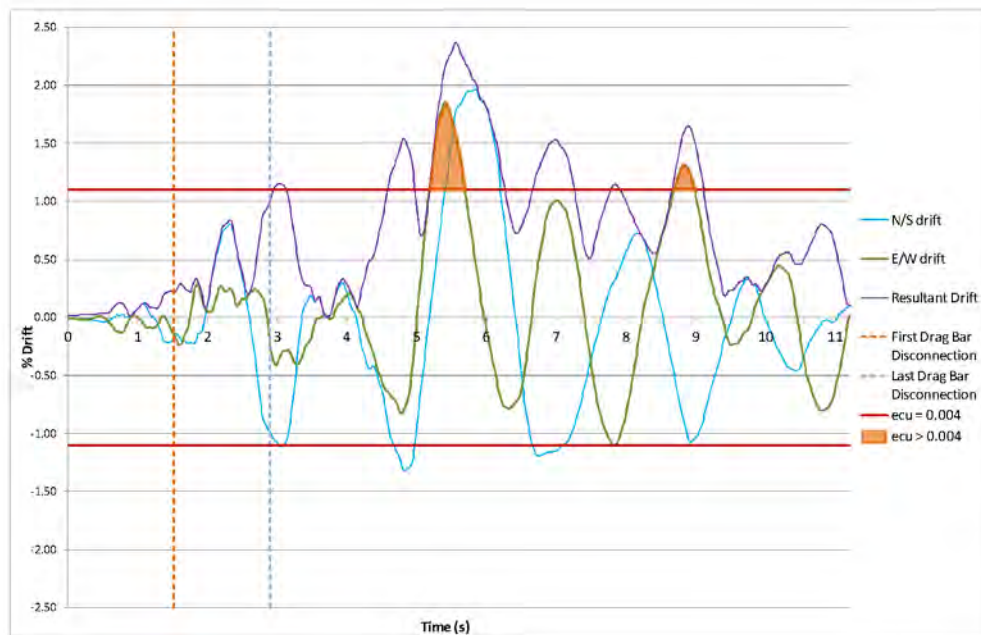
2. The earthquake record used is CBGS because that is representative of the average response in the north-south direction.
3. The maximum concrete compressive strain limit of 0.004 is calculated to have been reached at a drift of around 1.3% (the red horizontal lines) with no spandrel interaction, or at 1.0% (the orange horizontal lines) in the case of a Spandrel Panel adjacent to the column with no initial gap. 1.3% drift was not exceeded using the September Earthquake record, but it was well exceeded using the February Aftershock record, as indicated by the orange shading.

4. The times when the floors were calculated to have disconnected from the steel angle Drag Bars on the lift shaft walls at levels 4 to 6 are shown by the dashed vertical lines.

Figure 139 - Column D2 Level 3, CHHC, 22 February Lyttelton Aftershock, no masonry.

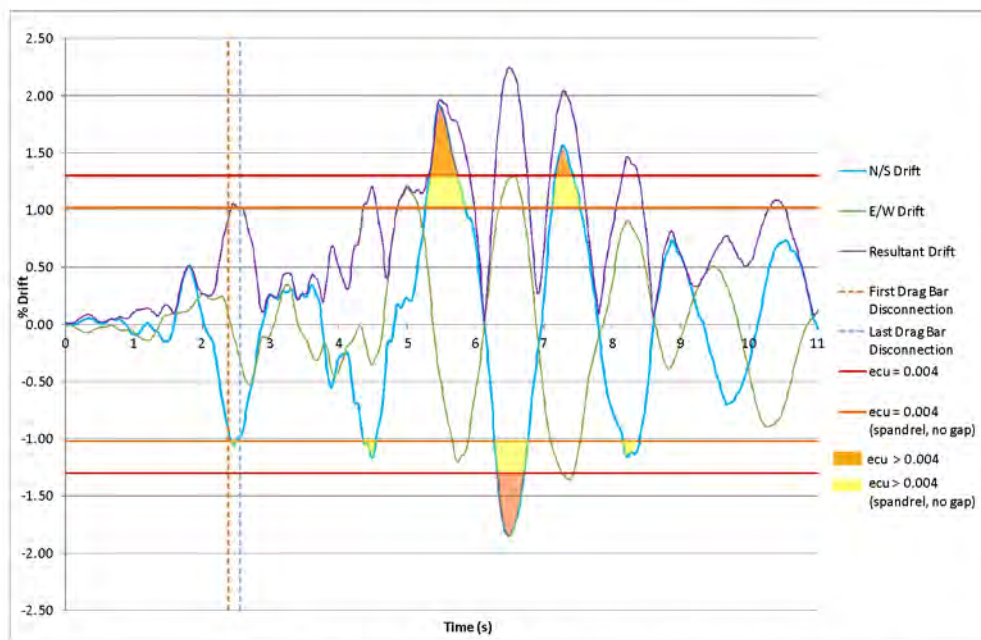
Key points to note from Figure 140 and Figure 141 are that, for the September Earthquake the maximum displacement demands are about half those calculated for the February Aftershock. Although there are two places where the September Earthquake displacements are shaded, only one of these is for the north-south drift. There are no cases where they exceed the maximum assessed capacity. The February Aftershock demands have many “excursions” shown shaded and three that exceed the maximum value by a noticeable margin.

Figure 140 - Column F2 Level 3 Drifts - CBGS, 22 February Lyttelton Aftershock, no masonry.

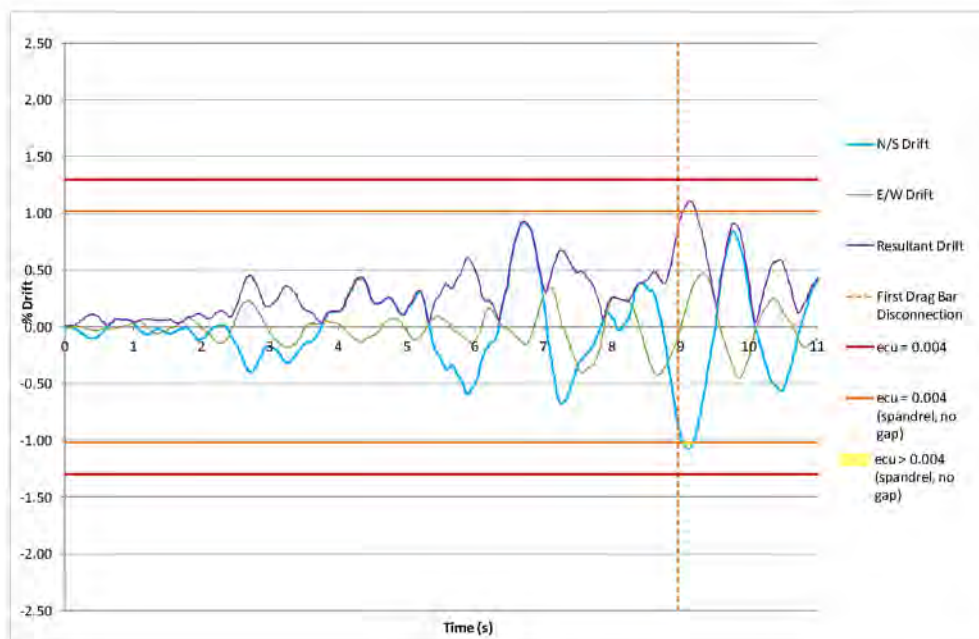
Figure 141 - Column F2 Level 3 Drifts - CBGS, 4 September Darfield Earthquake, no masonry.

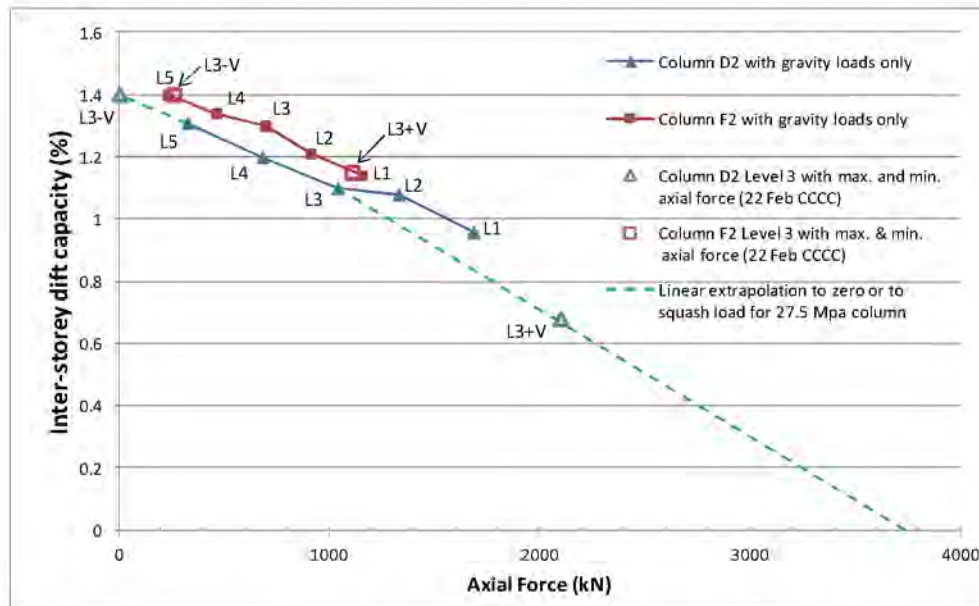
The potential effect of vertical accelerations on column drift capacity is indicated in Figure 142. The solid lines are a plot of the failure drift capacities of the indicator columns at grids F2 and D2, according to the criteria of 0.004 maximum compressive strain as determined from the non-linear pushover analysis of the whole structure (assuming expected concrete strengths and without vertical acceleration effects). The solid coloured markers each represent one level of the particular column, as indicated by the labels and show the drift capacity at the corresponding axial force. The hollow markers, labelled "L3+V" show the revised estimate of drift capacity, found by interpolation or extrapolation as indicated in the figure, for the Level 3 columns when the maximum assessed vertical earthquake axial compression force is included. Similarly the hollow markers labelled "L3-V" show the estimated drift capacity when the minimum axial compression force is included. The maximum and minimum vertical earthquake force is from the NTHA analysis with vertical accelerations only, for the CCCC record of the 22 February 2011 event, which gave the largest variation of axial forces of the two analyses completed (CBGS and CCCC).

Note from Figure 142 that for the grid F2 column at Level 3, an increase in axial force of 60% reduces the drift capacity from 1.3% to 1.15% which is a reduction of around 12% in drift capacity. Similarly for the grid D2 column at level three, a 100% increase in axial force reduces the drift capacity from 1.1% to 0.68% which is a reduction of around 38%. When there is a reduction in the axial force, the drift capacity increases as indicated by the L3-V markers in Figure 142.

Figure 142 - Column F2 and D2 drift capacities to failure ($E_{cu} = 0.004$) (including the effect of maximum vertical earthquake force on Level 3 columns) Notes: Concrete strength as specified + 2.5 MPa. Linear extrapolation is indicative only.

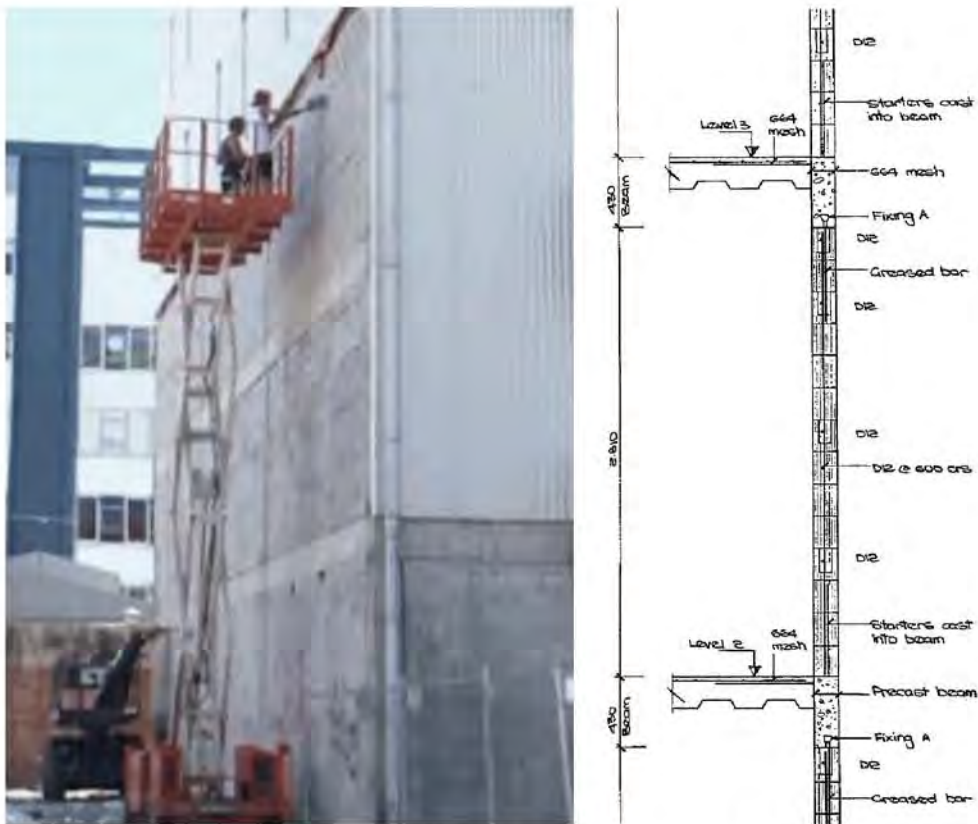
The design drawings show that the Line A wall should have been fully grouted of the horizontal pre-cast concrete boundary members. Greased starter bars at 600 mm centres were fixed into the under-side of the precast beams along Grid A (Figure 149 DENG Dwg S9 section 6). There was a D12 horizontal bar shown in the shaded top course of the infill masonry in Section 6 of S9, and a note on Dwg S17 required "Grade B masonry all cells filled" indicating that it was to have been filled. As it was Grade B masonry, it required observation by an engineer during construction.

The rectangular columns sat out proud of the wall face by 20 mm or so. Photos showed vertical separation gaps between the corner column (Grid I/A) and the short Line 1 return wall on the south face of the building. A horizontal separation gap appeared to be evident between the Line 1 wall and the beam above it (Figure 149). However no vertical or horizontal gaps were evident from the photo on the West wall along Grid A.

Figure 149 - West wall on Line A (left to right) : Being prepared for strapping and cladding a day or so before collapse on 22nd February; b) Connection of west wall block work into floor beams top and bottom (portion of DENG Dwg S9 Section 6), showing the fixing of the top of the wall into the structure.

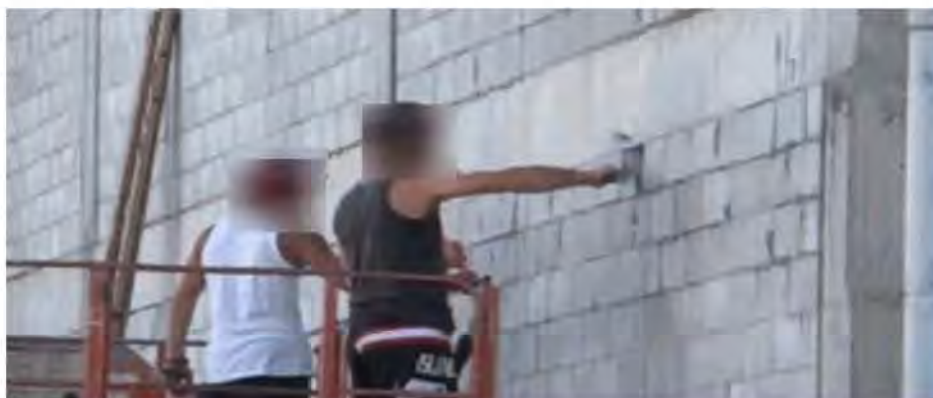
However based on the statement of Eyewitness 16 complete grout filling of the top courses may not have been achieved. The adjacent building had been demolished after the September Earthquake leaving the wall exposed to the weather. Eyewitness 16 and another worker were required to remove mortar trimmings off the face of the wall in preparation for strapping and cladding the wall a day or so before the February Aftershock. They found that the top courses of the masonry infill at each level were apparently hollow, and no vertical gaps were apparent to them between the masonry and the columns, but some horizontal gaps were found in places between the top courses and the beams. They were able to knock out the face of one top course block on the Level 1 portion of the wall with hammer blows which showed it was hollow (Figure 150).

Figure 150 – Workers (including Eyewitness 16) hammering face of top course block away on west wall near Line A / I corner column. This indicates hollow blocks occurred in the top course and no separation joints on the outer face of the masonry.

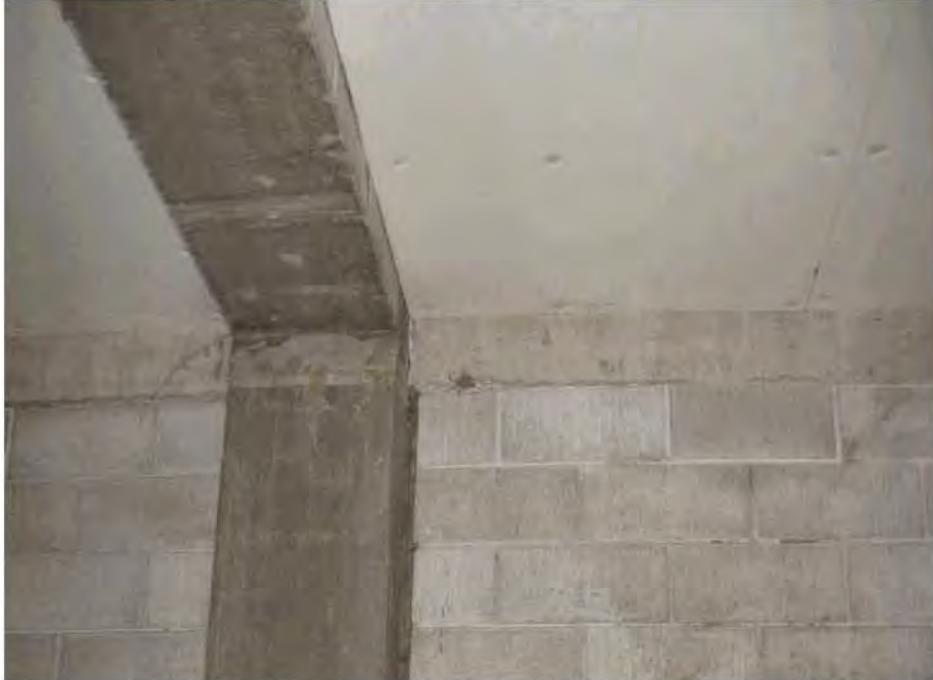
Figure 151 - Line A infill masonry wall adjacent to column with no obvious cracking after the 4 September earthquake. Flexible sealant is visible between masonry and column.

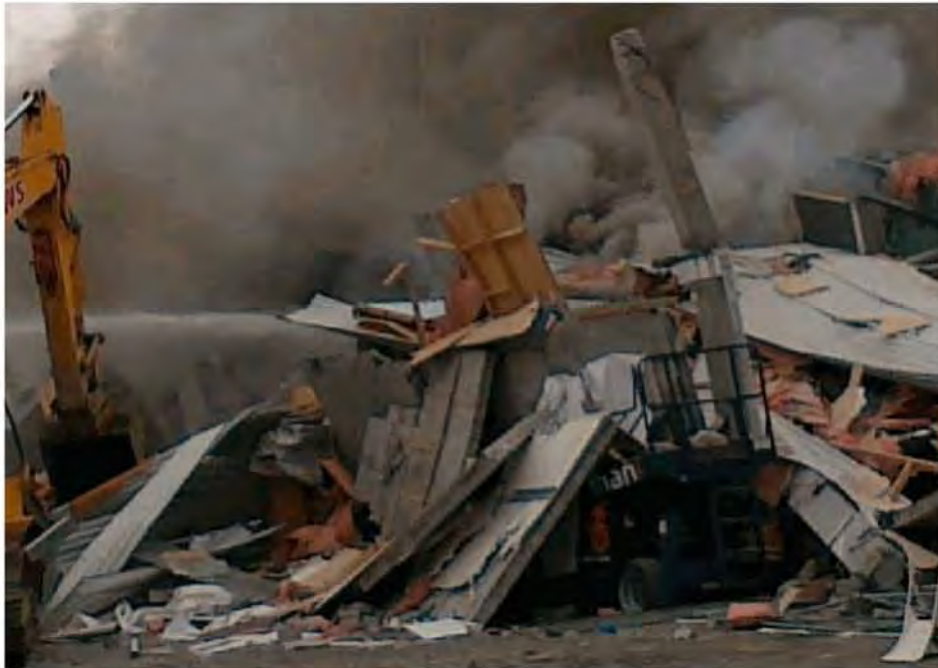
Figure 153 - West wall on Line A at southwest corner shortly after the collapse.

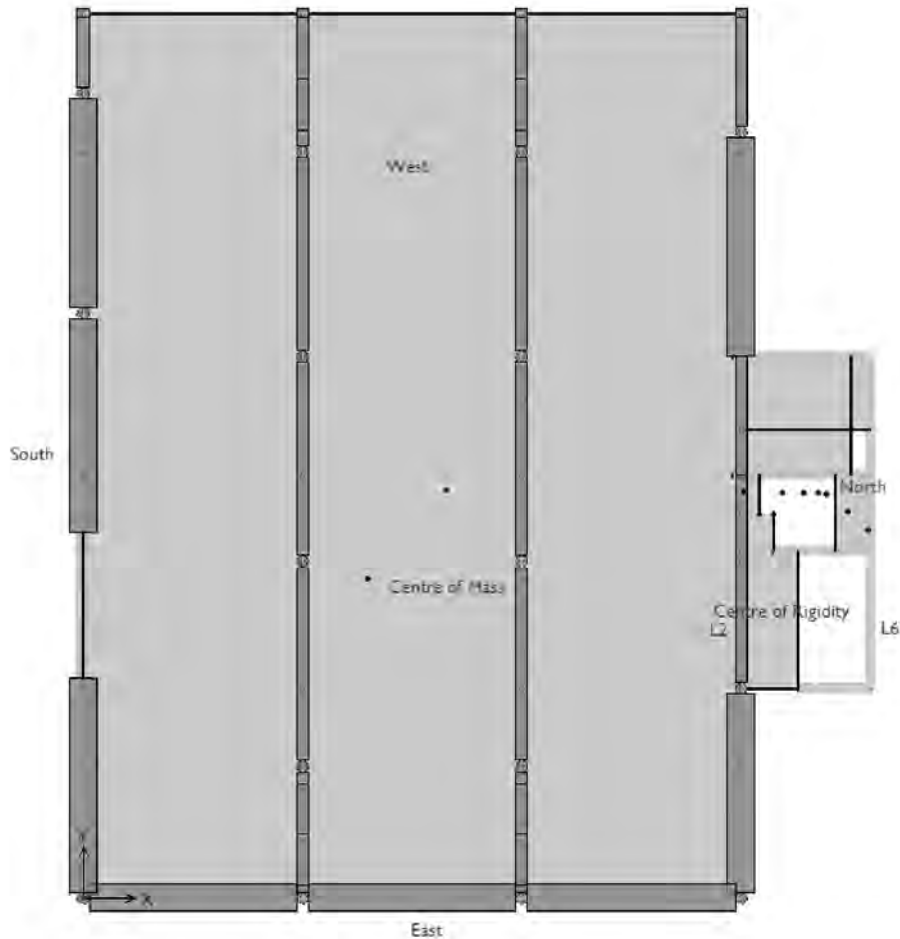
Figure 155 - Centre of Mass and Centres of Rigidity for each Floor (North Core and South Wall only as primary seismic resisting system) The centre of rigidity is close to alignment with the centre of mass for North-South excitation, but highly eccentric from the centre of mass for east-west excitation. This means that the building would have more torsional or twisting response to east-west components of earthquake ground accelerations than to north-south ground accelerations if the Line A masonry infill wall was adequately separated from the structure.

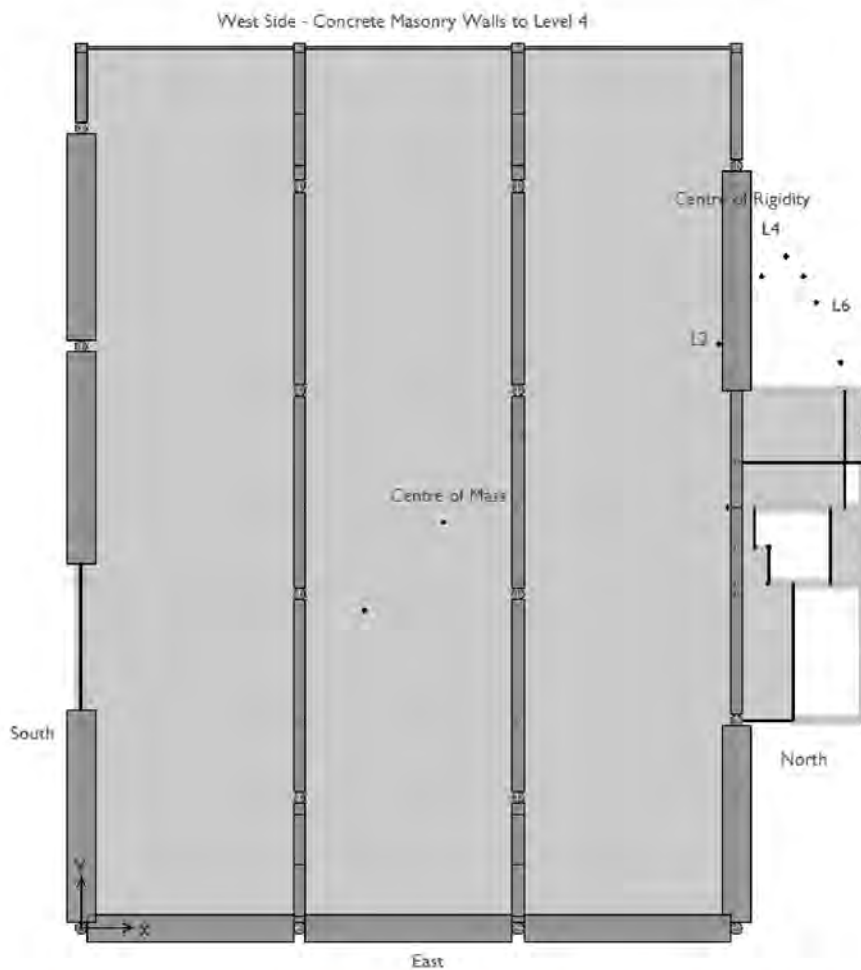
Figure 156 - Centre of Mass and Centres of Rigidity for each Floor (North Core, South Wall and Line A masonry infill wall in contact with structure). The centre of rigidity is highly eccentric from the centre of mass in both directions due to the participation of the west side Line A masonry infill wall below Level 4. The earthquake loads act through the building's centre of mass at each floor level, and the building tries to resist the earthquake actions through its centre of rigidity at each level. The offset between the centre of mass and the centre of rigidity is the eccentricity that determines the level of twist or torsion that results. With Line A masonry wall in full contact with the structure the building will have increased torsional response to north-south earthquake ground motions.

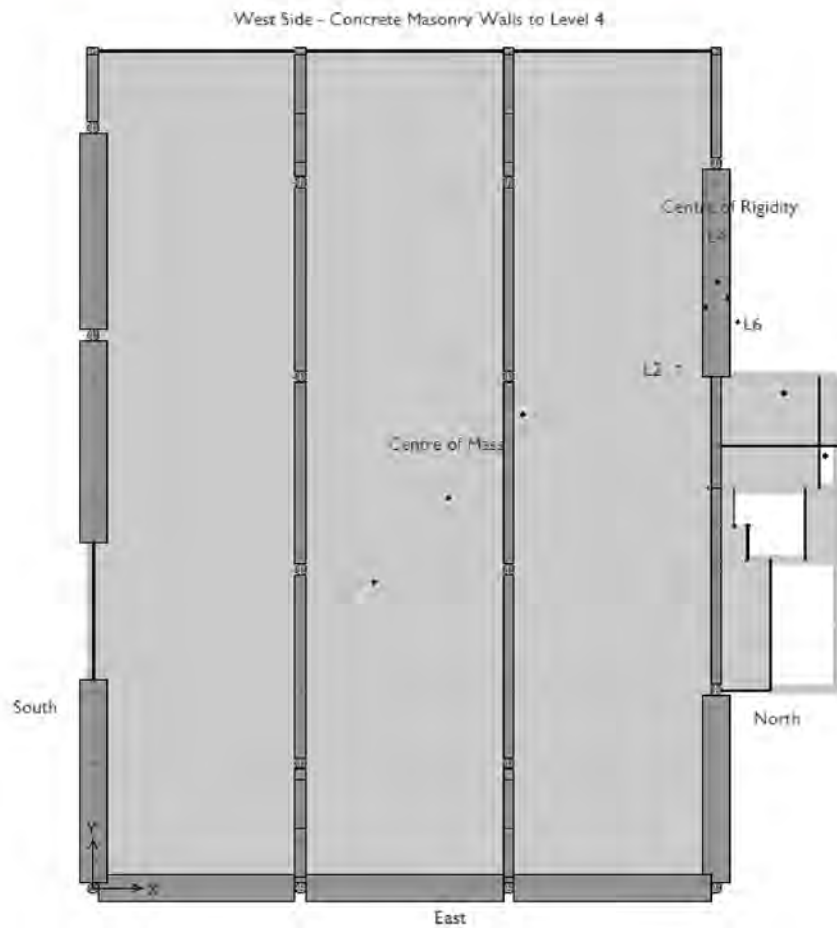
Figure 157 - The changes in the locations of the Centre of Mass and Centres of Rigidity for the building each Floor (North Core, South Wall and Line A masonry infill walls and secondary frames on Lines 1, 2, 3, 4 and F). The centre of stiffness moved south and west, reducing the torsional response of the building, due to the effect of the secondary frames.

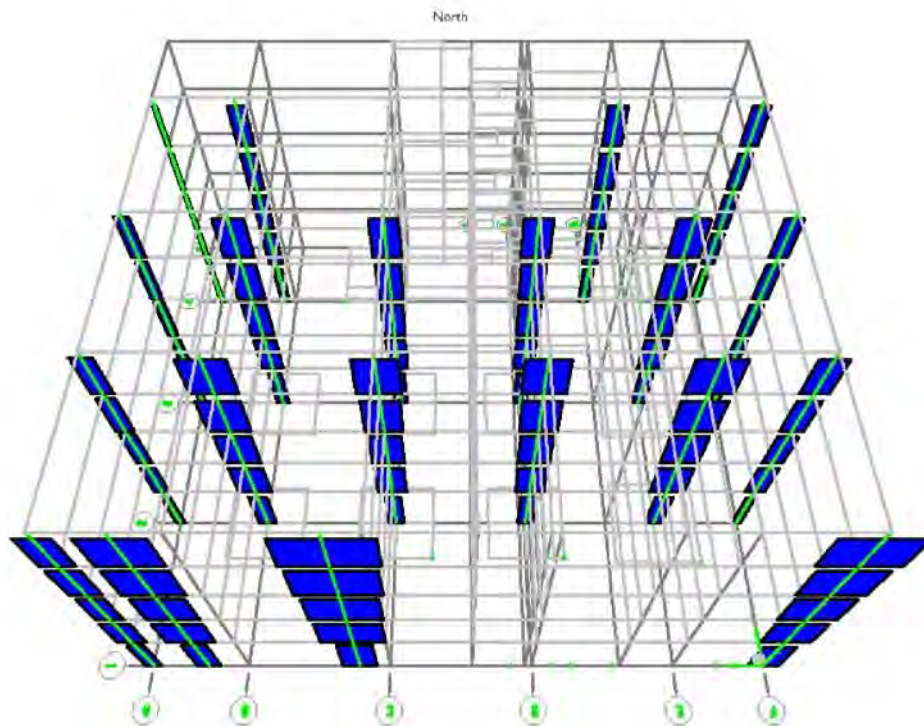
Figure 158 is a plot of shear actions (which are related directly to the level of column drift) on the east-west axis of the columns. The columns nearer to the south side and nearer to the top of the building were subject to higher drifts and shear actions (and corresponding bending moments). This is because they were furthest from the centre of rigidity and so experienced more seismic drift, and because the frame attracted a bigger proportion of the total storey shear compared with the walls nearer the top of the building.

Figure 158 - Plot of column shear actions on east-west column axis for earthquake shaking in east-west direction.

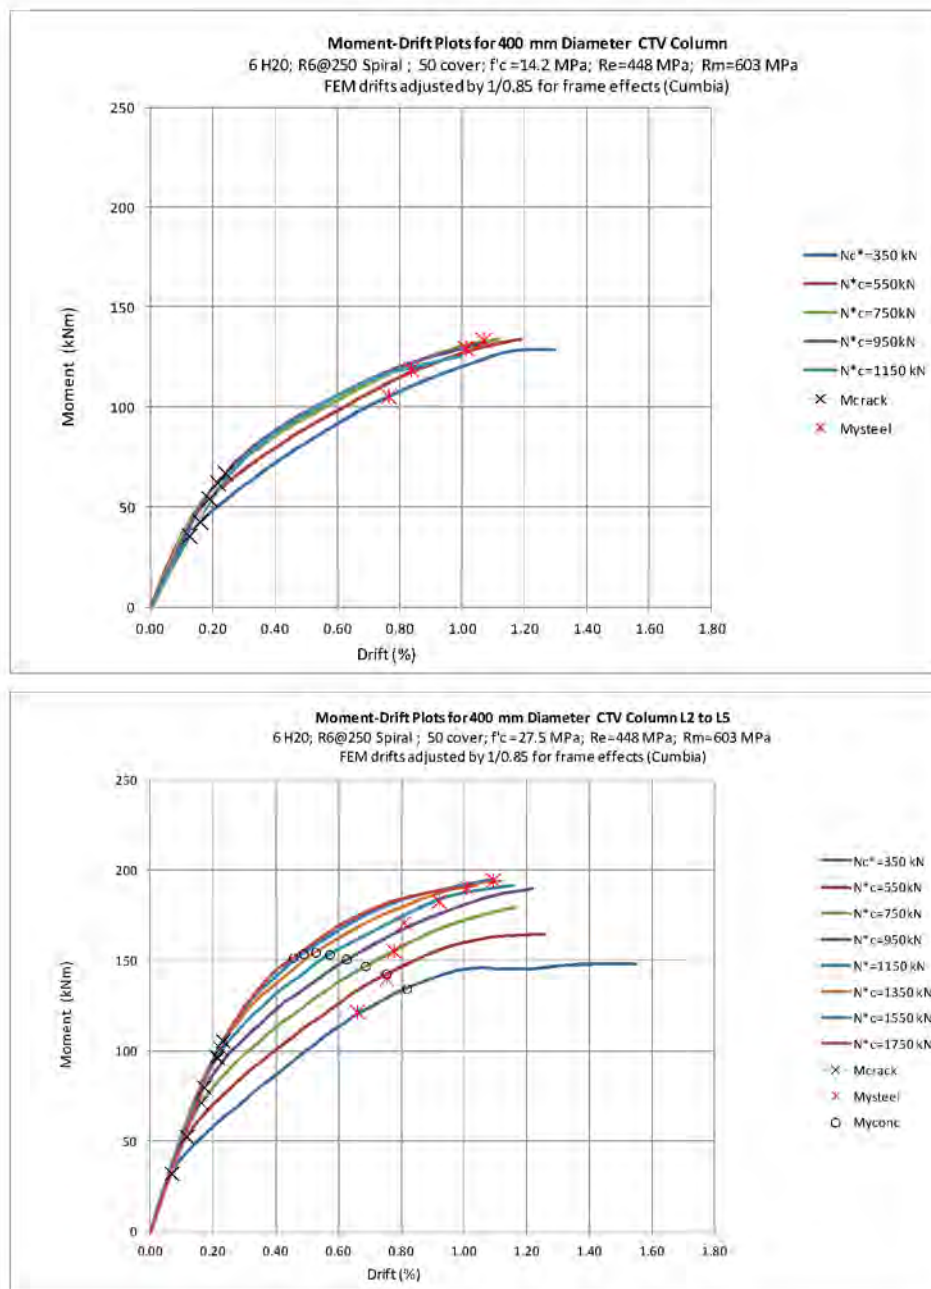
Moment-drift plots were developed using displacement and moment curvature relationships at varying axial actions calculated using Cumbia software (Montejo and Kowalsky 2007). The plots of the moment-drift curves for $f_c = 14.2$ and $f_c = 27.5$ MPa concrete are shown in Figure 159 up to a limiting concrete compression strain of 0.004. These curves show how the moment–drift relationship varies significantly with concrete strength and axial compression. The drifts to cracking moment, tensile yield of reinforcing steel and concrete yield at 0.002 strain are also shown.

Figure 159 - Moment-Drift plots for 400 mm diameter CTV columns for $f'_c=14.2$ and 27.5 MPa concrete, using Cumbia software for fixed end conditions adjusted for line 1, 4 and F frame effects. Concrete limiting strain was set at 0.004. This shows that yielding of the reinforcing steel starts at higher drifts as the axial compression action increases. Similarly the ability of the columns to drift more after starting to yield reduces as the axial compression action increases. Columns in the upper levels had lower axial compression actions compared to the lower level columns, and so were able to sustain more inelastic demand than those at lower levels. The crosses indicate the point at which yield of the extreme reinforcing steel bar occurs designated as the yield moment of the column. Due to the wide spacing of the spiral reinforcing, loss of concrete cover may have led to buckling of the H20 bars. For loads greater than 1550 kN the column drift capacity appears to reduce back along the upper drift curve back to squash capacity.

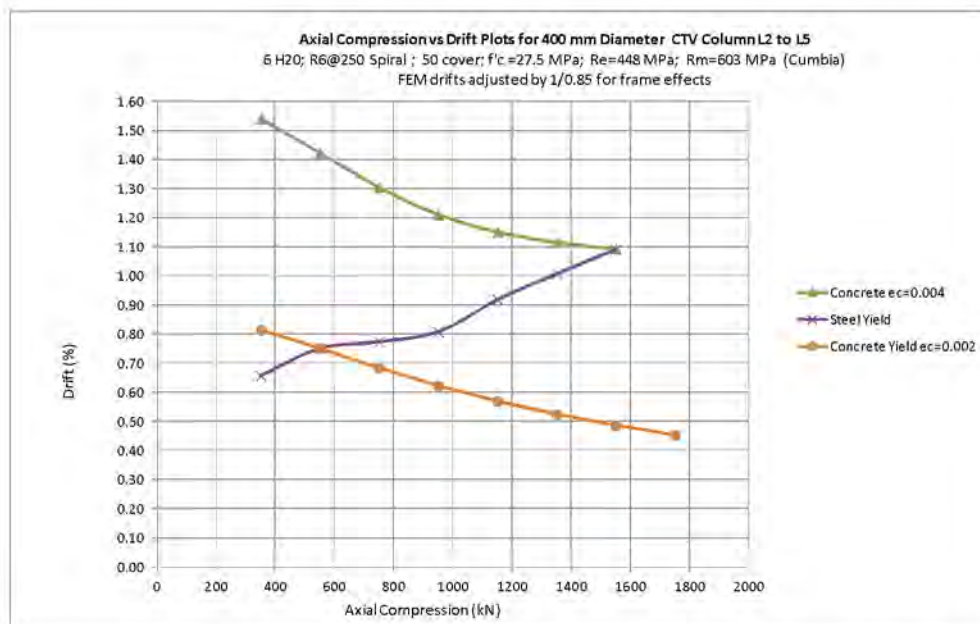
Figure 161 - Axial compression vs Drift for L2 to L5 columns on Lines I, 4 and F ($f'_c=27.5$ MPa).

On the basis of the drift capacity reduction as column axial compression action increase shown in Figure 161 for concrete of $f_c=27.5$ MPa a reduction of drift of between 0.25% to 0.50% /1000 kN increase in axial demand may be justifiable .

Based upon a comparison of the drift capacities shown in Figure 160 and Figure 161, it appears that a reduction in concrete strength from near the mean to the lower 5% strength measured during testing, (ie. a reduction of approximately 13 MPa), could lead to a reduction in column drift capacity of up to 15%.
