CTV BUILDING

CTV BUILDING COLLAPSE INVESTIGATION
FOR DEPARTMENT OF BUILDING AND HOUSING
25TH JANUARY 2012

Part 3 of 3

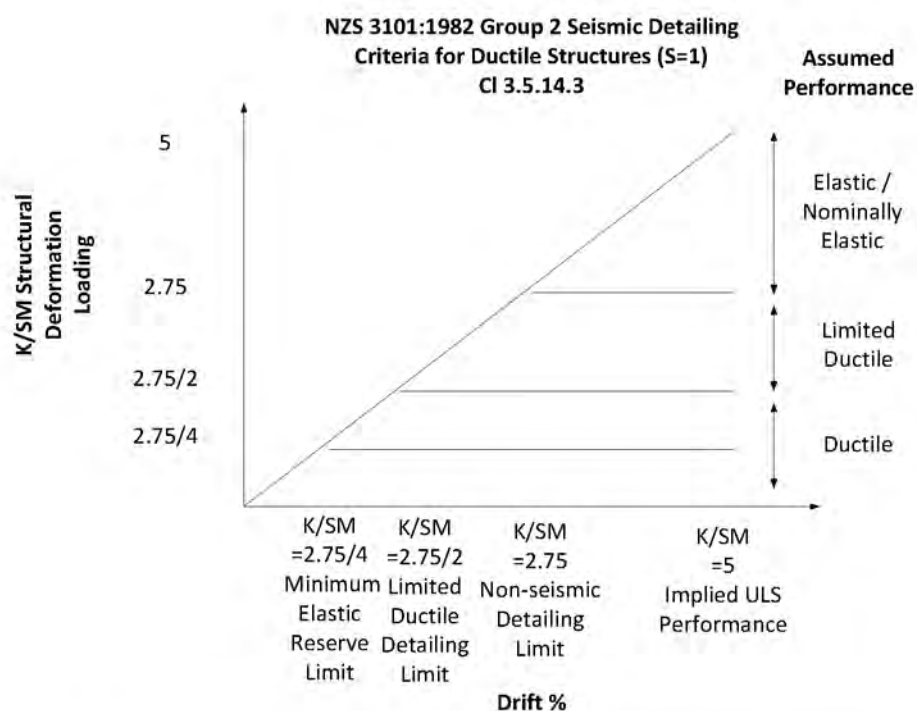
Figure 162 – Design and detailing limits from NZS 3101:1982 and implied performance for the CTV Building Group 2 columns.

The seismic design and detailing requirements for the Group 2 CTV Building columns in NZS 3101:1982 are interpreted as follows and as illustrated in Figure 162.

If the column did not remain elastic at deformation induced by loads on the primary structure of greater than $K/SM = 2.75/2$ but not greater than $K/SM = 2.75$, then it was required to be detailed using the limited ductility provisions of Chapter 14 in NZS 3101:1982. The implication being that it would then be capable of achieving the $K/SM=5$ drift without loss of strength (CI 3.5.14.3 f).

If the column did not remain elastic at deformation induced by loads on the primary structure of less than $K/SM = 2.75/2$, then it was required to be detailed using the full ductility provisions of NZS 3101:1982. The implication being that it would then be capable of achieving the $K/SM=5$ drift without loss of strength (CI 3.5.14.3 b).

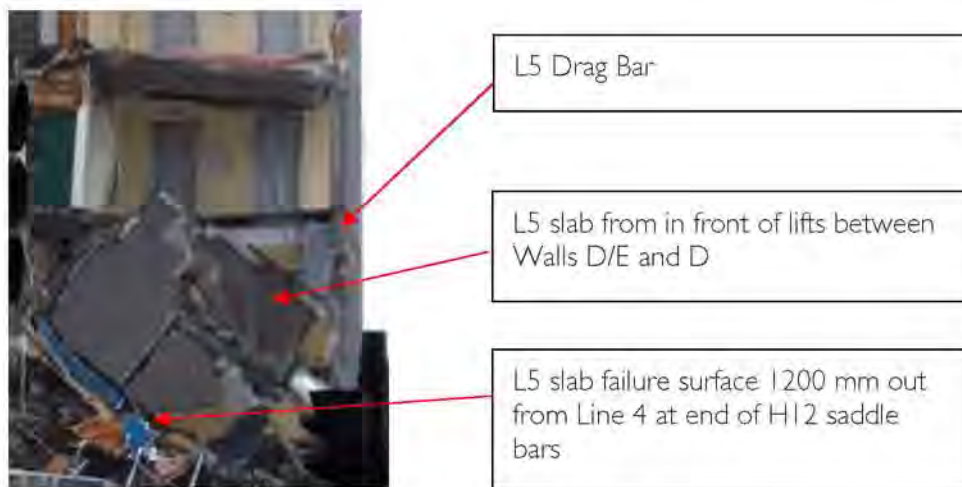
Figure I 64 - Level 5 slab from in front of lifts shortly after the collapse.

The Line 4-D/E column adjacent to the North Core may then have been pulled down as the collapse progressed and the portions of slab immediately outside the lifts between walls D and D/E rotated downwards and pulled away from the Drag Bars.

The epoxied concrete anchors, that attached the Drag Bars to the slab, appeared to have held adequately in shear (as evidenced by the Level 6 slab which was still being held up by the Drag Bars). However as the slab portions rotated downwards the slab pried away from the anchors in tension, leaving the anchors at the north end of the Drag Bars vertical and those on the bent down outstand bent over by around 30 degrees.

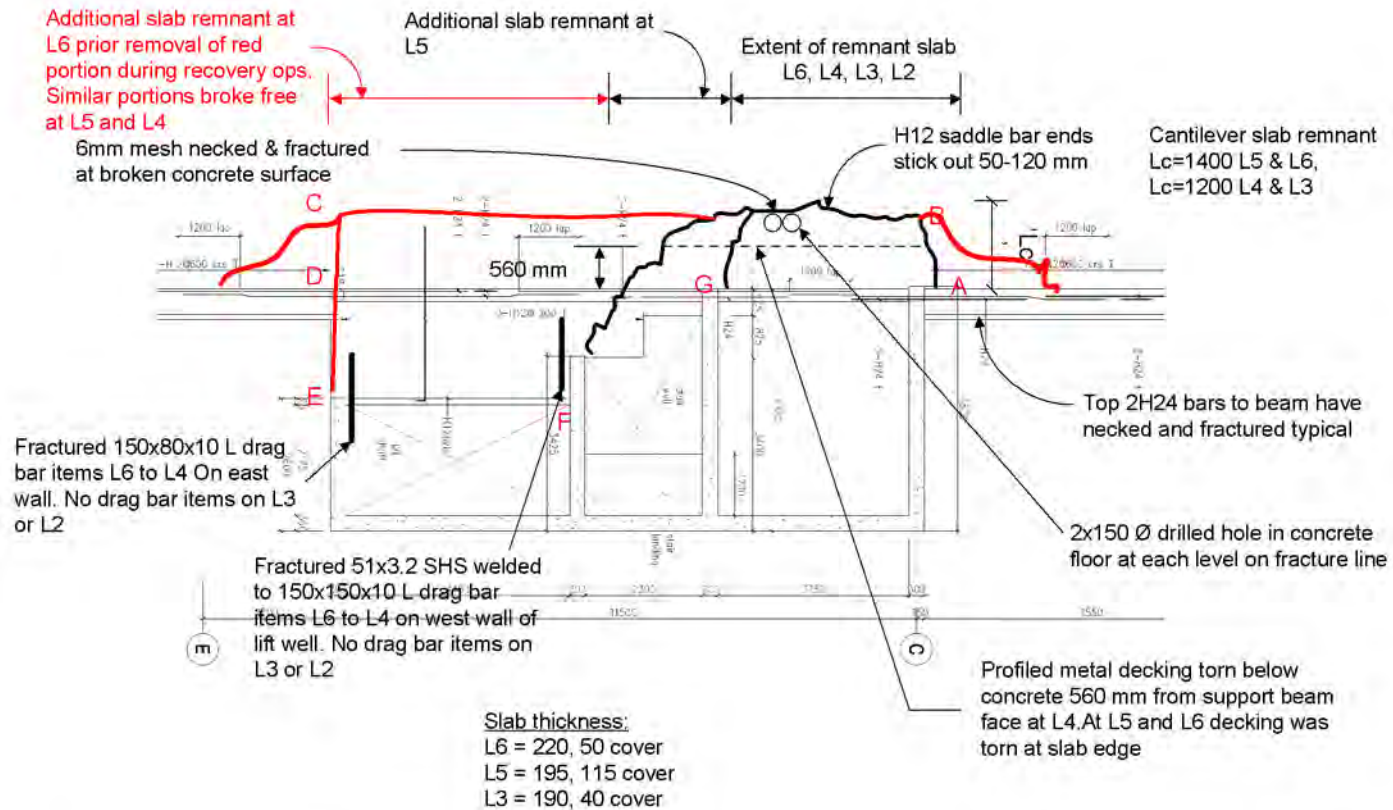
Figure 166 - North Core slab remnants after collapse based on site measurements in black and inferred by collapse photos in red..

Analysis of the in-plane bending capacity of the diaphragm compared in-plane bending capacity along two critical failure sections shown in Figure 166. The first along the perimeter ABCD running from the edge of the Line C wall out 1200 mm to the ends of the slab saddle bars and along 11.35 m then back 1200mm the Line D/E wall. The second failure section EFGA ran from the attachment point of the Drag Bars at walls D/E and D and along the slab at Line 4 between Walls C and C/D.

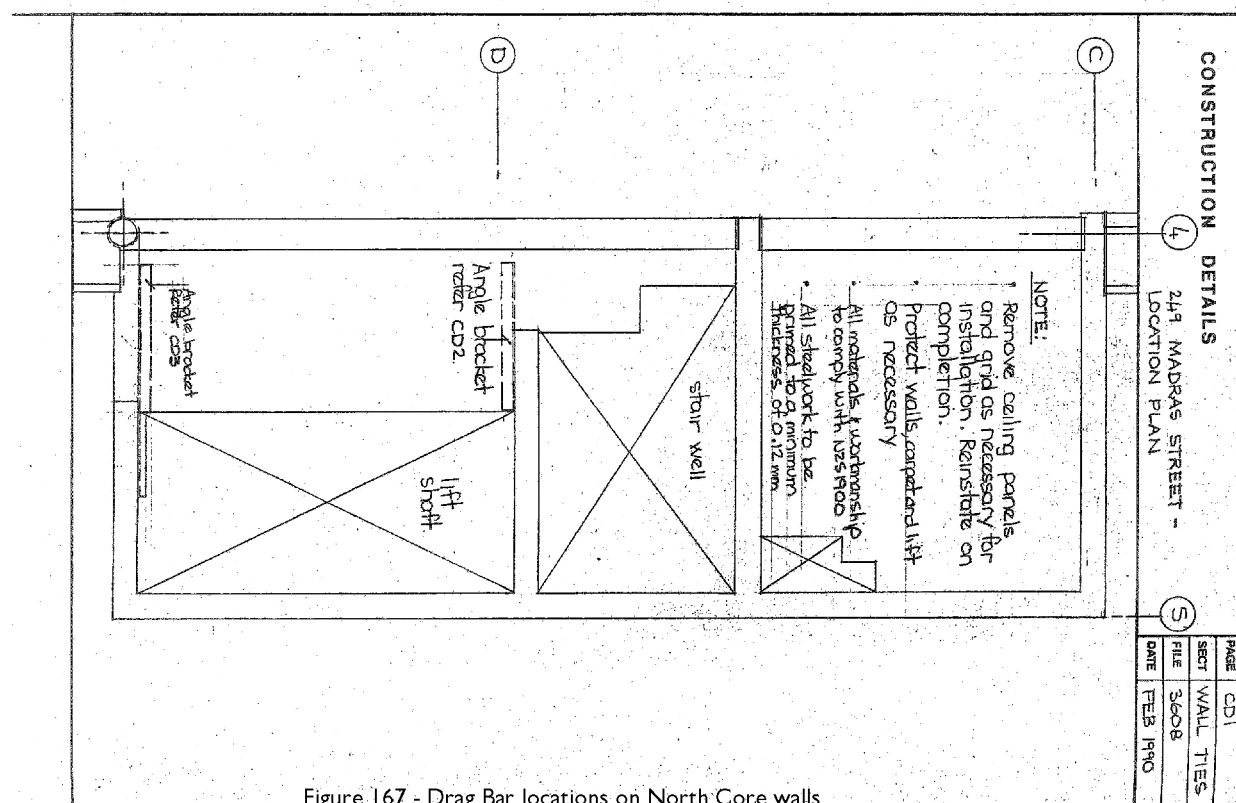
Figure 167 - Drag Bar locations on North Core walls

The documentation of the connection of the Drag Bar ties into the slab and walls obtained from the Design Engineer (Figure 167 and Figure 168), showed that the Drag Bar actions were calculated following the provisions of NZS 4203:1984. Bars were not designed or installed in Levels 2 and 3. This seems to have been deliberate and appeared to be based on the assumption that adequate shear capacity was
