# CTV BUILDING

CTV BUILDING COLLAPSE INVESTIGATION  
FOR DEPARTMENT OF BUILDING AND HOUSING  
25TH JANUARY 2012

Part 2 of 3

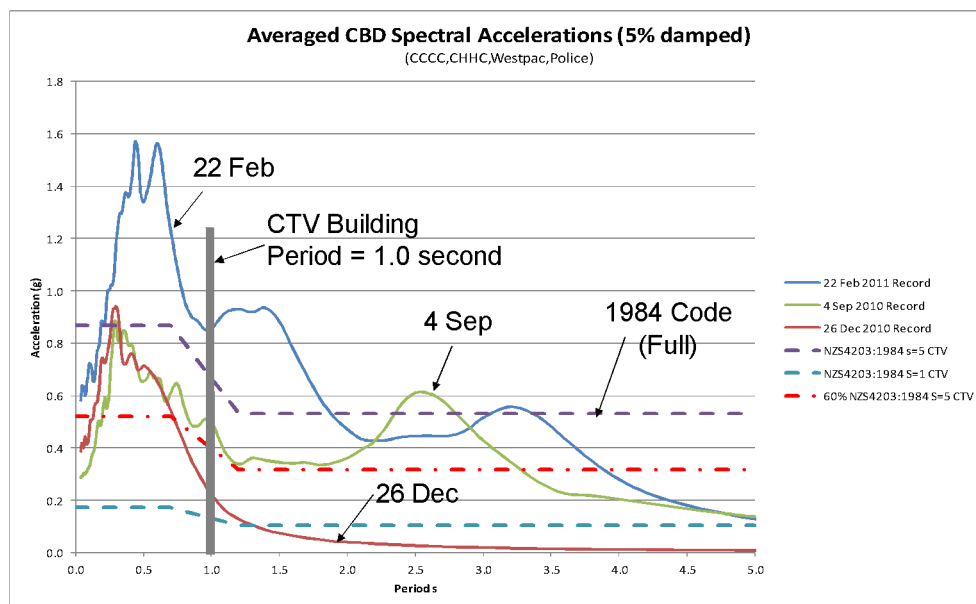
The graphs give an indication of the relative intensities of ground shaking records in the September Earthquake, December Aftershock and February Aftershock (solid lines). The response spectra used for design in 1986, when the CTV Building was designed. (dashed lines) The upper dashed line represents “full” design level expectation of the standards which represents the fully elastic response spectra loading that the structure was expected to be able to match in terms of equivalent inelastic or ultimate displacement without collapsing.

The lower dashed line represents the level that the seismic resisting North Core and South Wall were required to resist prior to developing their axial / flexural dependable strength. For design of members, strength reduction or safety factors are applied when using that level of loading.

Figure 49 – Response spectra records for the September Earthquake, December Aftershock and the February Aftershock. Also shown (dashed lines) are the design spectra for the CTV building according to NZS 4203:1984. The lower dashed line is the spectra for ductile design that the North Core and South Wall were required to have axial / flexural dependable strength in excess of. The upper most dashed line is the elastic response spectra that the structure was expected to be able to match in terms of ultimate displacement without collapsing.
