EXPERT PANEL REPORT

Structural Performance of Christchurch CBD Buildings in the 22 February 2011 Aftershock

February 2012

**Report of an Expert Panel
appointed by the New Zealand Department of Building and Housing**

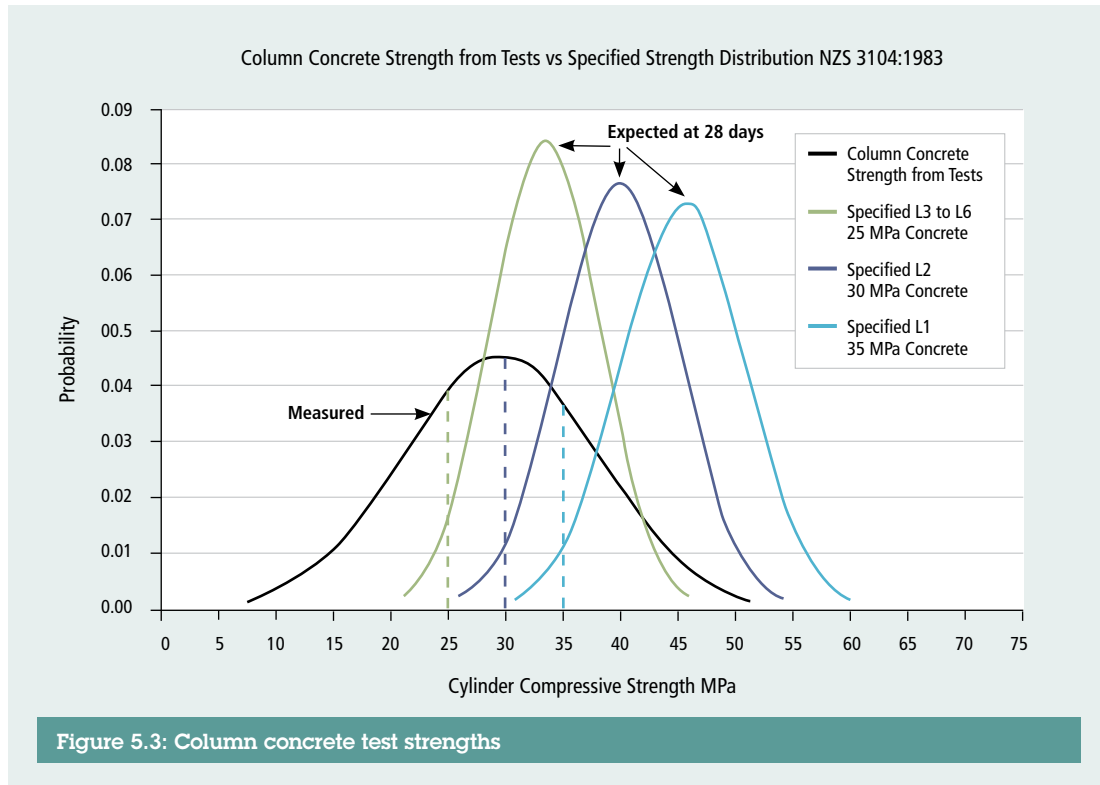
The position in relation to the column samples is summarised in Figure 5.3. The black line indicates the inferred distribution of concrete strengths from the tests. The other three distributions are the expected strength distributions at 28 days from pouring of concrete based on the specified concrete strengths (after 28 days) which were 35 MPa for Level 1 columns, 30 MPa for Level 2, and 25 MPa for Levels 3 to 6. Even though it is not known which of the measurements applies to which expected strength distribution, it can be seen that a higher than expected proportion of the results is below the specified level in all cases.

While it is recognised that the tests were conducted on members that had been involved in the collapse, the results indicate that column concrete strengths were significantly less than the expected strength considering the specified strengths, the conservative approach to achieving specified strengths, and the expected strength gain with age.

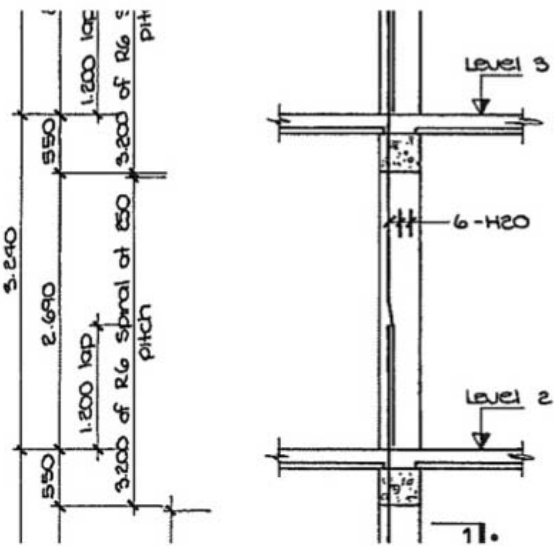
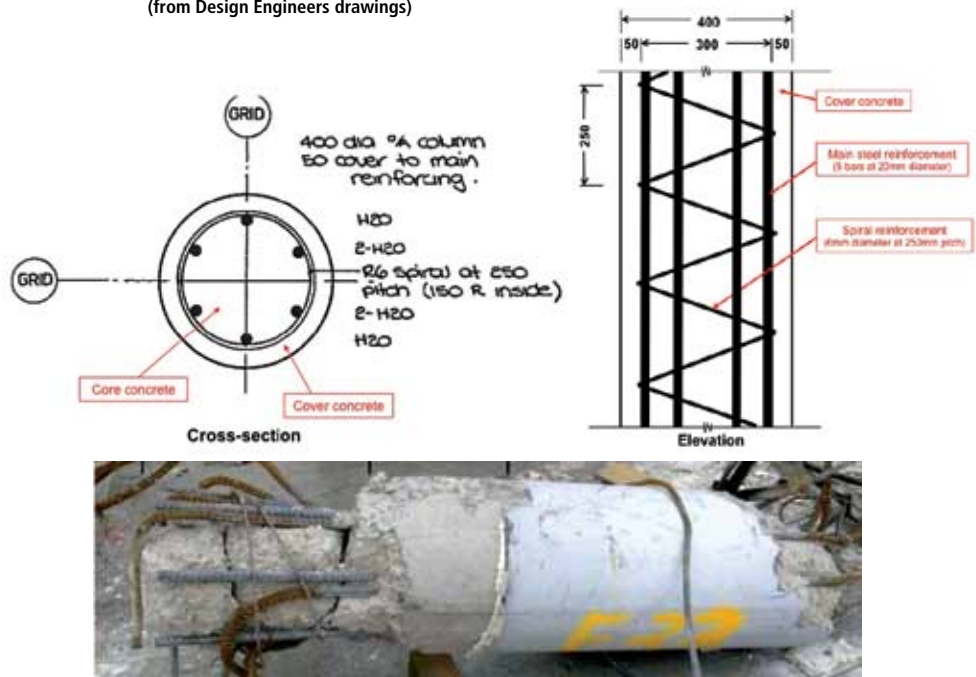
Figure 5.4: Typical 400mm diameter column

Details of a typical 400mm diameter column are shown in Figure 5.4. Vulnerabilities identified in relation to column structural performance were:

- non-ductile reinforcement details in the columns
- less than required minimum spiral reinforcing for shear strength
- relatively large proportion of cover concrete in the columns
- possibility of significantly lower than specified concrete strength in critical columns
- lack of ductile detailing in beam-column connections.

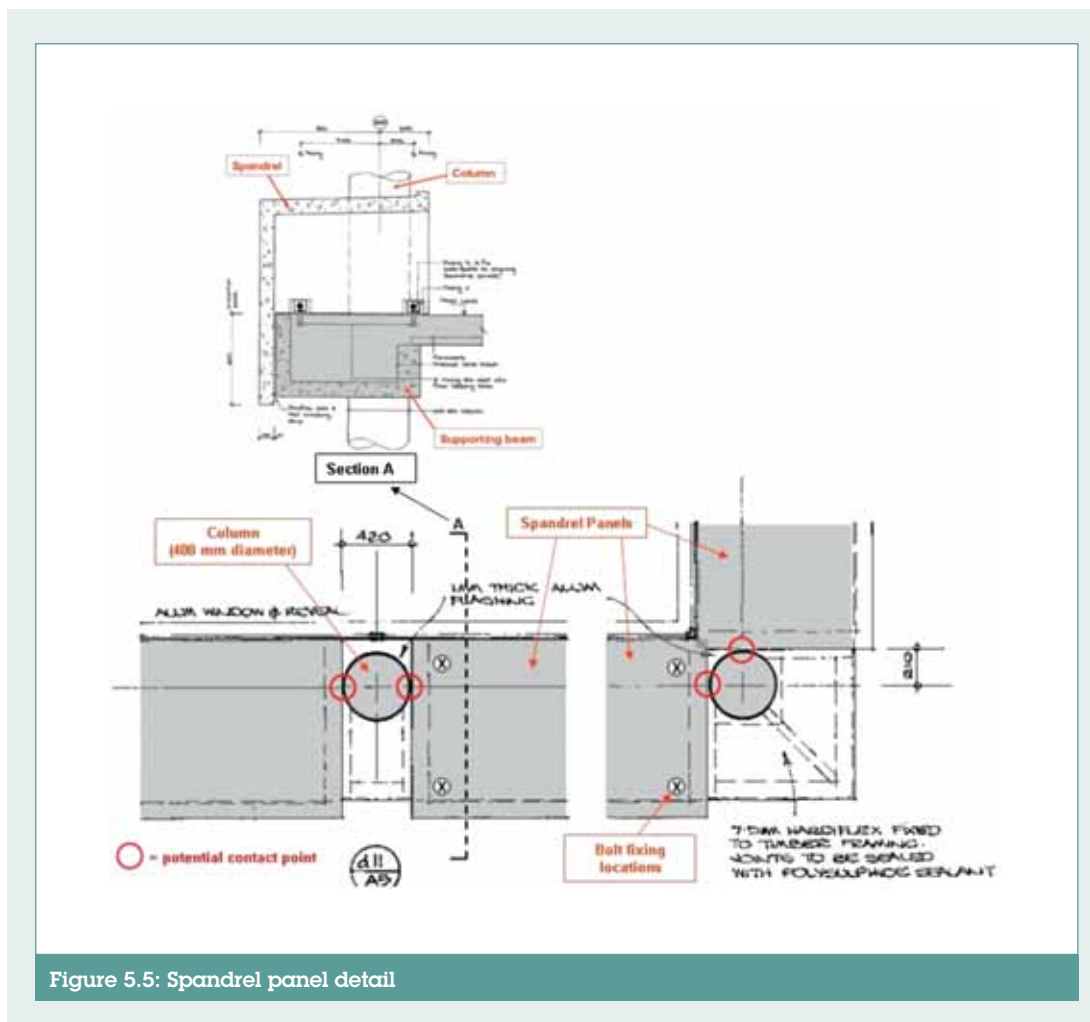
Figure 5.5: Spandrel panel detail

A plan and a cross-section of the typical column and spandrel panel arrangement are shown in Figure 5.5.

The pre-cast reinforced concrete spandrel panels were fixed to the floor slab and were placed between columns. The gap between the ends of adjacent spandrels was specified to be 420mm giving a nominal 10mm gap either side between the spandrel and the column. It is possible that these gaps varied from the nominal 10mm and it is estimated they may have ranged between 0 and 16mm. It is not known what the sizes of the gaps actually were, but analyses showed a significant reduction in column drift capacity for the case where no gap was achieved. Forensic evidence indicated that interaction may have occurred between some columns and adjacent spandrel panels in the 22 February 2011 event. There were also indications of cracking reported in some of the upper level columns after the September earthquake that may have indicated some interaction with the spandrel panels.

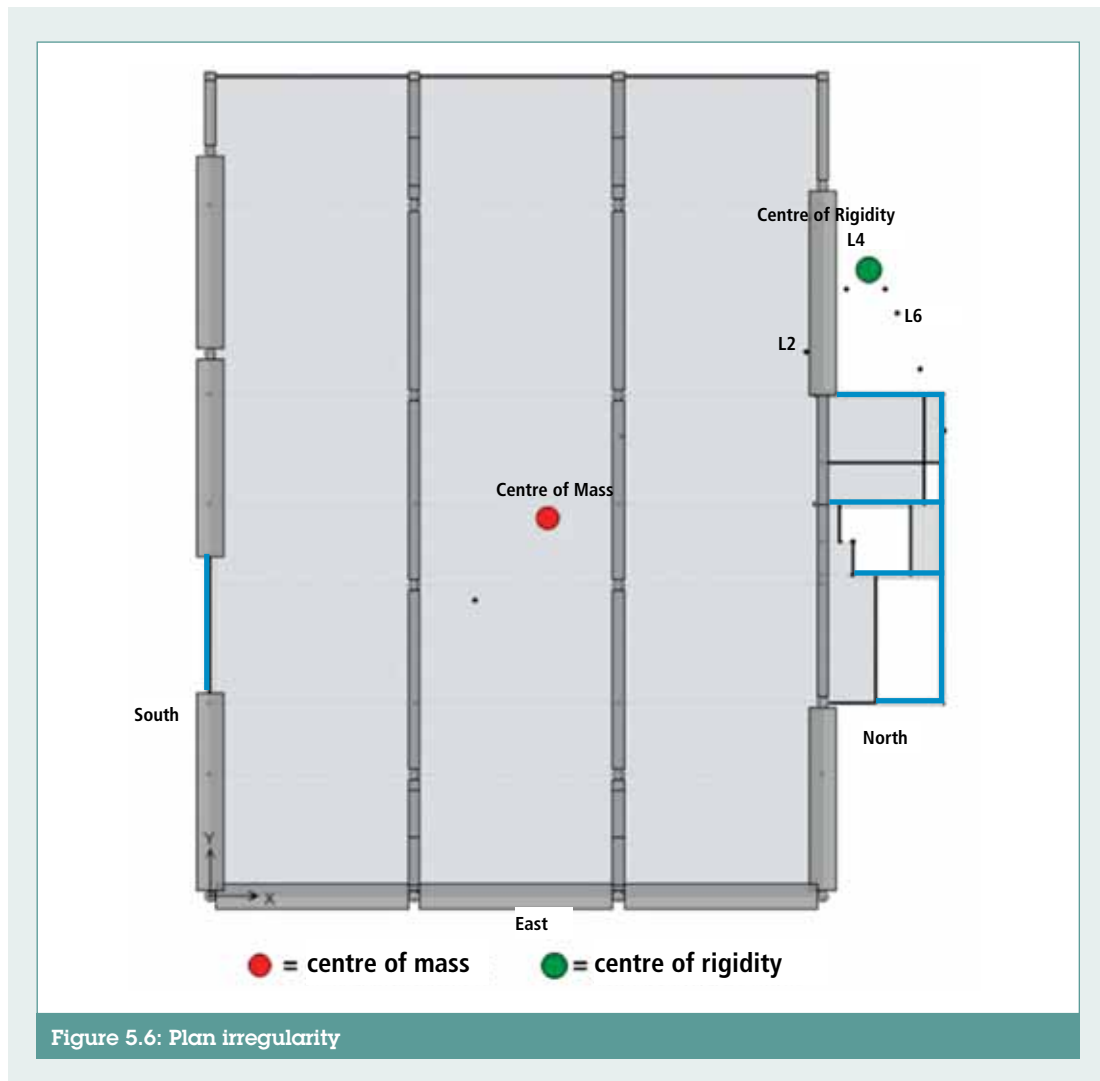
It was considered that the lack of symmetry in plan could cause displacements on the south and east faces to increase as the building rotated in plan. Figure 5.6 illustrates the results of one examination of this effect. The centre of mass indicates where the lateral forces would act. The centre of rigidity indicates where lateral forces, at Level 4, would be resisted. The horizontal distance between these points is a measure of the tendency of the building to twist when subject to horizontal ground motions.

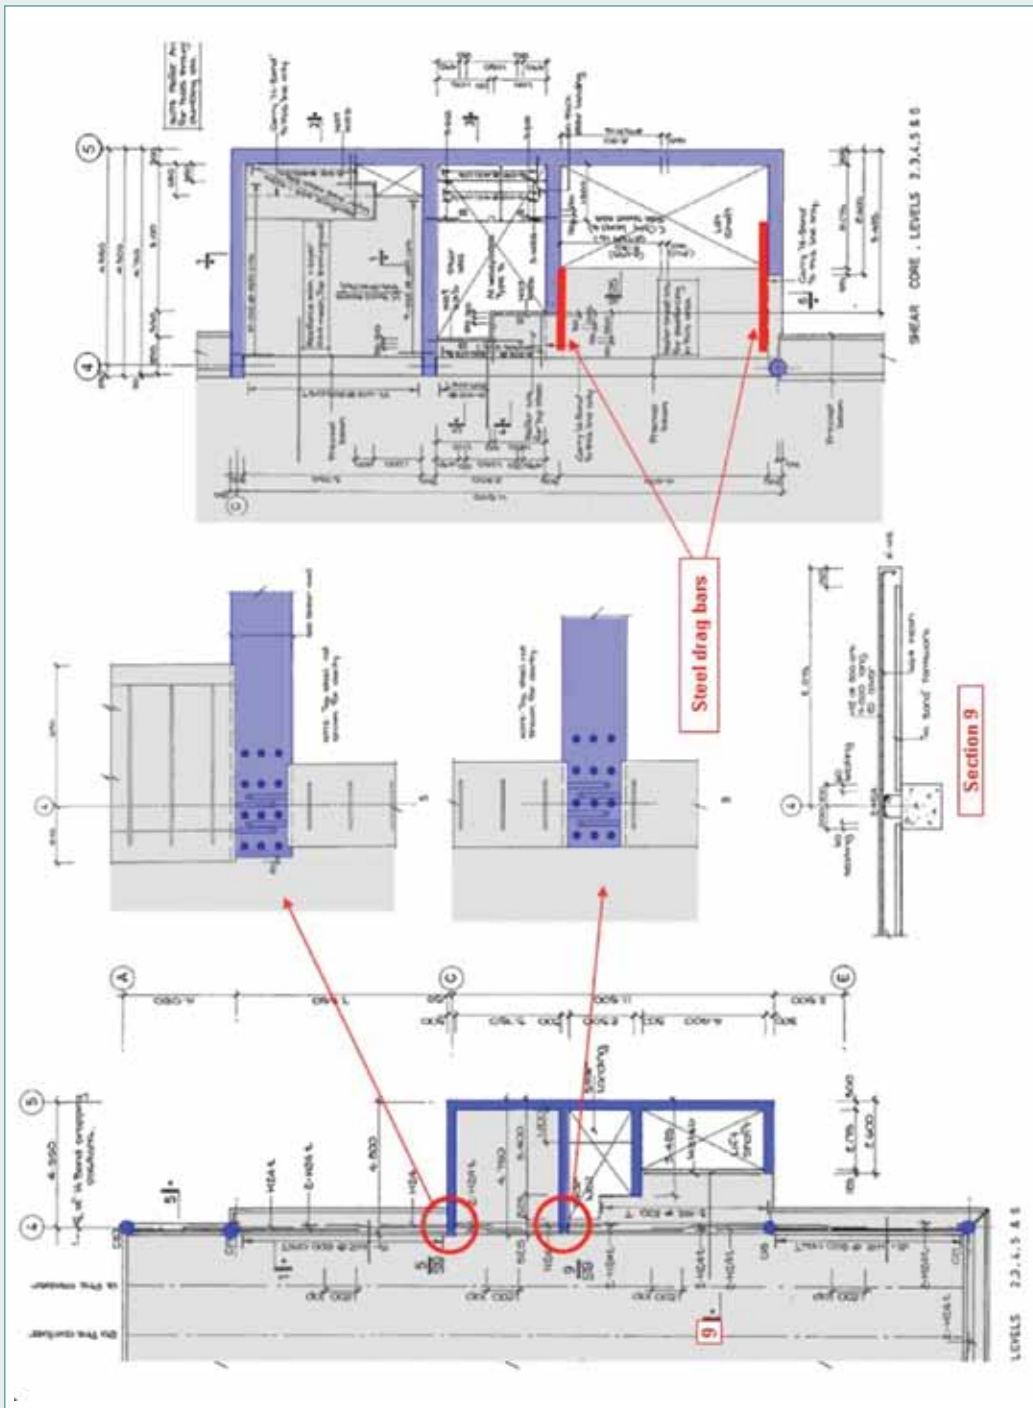
Figure 5.7: Diaphragm connections at north core

Following an independent consulting engineer's pre-purchase review in January 1990, drag bars were designed by the design engineer in October 1991 and subsequently installed at Levels 4, 5 and 6 to improve the connections between the floor slabs and the walls of the north core (refer to Figure 5.7). These connections were vital to the integrity of the building since the walls provide lateral stability and strength to the building.

Figure 5.7 shows plans of the area where a typical floor slab (shaded grey) meets the stabilising walls of the north core (shaded blue). The large lateral forces from the floor slab must be transferred to the walls at the (limited) places where slab and wall elements meet and through the drag bars (shaded red) which were added at Levels 4, 5 and 6 in October 1991. These connections were seen as vulnerable and there was a possibility that the diaphragm (slab) would separate from the walls, resulting in increased lateral displacements and higher demands on critical columns.

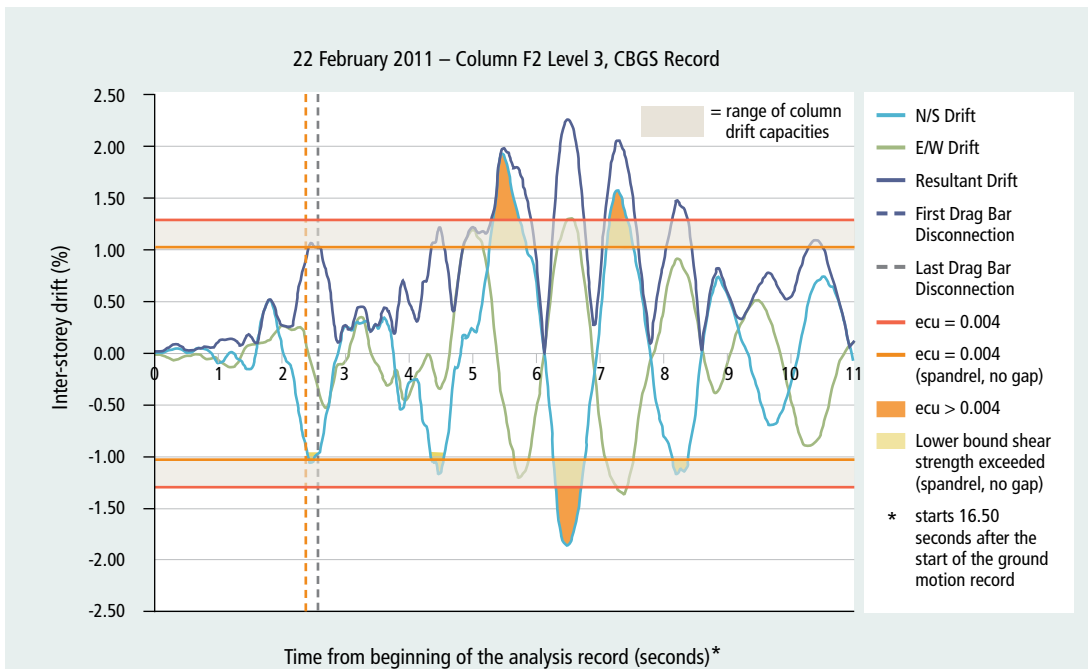
Figure 5.11: Comparison of drift demand and capacity – column F2 Level 3

Figure 5.10 and Figure 5.11 show output from the non-linear time history analyses for column F2. Figure 5.12 shows output from the analyses for column D2. The vertical axis shows the amount of inter-storey displacement (drift) at this column location. The horizontal axis is the time from start of shaking (as input into the analysis). The wavy lines plot the drift level over time and are based on application of the full ground shaking record in the analyses. This drift is a key measure of demand on the column. The light blue line shows the north-south drift which is critical for the grid F columns, taking into account the stiff façade beams and the potential interaction with spandrel panels. The dark blue line indicates the resultant drift of the north-south and east-west drifts.

The horizontal lines represent the estimated capacity of this column to sustain the drift without failing according to various criteria (assuming average concrete strength and without vertical earthquake effects). The band between the horizontal lines in Figures 5.10 and 5.11 reflects the difference between “no interaction with the spandrels” (higher value) and “full interaction with the spandrels”. The areas where the drift has exceeded the estimated capacity are shown shaded dark orange. The band showing the range of capacities would be wider if allowance was made for the effect of variable concrete strength and vertical earthquake forces in the column.

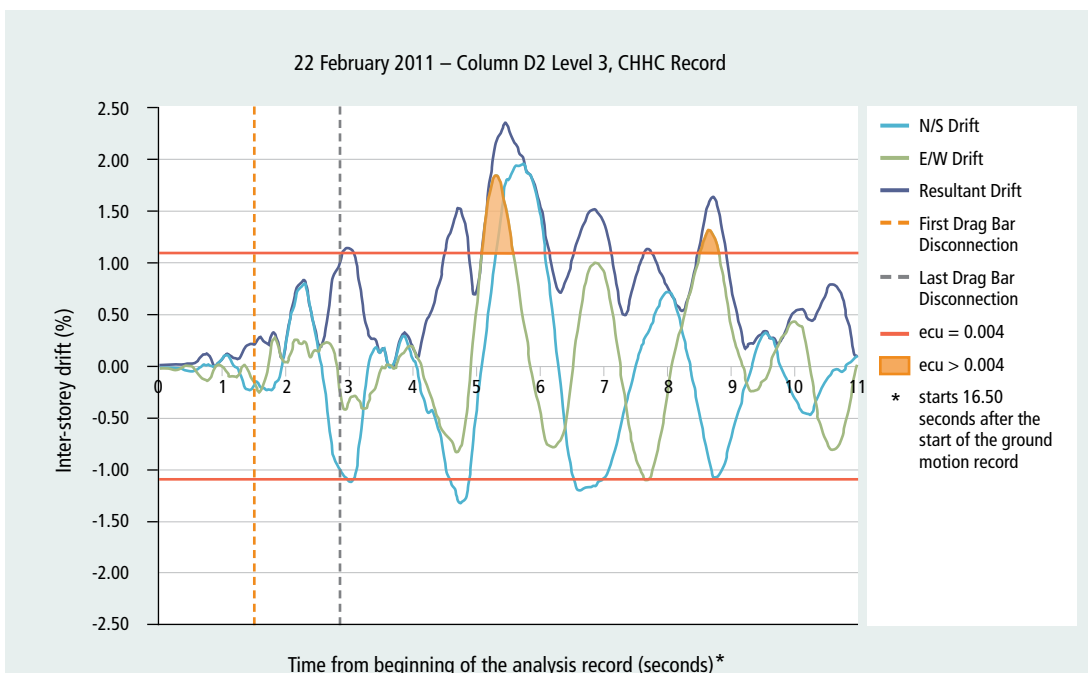
Figure 5.12: Comparison of drift demand and capacity – column D2 Level 3

Similar plots were made for column D2 at Level 3, shown in Figure 5.12, with similar conclusions being reached regarding the likely performance of this column in the 22 February 2011 event.

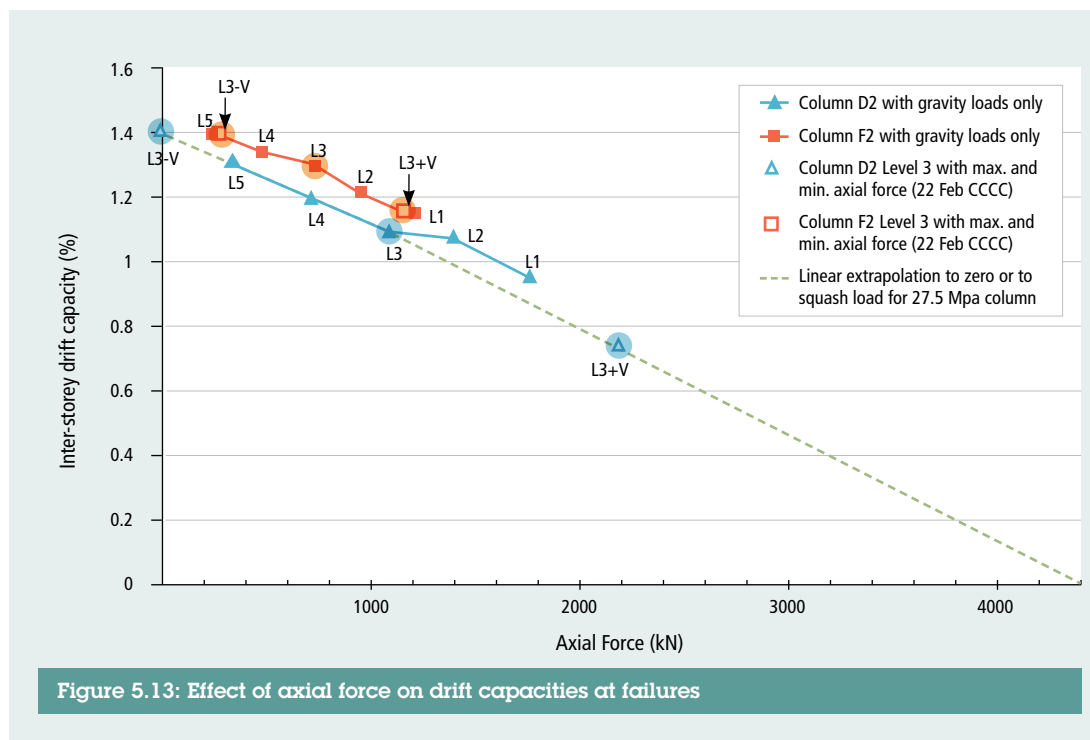
The highlighted markers on each plot in Figure 5.13 show the situation for two columns at Level 3. The middle highlighted marker shows the axial force and drift capacity without earthquake effects. The highlighted markers to the right and left show the effects of vertical earthquakes, reducing (left mark), or increasing (right mark) the column axial force (compression). It can be seen that in these examples, the effect on drift capacity is significant, ranging up to more than 30%.

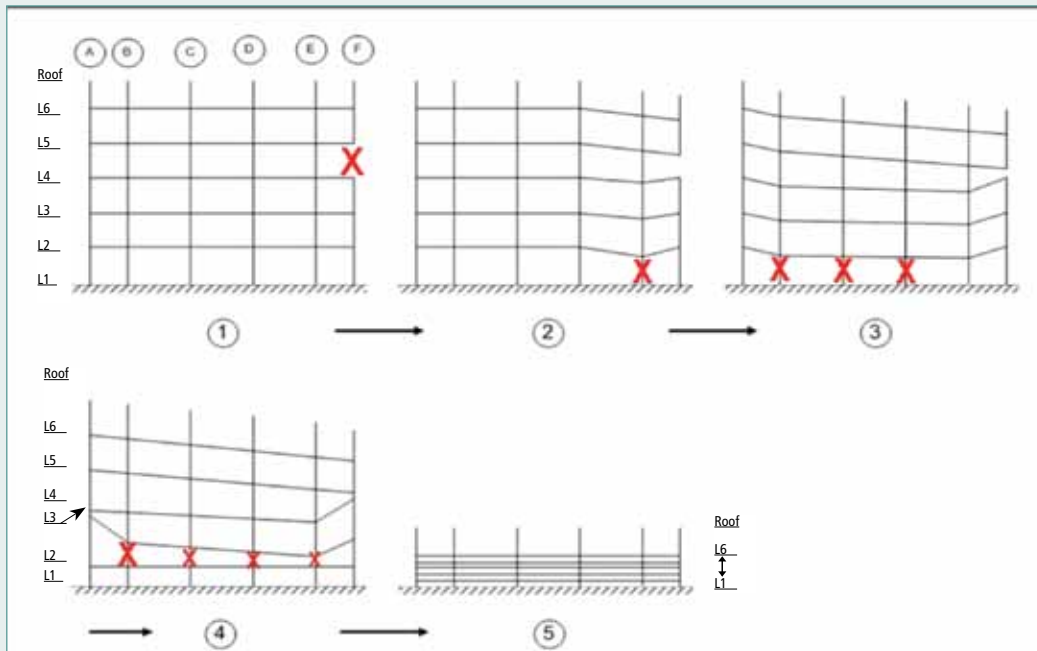
Figure 5.15: Inferred collapse sequence on Line 2

Figure 5.14 shows the situation for this scenario with no spandrel interaction (A) and with spandrel interaction (B and C). Figure 5.16 illustrates the case of failure of ground floor columns on Line D for this scenario and the subsequent collapse of the floor slabs and frames for this inferred collapse sequence. Figure 5.15 shows the case along Line 2 of the scenario involving initiation on Line F.

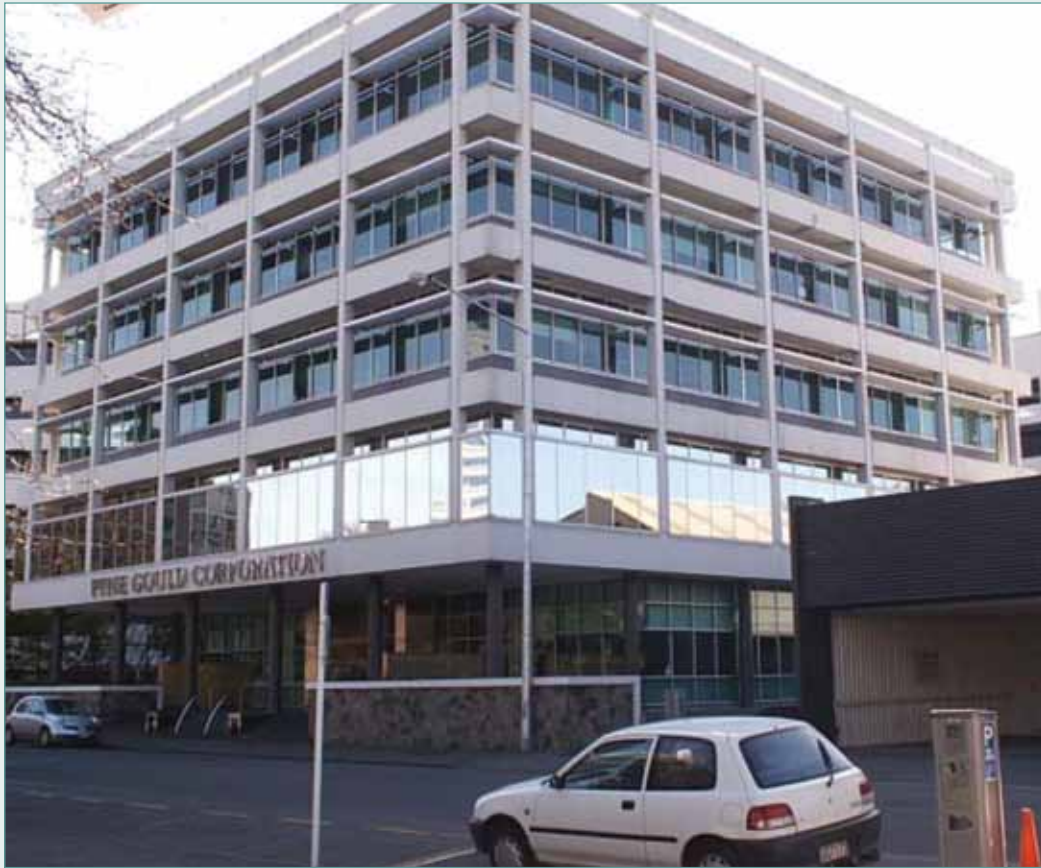
Figure 6.1: PGC Building prior to collapse (source: S. Tasligedik)

The PGC Building collapse appears to have been initiated by the failure in compression of the eastern core wall between Levels 1 and 2. Almost no structural damage was observed between Ground Level and Level 1. The core walls above Level 2 were reportedly largely undamaged. The east half of the roof detached itself from the core and slid partly off the level below on to the adjacent building.

Analyses and site observations indicate the following sequence of collapse (refer to Figure 6.5). The PGC Building collapsed when the east and west reinforced concrete walls of the core between Level 1 and Level 2 failed during the aftershock. The west wall yielded in vertical tension, and then the east wall failed catastrophically in vertical compression. The ground floor structure stayed intact, virtually undamaged as it was significantly stronger and stiffer than the structure above. Torsional response (ie twisting of the building about a vertical axis) was not a significant factor. Once the west wall had failed, the horizontal deflections to the east increased markedly. The perimeter columns and/or joints between the columns and the beams, and the connections between the floor slabs and the shear-core failed consequentially at some levels, causing the floors to collapse.

The reason the PGC Building collapsed was that the shaking experienced in the east-west direction was almost certainly several times more intense than the capacity of the structure to resist it. In addition, the connections between the floors and the shear-core, and between the perimeter beams and columns, were not designed to take the distortions associated with the core collapse. Neither foundation instability nor liquefaction was found to be a factor in the collapse.

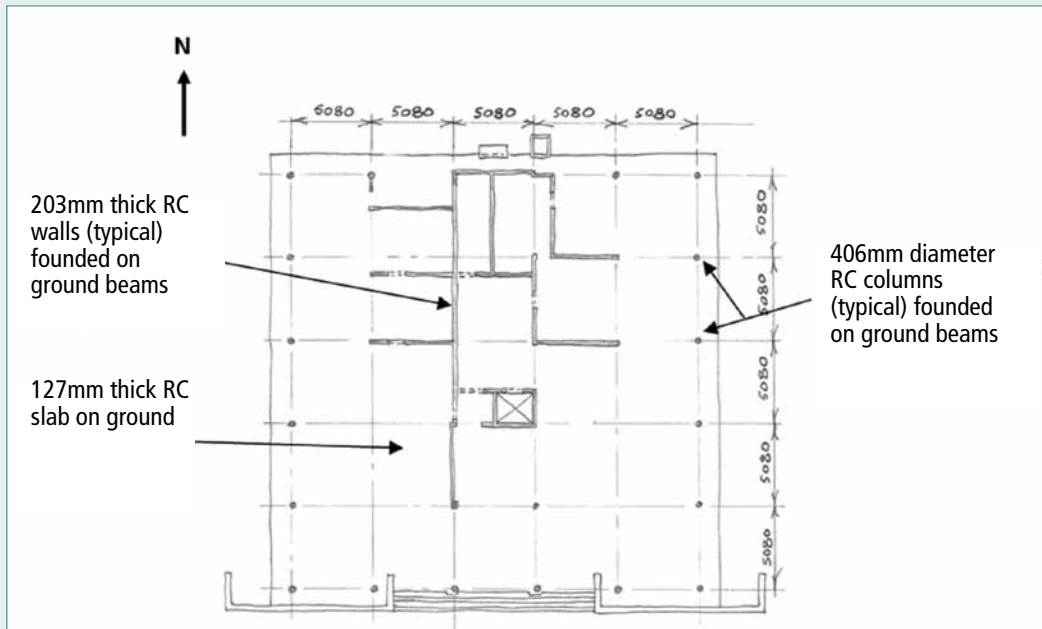
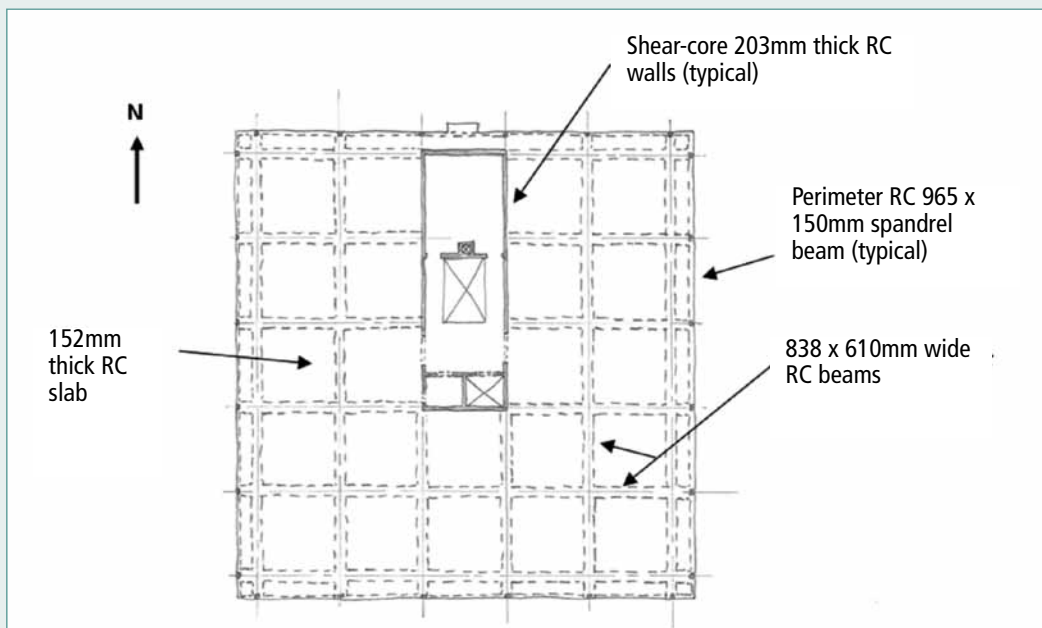
A feature of the building, that affected the way in which it responded to the 22 February 2011 aftershock, was that the structure between Ground Level and Level 1 was significantly stronger and stiffer than immediately above Level 1. Refer to Figures 6.3 and 6.4.

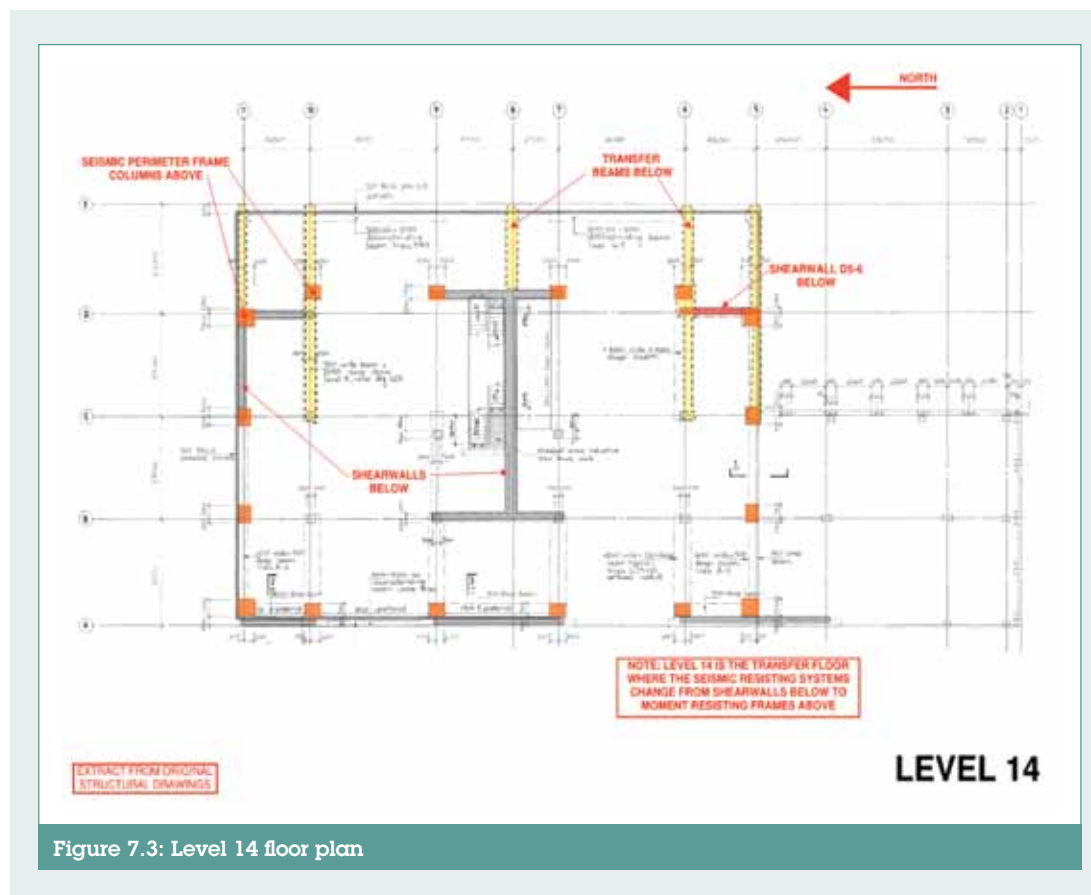
Figure 7.3: Level 14 floor plan

During the approximate 12 seconds of intense shaking that occurred in the 22 February 2011 aftershock, the Hotel Grand Chancellor Building suffered a major structural failure with the brittle rupture of a shear wall (D5-6, refer to Figure 7.3) in the south-east corner of the building. This shear wall provided vertical support for approximately one-eighth of the building's mass and was also expected to carry a portion of lateral earthquake loads. Damage to the base of the shear wall is shown in the photograph in Figure 7.4.

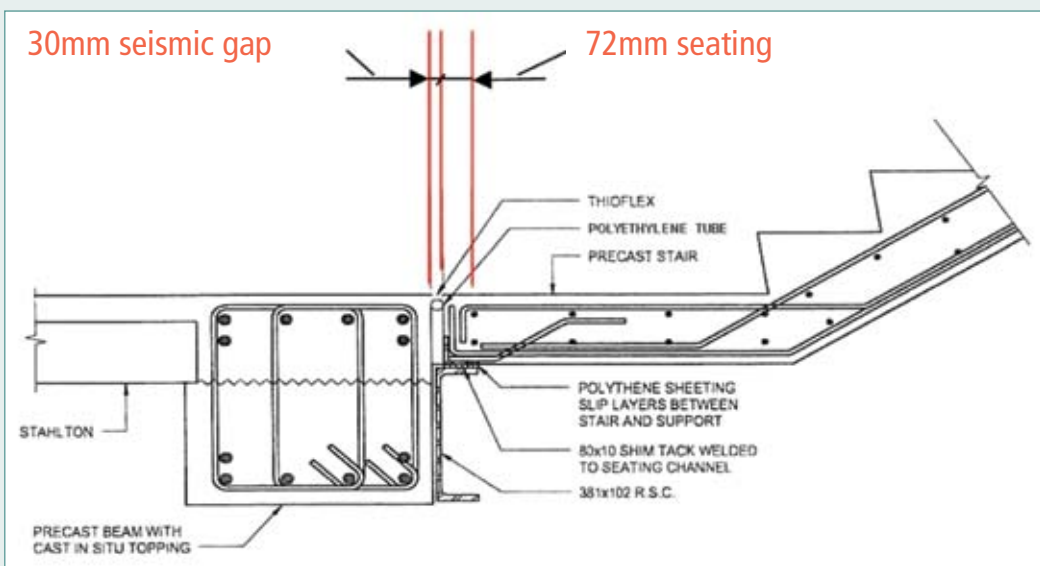
Figure 8.4: Typical stair bottom support detail

The stairs are orientated diagonally within the tower in a north-east/south-west direction. The majority of the stair flights were pre-cast units cast into the landing at their upper ends, and seated on a steel channel at their lower ends which, in an earthquake, allowed the lower end to slide within limits. This provided a horizontal gap specified at 30mm wide for the closing cycle and 72mm for opening (refer to Figure 8.4).

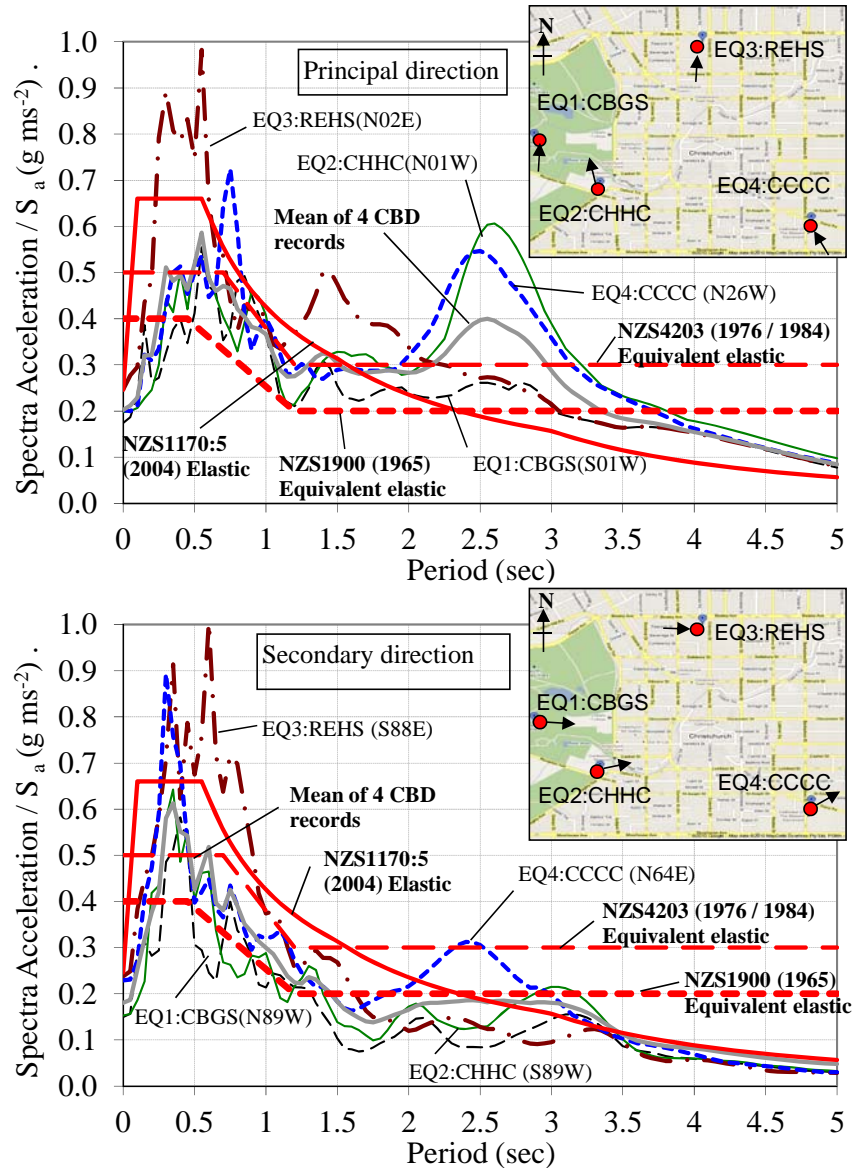
The comparison of Figure 6a and Figure 6b shows a strong polarization in the long-period excitation ($T_1 > 1.5s$) in the North-South (principal) direction, which is approximately normal to the surface trace of the Greendale Fault rupture. This could be associated with forward directivity effects of the principal horizontal motion in addition to complex interaction of the soft soil and underneath rock/gravel (basin effects) and site effects (e.g. soft soil amplification) (Berrill, 2011, Cousins and McVerry, 2010). Similarly the observed building damage also suggested that high-rise buildings (and building contents) suffered higher damage in the North-South direction.

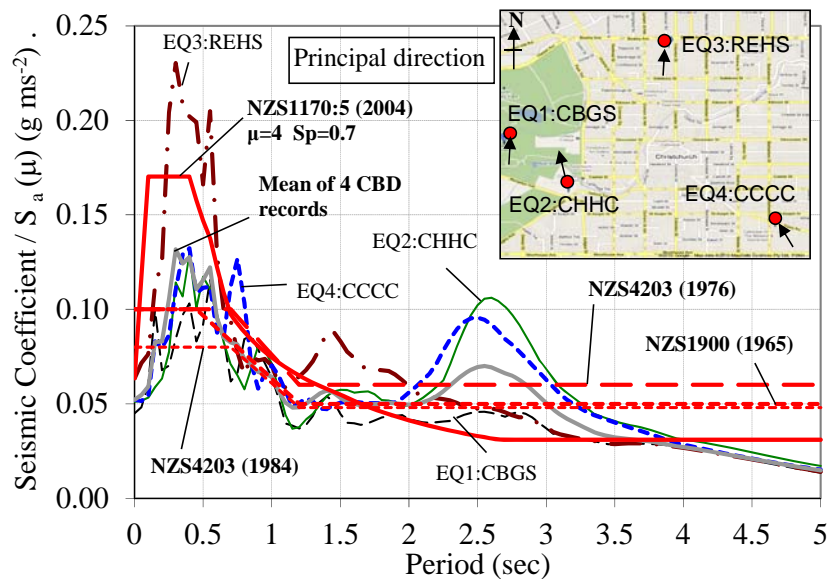
Based on Figure 7, the seismic demands (in acceleration/forces) were close to or below the NZS1170:5 (2004) design level (minimum expected capacity) for very recently designed structures with periods between 0.5s and 2.0s. At lower periods ($<0.5\text{s}$), the seismic demands (in acceleration/forces) were generally lesser than the NZS1170.5 (2004) design spectra but exceeded the older codes design spectra. In the period range ($0.6\text{s} < T_1 < 1.6\text{s}$), corresponding to the typical mid-rise RC building in the CBD, the NZS4203 (1976) and NZS1170:5 (2005) specify comparable seismic coefficients, while NZS4203 (1984) and NZS1900 (1965) requirements are approximately 33% lower. The higher spectral ordinate demands for longer periods ($T_1 > 2.0\text{s}$) suggests that high rise buildings designed to the NZS1170:5 (2004) may have sustained significant seismic demand.

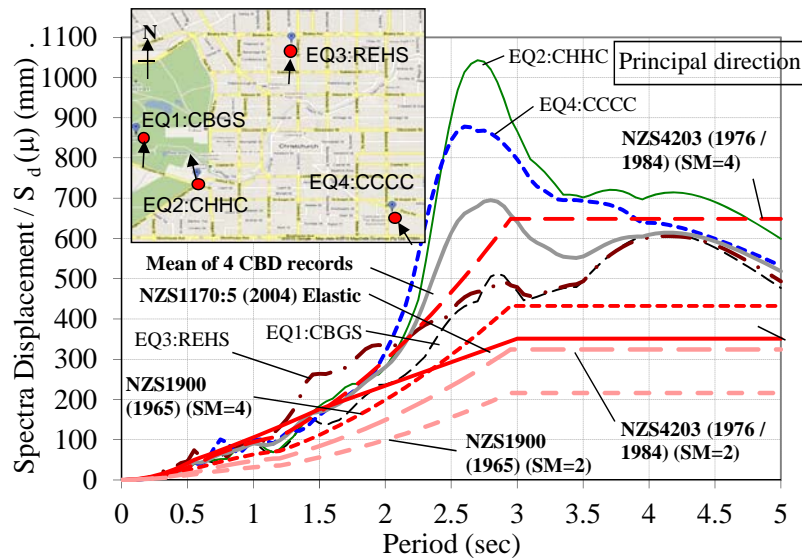
The seismic displacement demand implied by the elastic displacement spectra shown in Figure 8, also suggests that the deformation demands at lower building periods ($T_1 < 1.5s-2.0s$) were generally low. For instance, the displacement demand, S_d of 90mm at effective/elastic period of 1.0s, suggests an inter-storey drift (relative displacement between two consecutive storeys divided by the height of the storey

Significant displacement demand can be observed at the long period range ($T_1 > 2.5s$), suggesting some higher level of deformation demands for high-rise buildings with relatively flexible system (e.g. moment-resisting frames). Incidentally, from a displacement-based design and assessment point of view, it seems that the NZS1170:5 (2004) design spectra, being derived as a pseudo-displacement spectra generated by the acceleration spectra, do not adequately capture the long period demand.

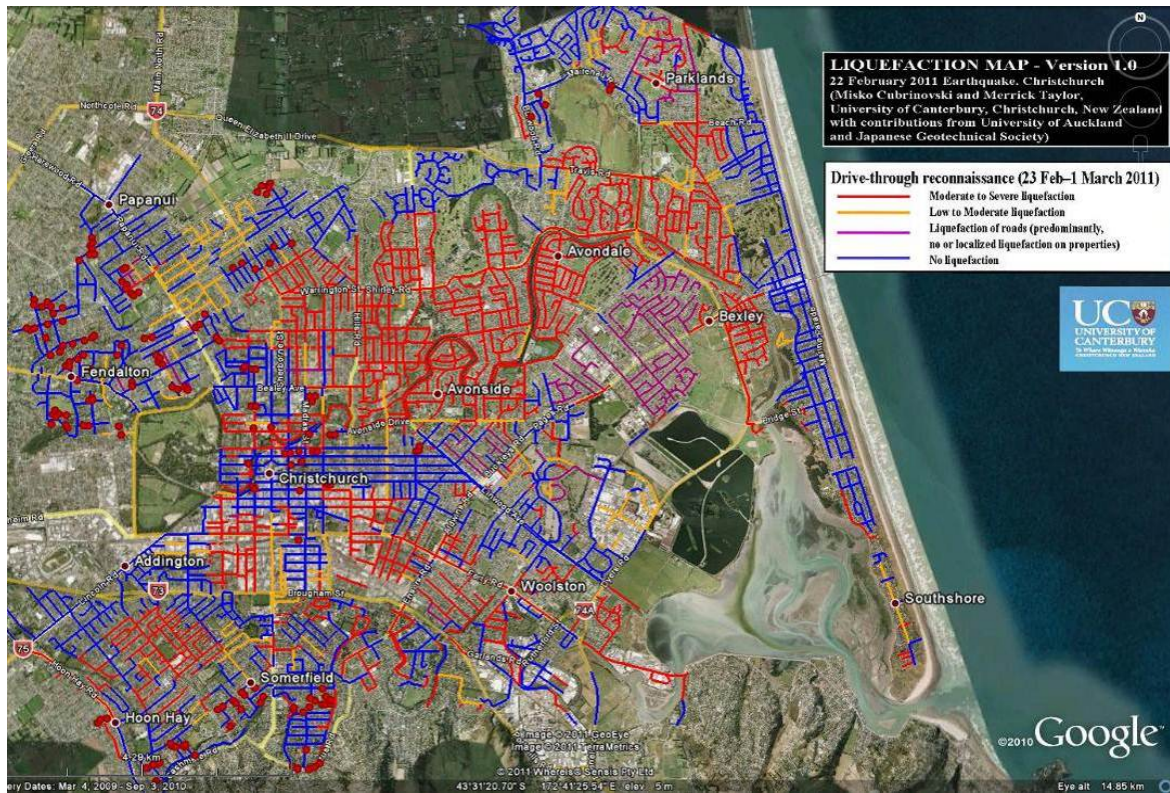
In the 22nd Feb 2011 6.2M_w Christchurch earthquake, many of the eastern Christchurch suburbs again had severe liquefaction and lateral spreading land damage. Figure 16 shows a preliminary liquefaction-damage map from the 22nd February 2011 earthquake. In comparison to the September earthquake, Christchurch City Council has removed 322000 tonnes of silt (as of 10 March 2011). Within the Christchurch CBD, severe liquefaction and moderate lateral spreading was observed in several concentrated zones: a) areas along the Avon riverbanks e.g. Oxford and Cambridge Terraces; b) segments of Kilmore Street; c) segments of Armagh Street; d) segments of the North-East of Madras, Manchester and Salisbury Streets and e) segments of Fitzgerald and Moorhouse Avenues. Interestingly, many of the liquefaction-affected zones were former Avon River tributaries, as suggested by the 1850s Christchurch Map (Figure 17). Figure 18 and Figure 19 show severe liquefaction damage in the eastern suburbs and in the CBD area, respectively.

Figure 16: Liquefaction damage map around Christchurch city (courtesy of M. Cubrinovski and M. Taylor, source NZSEE Clearinghouse).

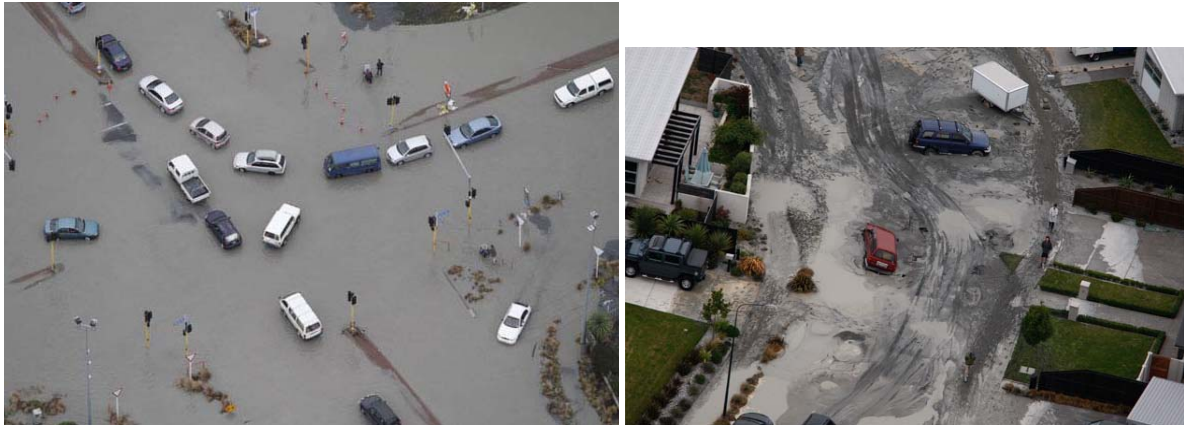
Figure 18: Widespread and severe liquefaction and temporary flooding in the eastern Christchurch suburbs

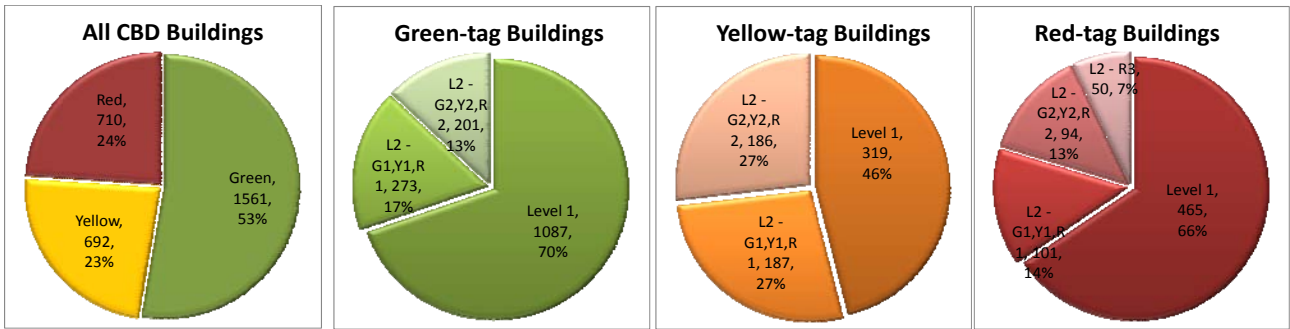
Slightly over half the buildings inspected within the Christchurch CBD were given the “Green – Safe for Occupation” placard, with about 70% was only assessed with Level 1 rapid assessment. As there is no current legislative requirement for Level 2 assessments or detailed post-earthquake seismic assessment for all the building stock (especially for green-tagged buildings), it is hard to ascertain whether the damage statistic is completely accurate. Canterbury Earthquake Recovery Authority (CERA) and CCC are currently developing requirements for detailed post-earthquake seismic assessment ((EAG), 2011).

Figure 27: Distribution of buildings tagging statistics in Christchurch CBD. Building tagging is based on the CCC/Civil Defence Building Safety Evaluation procedure. (Statistics data is updated to 12 June 2011)

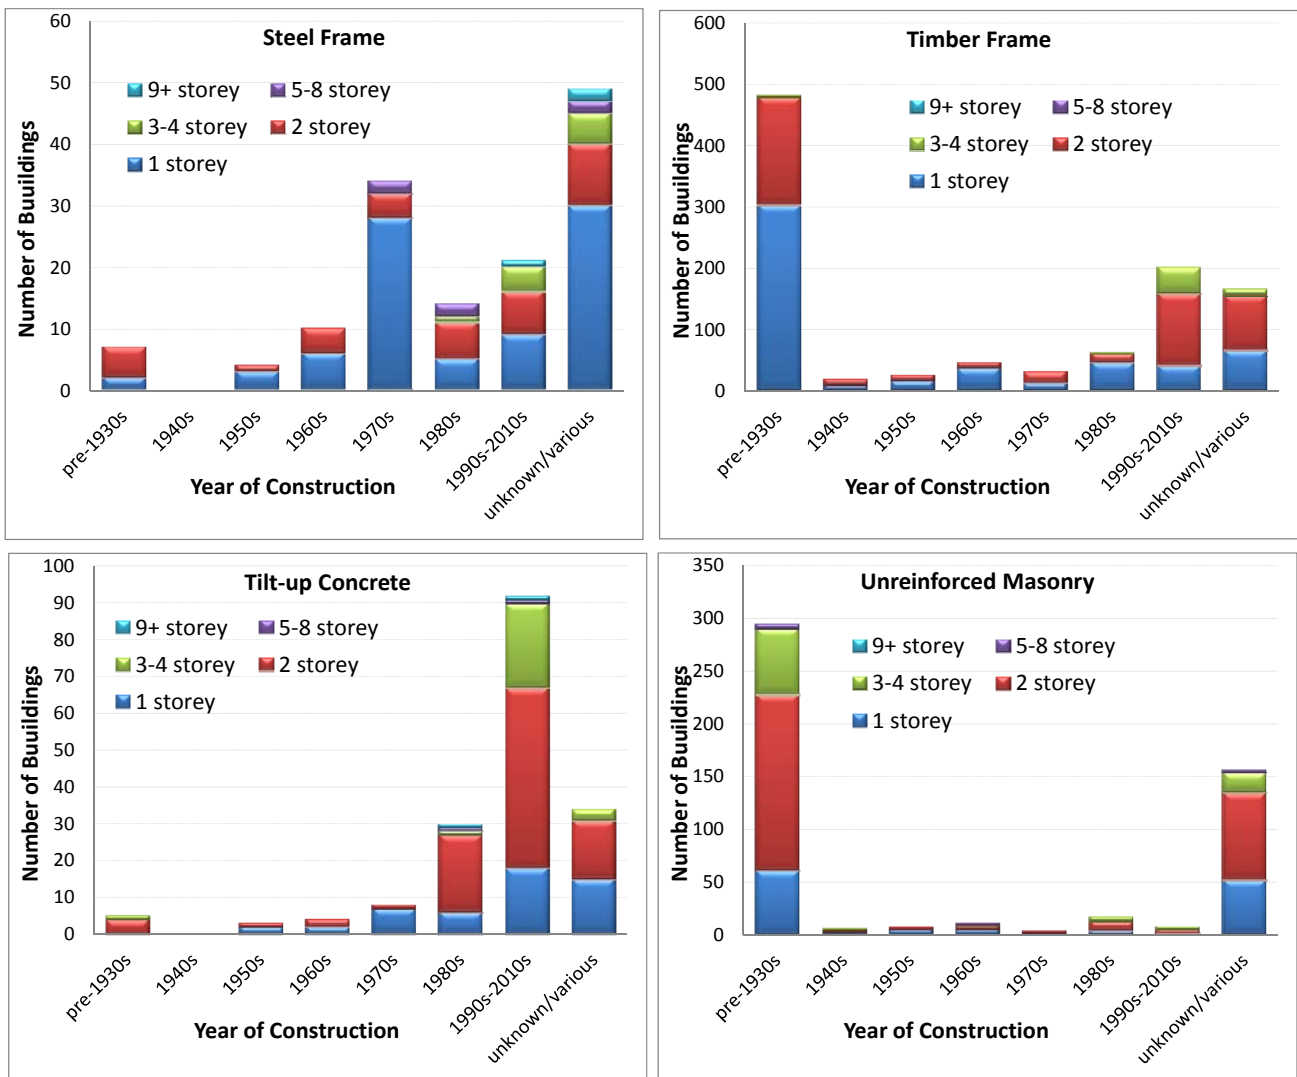
Figure 28: Building stock distribution in terms of construction year and number of storey in Christchurch CBD

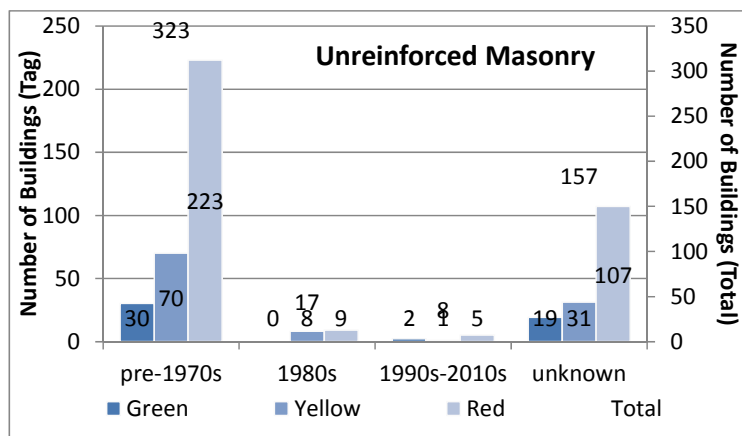
Figure 32: Damage statistics of unreinforced masonry buildings

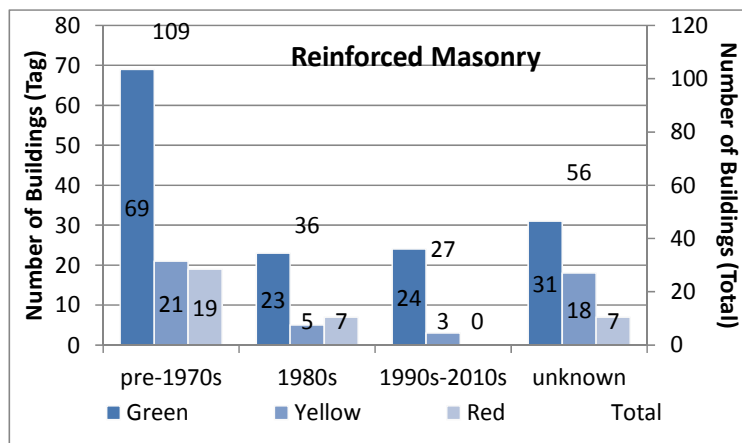
Figure 34: Damage statistics of reinforced concrete masonry buildings

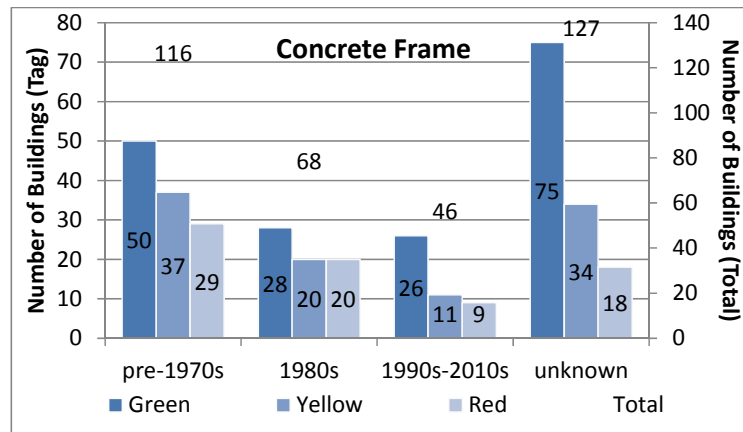
Figure 37: Damage statistics of reinforced concrete moment-resisting frame buildings
