EXPERT PANEL REPORT

Structural Performance of Christchurch CBD Buildings in the 22 February 2011 Aftershock

February 2012

**Report of an Expert Panel
appointed by the New Zealand Department of Building and Housing**

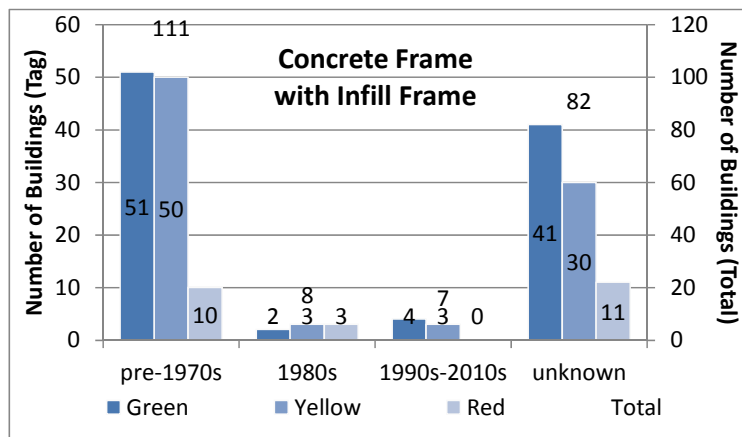
Figure 39: Damage statistics of reinforced concrete frame with infill buildings

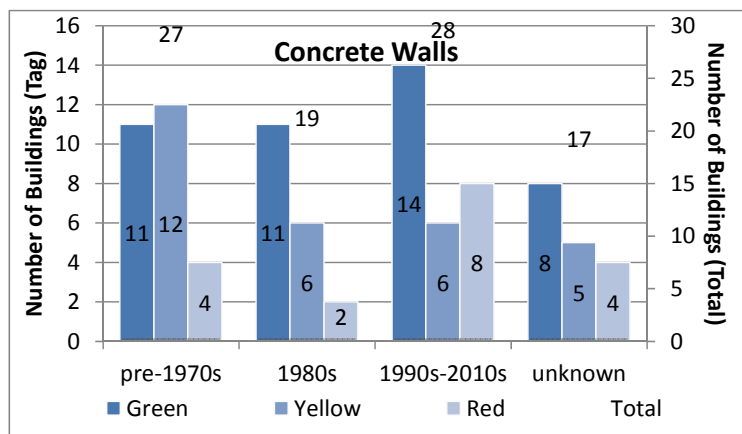
The high number of severely damaged reasonably new reinforced concrete wall buildings (see Figure 42) has indicated that the current design for slender reinforced concrete walls with inadequate confinement steel outside the boundary zone and with inter-panel grouted lap-splice (often poorly confined) is inadequate. In addition, many reinforced concrete walls suffered premature compression failure (e.g. Figure 41), particularly for L-, T- and V- shaped walls, in some cases likely to be exacerbated by the high level of vertical acceleration. The lack of a well distributed cracking pattern in the plastic hinge zone of the reinforced concrete walls was also an unexpected observation that requires further research and investigation.

Figure 42: Damage statistics of reinforced concrete structural wall buildings (as per 12 June 2011)

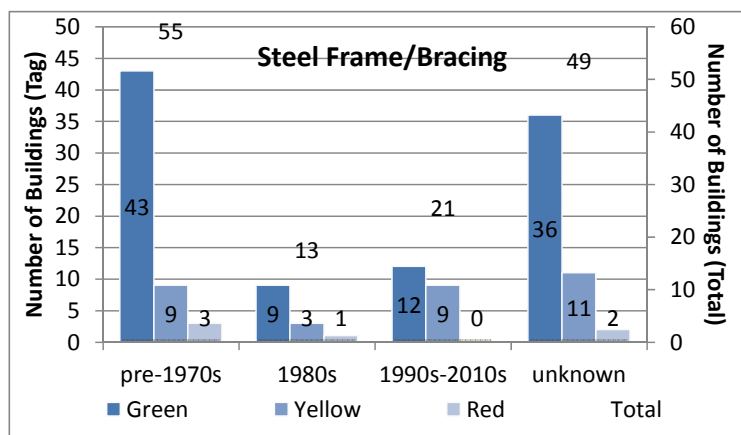
Figure 46: Damage statistics of steel frame and steel-braced buildings (as per 12 June 2011)

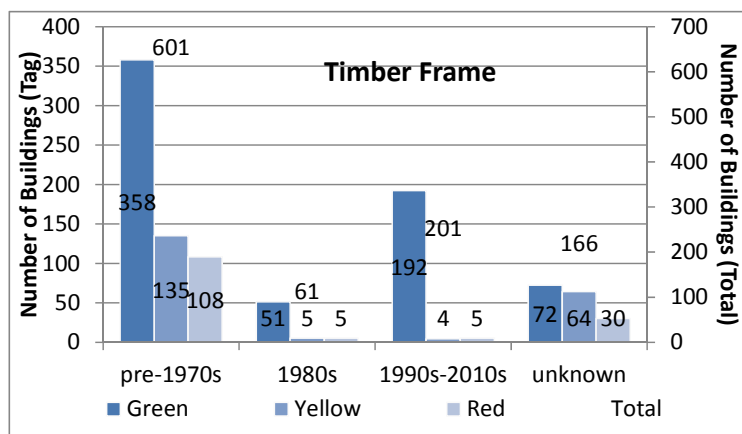
Figure 48: Damage statistics of timber frame buildings (as per 12 June 2011).

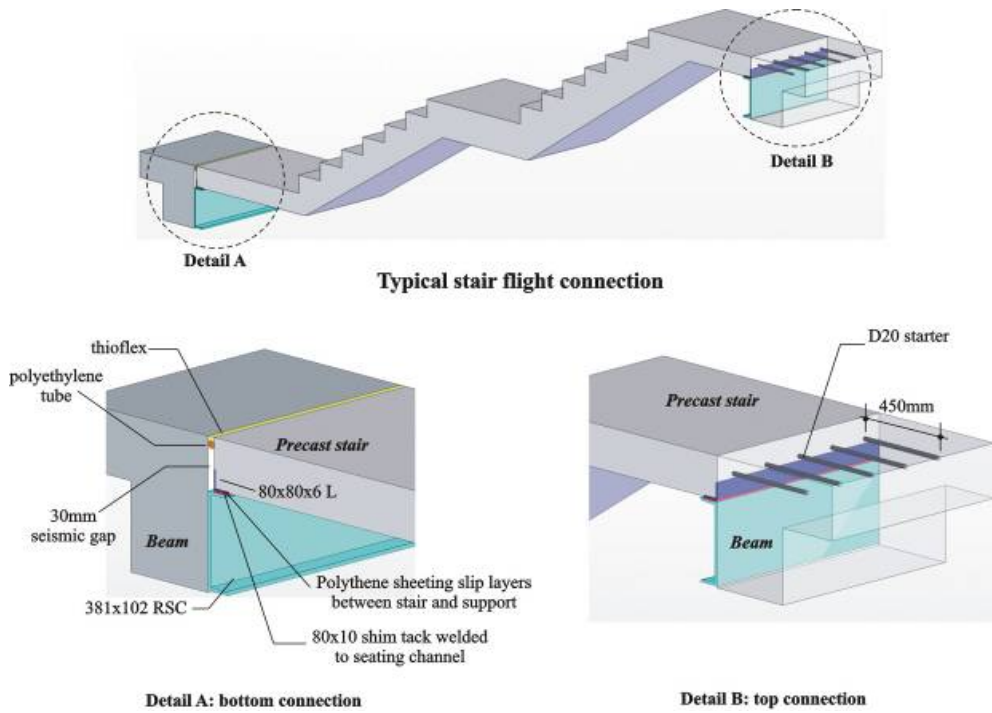
Type A aims to isolate the staircases from the lateral system, thus preventing or minimizing interaction between stairwell system and the surrounding structure. The Type A details require sufficient sliding gap at the free landing in order to allow for the displacement demand imposed by the earthquake. If this gap is insufficient or accidentally or erroneously grouted, the staircases are subjected to unexpected compression forces (that it is likely not designed for) or the staircase might be completely unseated (pulled away from the support). The damage observed in the earthquake indicates that the design displacement limits for the staircases were generally inadequate, when compared to the seismic demand of the 22 Feb earthquake, to prevent such compression to occur.

Figure 51: Typical detailing of staircase- Type A - Partially pinned-slide bottom connection; cast-in-situ connection at top with longitudinal starter bars lapped at landing. (Photo is courtesy of Umut Akguzel).
