### Update on the review of ventilation systems at Managed Isolation and Quarantine facilities

<b>Date:</b>	8 June 2021	<b>Priority:</b>	Medium
<b>Security classification:</b>		<b>Tracking number:</b>	2021-4016

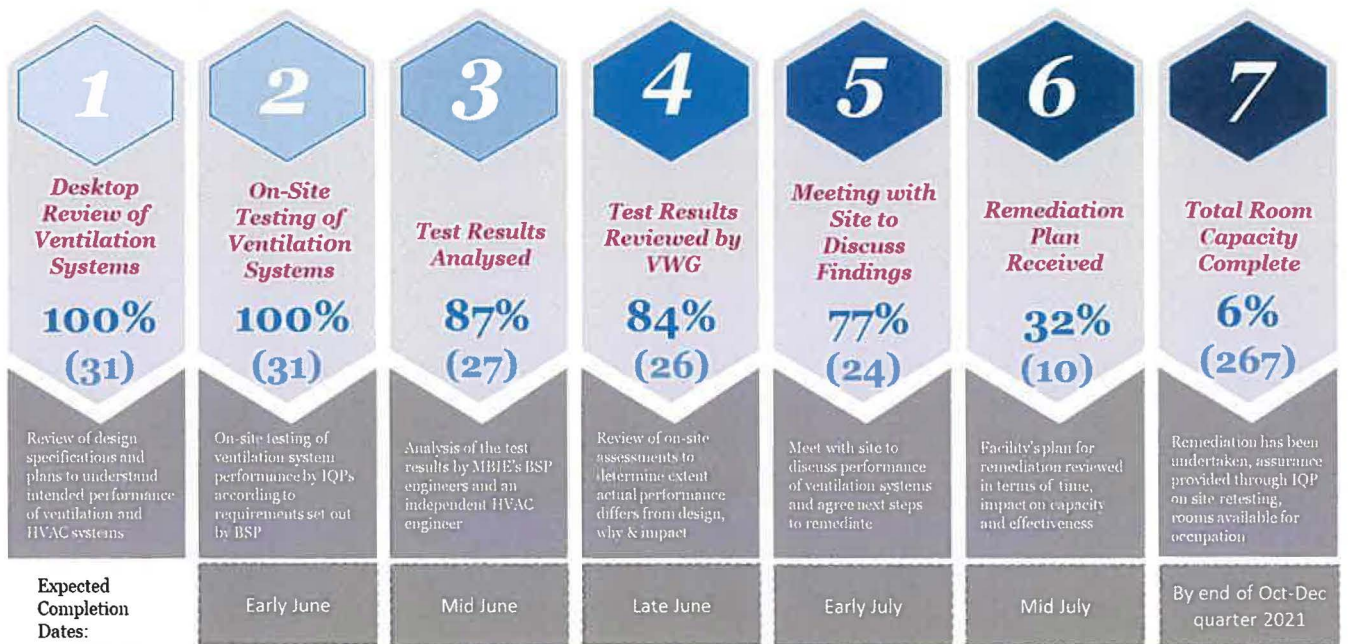
11. Overall the MIQ Ventilation Review Programme is progressing well.
12. **Diagram 1** summarises the progress of the individual stages of the Review, showing the percentage complete and the number of individual facilities that have been through each step. For the final step showing total room capacity, the figures show percentage of total MIQ capacity and number of actual rooms within remediated facilities. Annex One shows the progress of each of the individual MIQ facilities.

1 Independent Qualified Person, 2 Building Systems and Performance Group, MBIE, 3 Ventilation Working Group  
 Note: 'Percentage Complete' calculations are based on a total number of MIFs of 31
